## VOLKSWAGEN DEALERSHIP COMMUNICATION

Subject: August 2010 Customer Notification - Voluntary Emissions Service Action 28F3 -Ignition Coils

**Subject: 2001-2007 Volkswagen Gasoline Engine Vehicles  
Inspect, and If Necessary, Replace Ignition Coils**

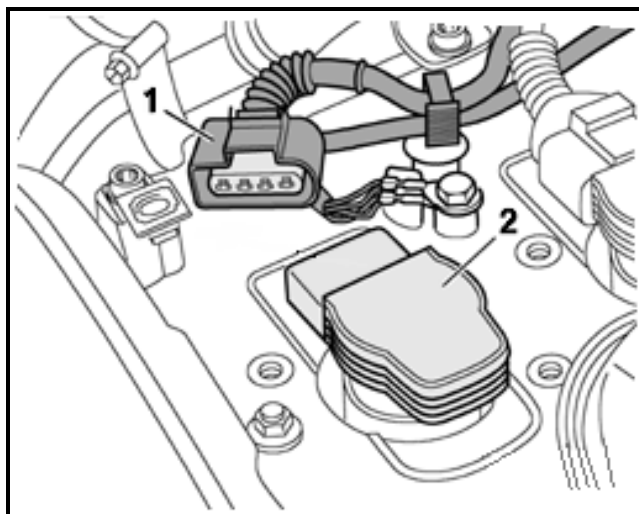
⇐ Disconnect connectors -1- from all ignition coils -2- (illustration)

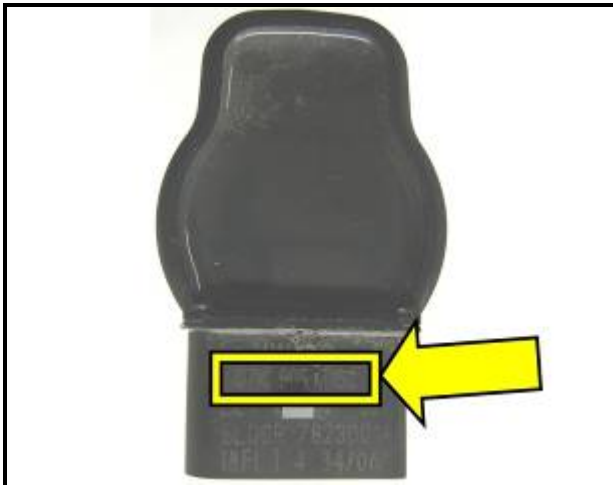
⇐ Inspect all ignition coils for part number(s)

• All coils with any of these part numbers do not need to be replaced:

• Coil(s) with any other part number, proceed to Section B – Replace Ignition Coils

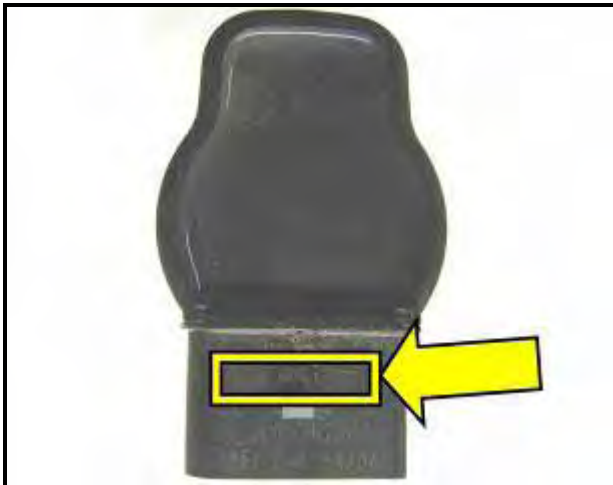
⇐ Inspect all ignition coils for part number(s)

• All coils with any of these part numbers do not need to be replaced:

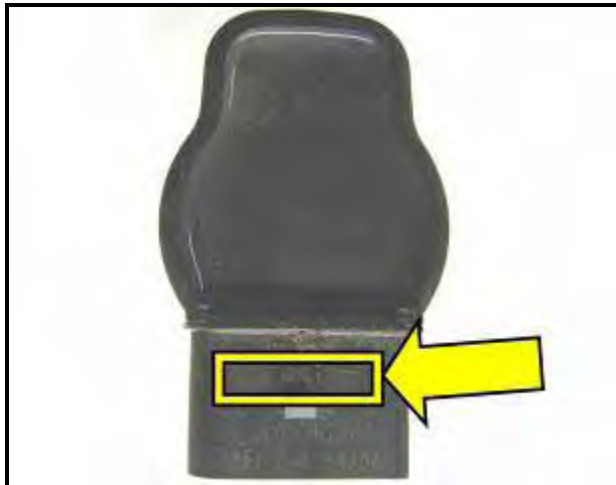
Tip: Picture is for part number placement only. Actual part number(s) not pictured

- ⇐ Inspect all ignition coils for part number(s)
- All coils with any of these part numbers do not need to be replaced:
  - 06A 905 115D
  - 06B 905 115R
  - 06C 905 115L
  - 06C 905 115M
- Coil(s) with any other part number, proceed to Section B – Replace Ignition Coils
- ⇐ If all coils have one of the above part numbers, continue to next step

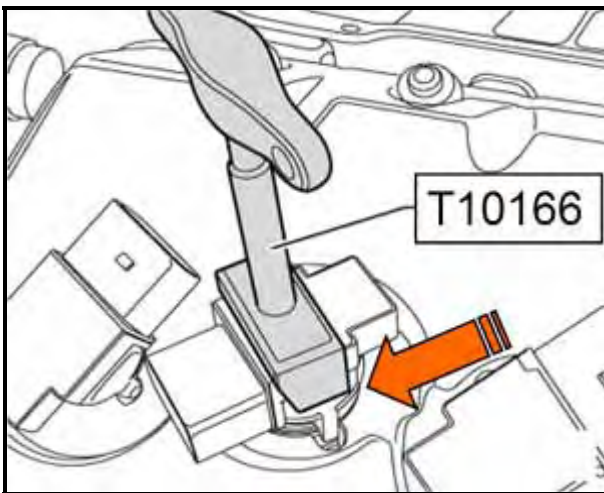
- Pull connectors off ignition coils 1 through 8 using Assembly Tool –T10118 or equivalent
- ⇐ Slide Ignition Coil Puller –T10166 onto ignition coil in -direction of arrow-, and pull out ignition coil with power output stage
- Check part number of each ignition coil
- ⇐ Any coil with one of these part numbers does not need to be replaced:
  - 07C 905 115 J
  - 07C 905 715 A
- ⇐ If coil(s) are not listed above, proceed to next step
- ⇐ Reinstall or replace ignition coil(s) with part number 07C 905 715A by inserting ignition coil into the spark plug shaft so that the electrical connectors do not touch the cylinder head cover
- Push the ignition coil(s) 1 through 8 onto the spark plug by hand

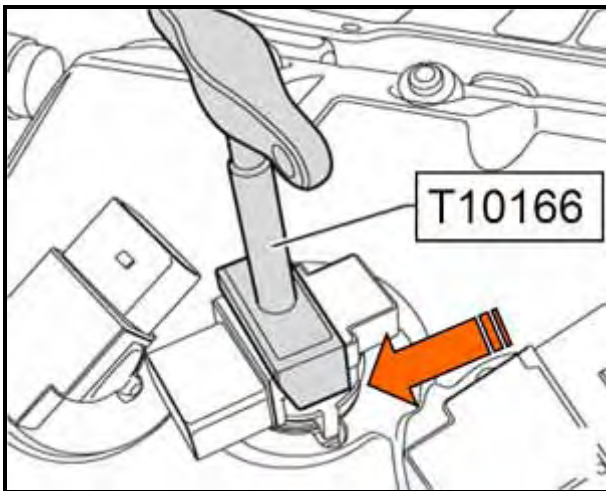
- Pull connectors off ignition coils 1 through 12 using Assembly Tool T10118 or equivalent
- ⇐ Slide Ignition Coil Puller T10166 onto ignition coil in -direction of arrow-, and pull out ignition coil with power output stage
- Check part number of each ignition coil
- Any coil with one of these part numbers does not need to be replaced:
  - 07C 905 115 J
  - 07C 905 715 A
- If coil(s) are not listed above, proceed to next step
- Reinstall or replace ignition coil(s) with part number 07C 905 715 A by inserting ignition coil into the spark plug shaft so that the electrical connectors do not touch the cylinder head cover
- Push the ignition coil(s) 1 through 12 onto the spark plug by hand

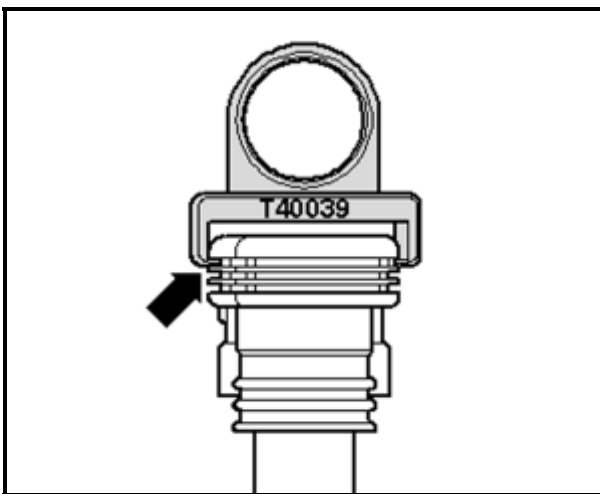
**WARNING!**

To remove ignition coils, place tool T40039 on the top-most thick rib -arrow- of the ignition coil with power output stage

Lower ribs may be damaged if they are used

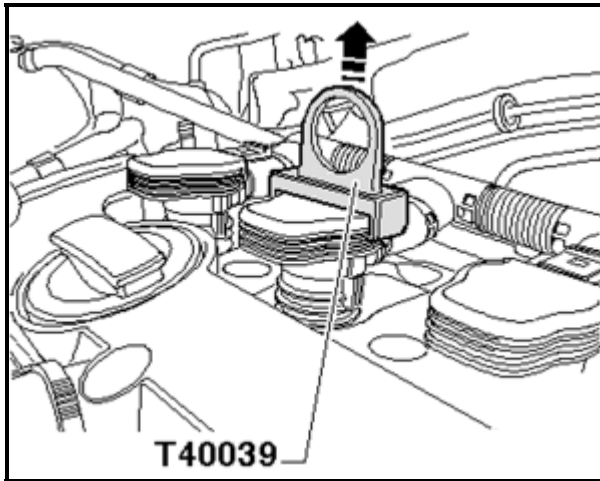
- ⇐ Remove all ignition coils from spark plug ports using tool T40039
- Check each ignition coil part number
- Any coil with one of these part numbers does not need to be replaced:
  - 07K 905 715D (black)
  - 07K 905 715E (black)
  - 07K 905 715F (black)
  - 06F 905 115F (black)
  - 06H 905 115 (black)
  - 06D 905 115K (red)
  - 06E 905 115D (red)
  - 06E 905 115E (red)
- If coil(s) are not as listed above, proceed to next step
- Reinstall or replace ignition coil(s) with the following:
  - 06H 905 115 (black)
  - 06E 905 115E (red)

**!** Note: Mixing of valid part numbers is permitted, with the exception of part number 07K 905 715E

Damage may occur to engine if part number 07K 905 715E is mixed with other coils

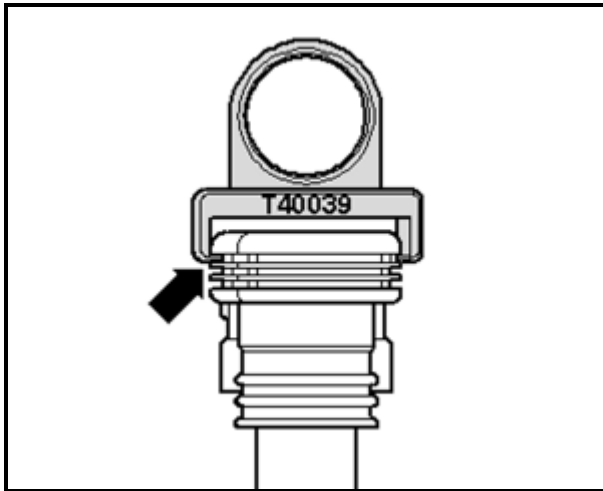
**WARNING!**

To remove ignition coils, place tool T40039 on the top-most thick rib -arrow- of the ignition coil with power output stage

Lower ribs may be damaged if they are used

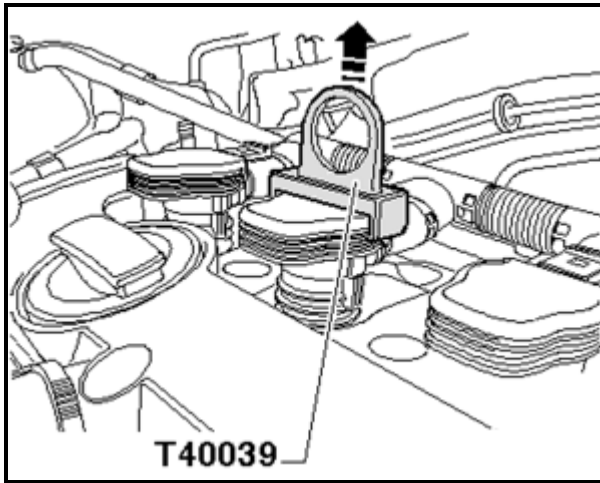
- Check part number of each ignition coil
- Any coil with one of these part numbers does not need to be replaced:
  - 07K 905 715D (black)
  - 07K 905 715E (black)
  - 07K 905 715F (black)
  - 06F 905 115F (black)
  - 06H 905 115 (black)
  - 06D 905 115K (red)
  - 06E 905 115D (red)
  - 06E 905 115E (red)
- If coil(s) are not as listed above, proceed to next step
- Reinstall or replace ignition coil(s) with the following:
  - 07K 905 715F (black)
  - 06E 905 115E (red)

**Mixing of valid part numbers is permitted, with the exception of part number 07K 905 715E**

**Damage may occur to engine if part number 07K 905 715E is mixed with other coils**

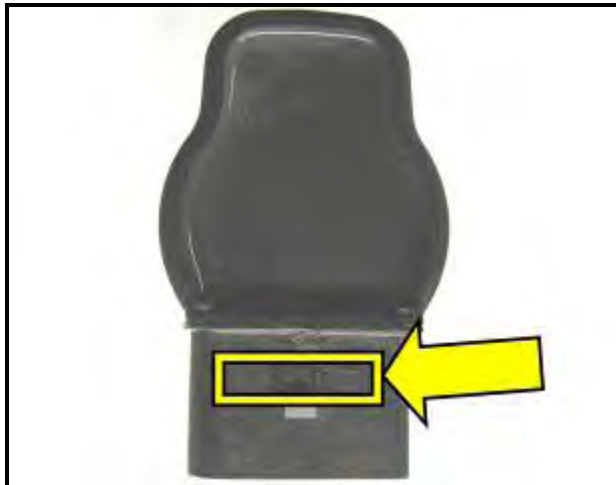
- ⇐ Inspect all ignition coils for part number(s)

- All coils with any of these part numbers do not need to be replaced:

- Coil(s) with any other part number, proceed to Section B – Replace Ignition Coils

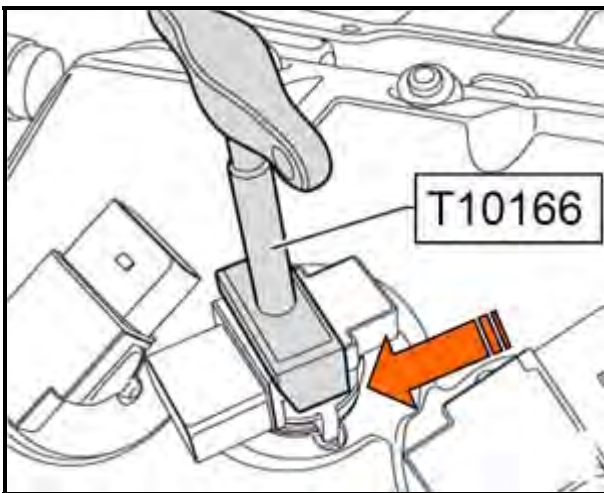
- Pull connectors off ignition coils 1 through 8 using Assembly Tool –T10118 or equivalent
- ⇐ Slide Ignition Coil Puller –T10166 onto ignition coil in -direction of arrow-, and pull out ignition coil with power output stage
- Check part number of each ignition coil
- ⇐ Any coil with one of these part numbers does not need to be replaced:
  - 07C 905 115 J
  - 07C 905 715 A
- ⇐ If coil(s) are not listed above, proceed to next step
- ⇐ Reinstall or replace ignition coil(s) with part number 07C 905 715A by inserting ignition coil into the spark plug shaft so that the electrical connectors do not touch the cylinder head cover
- Push the ignition coil(s) 1 through 8 onto the spark plug by hand

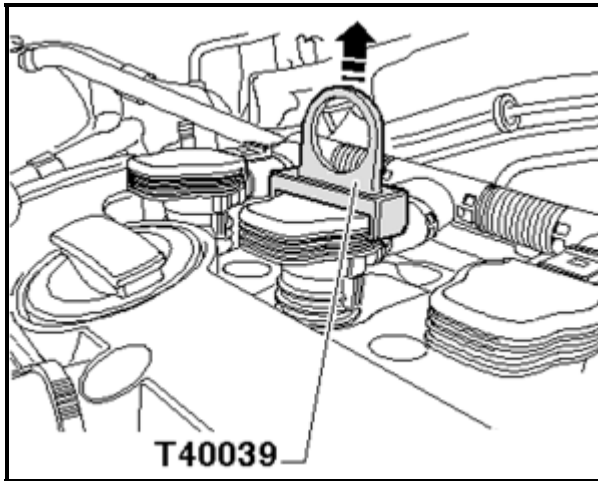
- ⇐ Remove all ignition coils from spark plug ports using tool T40039
- Check each ignition coil part number
- Any coil with one of these part numbers does not need to be replaced:
  - 07K 905 715D (black)
  - 07K 905 715E (black)
  - 07K 905 715F (black)
  - 06F 905 115F (black)
  - 06H 905 115 (black)
  - 06D 905 115K (red)
  - 06E 905 115D (red)
  - 06E 905 115E (red)
- If coil(s) are not as listed above, proceed to next step
- Reinstall or replace ignition coil(s) with the following:
  - 06H 905 115 (black)
  - 06E 905 115E (red)

**!** Note: Mixing of valid part numbers is permitted, with the exception of part number 07K 905 715E

Damage may occur to engine if part number 07K 905 715E is mixed with other coils

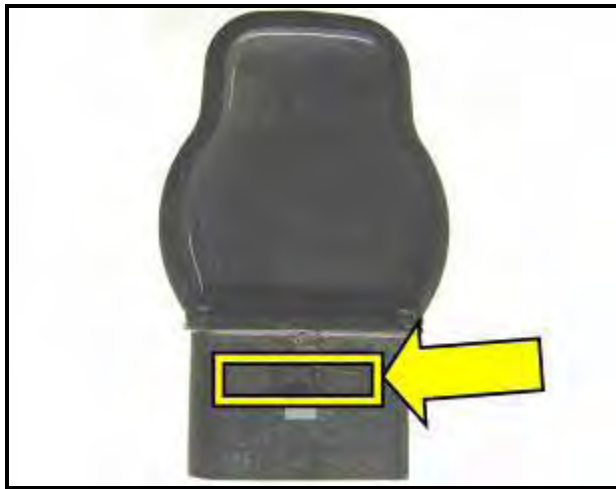
- ⇐ Inspect all ignition coils for part number(s)
- All coils with any of these part numbers do not need to be replaced:
  - 06A 905 115D
  - 06B 905 115R
  - 06C 905 115L
  - 06C 905 115M
- Coil(s) with any other part number, proceed to Section B – Replace Ignition Coils
- ⇐ If all coils have one of the above part numbers, continue to next step

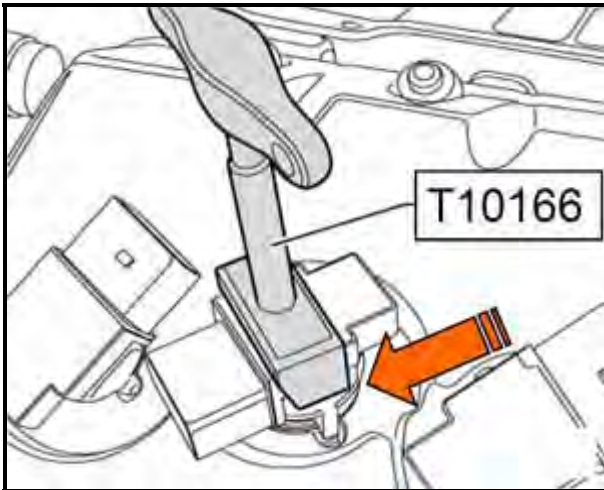
- Pull connectors off ignition coils 1 through 8 using Assembly Tool –T10118 or equivalent
- ⇐ Slide Ignition Coil Puller –T10166 onto ignition coil in -direction of arrow-, and pull out ignition coil with power output stage
- Check part number of each ignition coil
- ⇐ Any coil with one of these part numbers does not need to be replaced:
  - 07C 905 115 J
  - 07C 905 715 A
- ⇐ If coil(s) are not listed above, proceed to next step
- ⇐ Reinstall or replace ignition coil(s) with part number 07C 905 715A by inserting ignition coil into the spark plug shaft so that the electrical connectors do not touch the cylinder head cover
- Push the ignition coil(s) 1 through 8 onto the spark plug by hand

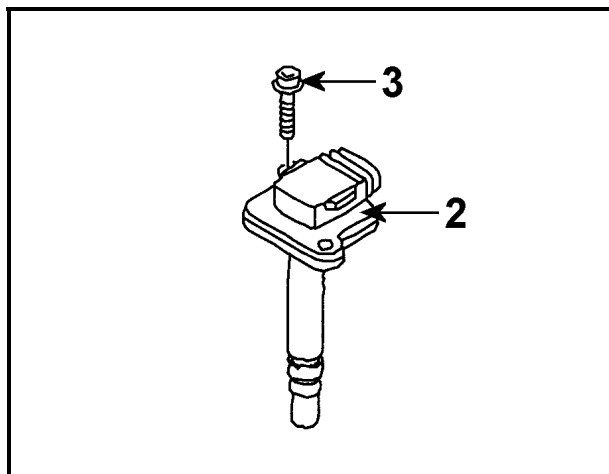
- Open hood and remove engine cover
- If applicable, remove screw securing vacuum reservoir located above ignition coils
- Check type of ignition coil
- ⇐ If ignition coils -2- with part number (06B 905 115E), look like the illustration to the left and are bolted to the cylinder head with two bolts -3-; **NO FURTHER WORK IS REQUIRED**
- Reinstall engine cover
- ⇐ Fill out and affix Campaign Completion label, part number CAMP 010 000, next to the vehicle emission control information label

- Close hood – **WORK IS COMPLETE**
- IF ignition coils are not bolted to the cylinder head, continue to next step

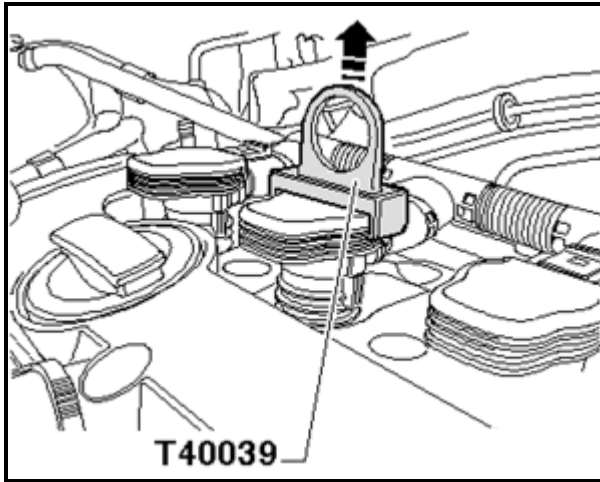
- Check part number of each ignition coil
- Any coil with one of these part numbers does not need to be replaced:
  - 07K 905 715D (black)
  - 07K 905 715E (black)
  - 07K 905 715F (black)
  - 06F 905 115F (black)
  - 06H 905 115 (black)
  - 06D 905 115K (red)
  - 06E 905 115D (red)
  - 06E 905 115E (red)
- If coil(s) are not as listed above, proceed to next step
- Reinstall or replace ignition coil(s) with the following:
  - 07K 905 715F (black)
  - 06E 905 115E (red)

**⚠ WARNING!**  
**Mixing of valid part numbers is permitted, with the exception of part number 07K 905 715E**  
**Damage may occur to engine if part number 07K 905 715E is mixed with other coils**

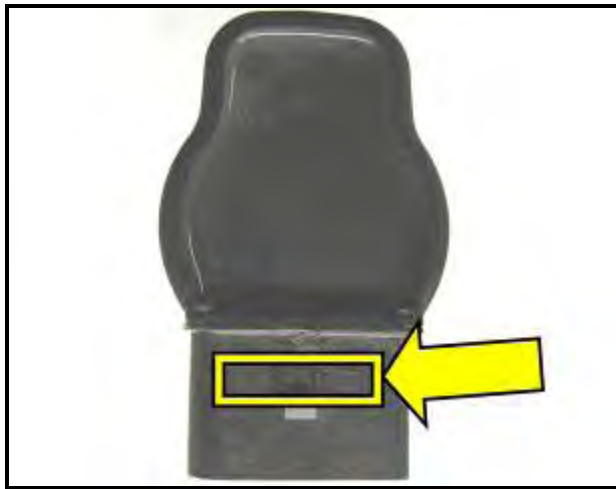
Tip: Picture is for part number placement only. Actual part number(s) not pictured

- ⇐ Inspect all ignition coils for part number(s)
- All coils with any of these part numbers do not need to be replaced:
  - 06A 905 115D
  - 06B 905 115R
  - 06C 905 115L
  - 06C 905 115M
- Coil(s) with any other part number, proceed to Section B – Replace Ignition Coils
- ⇐ If all coils have one of the above part numbers, continue to next step

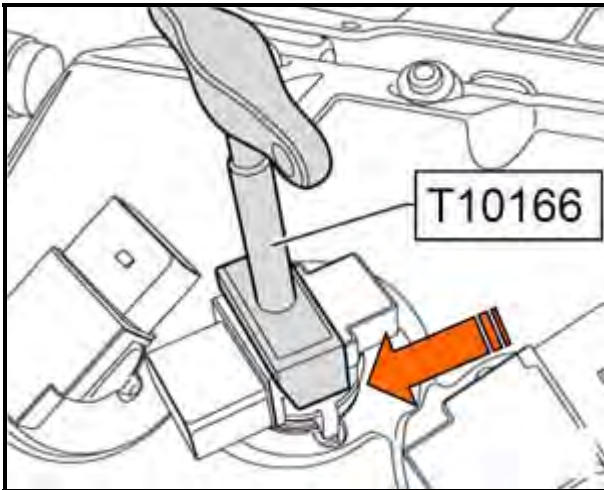
- Pull connectors off ignition coils 1 through 8 using Assembly Tool –T10118 or equivalent
- ⇐ Slide Ignition Coil Puller –T10166 onto ignition coil in -direction of arrow-, and pull out ignition coil with power output stage
- Check part number of each ignition coil
- ⇐ Any coil with one of these part numbers does not need to be replaced:
  - 07C 905 115 J
  - 07C 905 715 A
- ⇐ If coil(s) are not listed above, proceed to next step
- ⇐ Reinstall or replace ignition coil(s) with part number 07C 905 715A by inserting ignition coil into the spark plug shaft so that the electrical connectors do not touch the cylinder head cover
- Push the ignition coil(s) 1 through 8 onto the spark plug by hand

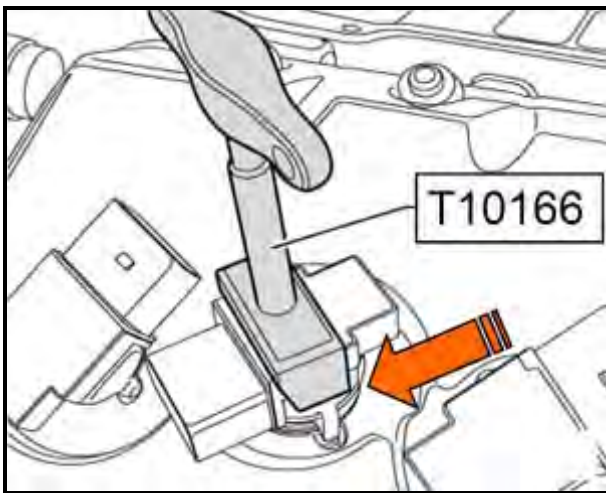
- Pull connectors off ignition coils 1 through 12 using Assembly Tool T10118 or equivalent
- ⇐ Slide Ignition Coil Puller T10166 onto ignition coil in -direction of arrow-, and pull out ignition coil with power output stage
- Check part number of each ignition coil
- Any coil with one of these part numbers does not need to be replaced:
  - 07C 905 115 J
  - 07C 905 715 A
- If coil(s) are not listed above, proceed to next step
- Reinstall or replace ignition coil(s) with part number 07C 905 715 A by inserting ignition coil into the spark plug shaft so that the electrical connectors do not touch the cylinder head cover
- Push the ignition coil(s) 1 through 12 onto the spark plug by hand
