EA11-003

VW

6/15/2012

WAVE 10

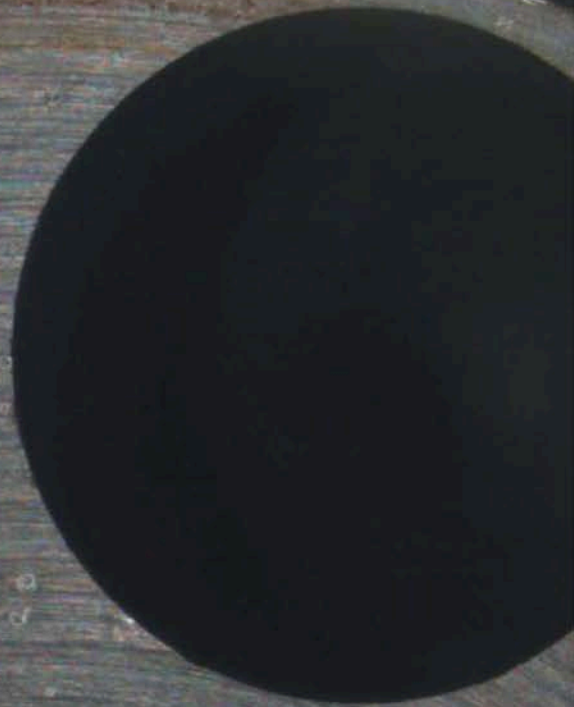
The 2nd return feed pump from the Audi USA tests (0445010613 #080428-0876 with 141925km) has Category I drivetrain damage and also indications of water in fuel at RS, tappet body, tappet spring and spring plate. VVT-No. 2009-CP4_0500
