CR pump CP4 - Findings report		Report no. 19427																																																															
				Date 11.01.2008																																																															
Department: Non-responsive content removed	Person responsible: Non-responsive content removed	Telephone: Non-responsive content removed	Use <table border="1" style="float: right;"> <tr> <td>internal</td> <td></td> </tr> <tr> <td>external</td> <td style="text-align: center;">x</td> </tr> </table>		internal		external	x																																																											
internal																																																																			
external	x																																																																		
To: Non-responsive content removed																																																																			
Attn. of: Non-responsive content removed

Pump type: CP4.1S_348_2x5.25_REC_3.3_1.95_MT4.2	Customer: VW	Project: R4 2,0 BIN5	Project/ design sample version C / C2

CP4 – Findings on VW R4 2.0 BIN5 / #686-0163

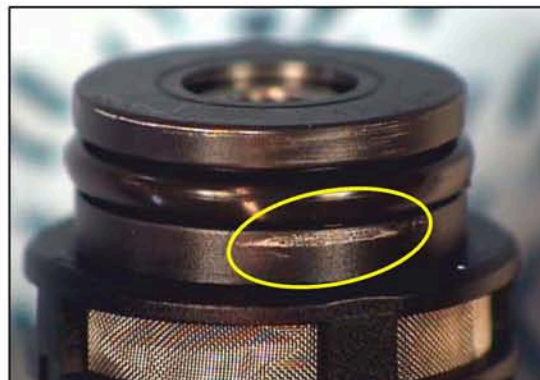
3.7 Built-on components (metering unit, overflow valve, counting point)
 Marks from installation on the magnet core on the outside of the metering unit (see Fig. 12)
 Overflow valve screen inverted (see Fig. 13) and with locally reddish covering (see Fig. 14)

Fig. 12. Metering unit, magnet core on outside (scrape mark)
