Date: 17.03.2011 11:55:00  
Subject: Re: USA Failure RP1  
Attachments: [Lebenslauf USA-Pumpe.pdf](#)

**Subject:** USA Failure RP1

**Date:** 4/7/2010 8:21:20 AM  
**Topic:** 2.0 I TDI CR US\_07: Corrosion/water in the fuel/chips  
**Attachments:** [RE 578398 403158 escalation.msg](#)  
[FW 578398 403158 escalation.msg](#)

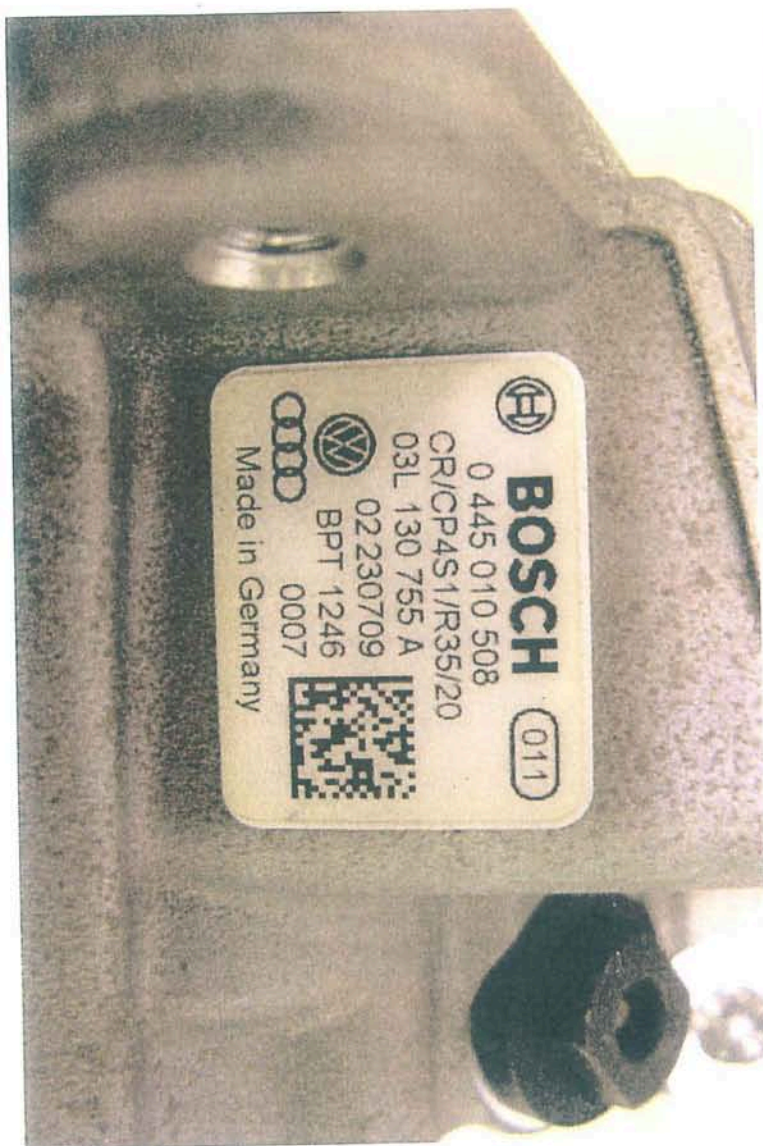
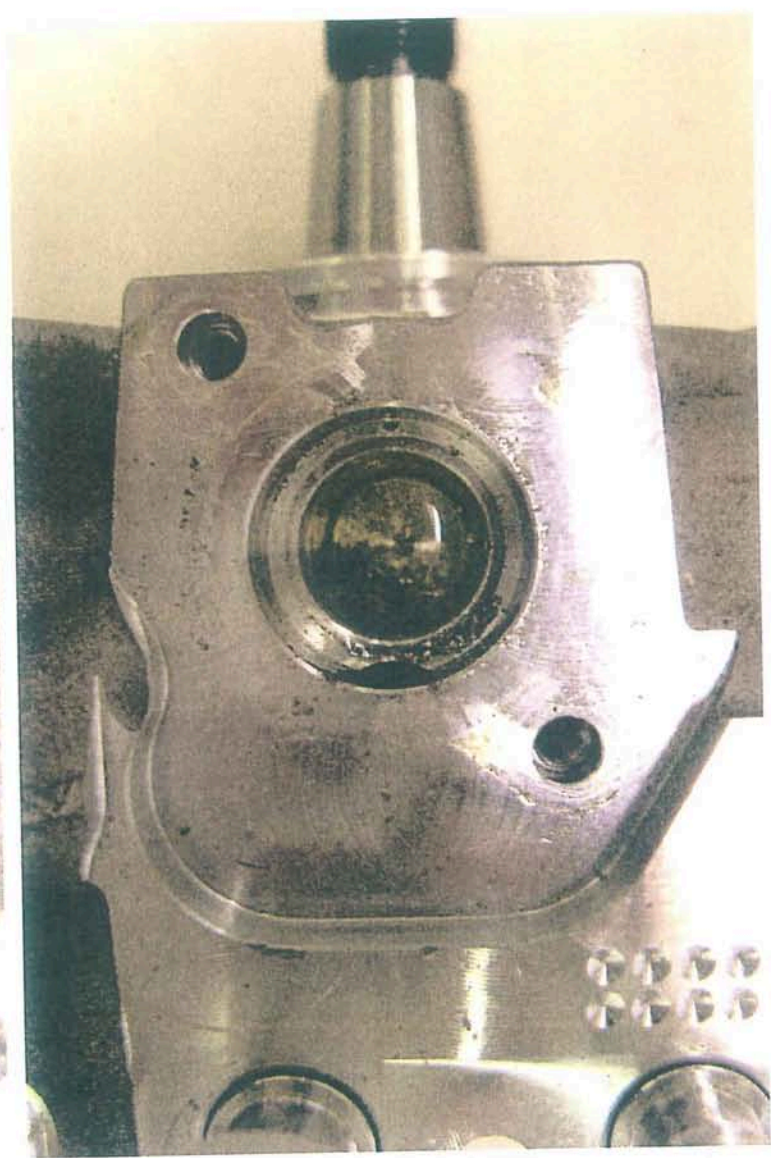
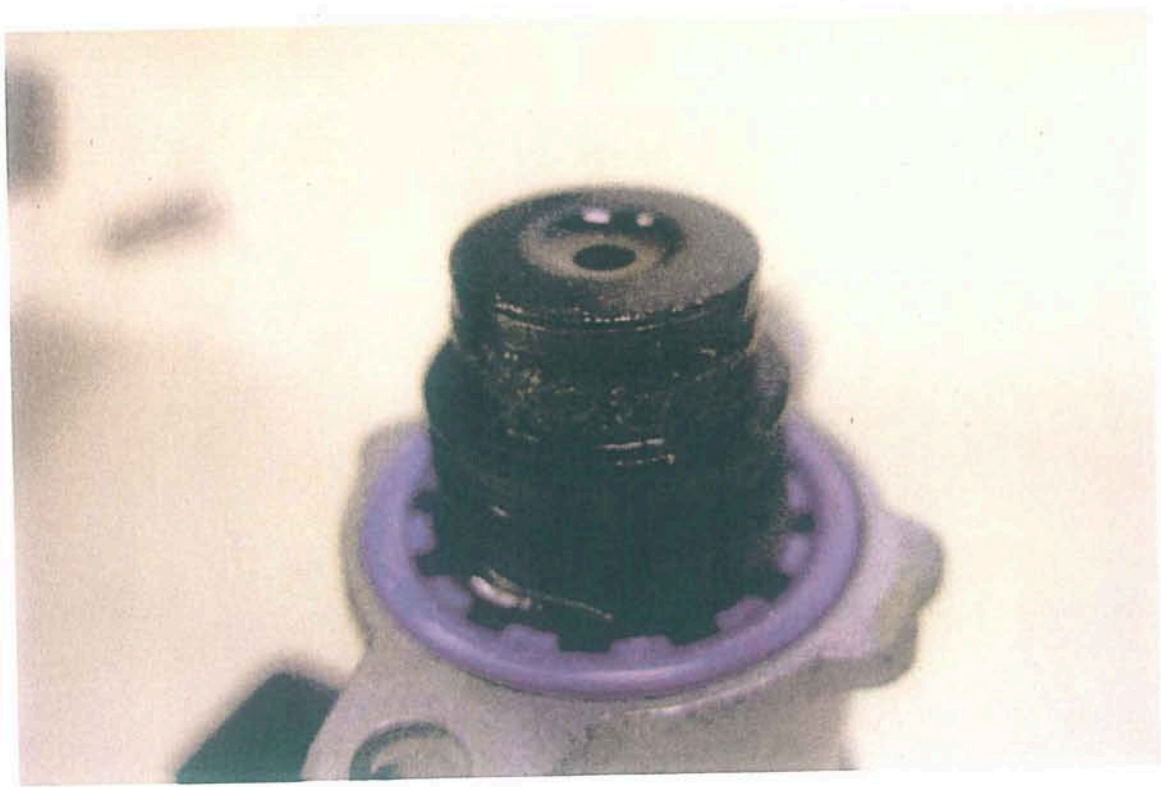
Date	Author	Visible to	Comment
01/27/2010	SAGA2	Retailer	TOW IN-ENGINE SHUT OFF WHILE DRIVING & WOULDN'T START-REPLAC
01/27/2010	SAGA2	Retailer	E INJECTORS, PUMP, RETURN LINE, SUPPLY LINE, FUEL FILTER, & O
01/27/2010	SAGA2	Retailer	THER PARTS NEEDED. C/S TOW IN, ENGINE SHUT IT
01/27/2010	SAGA2	Retailer	SELF OFF DRIVING DOWN FREEWAY, WILL NOT RESTART.
