Warm-up report 2.0l R4 CR 105 kW in B8 Lim.

Warm-up report 2.0l R4CR 105kW in B8

Audi R4

Rail pressure too low, pump noise

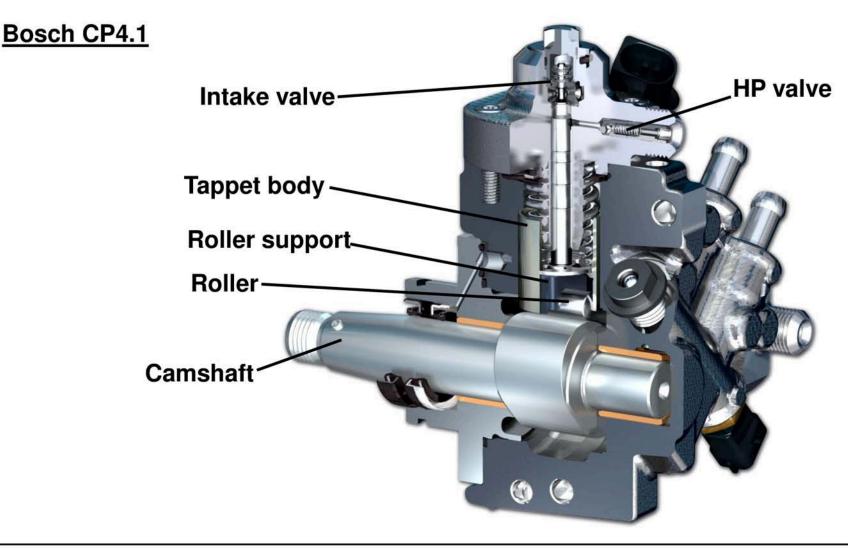
CP4-XX/1-xx - Standard pump

RP0: High-pressure plunger

Objective

- → Lower wear of HP plunger
- → Lower internal HP leakage

Measure

- → Optimized C2 layer on HP plunger
- → Reduced play between HP plunger and plunger guidance in cylinder head

Impact

- → Increased robustness against abrasive wear.
- → High hydraulic efficiency, even if low-viscosity fuels are used.
