Direct Information System Service (DISS)

Date: 11/16/2010, 11:23:22 AM
Subject: Re: V6 TDI block

Subject: Re: Failure of high-pressure fuel pump diesel C.R. [REDACTED] market - Current situation for 4-cylinder Engines

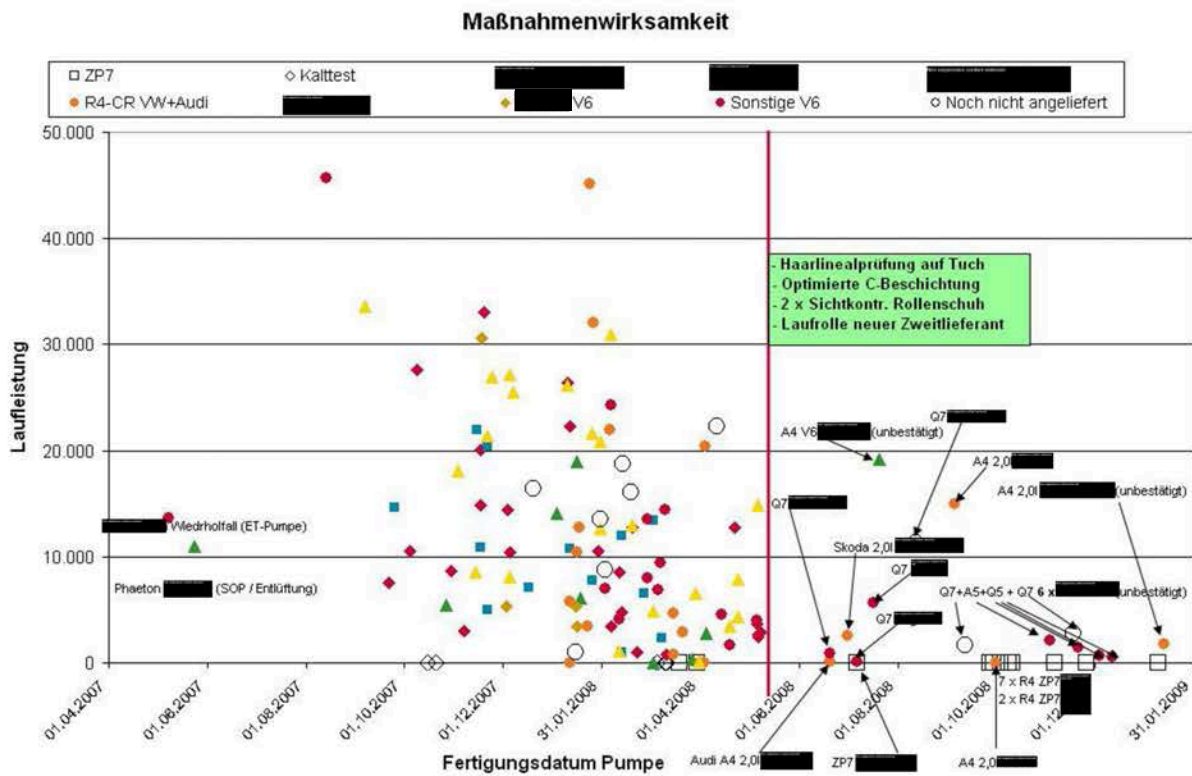
German	English
Maßnahmenwirksamkeit	Effectiveness of actions
ZP 7	CP 7
Kalttest	Cold test
Non-responsive content removed	
R4-CR VW + Audi	R4-CR VW + Audi
Non-responsive content removed	
Sonstige V6	Others V6
Noch nicht angeliefert	Not supplied yet
Laufleistung	Mileage
- Haarlinealprüfung auf Tuch	- Straightedge testing on cloth
- Optimierte C-Beschichtung	- Optimized C coating
- 2 x Sichtkontr. Rollenschuh	- 2 x visual inspection Roller support
- Laufrulle neuer Zweitlieferant	- Roller of new second source supplier
Non-responsive content removed

Non-responsive content removed		
Non-responsive content removed		
Non-responsive content removed		
^Fertigungsdatum Pumpe	^Production date of pump

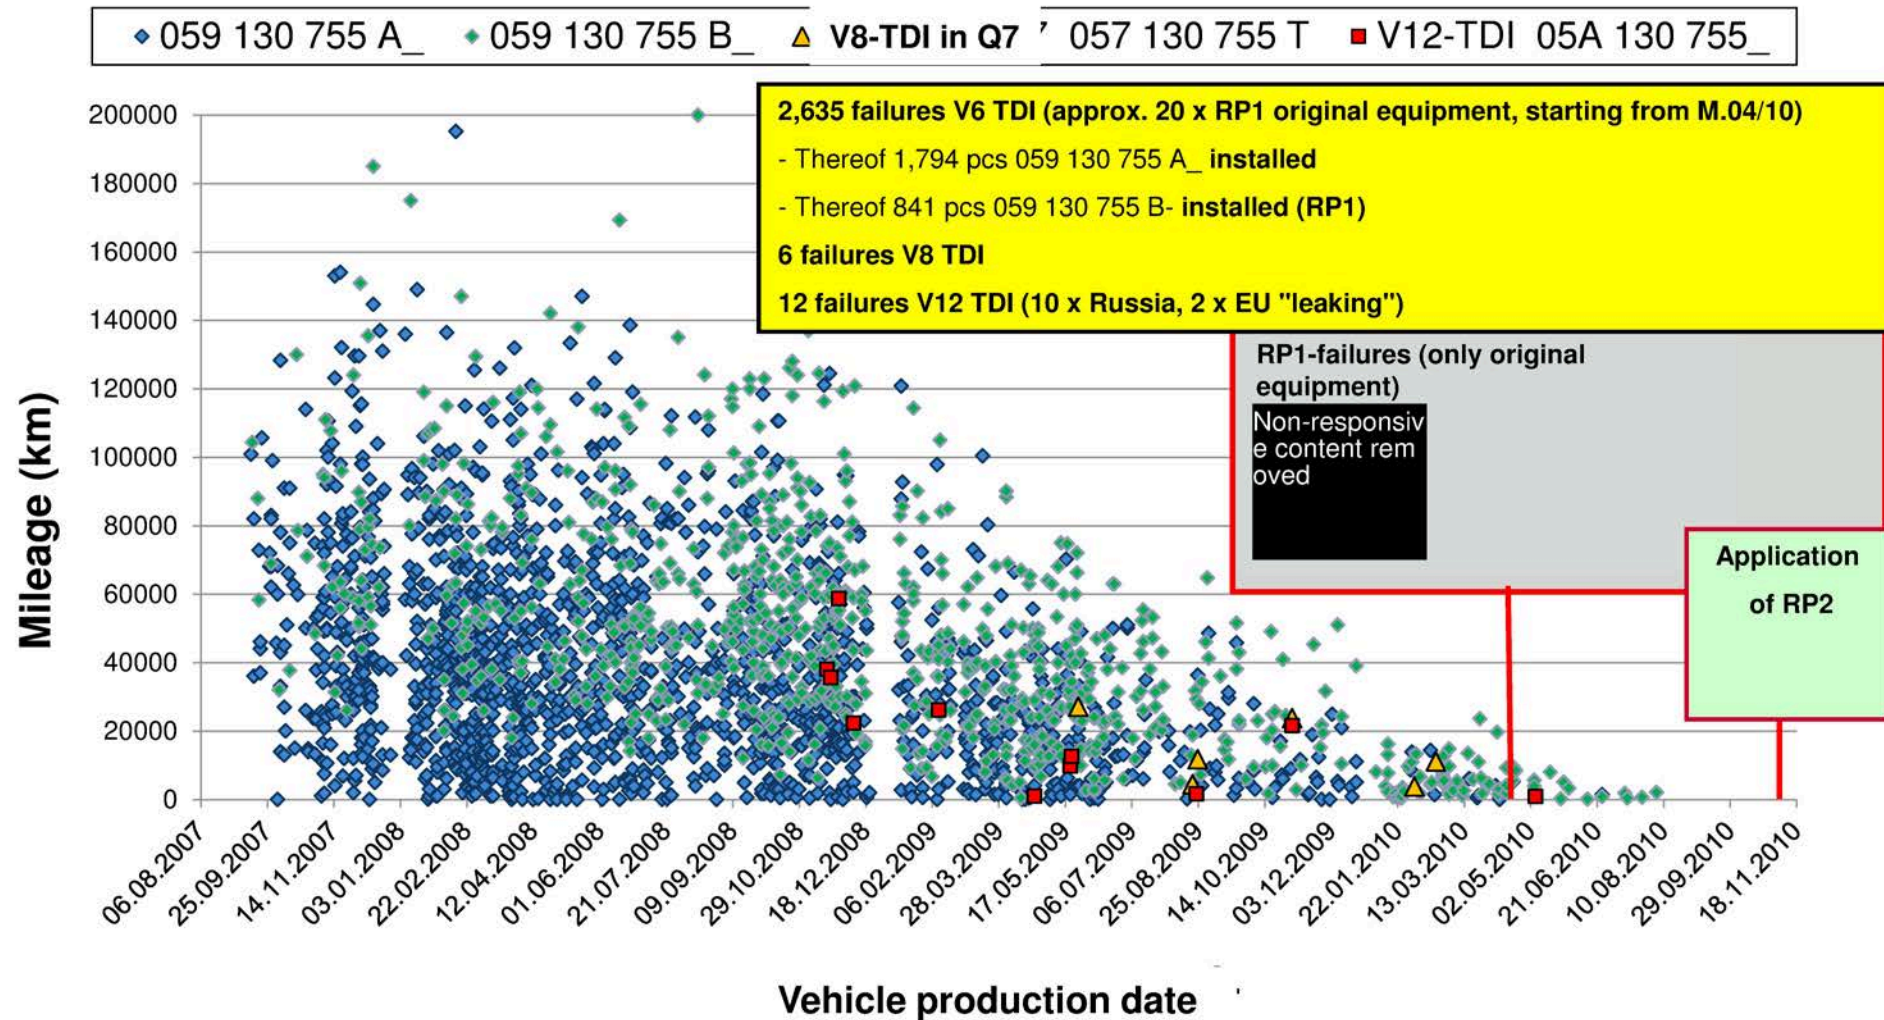
All bills of high-pressure fuel pumps V6-/V8-/V12-TDI Audi

SAGA as of 11.16.2010
