**From:** Non-responsive content removed**To:****CC:****Date:** 6/22/2009, 6:04:03 PM**Subject:** RE: CP4.1 assessment (R4 CR high pressure fuel pump from Bosch)

The following is a short summary of our telephone conversation on the unusual features of the disassembly audit of 06.19.2009

**Dismantlement and assessment of an R4 CR Bosch HP fuel pump 03L 130 755**

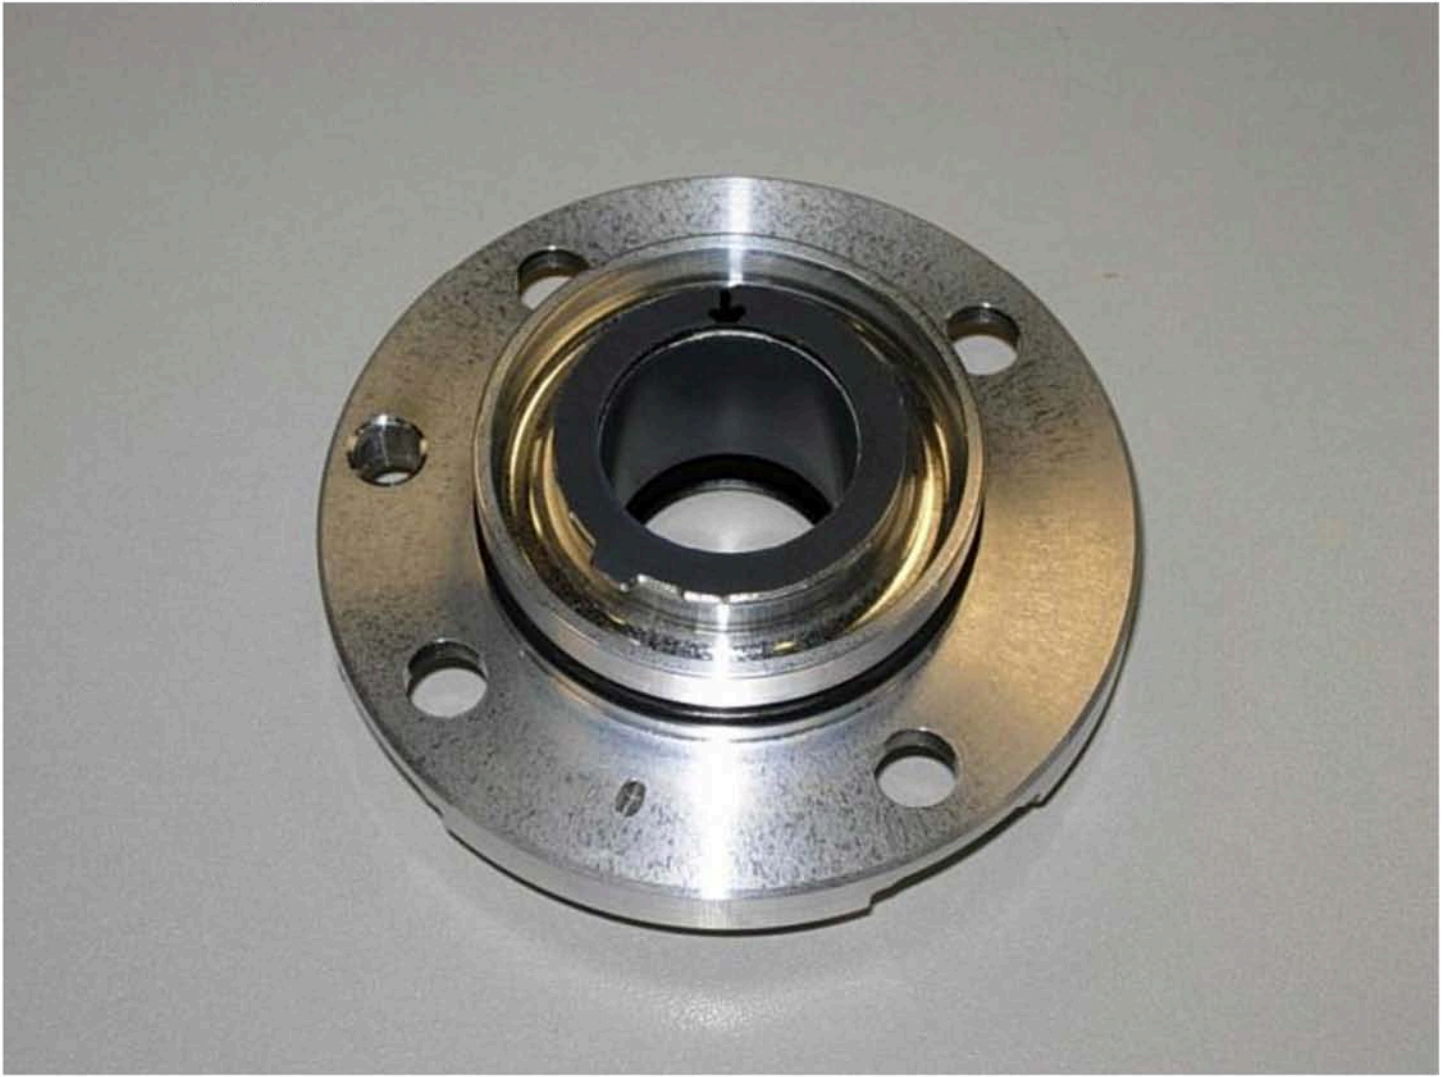
Fig.2 Shavings / burr pressed tight between tension pin and camshaft: Shavings occur when the tension pin is pressed into the camshaft. The shavings come from the tension pin. Bosch is aware of the matter and is currently working on it; the pressing geometry - chamfer on the camshaft - will be improved for this purpose. Loose shavings and shavings that protrude laterally, preventing the hub wheel from being pressed on, are not permitted, fixed shavings in the base material are permitted according to the visual inspection catalog and are not critical

Fig.2 Shavings / burr pressed tight between tension pin and camshaft: The shavings occur when the tension pin is pressed into the camshaft. The shavings come from the tension pin. Bosch is aware of the matter and is currently working on it; the pressing geometry - chamfer on the camshaft - will be improved for this purpose. Loose shavings and shavings that protrude laterally, preventing the hub wheel from being pressed on, are not permitted, fixed shavings in the base material are permitted according to the visual inspection catalog and are not critical.

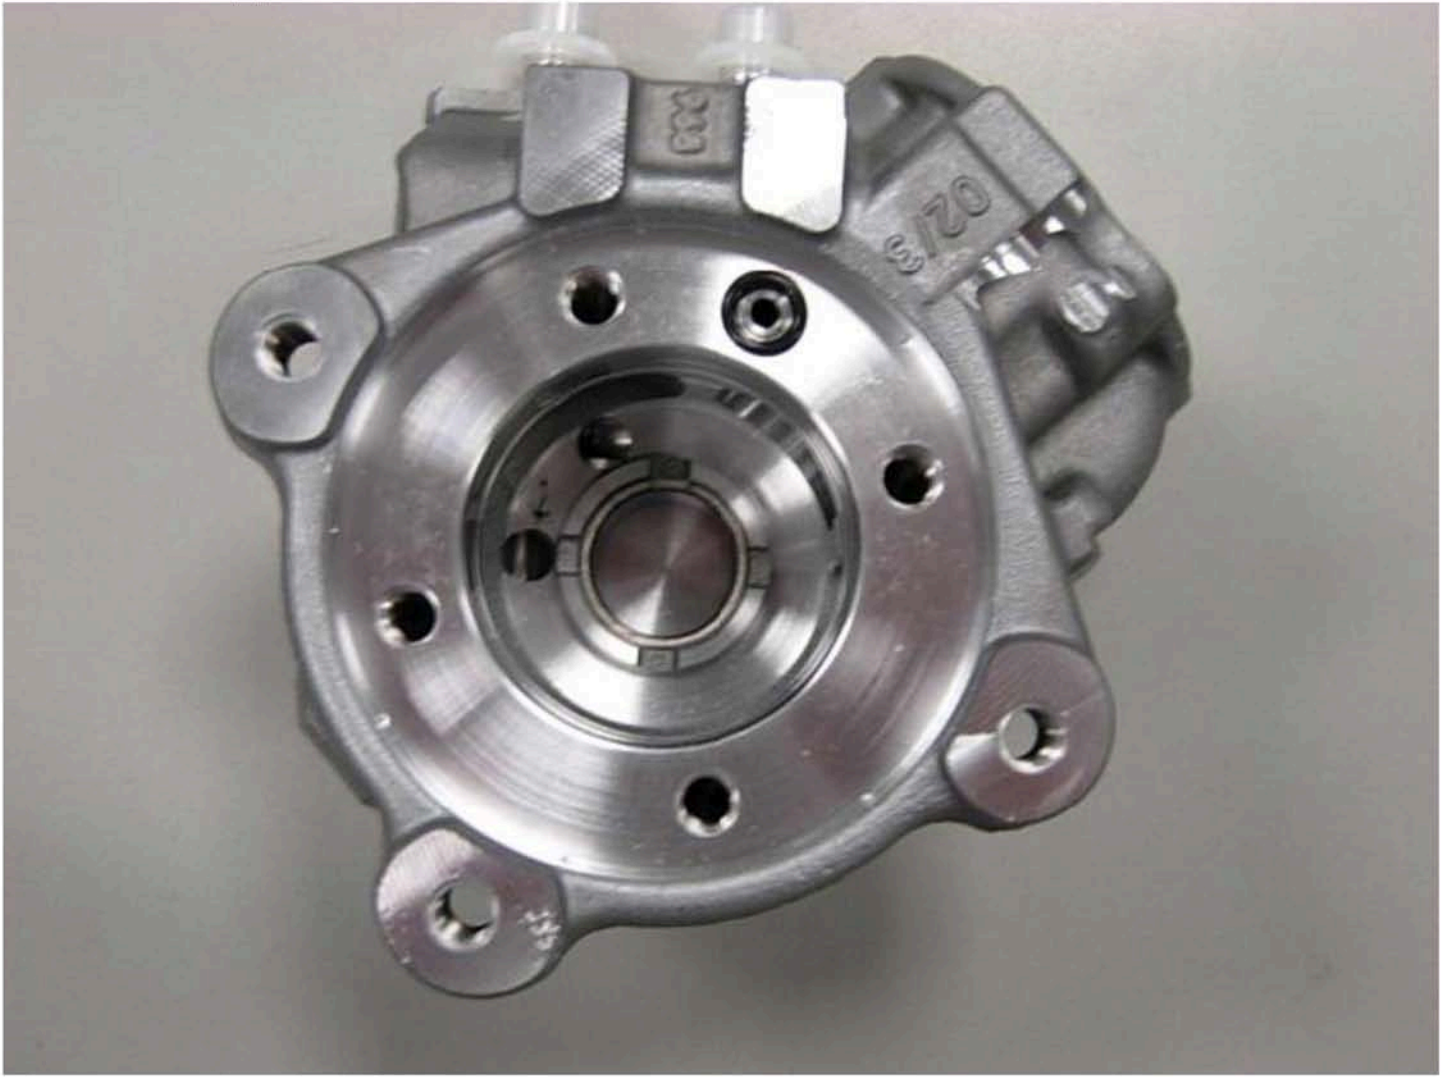
Fig. 3: Abrasion of the locking screw coating - non-critical

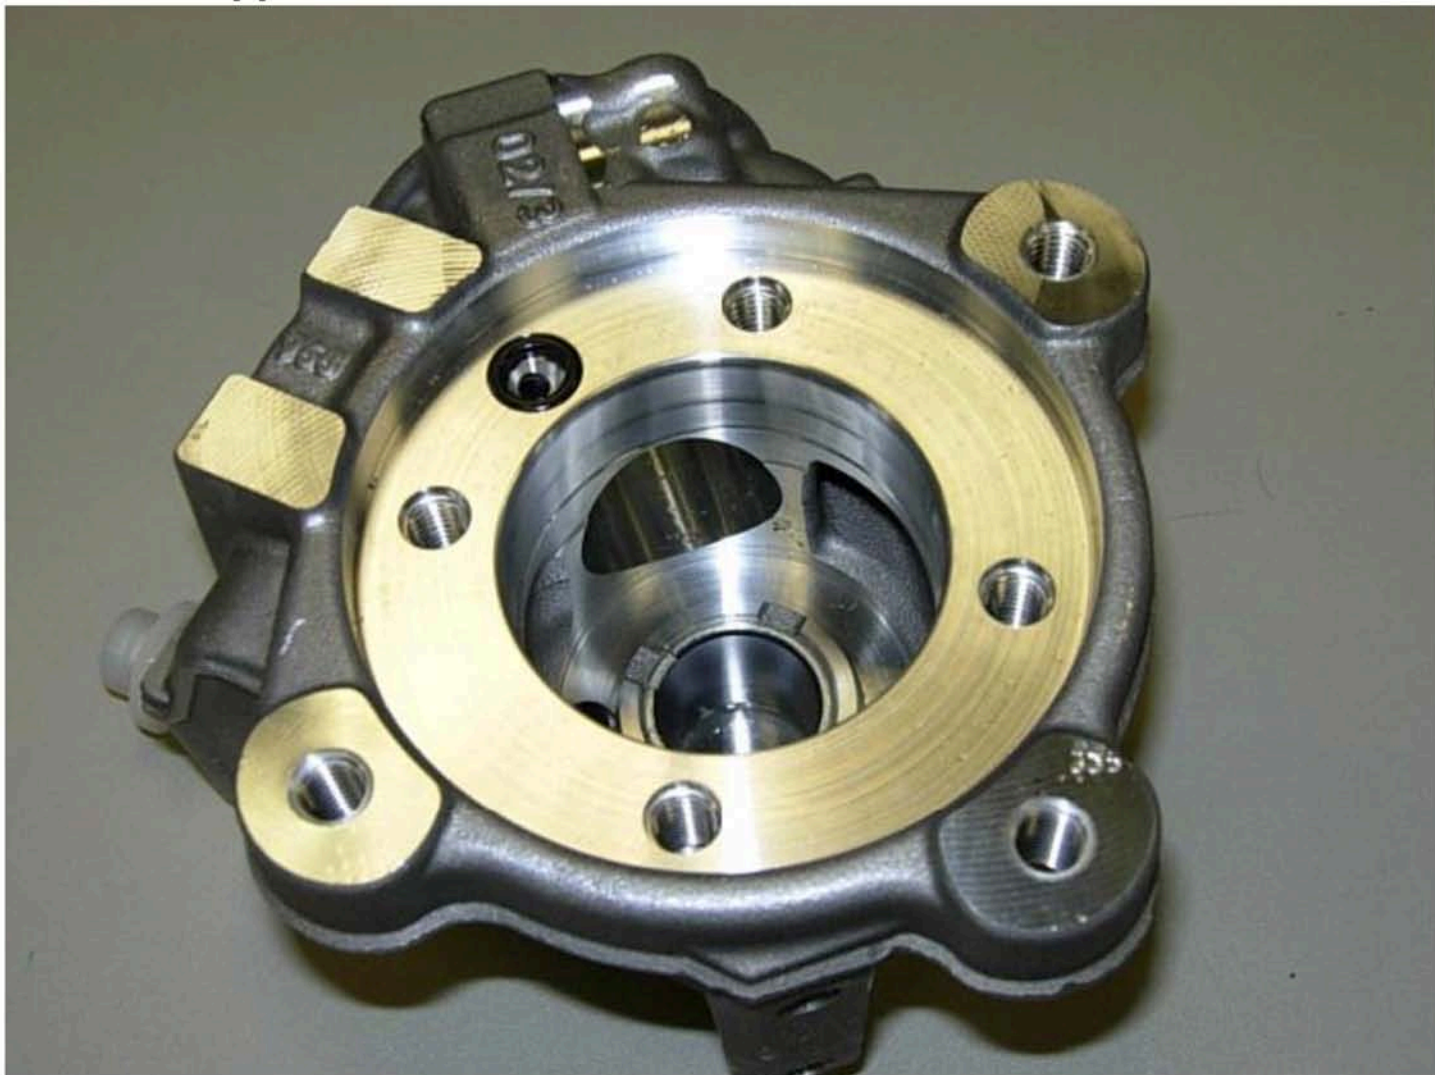
Fig. 4: Brown discoloration on the base of the outer surface of the cylinder head (transition with the cylinder head support surface - piston guide diameter, outer edge) - not functionally critical, however rust should generally be avoided. Topic under consideration

Pump no. 1 External mantle, piston bore. Rust

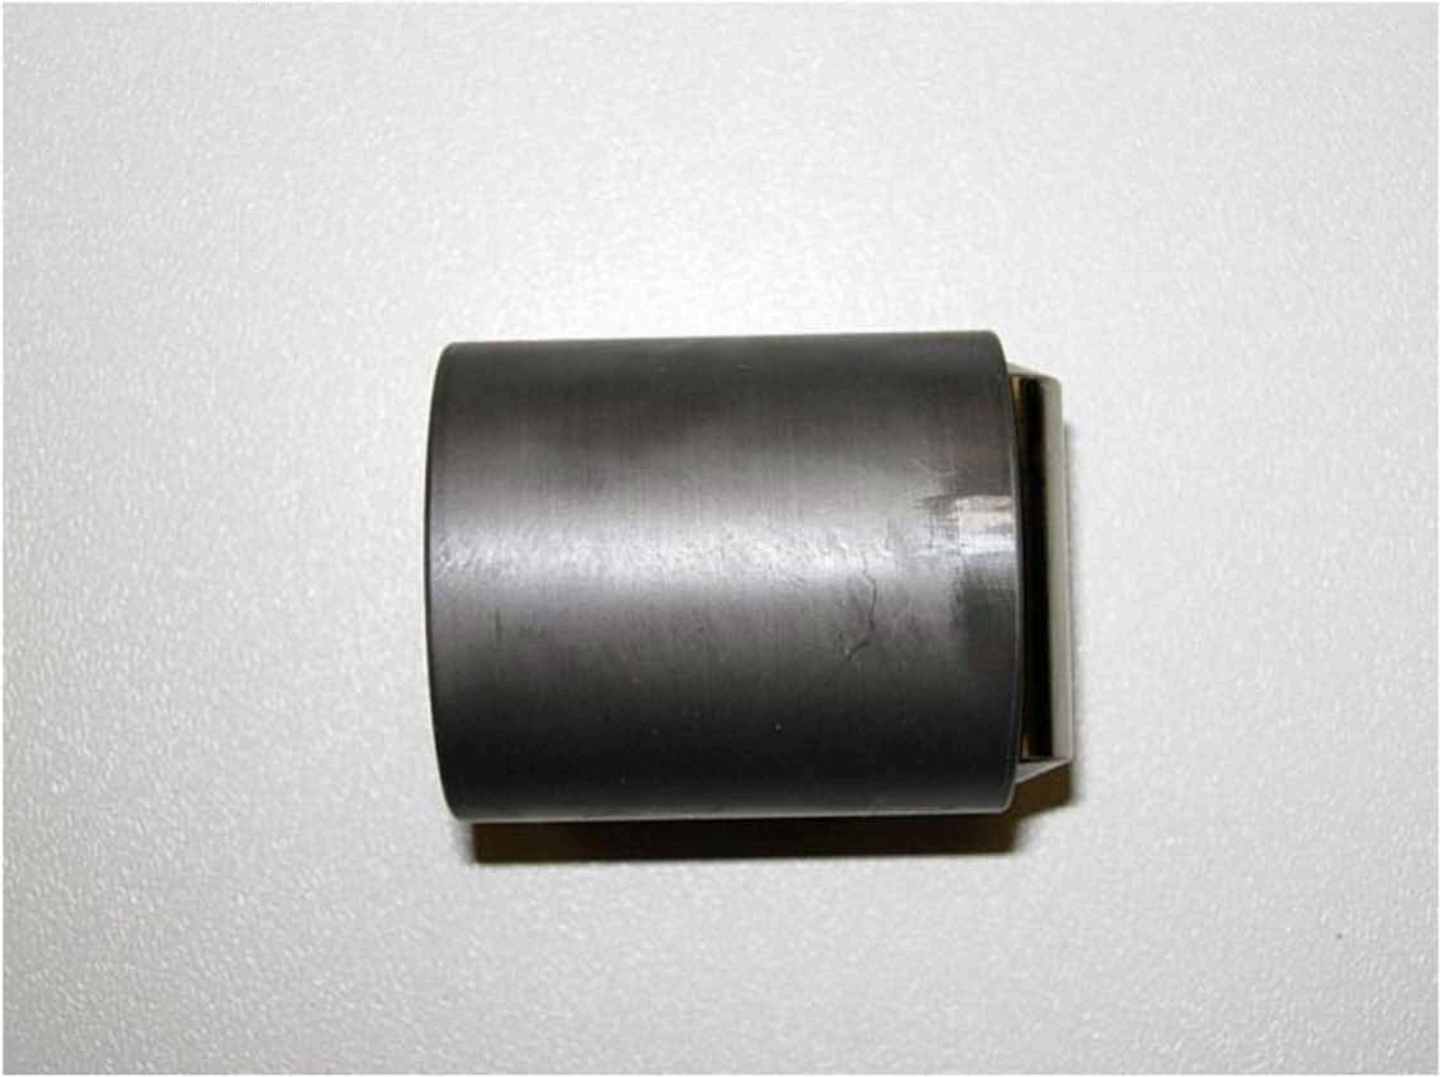
Fig. 5: Minor scratches on the roller in axial direction approx. 350 µm - familiar pattern, may be caused when the roller is manually inserted into the roller support. The roller can easily drop off in this area - not functionally critical

Pump no. 1 Roller, minor cracks on edge
