**Drivetrain damage - high-pressure diesel fuel pump CP4.2**

# Drivetrain damage - high-pressure diesel fuel pump CP4.2

**"Power loss" of high-pressure fuel pump, Touareg V6 TDI**

**R4-CR Drivetrain damage to HDP CP4.1**

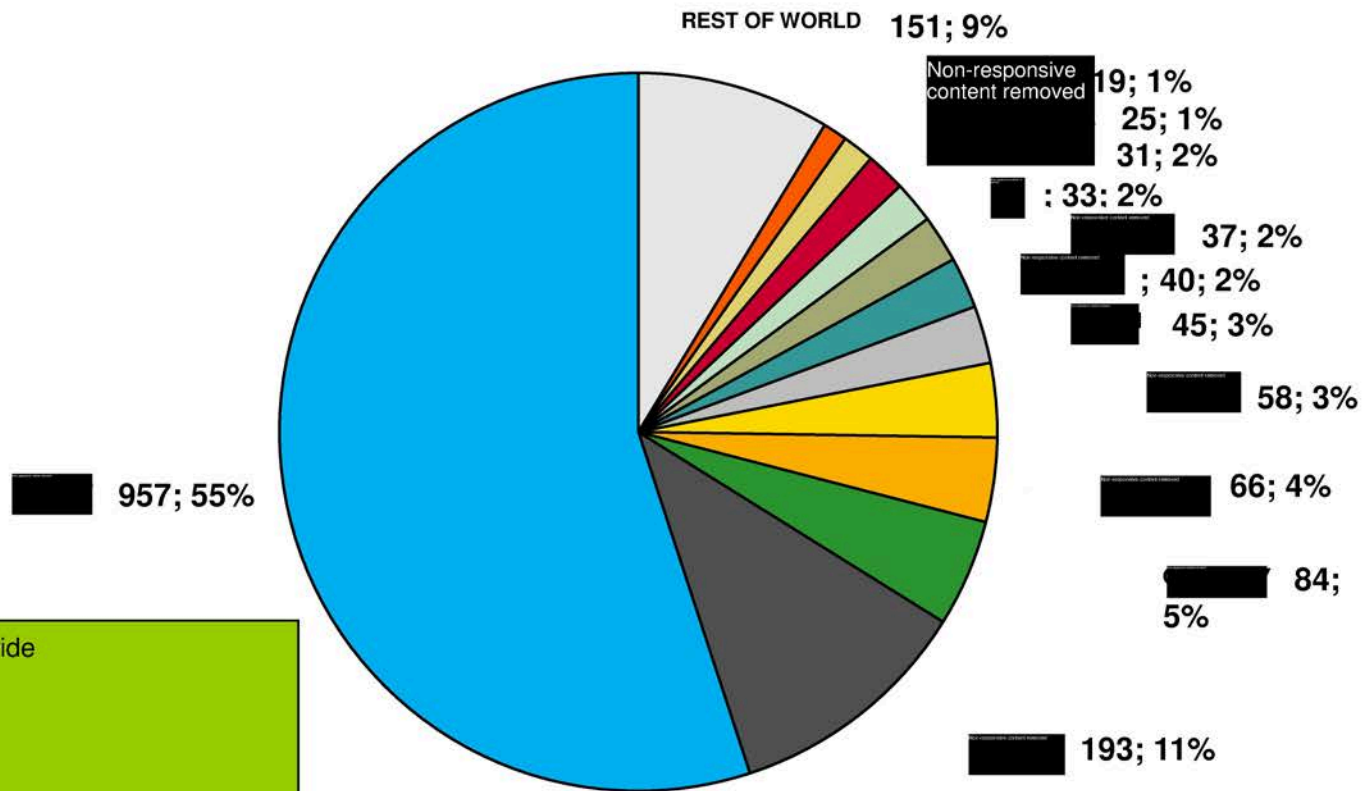
## Field failures of Audi V6-TDI by country SAGA – only exchanged pumps; 059\_/B\_)

Total V6-TDI: 1,739 cases worldwide  
 MY08: 849 cases  
 MY09: 782 cases  
 MY10: 108 cases  
 (SAGA, status 7/4/2010)

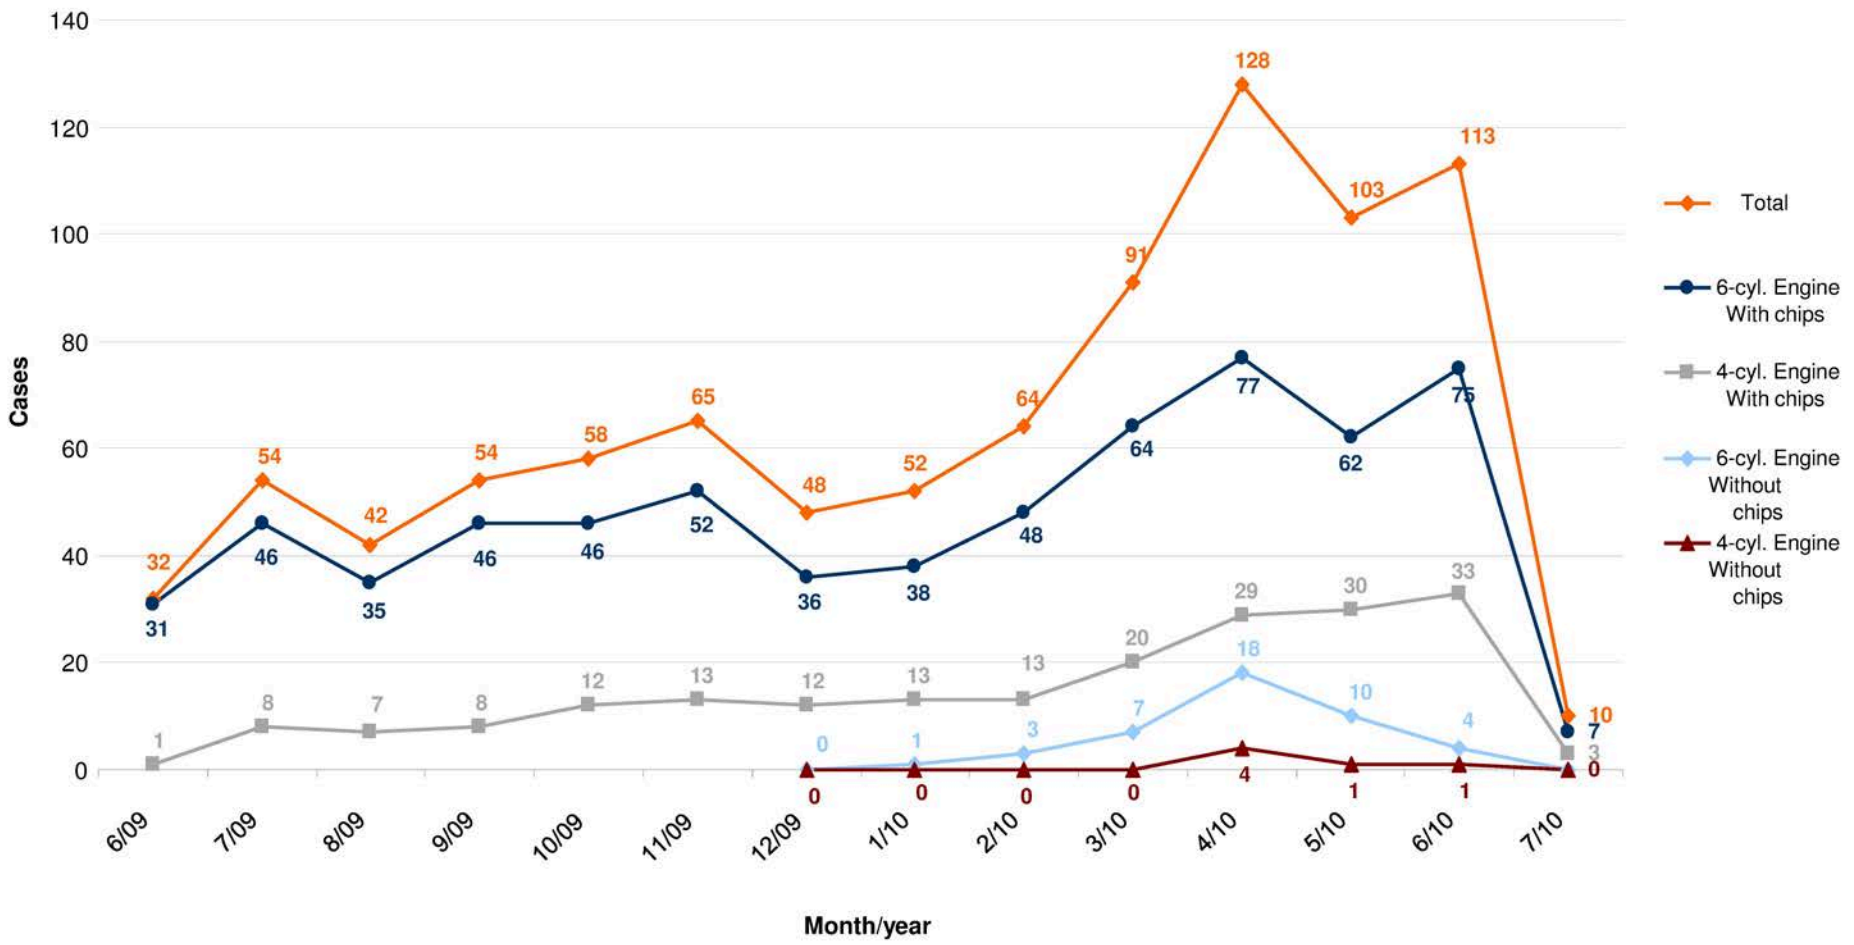
Failure of CR high-pressure Diesel pump - damage cases per month (as of 07/10 Wk 26)

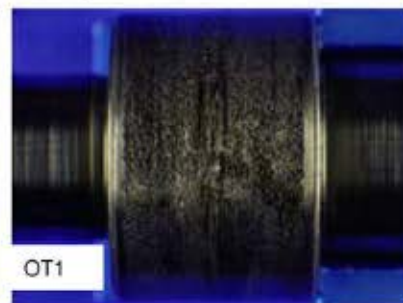
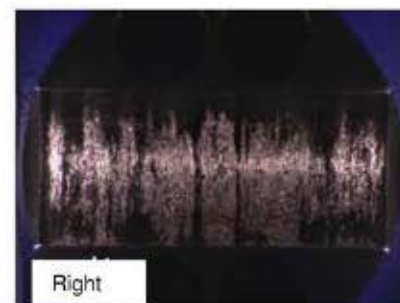
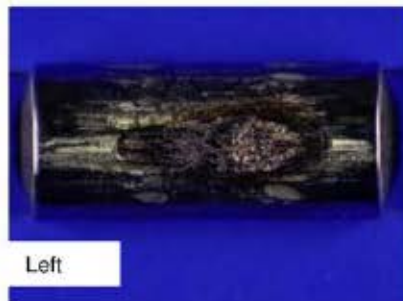
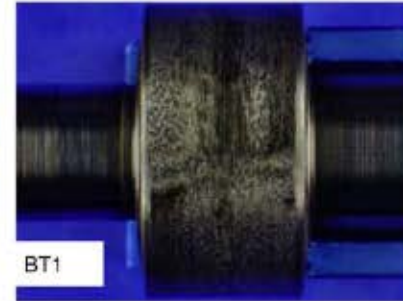
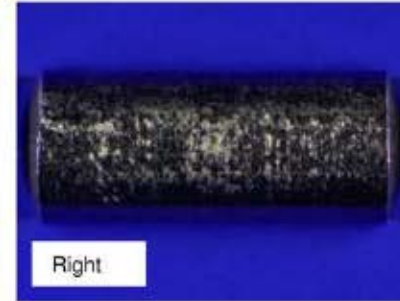
Failed pump field [REDACTED]; delivery date unknown

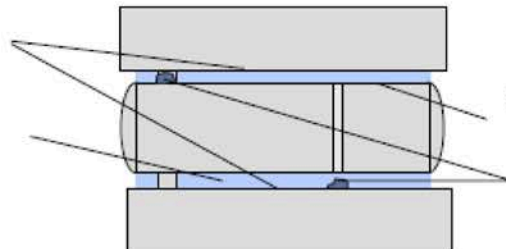
- Impermissible high mixed friction between roller and roller support result in "local" contact during operation
- The C layer is destroyed (wear and deposit of the C layer), the friction coefficient between roller and roller support increases
- When friction coefficient of roller-roller support > Friction coefficient roller-cam -> Brake plates
- Abrasive wear, particle formation -> Drivetrain damage

Hydrodynamic lubricating  
film =  $f$  (play, surface, fuel)

Elevated points  
(metal spatters on roller support; fusing on roller)

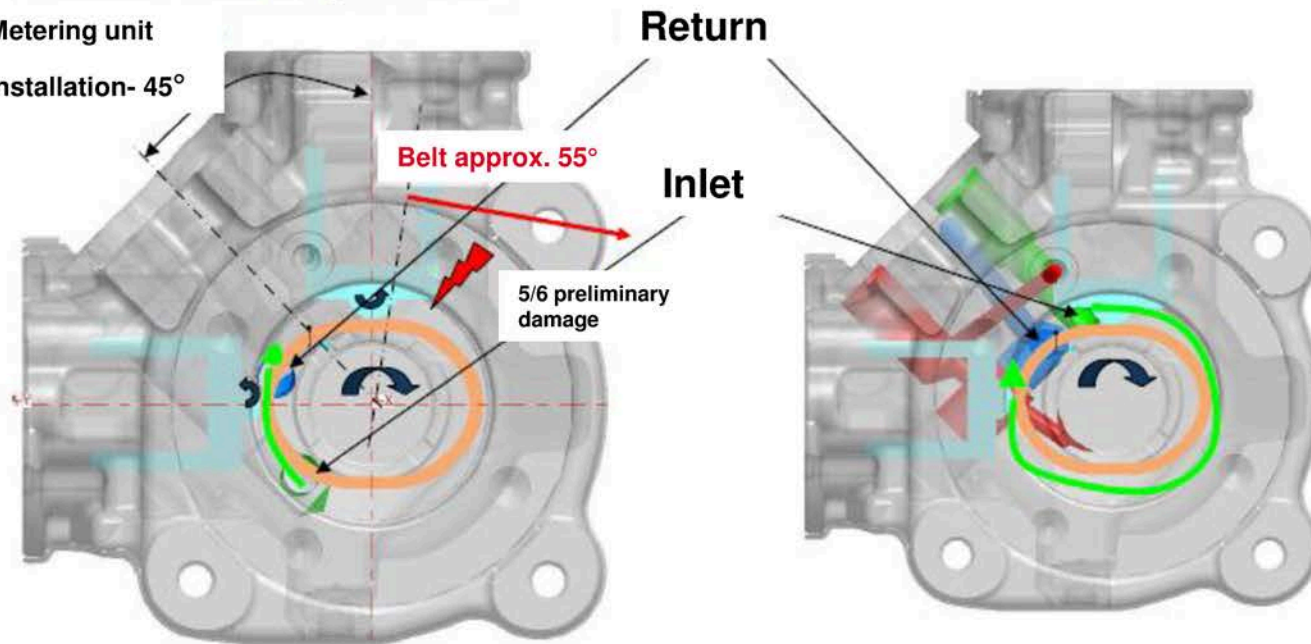
Fuel goes directly to return

**Anti wear package 2:**  
 Inlet/return connections switched  
 → Reduction of temperature in right roller support

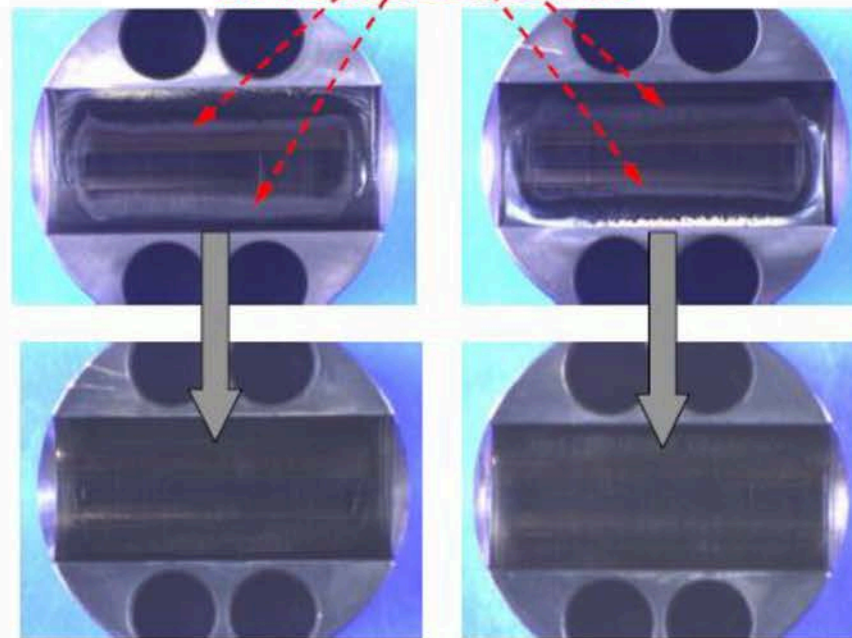
RP2

Reduction  
Deposit formation

Roller support  
from test  
2009-CP4\_0728  
**uncleaned**

Roller support  
from test  
2010-CP4\_304/305  
**uncleaned**

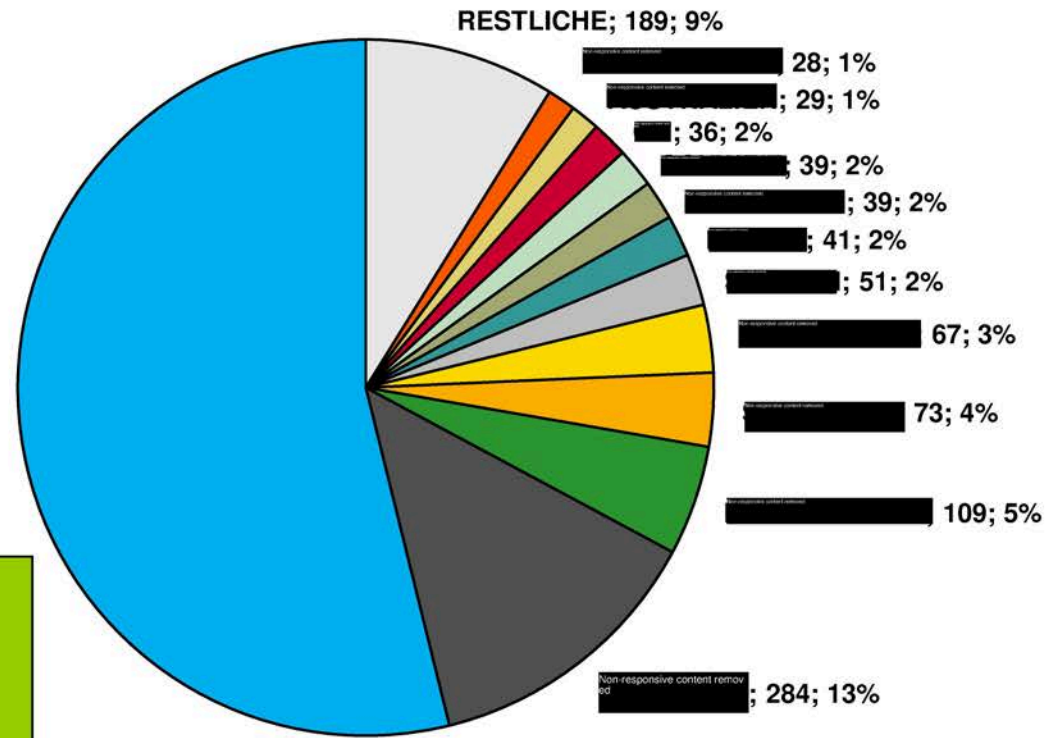
## Field failures of Audi V6-TDI by country (SAGA – only exchanged pumps; 059\_/B\_

Total V6-TDI: 2,135 cases worldwide  
 MY08: 935 cases  
 MY08: 935 cases  
 MY09: 1,018 cases  
 MY10: 181 cases  
 MY11: 1 case  
 (SAGA, status 9/5/2010)

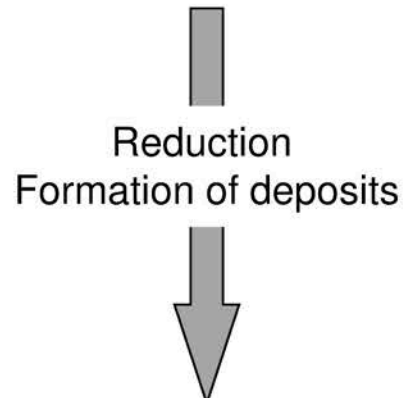
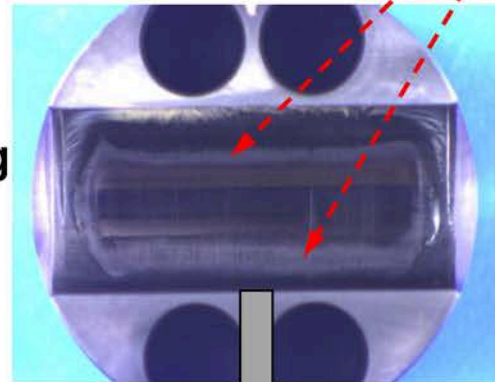
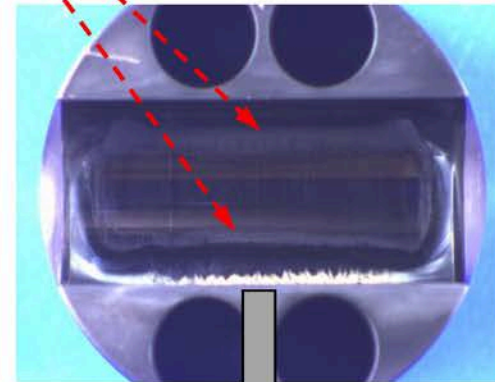
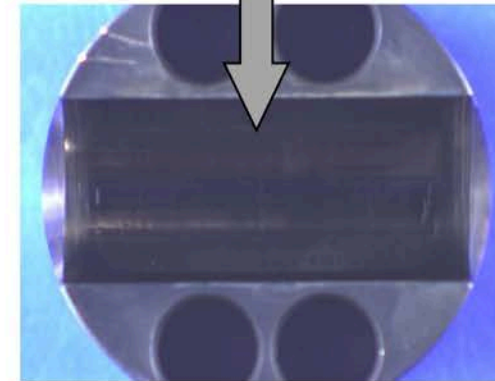
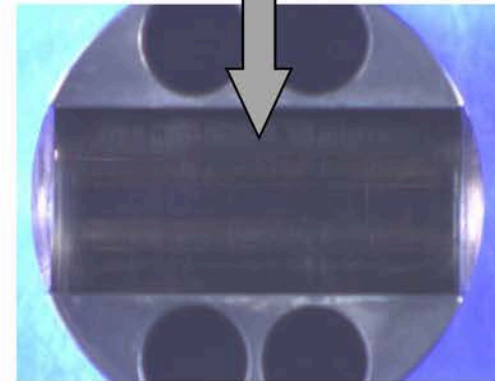
**Hard, solid deposits**

**Initial state**  
**Series with C3 coating**

**RP1+ RP2**

Roller support  
from test  
2009-CP4\_0728  
**uncleaned)**

Roller support  
from test  
2010-CP4\_304/305  
**uncleaned)**

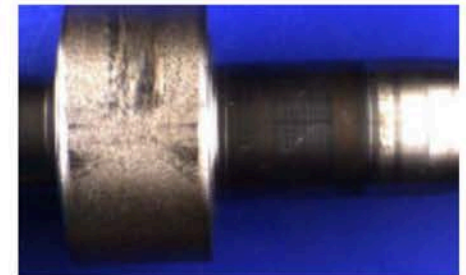
## Damage mechanism on 4 cylinder HFPP

### General cause of 4 cylinder HFPP powertrain damage:

- Inadmissible high mixed friction between the roller and the roller shoe has caused local contact when in operation.
- The C coating of the roller shoe is shattered (wear and the C coating is worn), the friction value increases between the roller and the roller shoe.
- Stiff roller
- Reinforcement factors: Fuel with lower viscosity, raised areas on the roller (melt points) and in the roller shoe (metal splashes), surface of roller/roller shoe

### Following HFPP powertrain damage:

- Swarf formation in the high-pressure fuel pump motor
- Distribution of the swarf throughout the entire fuel system
- Malfunctioning on the HFPP, pressure control valve, RDS, injectors, DHV

⇒ **breakdown**

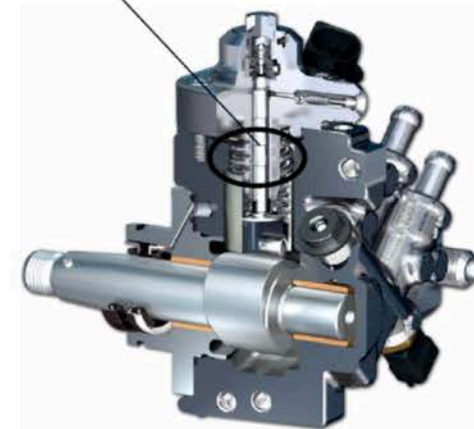
### Anti wear package 0

-> Reduce wear, avoid piston seizures

-> Improved resistance to wear, reduced wear

Pump piston

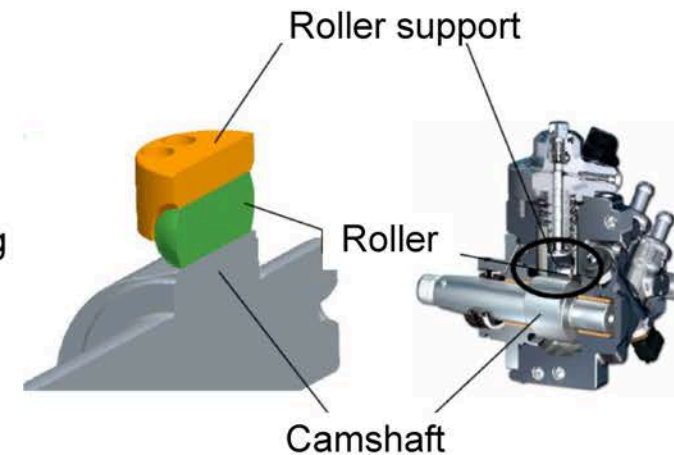
### Anti wear package 1

- > Increase of lubricating film thickness (approx. factor of 2), proven by test results

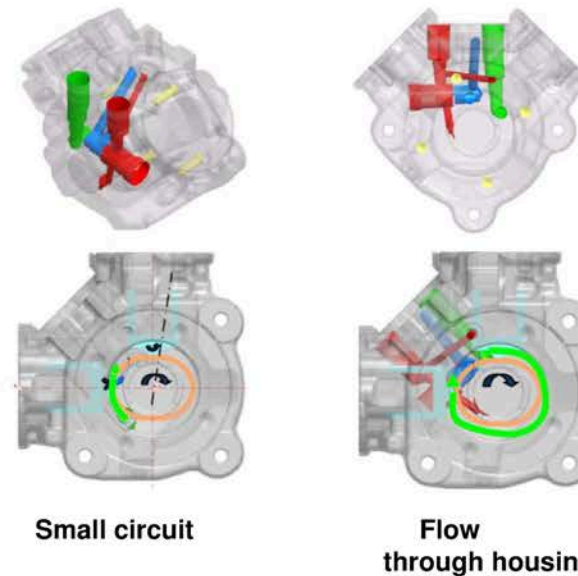
### Anti wear package 2

-> Significant drop in temperature (>15°C)

#### Change of supply flow and return bore

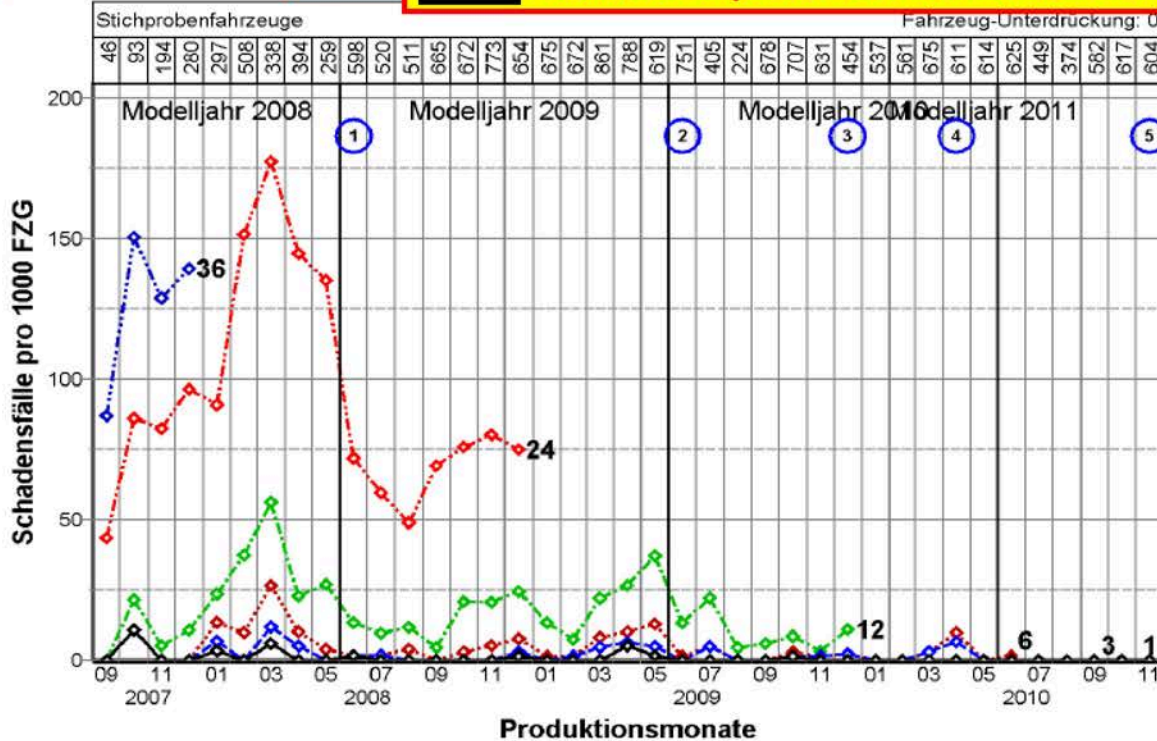
Continual improvement from MY08 → to MY11

- 1. Neuer Lieferant Laufrolle  
Optimierung C-Schicht-Prozess Rollenschuh
- 2. Entfall Strahlen Nockenwelle  
C2- statt C3-Schicht laufrollenkuppe  
Kamera-Prüfung Rollenschuh  
Weitere Optimierung C-Schicht-Prozess Rollenschuh  
Mehrbetankung für
- 3. KW-Waschen Rollenschuh vor C-Beschichten
- 4. Robustheitspaket 1  
C2- statt C3-Schicht Rollenschuh  
Einengung Spiel Laufrolle / Rollenschuh  
Optimierung Laufrollenform  
==> Erhöhung Schmierfilmdicke
- 5. Robustheitspaket 2  
Zu- und Rücklaufanschlüsse vertauscht  
Robuster Flansch  
==> Reduzierung Temperatur im rechten Rollenschuh

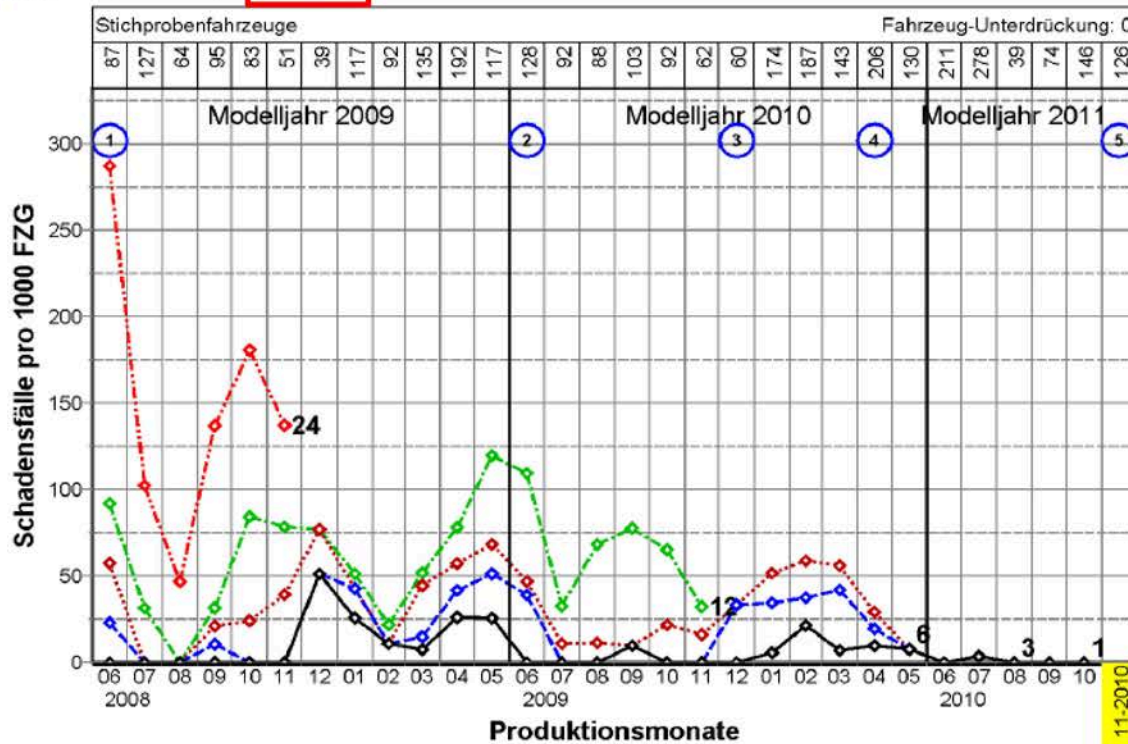
No improvement from MY09 → to MY10 / major improvement from MY10 → to MY11

- 1 **Haarlinealprüfung Laufrolle**  
Neuer Lieferant Laufrolle  
Optimierung C-Schicht-Prozess Rollenschuh
- 2 **Entfall Strahlen Nockenwelle**  
C2- statt C3-Schicht laufrollenkuppe  
Kamera-Prüfung Rollenschuh  
Weitere Optimierung C-Schicht-Prozess Rollenschuh  
Mehrbetankung für Non-responsive content removed
- 3 **KW-Waschen Rollenschuh vor C-Beschichten**
- 4 **Robustheitspaket 1**  
C2- statt C3-Schicht Rollenschuh  
Einengung Spiel Laufrolle / Rollenschuh  
Optimierung Laufrollenform  
==> Erhöhung Schmierfilmdicke
- 5 **Robustheitspaket 2**  
Zu- und Rücklaufanschlüsse vertauscht  
Robuster Flansch  
==> Reduzierung Temperatur im rechten Rollenschuh

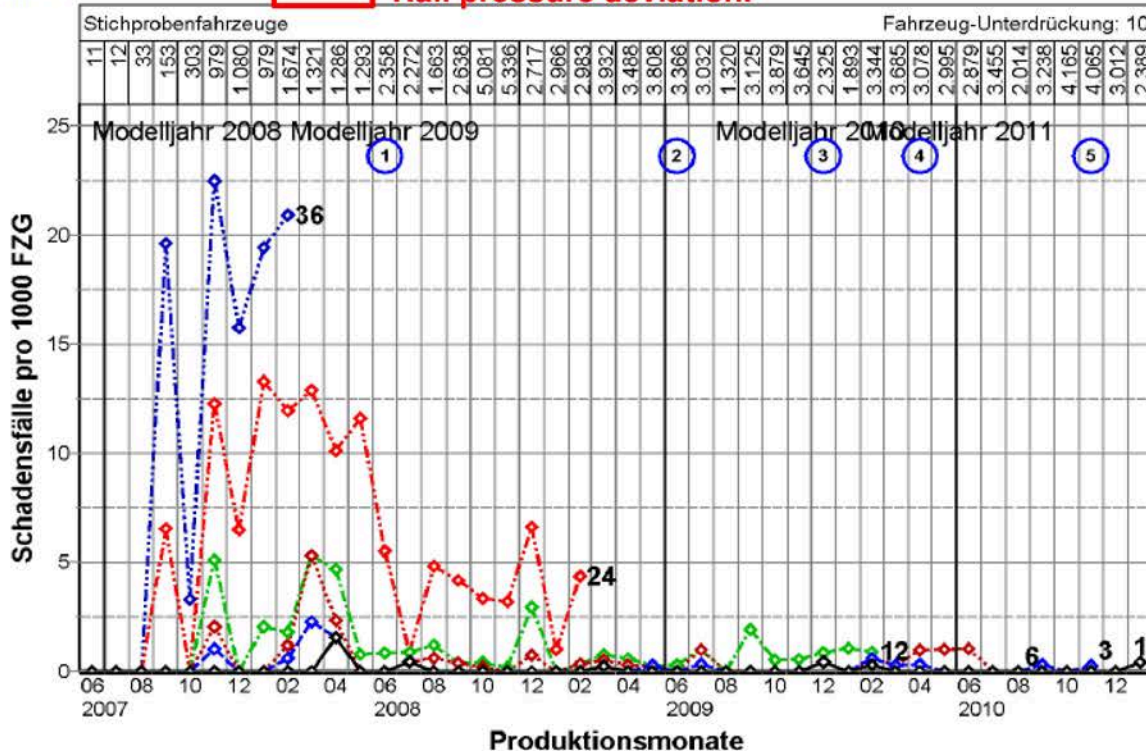
**D: Improvement from MY08 → to MY09 / then stagnation due to ambient noises, rest k.F.f. / Rail pressure deviation.**

- 1 **Haarlinealprüfung Laufrolle**  
Neuer Lieferant Laufrolle  
Optimierung C-Schicht-Prozess Rollenschuh
- 2 **Entfall Strahlen Nockenwelle**  
C2- statt C3-Schicht laufrollenkuppe  
Kamera-Prüfung Rollenschuh  
Weitere Optimierung C-Schicht-Prozess Rollenschuh  
Mehrbetankung für Non-responsive content removed
- 3 **KW-Waschen Rollenschuh vor C-Beschichten**
- 4 **Robustheitspaket 1**  
C2- statt C3-Schicht Rollenschuh  
Einengung Spiel Laufrolle / Rollenschuh  
Optimierung Laufrollenform  
==> Erhöhung Schmierfilmdicke
- 5 **Robustheitspaket 2**  
Zu- und Rücklaufschlüsse vertauscht  
Robuster Flansch  
==> Reduzierung Temperatur im rechten Rollenschuh

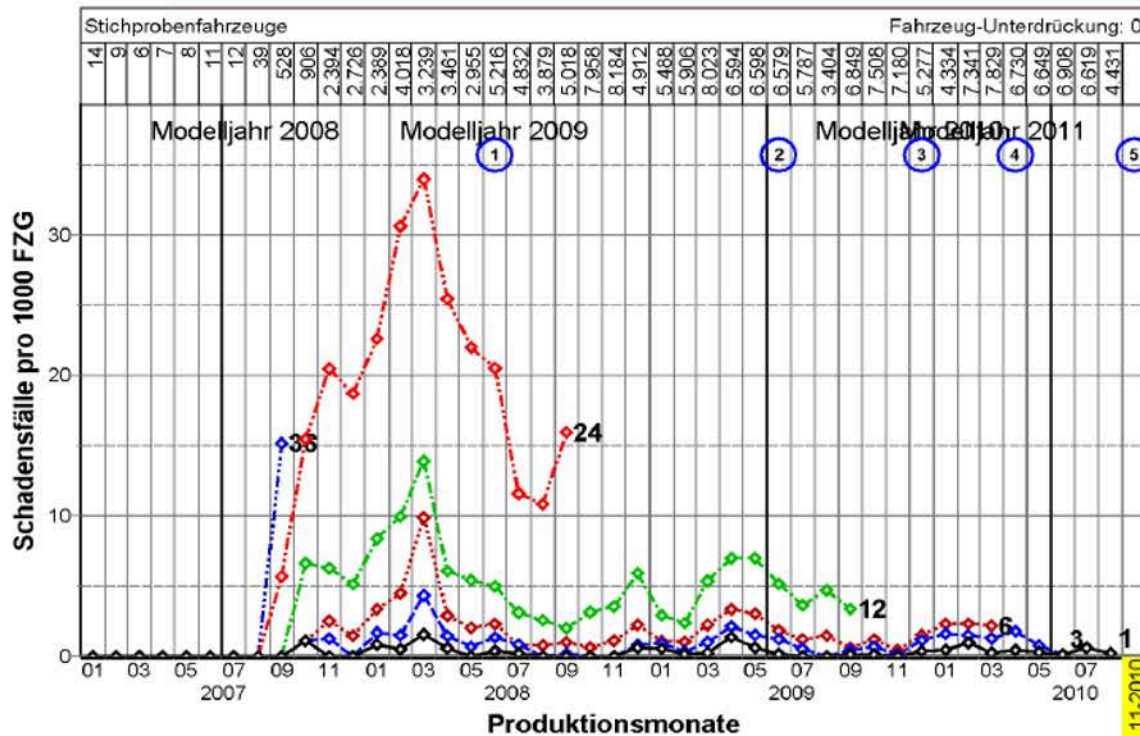
Non-responsive content removed **Except MY10, continual improvement from MY08 → to MY11**

- Haarlinealprüfung Laufrolle**  
 Neuer Lieferant Laufrolle  
 Optimierung C-Schicht-Prozess Rollenschuh
- Entfall Strahlen Nockenwelle**  
 C2- statt C3-Schicht laufrollenkuppe  
 Kamera-Prüfung Rollenschuh  
 Weitere Optimierung C-Schicht-Prozess Rollenschuh  
 Mehrbetankung für
- KW-Waschen Rollenschuh vor C-Beschichten**
- Robustheitspaket 1**  
 C2- statt C3-Schicht Rollenschuh  
 Einengung Spiel Laufrolle / Rollenschuh  
 Optimierung Laufrollenform  
 ==> Erhöhung Schmierfilmdicke
- Robustheitspaket 2**  
 Zu- und Rücklaufanschlüsse vertauscht  
 Robuster Flansch  
 ==> Reduzierung Temperatur im rechten Rollenschuh

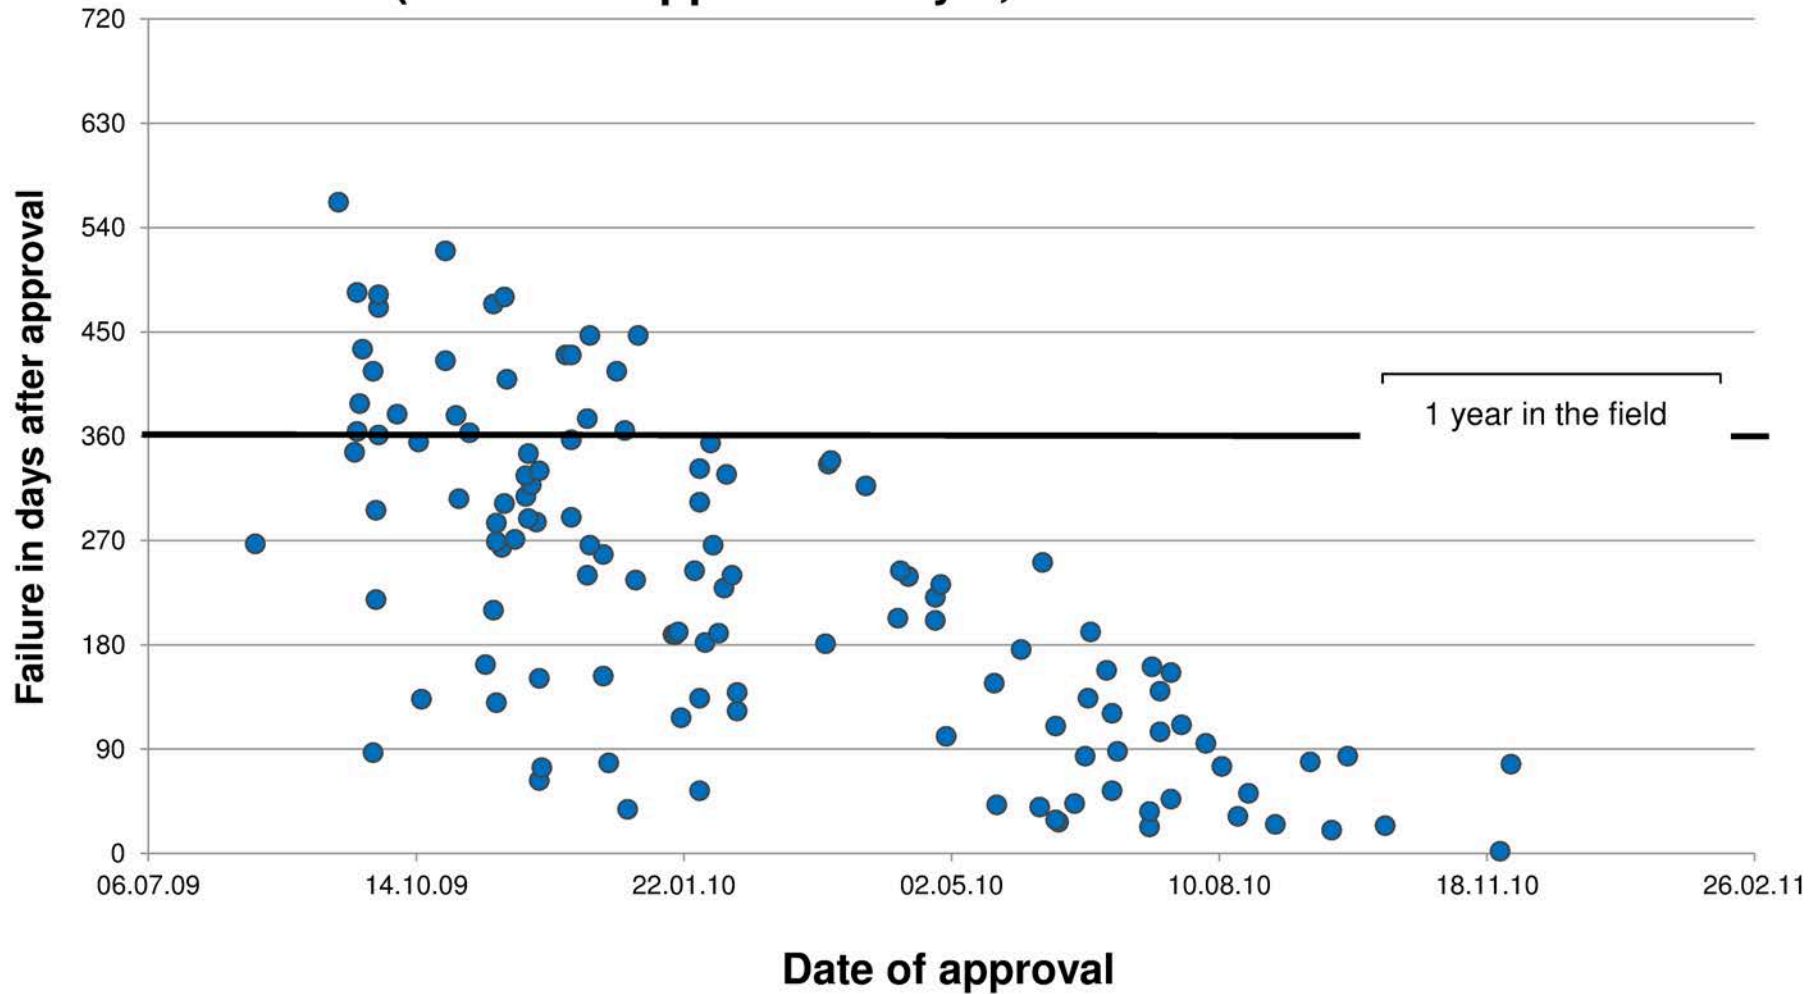
**Non-responsive content removed** - 123 failures in days after approval  
(based on approximately 4,500 sold vehicles)
