From: Non-responsive content removed
To: [Redacted]
CC: [Redacted]
Date: 8/25/2011 11:52:00 AM
Subject: ANS: HP from endurance run for diagnosis
Attachments: [VW361MECM01-0S 19808 mls 18.06.2011mit Motor aus.txt](#)
[Tankkarte VW361MECM01-0S.PDF](#)

Here is the story of the HPP from MNS (Q verification run, failure at 31,874 km)

Serious problem in [REDACTED] verification run

Component damage in CR development

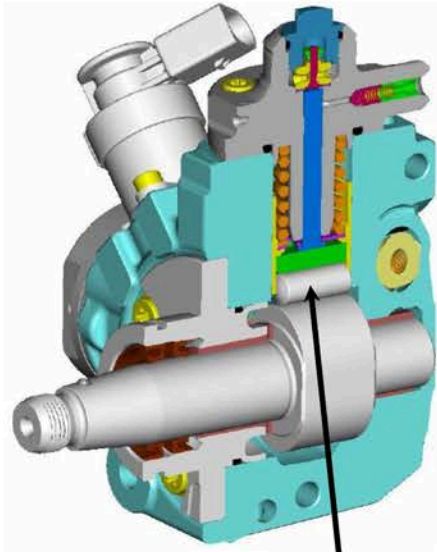
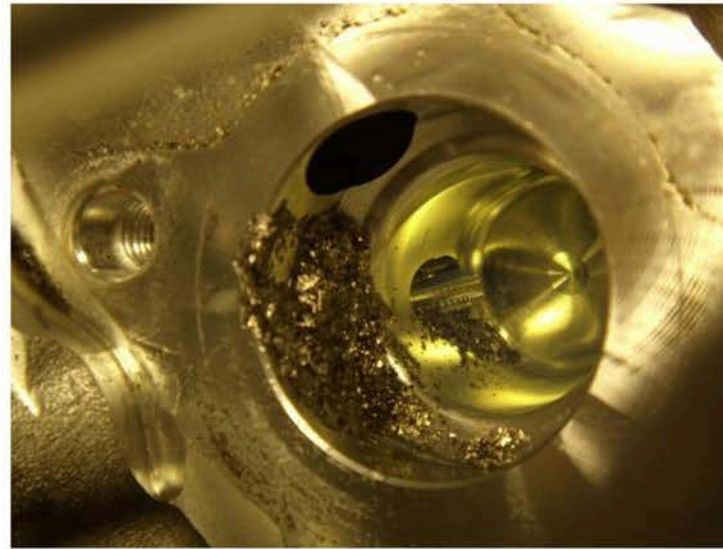
Right roller tappet

Analysis: 1st failure: Preliminary damage due to sluggish roller

2nd failure: Analysis at Bosch WK 28/08
Fuel analysis in [REDACTED] WK 29/08

3rd failure: HPP newest version. Parts sent to [REDACTED] for analysis

4th failure: HPP with DM 01/08 HPP exchanged in USA in WK28/08
Parts sent to [REDACTED] for analysis. Initial result WK 29/08

Anti-wear measures implemented by 04/07/2008.

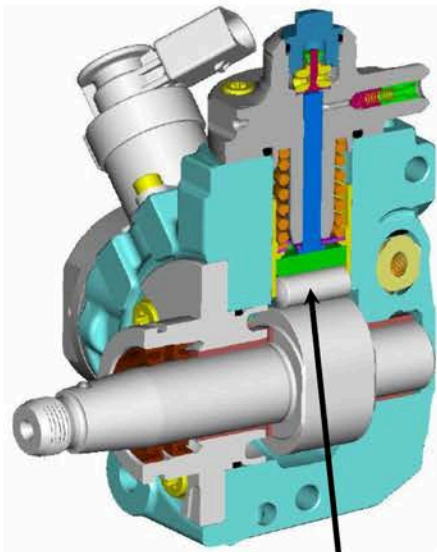
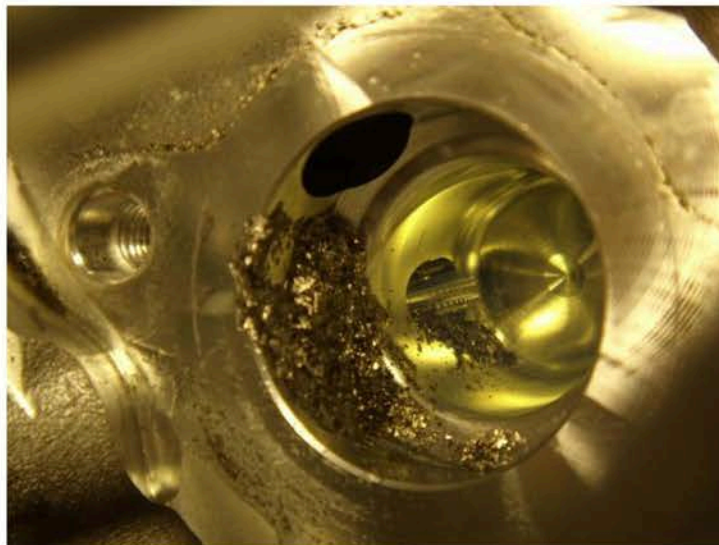
Right roller tappet

Analysis: 1st + 2nd failure: Preliminary damage due to sluggish roller

3rd failure: HPP newest version. Parts to Bosch for analysis

4th failure: HPP exchanged in USA in WK28/08
Parts to Bosch for analysis Initial result WK 30/08

Statement from Bosch: Failures are not U.S.-specific, series is also affected

Anti-wear measures implemented by 04/07/2008.

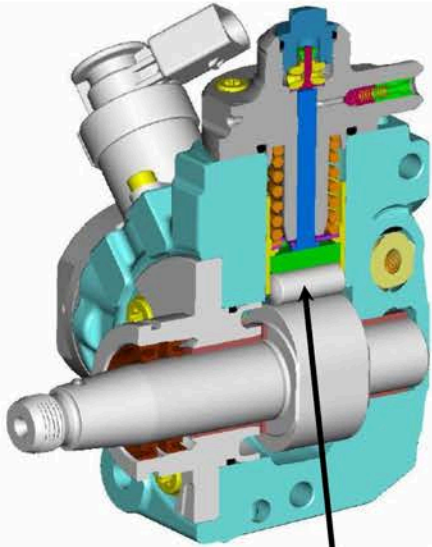
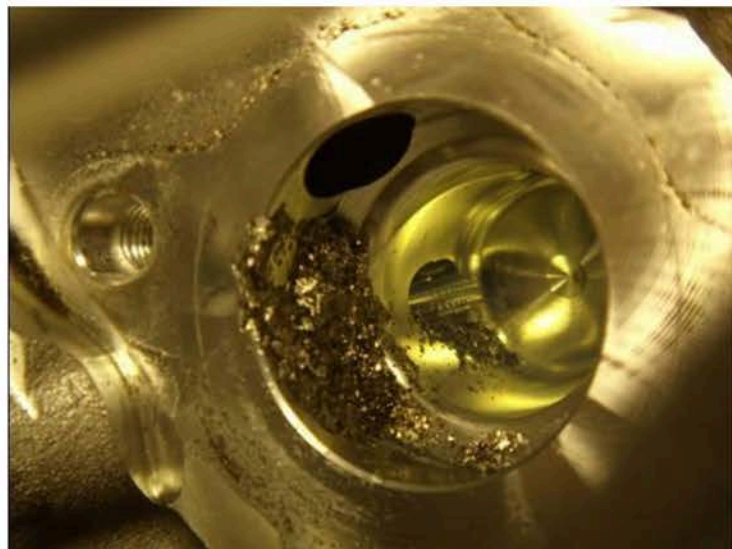
Right roller tappet

Analysis: 1st + 2nd failures: Preliminary damage due to sluggish roller

- 3rd failure:
- **No drivetrain damage.** Lateral roller start-up inconspicuous
 - Black particles on MU and OV strainers -> Fuel analysis underway
 - No particles found in intake valve/non-return valve

4rd failure: Parts to Bosch for analysis on 07/22/08 Initial result WK 30/08

Cause of drivetrain damage is a "sluggish roller".

Failures are not U.S.-specific, series is also affected.
