Subject: Re: SK31600010

Particle analysis - CP4.1-18 (interim report for strainer contamination)

EA189 2.0l CR Field Complaints**-High-Pressure Fuel Pump – U.S. Field Failures**

Problem: Drivetrain damage HPP

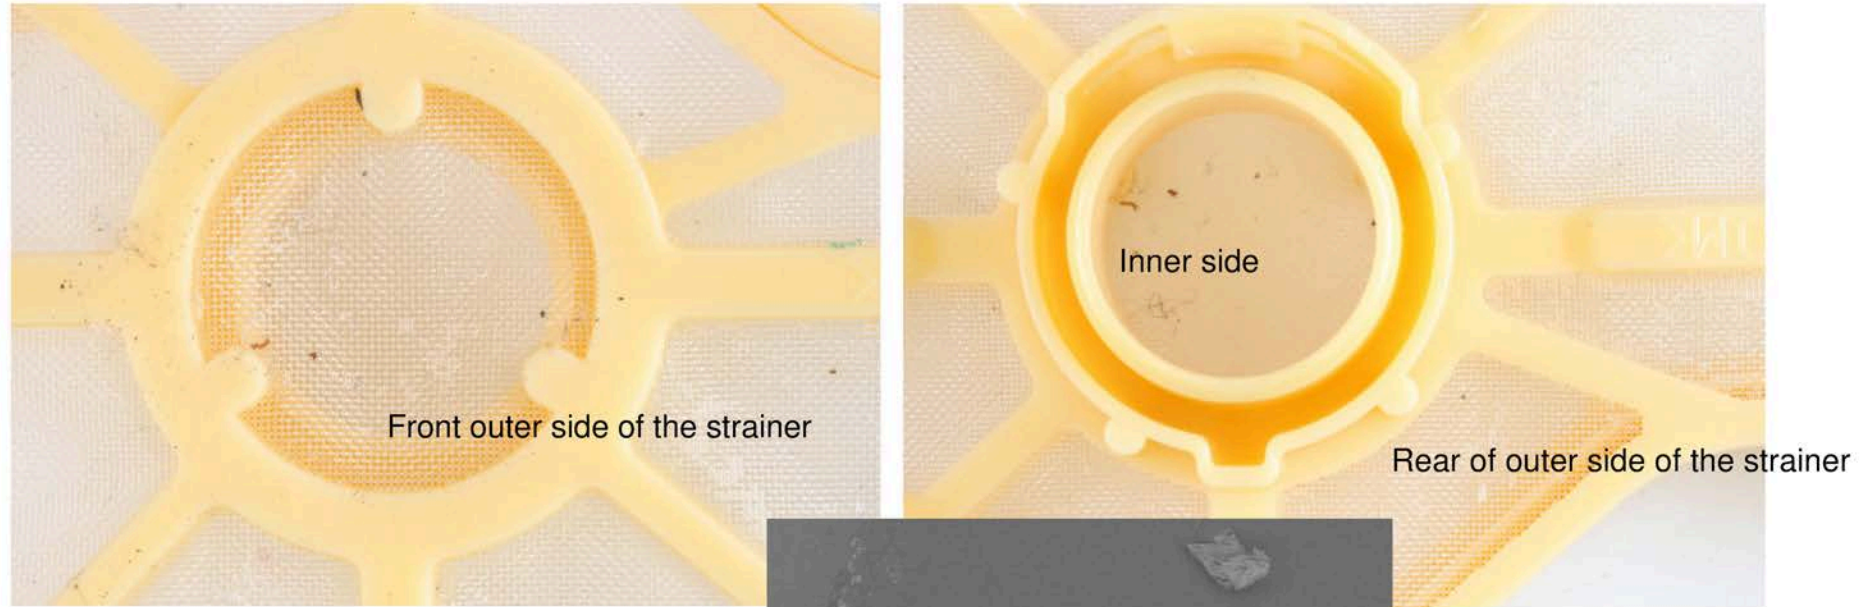
Analysis of the chips from the strainer of vehicle VW411 1-0080

Particles made of iron up to maximum 100 µm in size as well as particles and chips made of polymer on the front outer side of the strainer

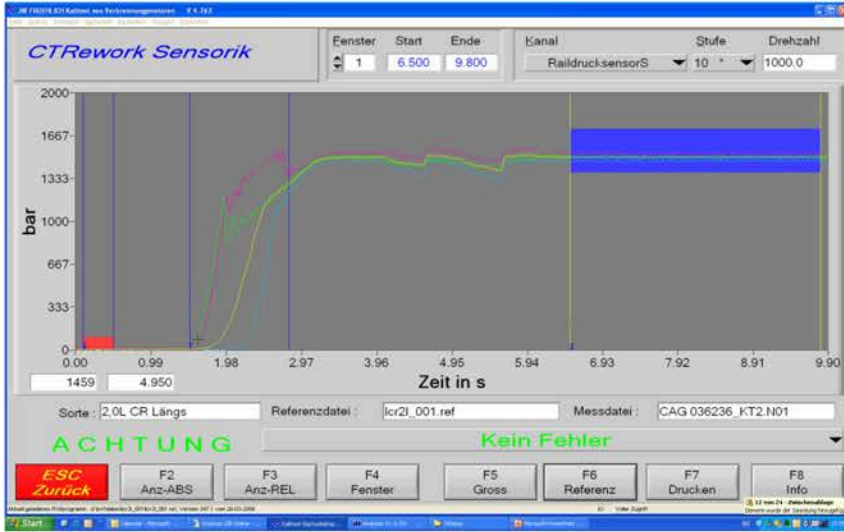
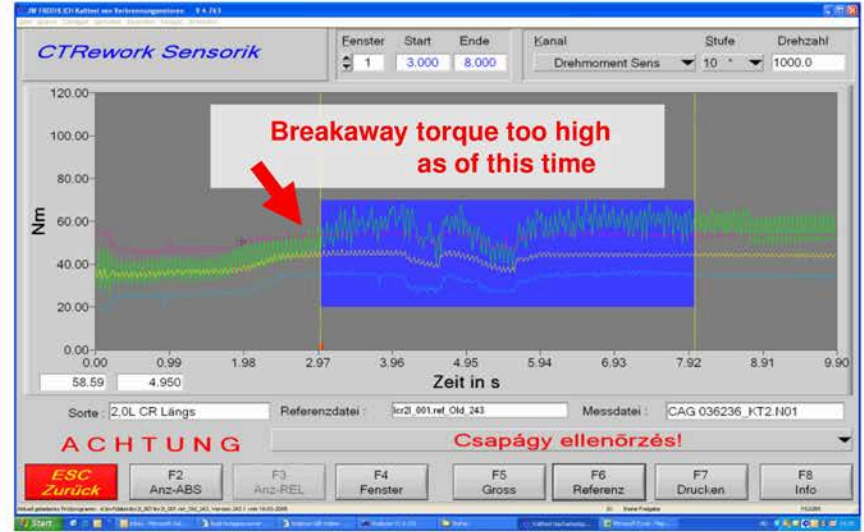
Rail pressure build-up and kept stable, but the torque curve has run up since approx. the second third to a level that is greater than the reference curves

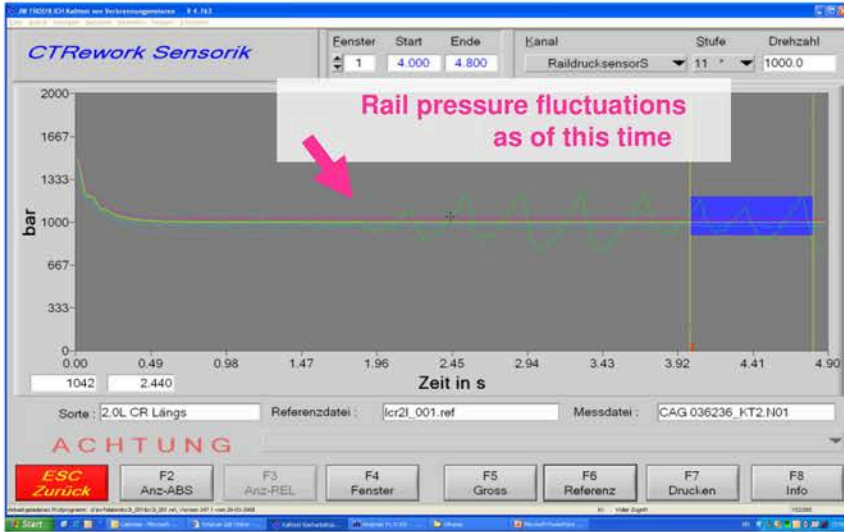
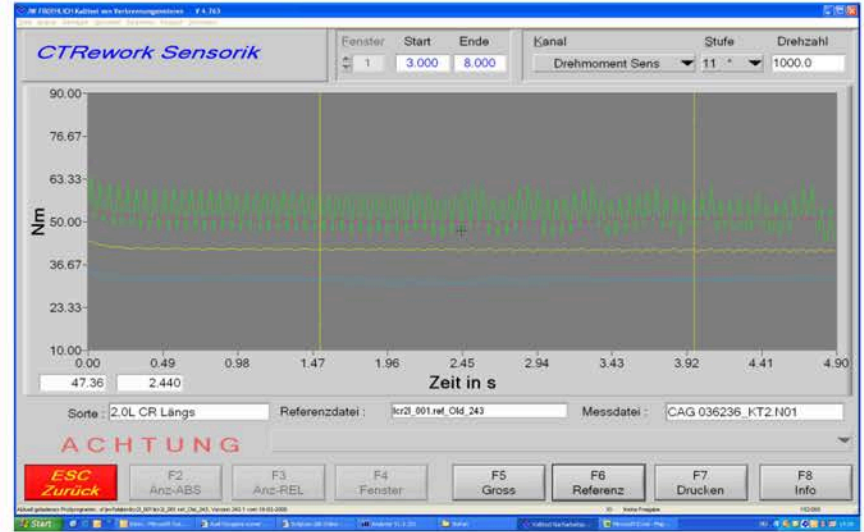
Within a few minutes, considerable rail pressure fluctuations occurred, breakaway torque remaining too high

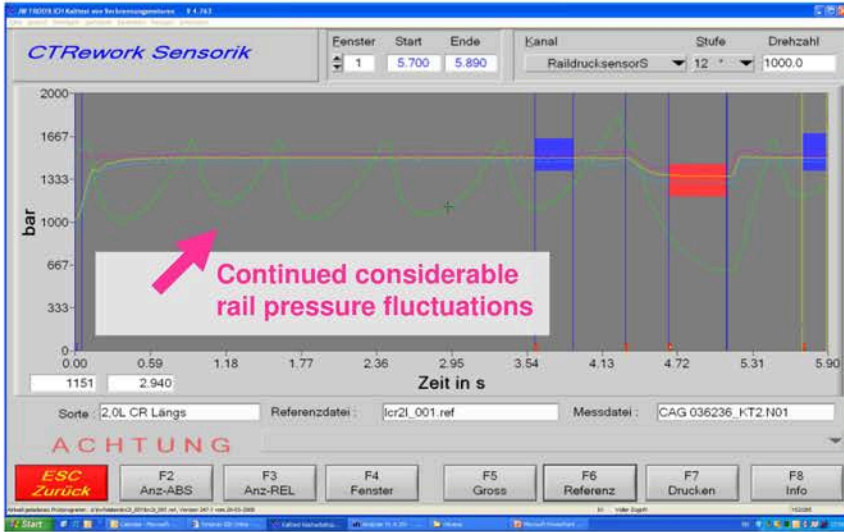
Rail pressure in the further phases of the testing were always unstable, engine not OK
