Status problems/measures CP 4
crack in oil seal

Status problems/measures CP 4.1 (4 cylinder) crack in oil seal: **Summary**

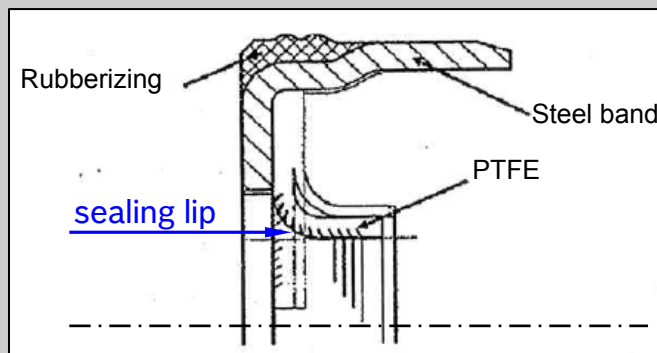
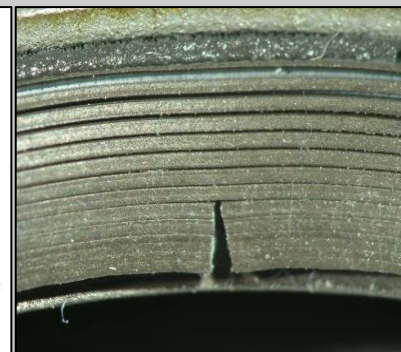
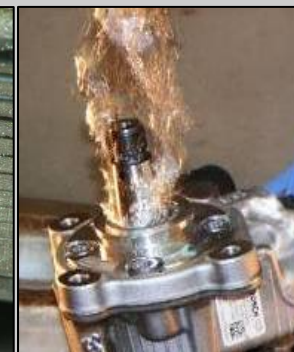
Problem	Leaking CP4 due to crack in oil seal	
Cause	<input type="checkbox"/>	Process temperature exceeded when pressing on the oil seal blanks at the supplier
Status	<input type="checkbox"/>	27 0 km (12 VW, 15 Audi), 7 (+ 5 not yet confirmed) VW field complaints
Immediate measure	<input type="checkbox"/>	Pulse bubble test of ongoing series production and warehouse stocks at Bosch and VW Group plants until clean date from 08/18/2010, done.
Corrective measures		Introduction of an additional air-conditioning system in the press space 07/23/2010, done
		Investigation of the temperature and flow profile in the press space by Bosch room climate experts (incl. temperature measurement with 10 sensors and data logger) 09/1-2/2010, done.
		Reduction of the limit temperature of room monitoring 09/20/2010, done.
		Concept for optimizing the room air conditioning 11/26/2010
		Direct, proximity-type temperature measurement of the billet under examination 11/26/2010
