# Audi - Bosch reliability program

## CP4 diesel high-pressure fuel pump in CR injection systems from 1800 bar (EU5)

Field failures V6 diesel high-pressure fuel pump CP4.2 - Non-responsive content removed

**Trouble ticket – Failure of high-pressure fuel pump in EC ER**

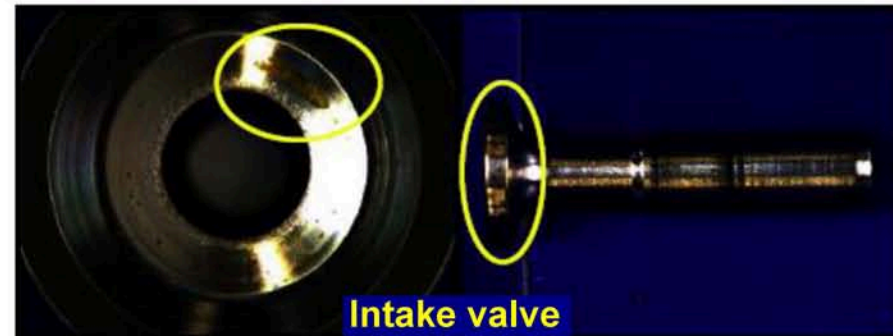
- Standard pump 0445010613
- Date of manufacture 04/2008 (i.e. before the introduction of the straightedge test and further quality improvement measures with respect to metal splashes / fusing on the roller or roller support)
- Drivetrain damage category I
- Circumferential abrasive wear and fatigue on cam track and roller
- Large areas of C coating in roller support worn

- Little evidence of periods of use with water in fuel (corrosion)
- The advanced state of the damage means that there is no longer any possibility of identifying anything unusual about the manufacture of the roller support or roller

**Summary:**

- The cause of the damage is no longer ascertainable
- Indications of periods of use with water in fuel. Evidence is too weak to enable definite conclusions to be drawn in relation to the cause of the damage.

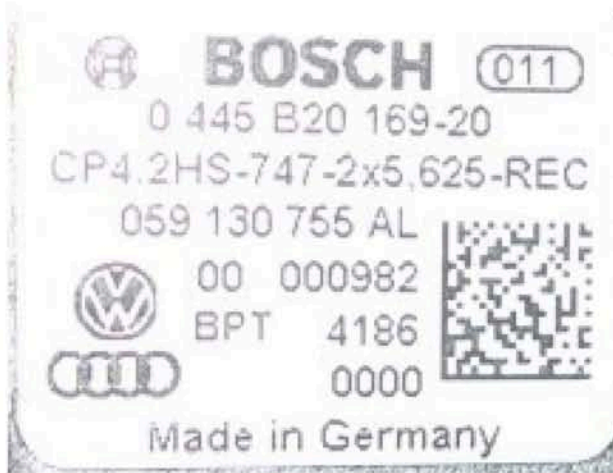
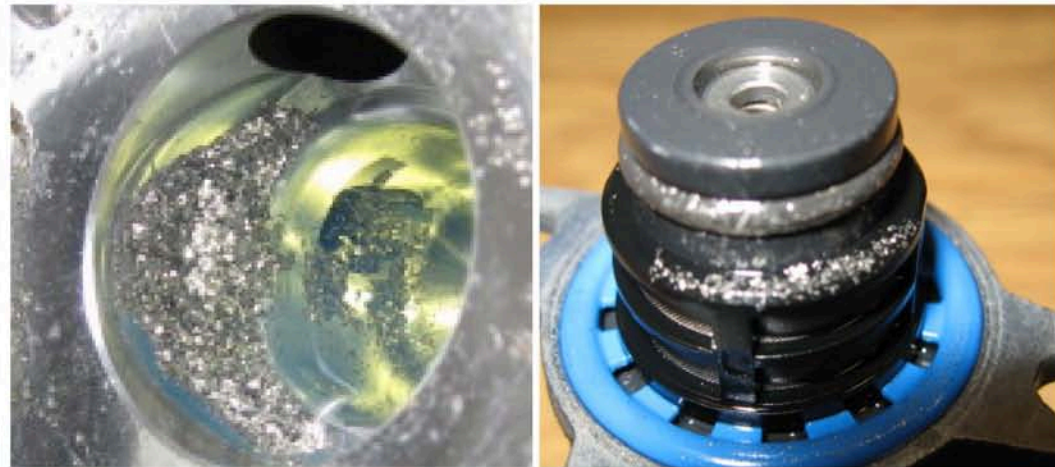
Vehicle: Q7 AU716 90229 MY10

Mileage: 89,543 mls (144,075 km)

- Sample pump 0445B20169\_20
- Date of manufacture 02/2009
- Drivetrain damage category I
- Circumferential abrasive wear on cam track and roller
- Large areas of C coating in roller support worn

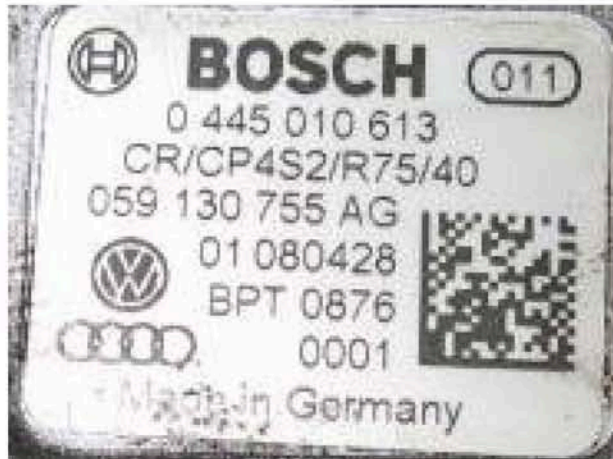
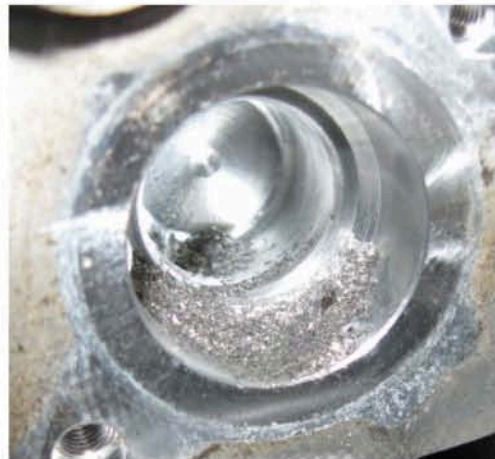
**Vehicle:** Q7 AU716 90390 MY10

**Mileage:** 88,426 mls (141,925 km)

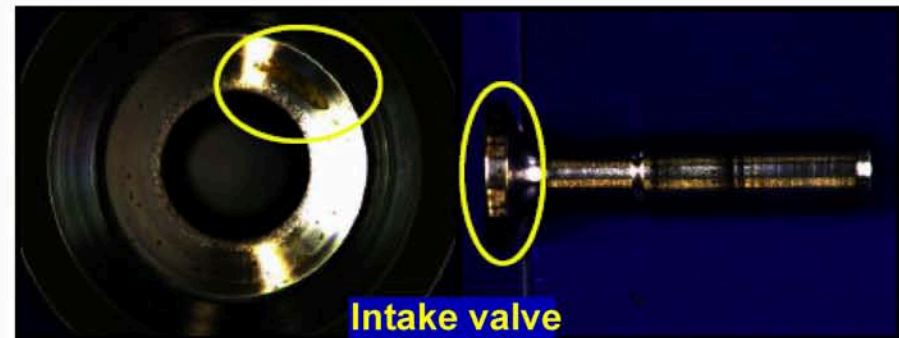
- The cause of the damage is no longer ascertainable
- Indications of periods of use with water in fuel.

Evidence is too weak to enable definite conclusions to be drawn in relation to the cause of the damage.

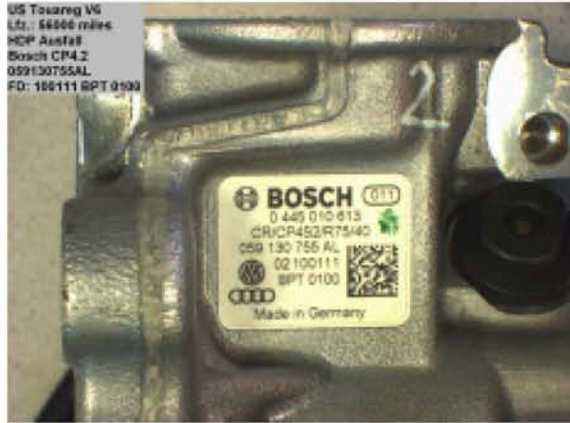
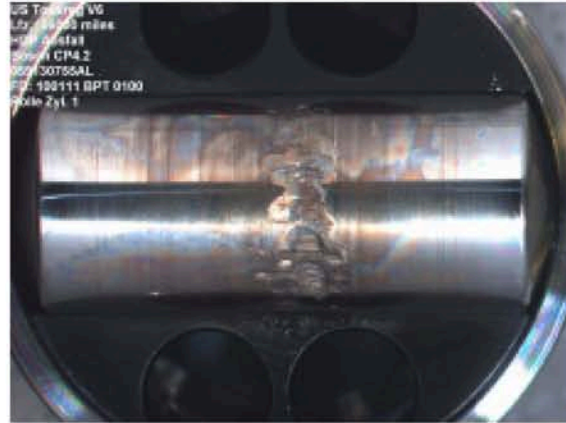
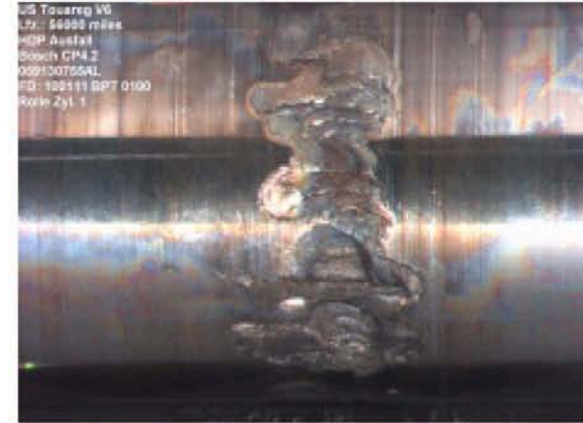
Roller cylinder 1

# Status of Touareg failure with Bosch CP 4.2
