**Subject:** Documents for Q offensive

**From:** Non-responsive content removed  
**To:** [REDACTED]  
**CC:**  
**Date:** 2/6/2009 4:33:00 PM  
**Subject:** CP4 robustness  
**Attachments:** [Bemerkung zur Robustheit CP4.doc](#)

**CC:**  
**Date:** 18/02/2008 14:24:23  
**Subject:** Minutes and attachments for CP4 technical discussion on 13/02/2008 in [redacted]  
**Attachments:** [882801 Protokoll CP4 Fachgespräch am 13.02.08 bei \[redacted\].pdf](#)  
[Übersicht DL-Ppen für Audi.pdf](#)  
[CP4 Audi\\_080213.pdf](#)

**From:** Non-responsive content removed  
**To:** [REDACTED]  
**CC:** [REDACTED]  
**Date:** 12/3/2010 3:58:22 PM  
**Topic:** RE: RP1 Failure USA \_BC / QTS 3833800  
**Attachments:** [4A970 Zwischenbericht.pdf](#)

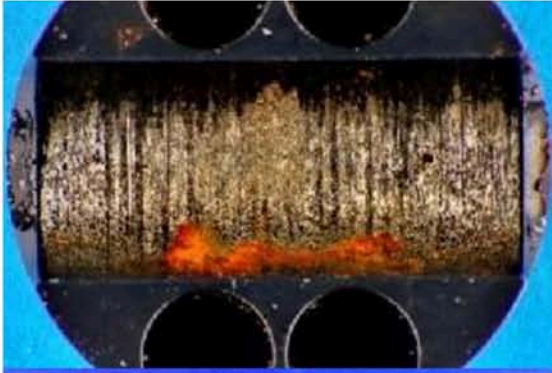
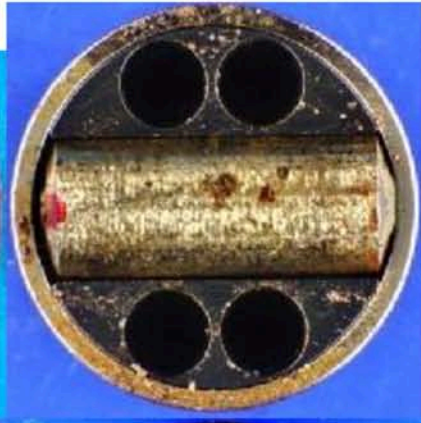
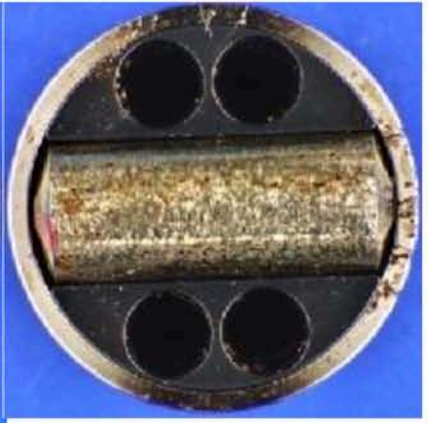
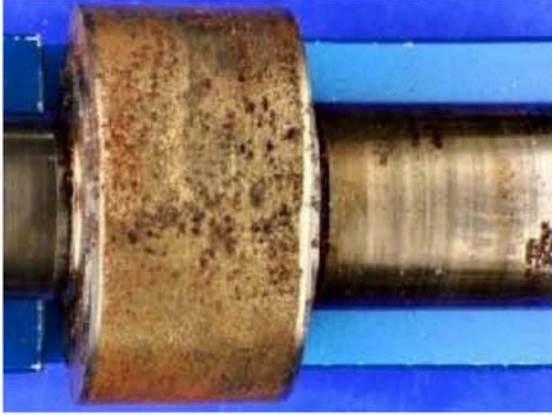
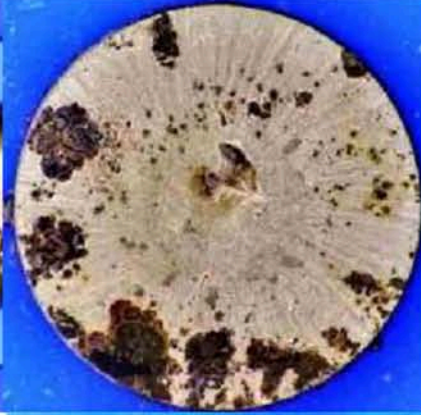
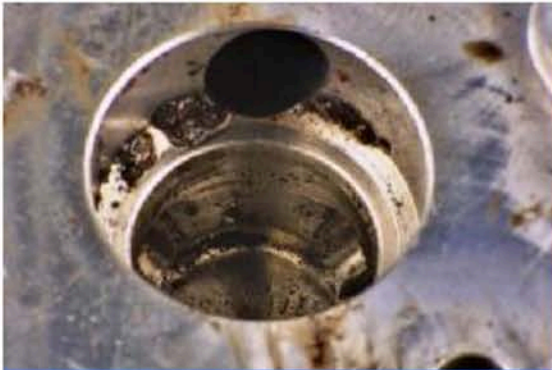
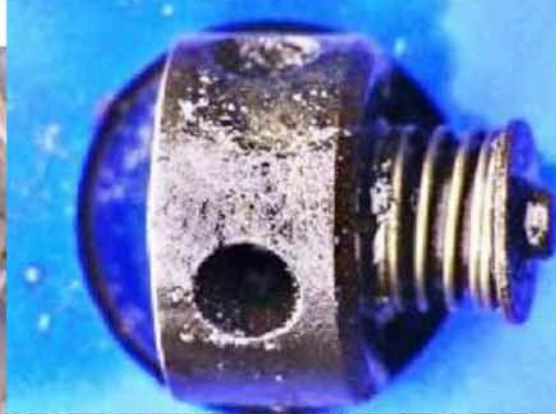
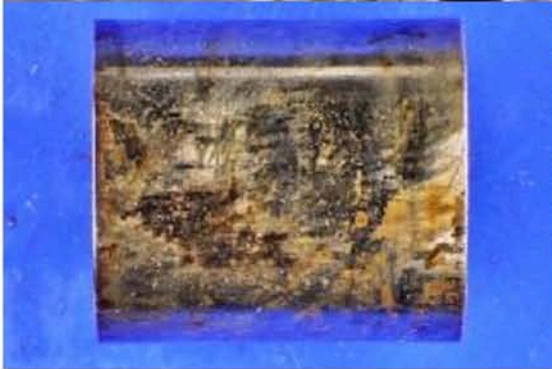
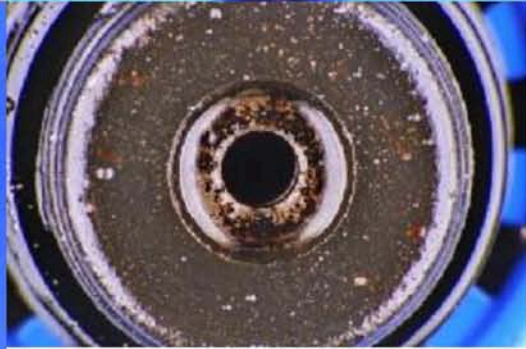
**Summary:**  
Deposits were found on all pump parts.  
Drivetrain damage occur only when the pumps are operated outside of the technical customer document (fuel type, air, starting conditions, temperature).  
We must reject the complaint for this reason.
