**Weekly report Service Technology WK 13/09**

**Audi A4, A5, Q7, Q5 V6 TDI EU 5 – cases of high-pressure fuel pump damage after installation**

**Drivetrain damage, high pressure diesel fuel pump CP4.2**

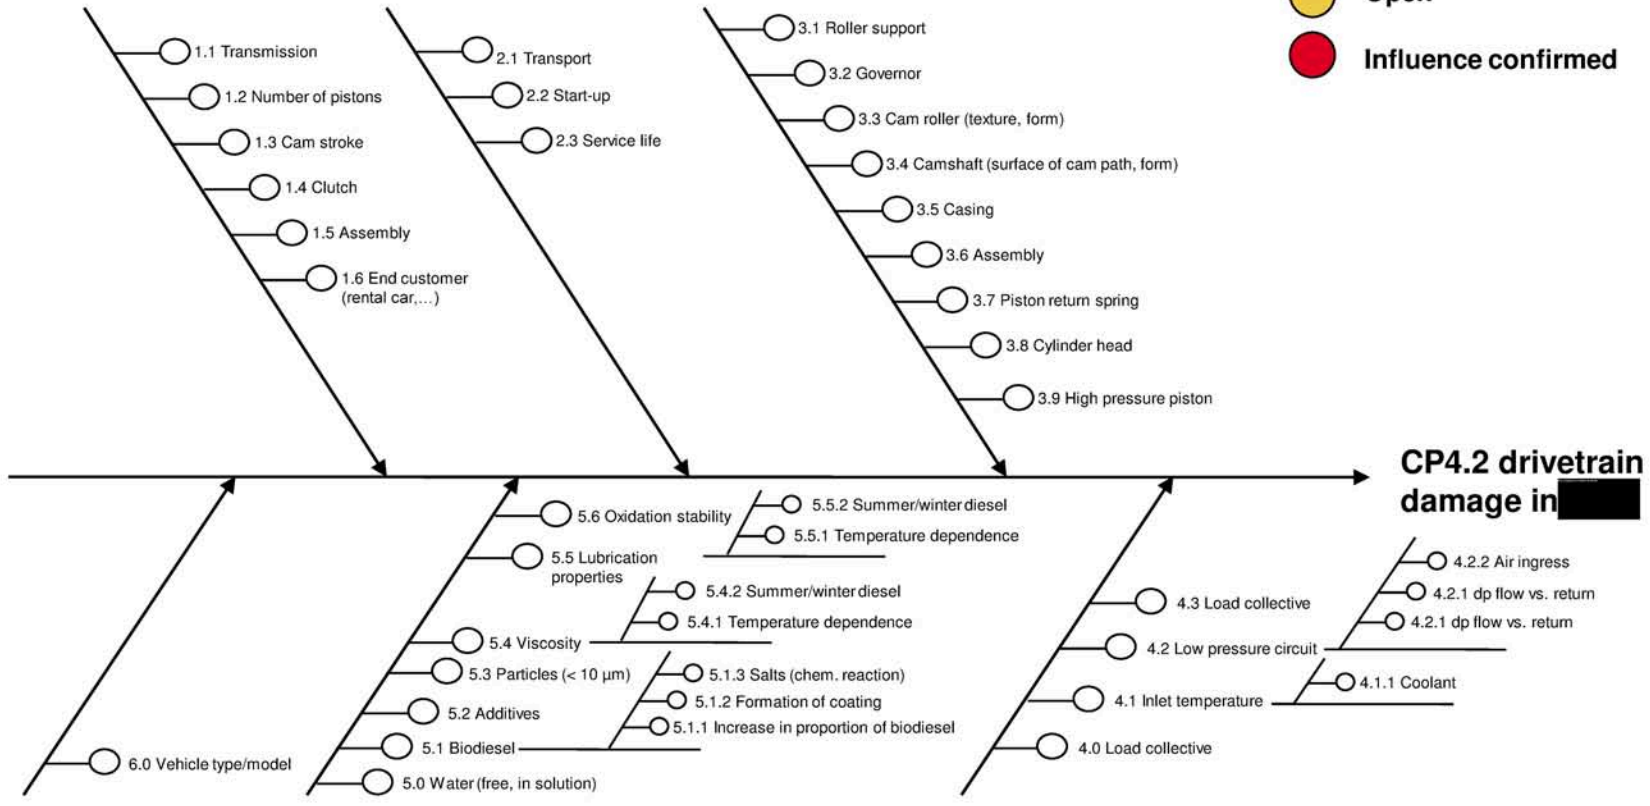
### CP4.2 drivetrain damage in

100% drivetrain damage

Result: CP4: partial coating, high level of WDR wear and signs of wear on the piston. Splinters in the suction valve Major smoothing of the cam shafts on 3 not fully destroyed pumps.

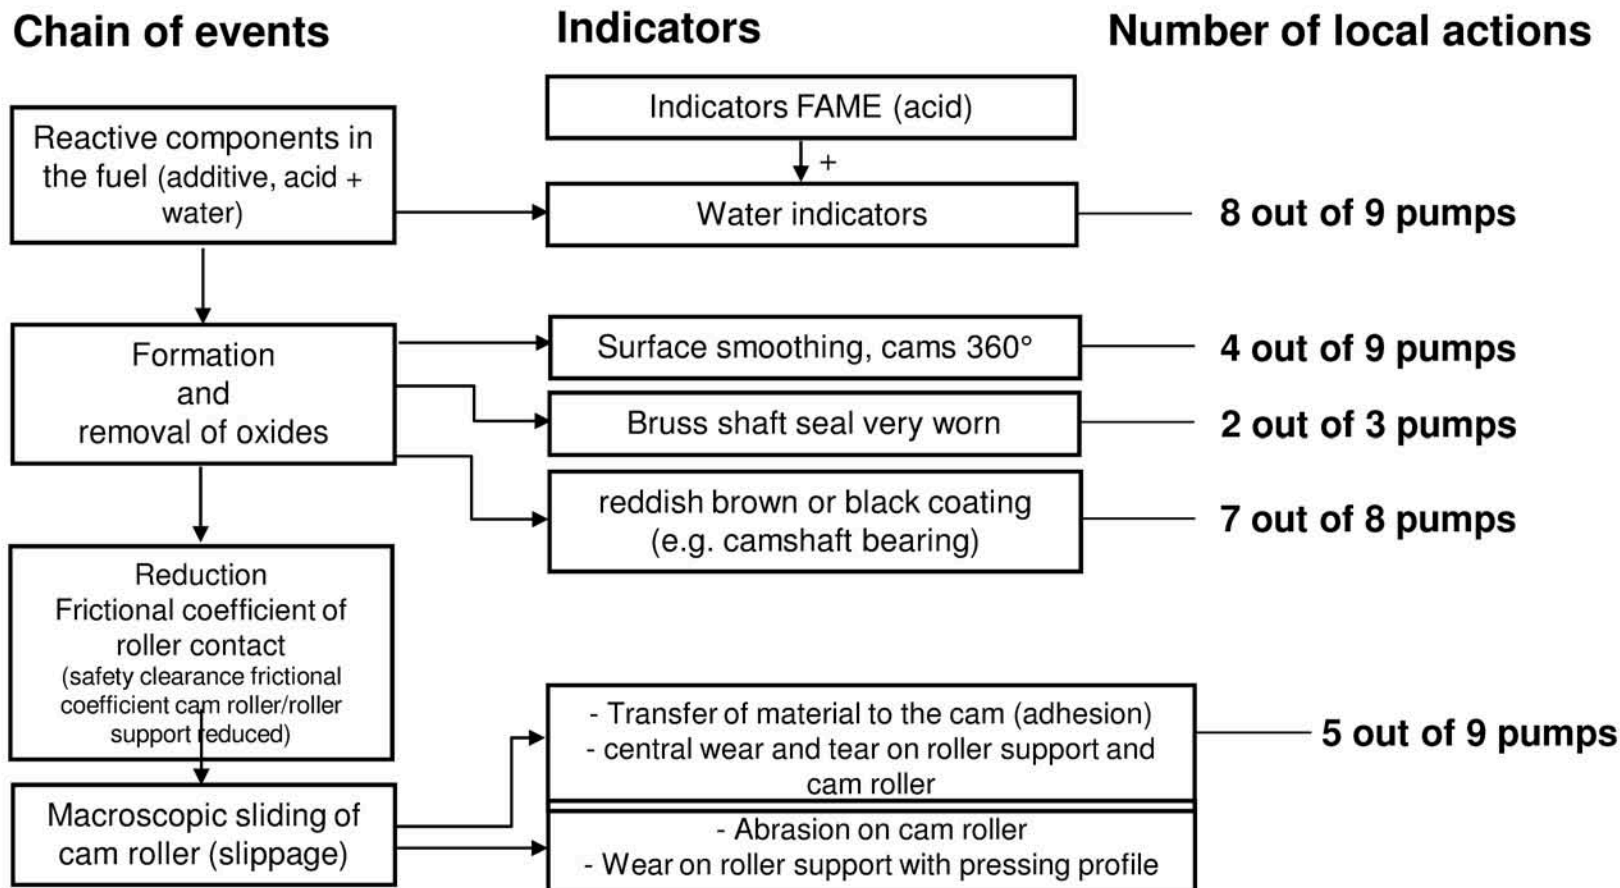
# Failure hypothesis 4: Fuel additives -> Tribochemicals

- Status: 29 pumps analyzed, 9 from FCT action.  
Detailed analysis carried out. 7 damage hypotheses developed.
- Result: 8/9 signs of corrosion, 8/9 black coating,  
4 polished camshafts, 9/9 feature 90° turned tappet.  
Most likely damage hypothesis (see slide 6) is therefore  
tribochemical wear and tear.
- Further action: Further detailed analysis of components and  
fuels from FCT action.
- Special features: Water and acid (twice as high as usual) found probably from  
spilled biodiesel.

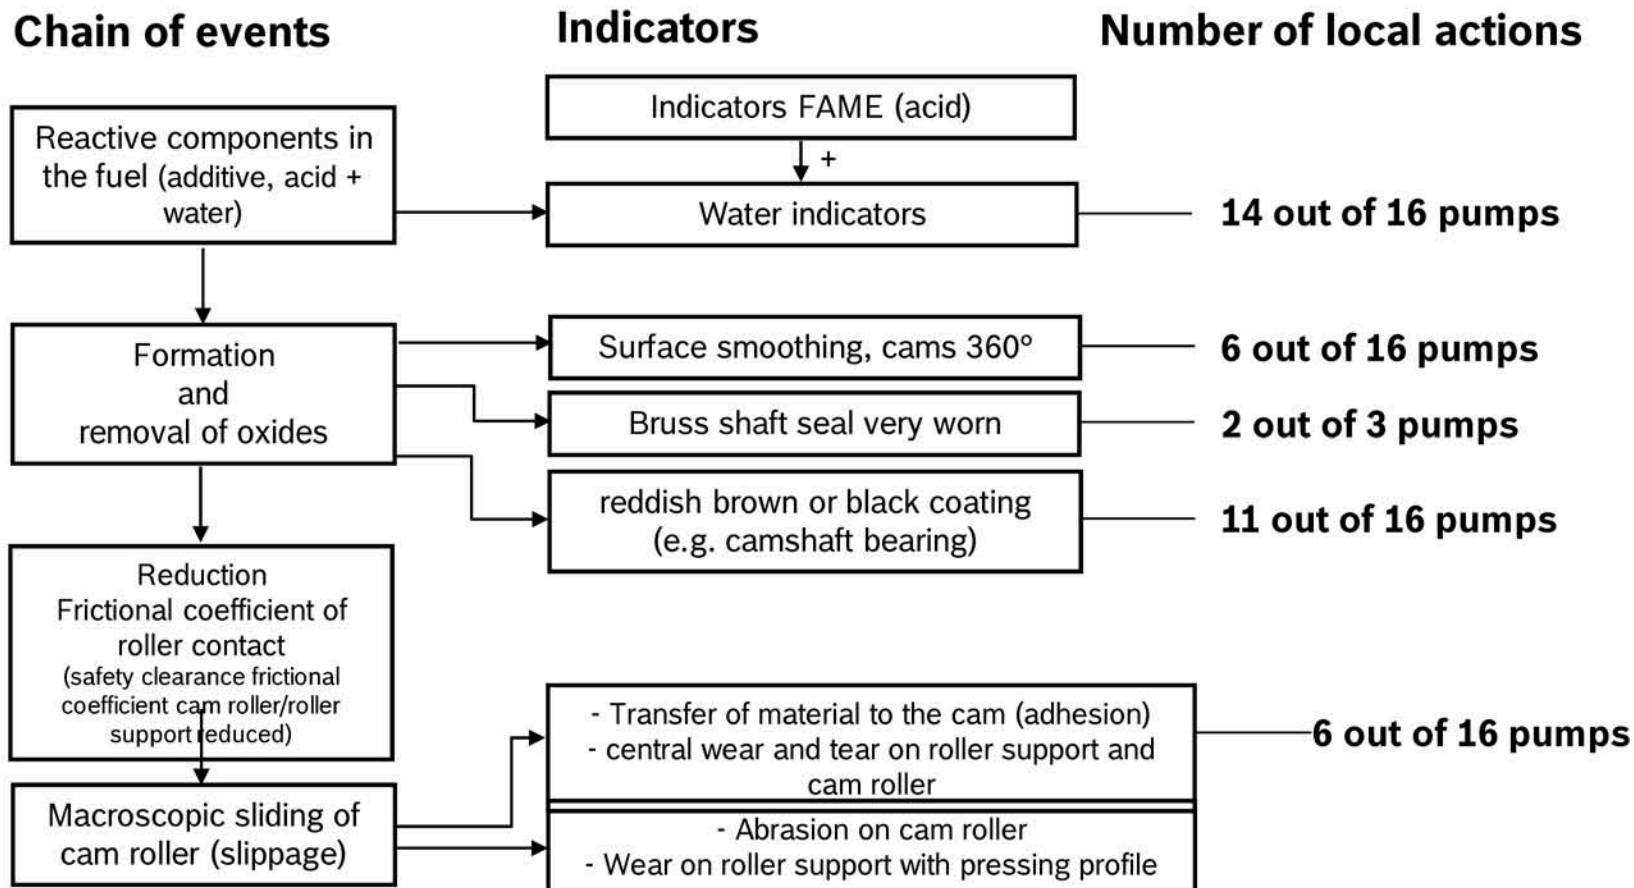
## Failure hypothesis: Fuel additives -> Tribochemicals

- 14/16 signs of corrosion
- 11/16 black coating on cams and bearings (under analysis)
- 6 camshafts smoothed (polished)
- 16/16 feature two tappets turned by 90°
- 2/3 Bruss shaft seals very worn

Most probable damage hypothesis is therefore tribochemical wear and jammed roller due to residue (such as soaps) -> anti-algal products

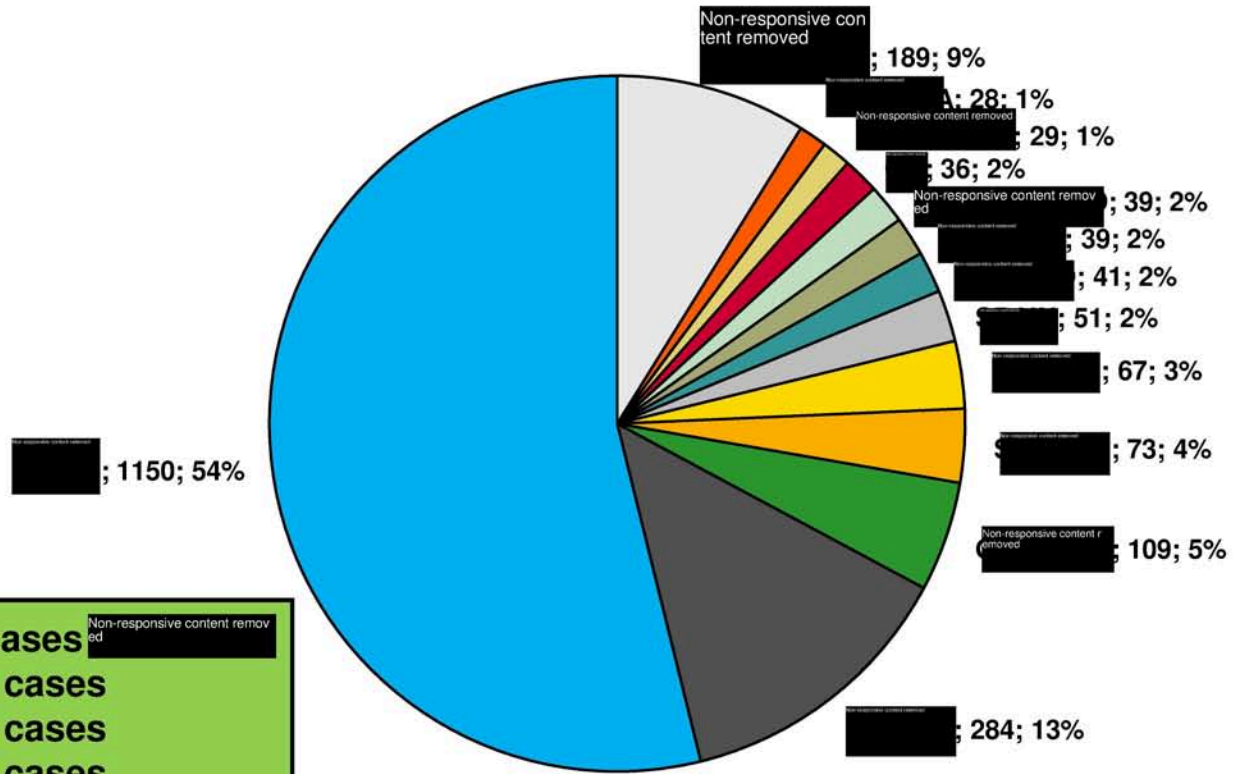
## AUDI V6-TDI failures in the field, broken down by country (SAGA - replaced pumps only, 059A\_/B\_)

**TOTAL V6-TDI: 2.135 cases**  
MY08: 935 cases  
MY09: 1.018 cases  
MY10: 181 cases  
MY11: 1 case  
(SAGA, Stand 05.09.2010)

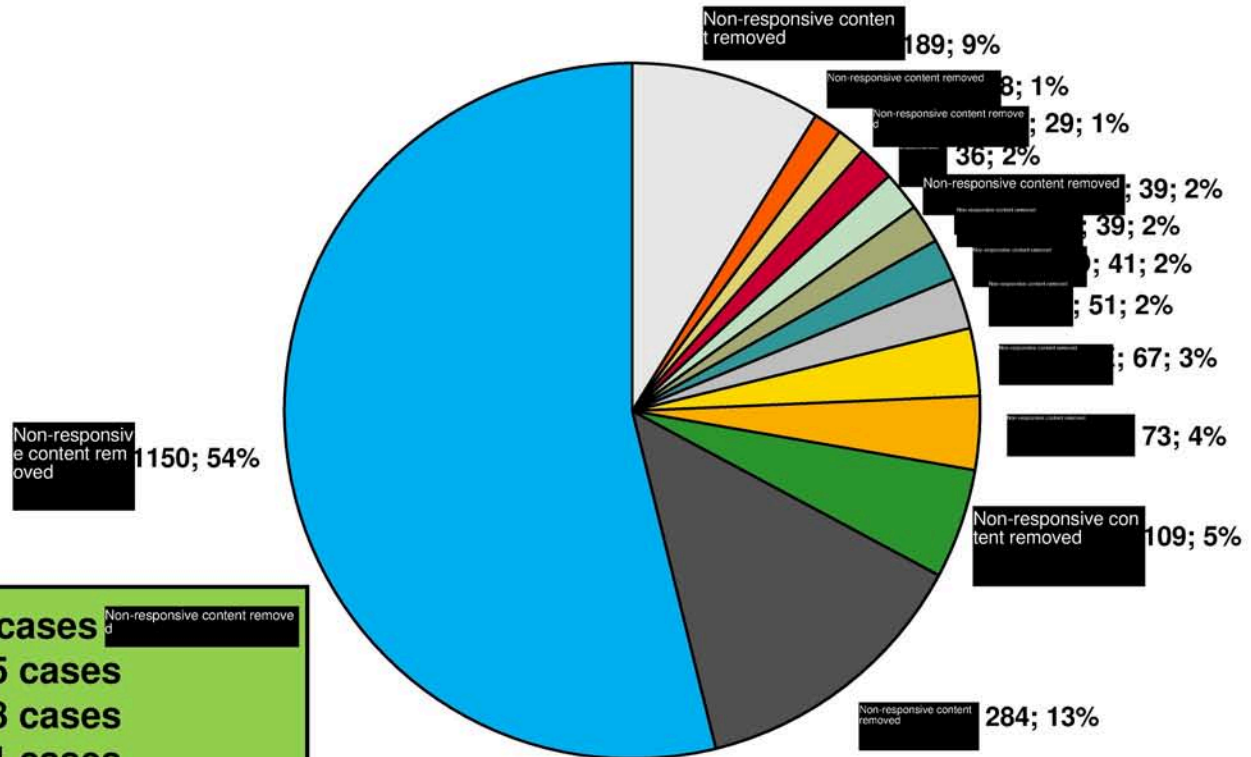
## AUDI V6-TDI failures in the field, broken down by country (SAGA - replaced pumps only, 059A\_/B\_)

**TOTAL V6-TDI: 2.135 cases**  
MY08: 935 cases  
MY09: 1.018 cases  
MY10: 181 cases  
MY11: 1 case  
(SAGA, Stand 05.09.2010)

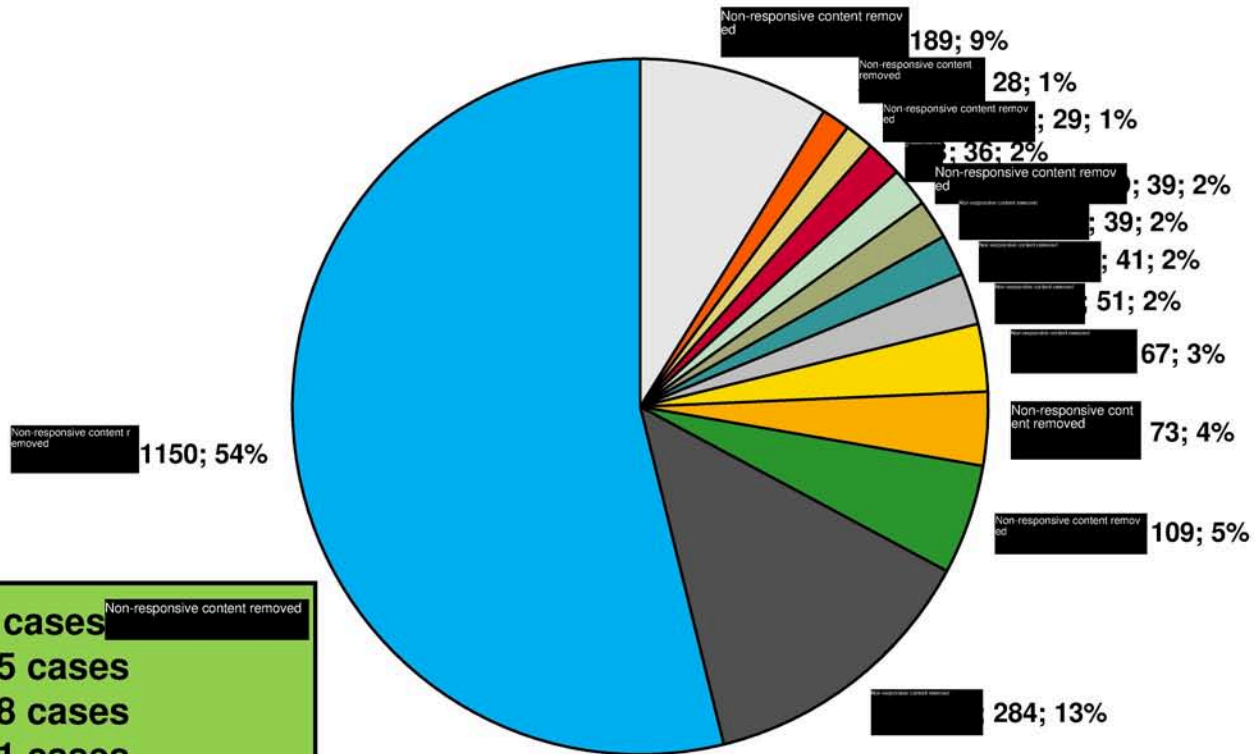
## AUDI V6-TDI failures in the field, broken down by country (SAGA - replaced pumps only, 059A\_/B\_)

**TOTAL V6-TDI: 2.135 cases**  
MY08: 935 cases  
MY09: 1.018 cases  
MY10: 181 cases  
MY11: 1 case  
(SAGA, Stand 05.09.2010)

in total 2,135 AUDI V6-TDI failures (CP4.2), for country-by-country breakdown see page 5. Total failure rate since vehicle production date 08.2009 declining, see page 6.

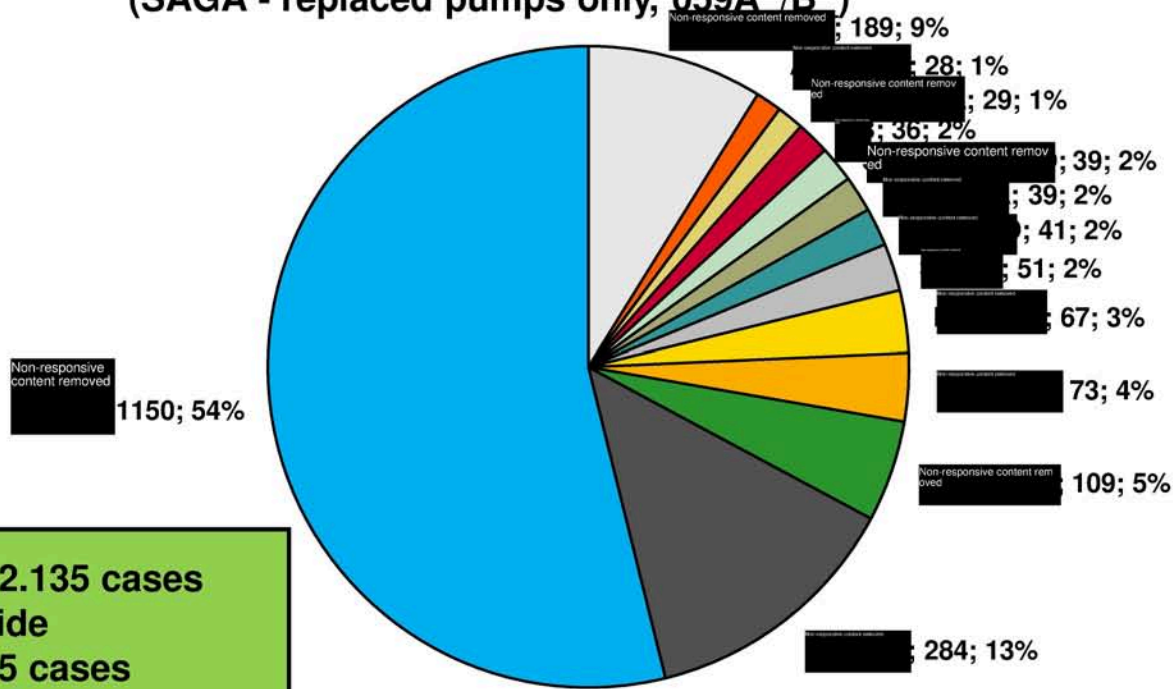
## AUDI V6-TDI failures in the field, broken down by country

**TOTAL V6-TDI: 2.135 cases worldwide**

**MY08: 935 cases**

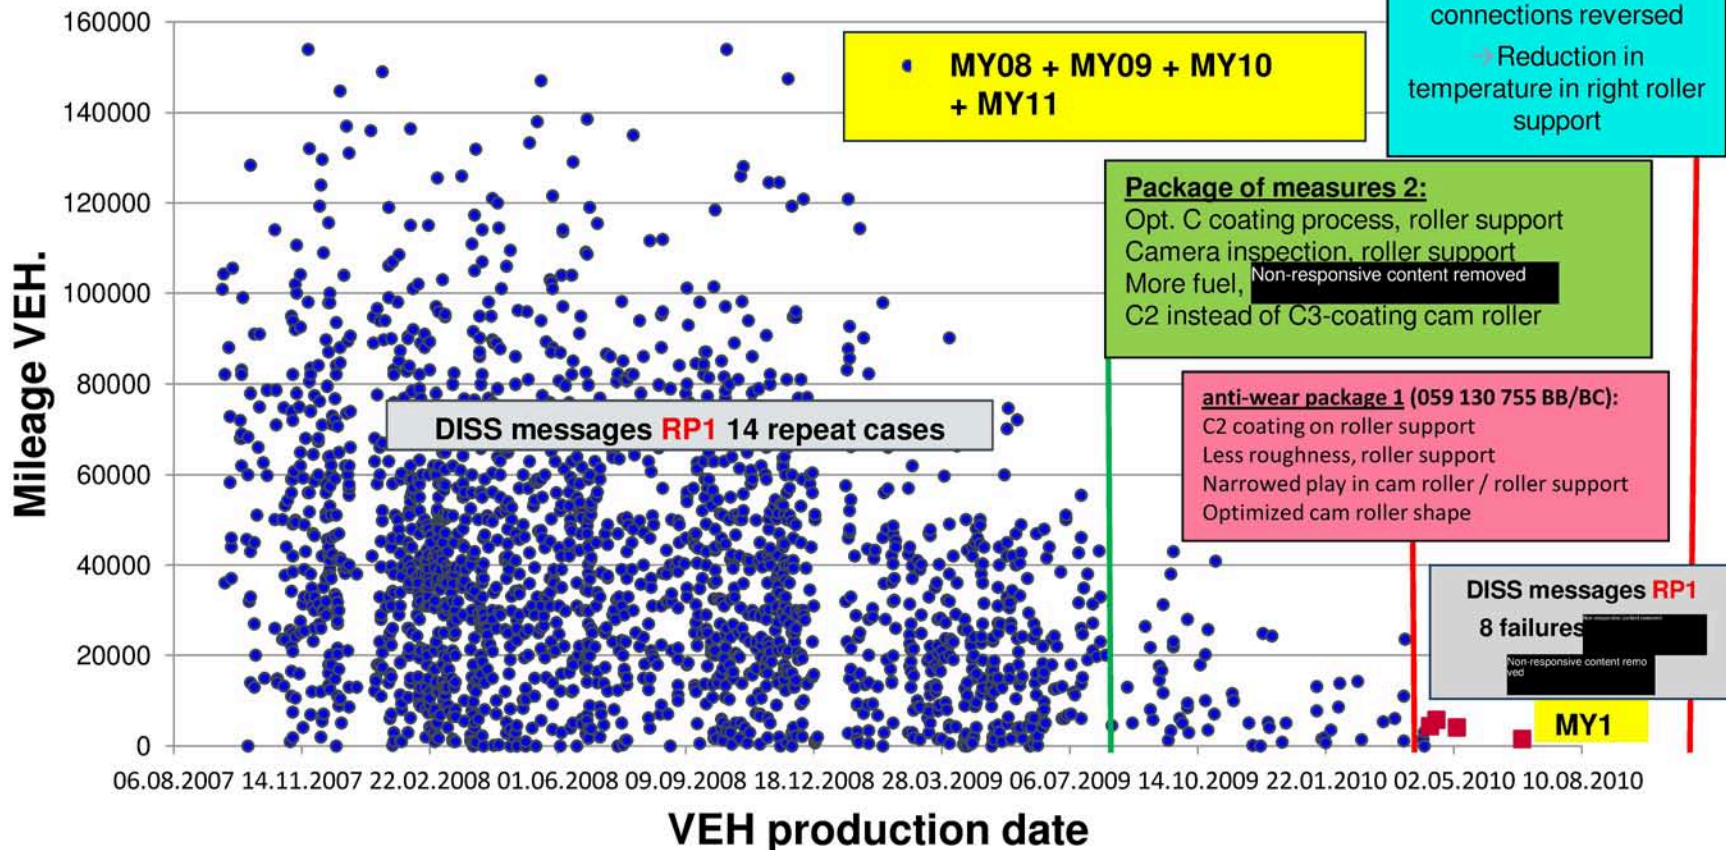
## Worldwide failures in the field involving high-pressure fuel pump CP4.2 Effectiveness of measures

- TOP Q meeting between RB and AUDI held on 10/28/2010.  
**Status at the beginning of September:** 2,135 AUDI V6-TDI failures Non-responsive content removed in total (CP4.2), for a breakdown by country **see page 5**. Total failure rate **since vehicle production date 08.2009 declining, see page 6**.

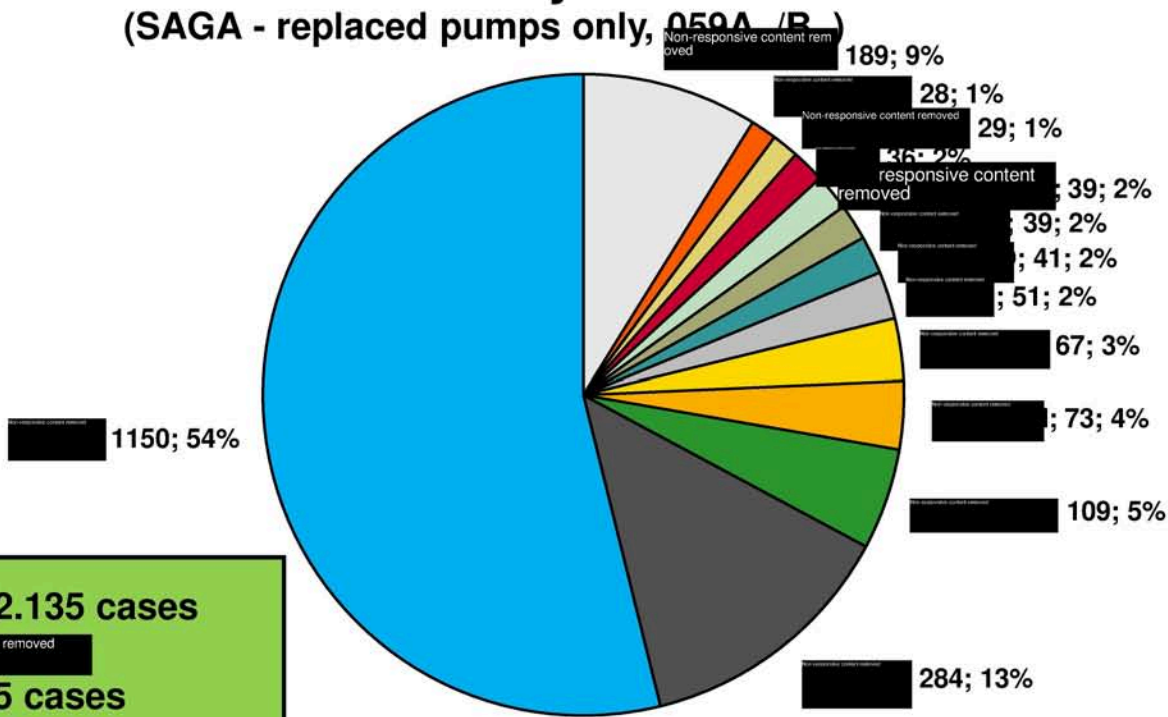
## AUDI V6-TDI failures in the field, broken down by country

**TOTAL V6-TDI: 2.135 cases**

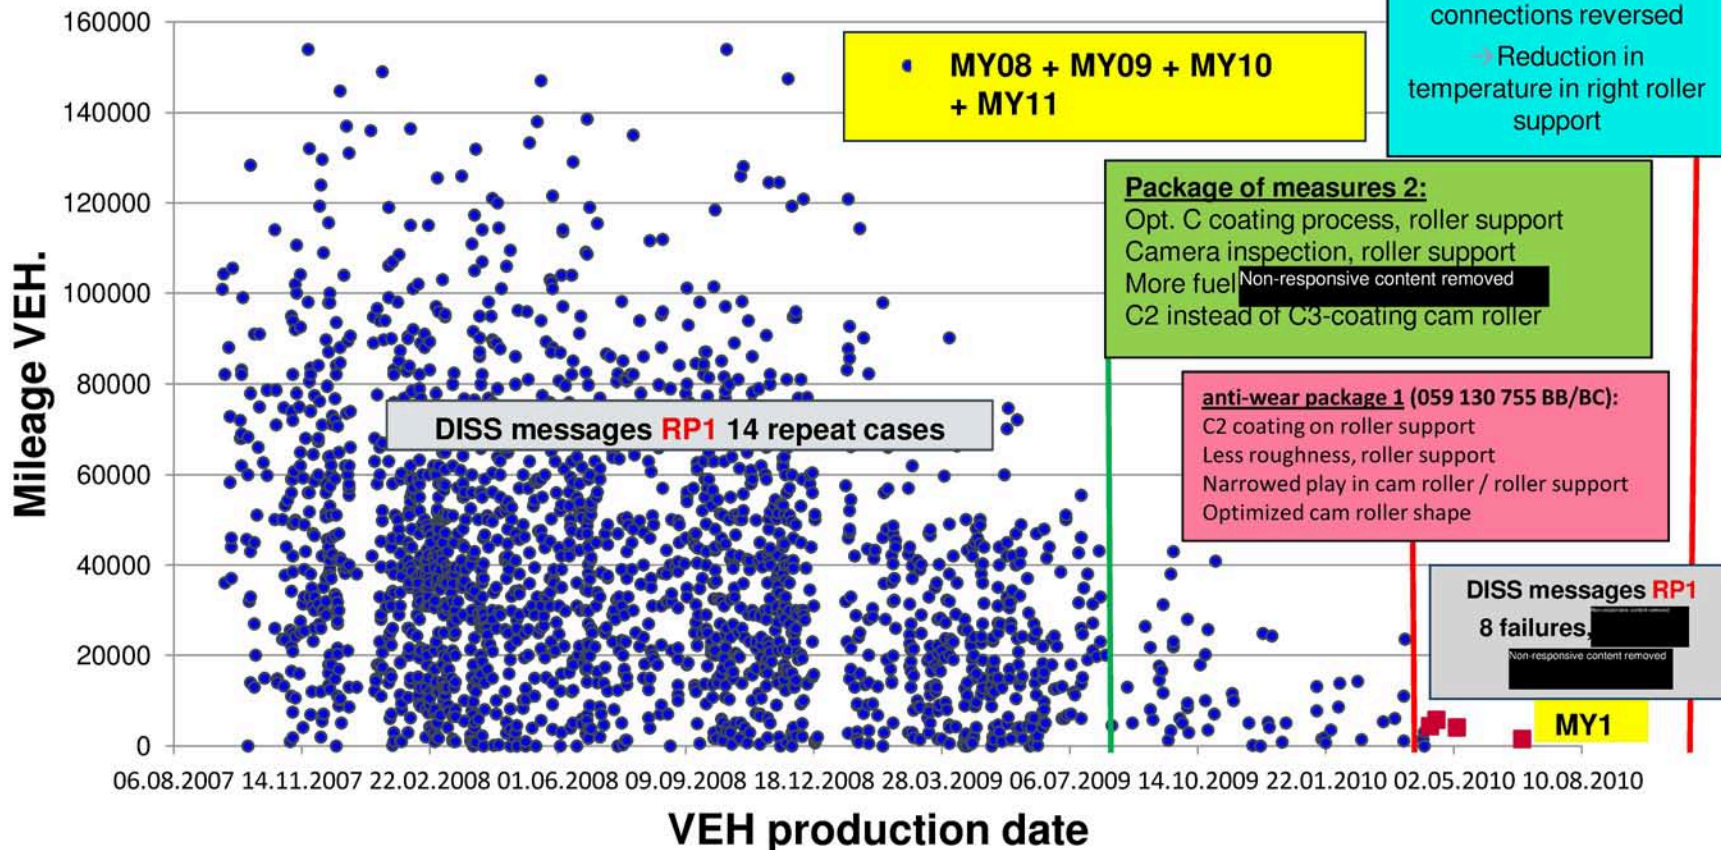
## Worldwide failures in the field involving high-pressure fuel pump CP4.2 Effectiveness of measures

- TOP Q meeting between RB and AUDI held on 10/28/2010.  
Total worldwide failures 2,635 AUDI V6-TDI, 6 x V8-TDI and 12 x V12-TDI (CP4.2), for a breakdown by country see see page 7.  
For the development of the failure situation see page 6.

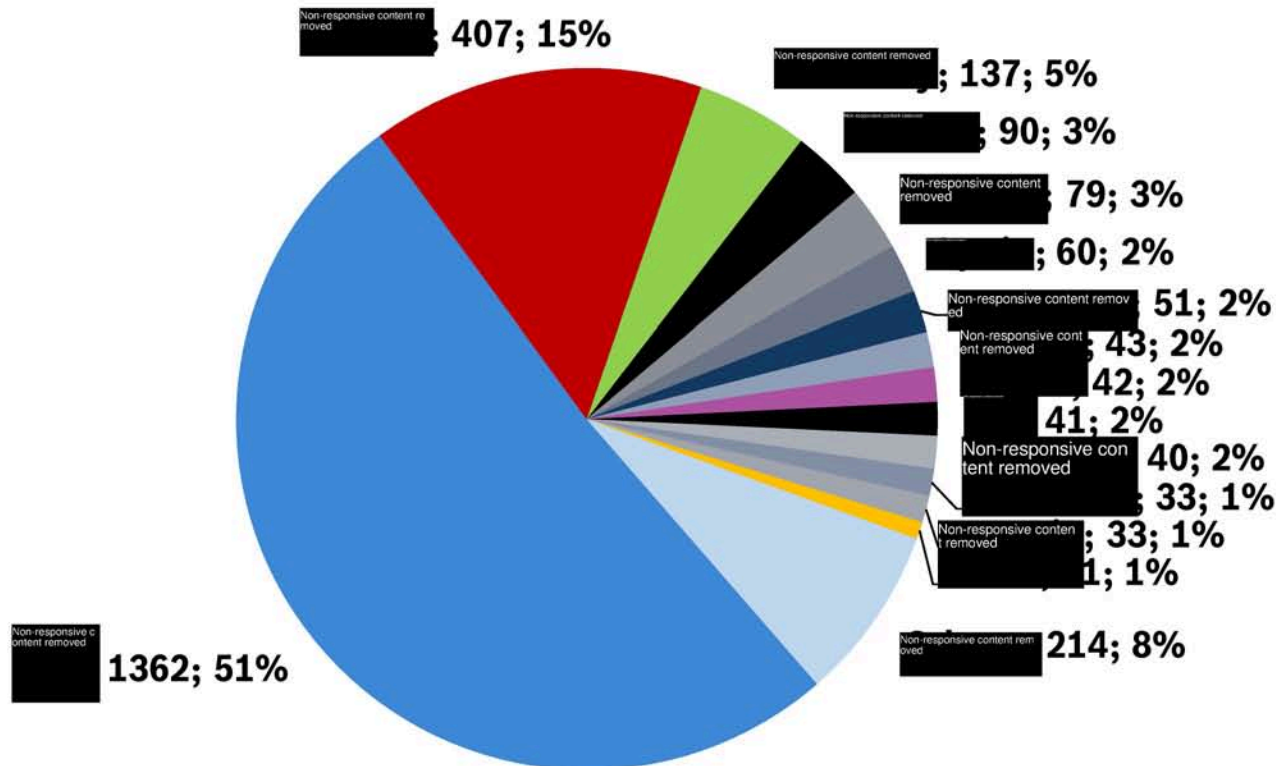
## Field failures V6/V8/V12 TDI (Audi only) by country

- TOP Q meeting between RB and AUDI held on 28.10.2010.  
Total worldwide failures 2,635 AUDI V6-TDI, 6 x V8-TDI and 12 x V12-TDI (CP4.2), for a breakdown by country see see page 7.  
For the development of the failure situation see page 6.
