CP4 rating catalog for visual findings

2 x CP4.2 drivetrain damage cases in US vehicle endurance runs

CP4 drivetrain damage: Damage mechanism:

Drivetrain damage, high-pressure diesel fuel pump CP4.2 TOP meeting between Bosch and Audi on 02/12/2010 in Non-responsive content removed

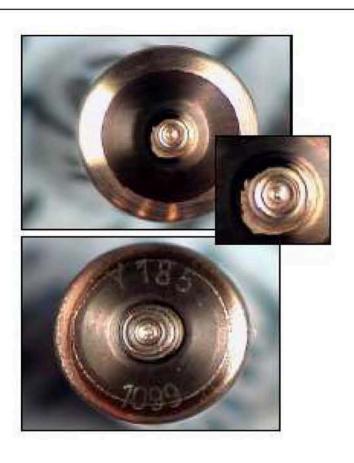
7

C coating worn away + slight wear from abrasive material (or slight seizing) up to Ø 3mm

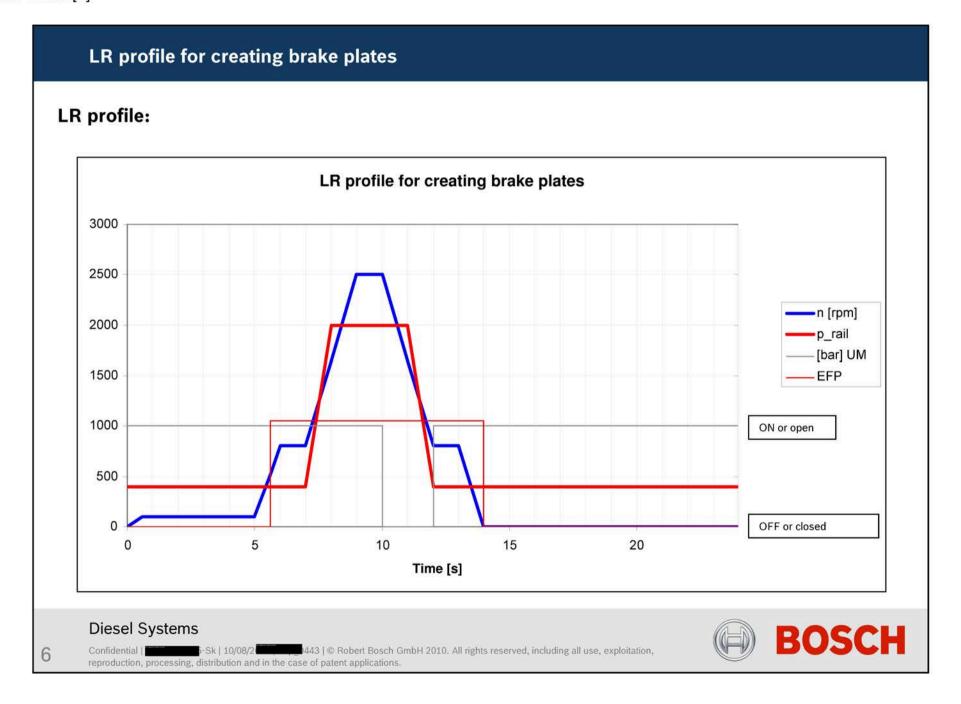
LR profile for creating brake plates

Fuel	T_AII [°C]	Starts	Remark	RL_L	RL_R	RS_L	RS_R	CmSh LP	CmSh UP
B20	50% @120°C, 50% @140°C	54,000	Elements below 45°	Discoloration R7 wear R6	Discoloration: R7 wear R7	Lining R/ wear R3	Lining R7 wear R3	R4	R3
EN590	80°C	9,900	With air in inlet. Elements below 45°	Discoloration: R1 wear: R4	Discoloration: R1 wear: R4	Lining R3 wear R3	Lining R3 wear R3	R3	R4
B20	140°C	18,000	Fuel foams with A4 tank, idle/venting at standstill, mounting position (right element vertical)	Pla Disco Wear:	in, dead	dline: op	pen g		
EN590 with 50% gasoline	140°C	18,000	Fuel foams with A4 tank, idle/venting at standstill, mounting position (right element vertical)	Pla Discooration. Wear:	in, dead	dline: op	pen wear

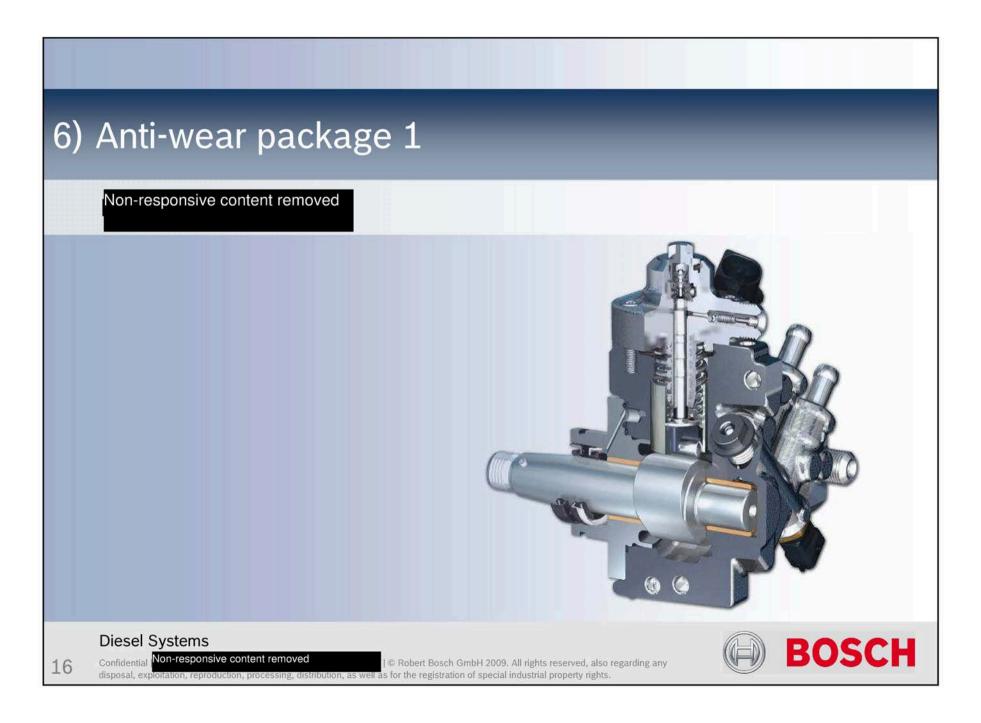
High-speed camera & start-up examinations with poor quality fuel 2/26/2010 Damage case with stopped (seized) roller can be reproduced with reappear test and Arctic Diesel.

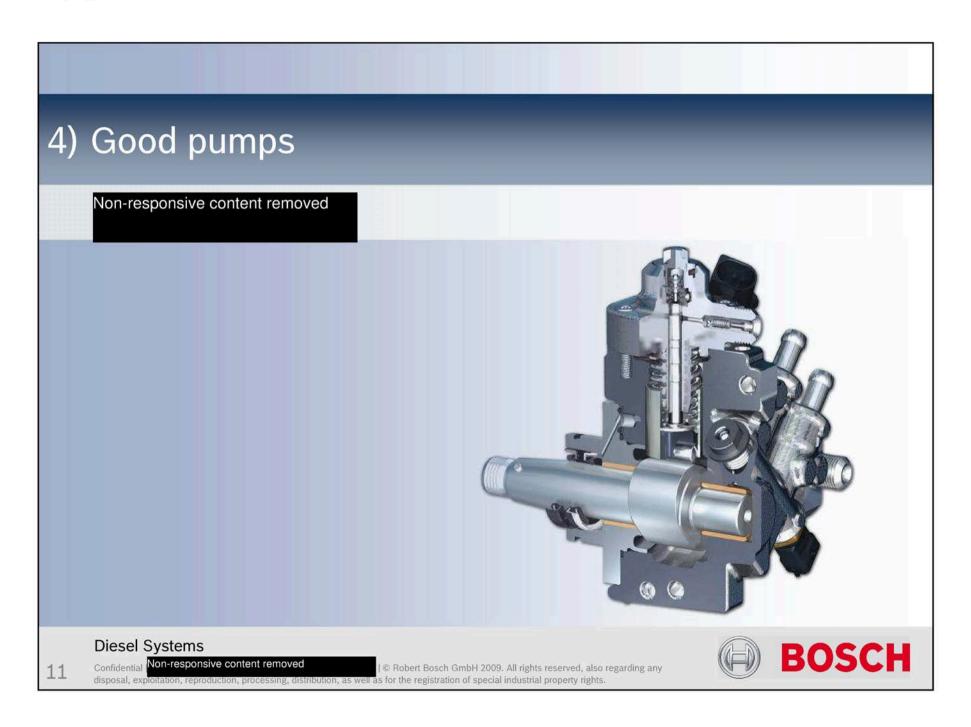
The conversion of the roller edge end to C2 in 5/2009 eliminated the fusing.

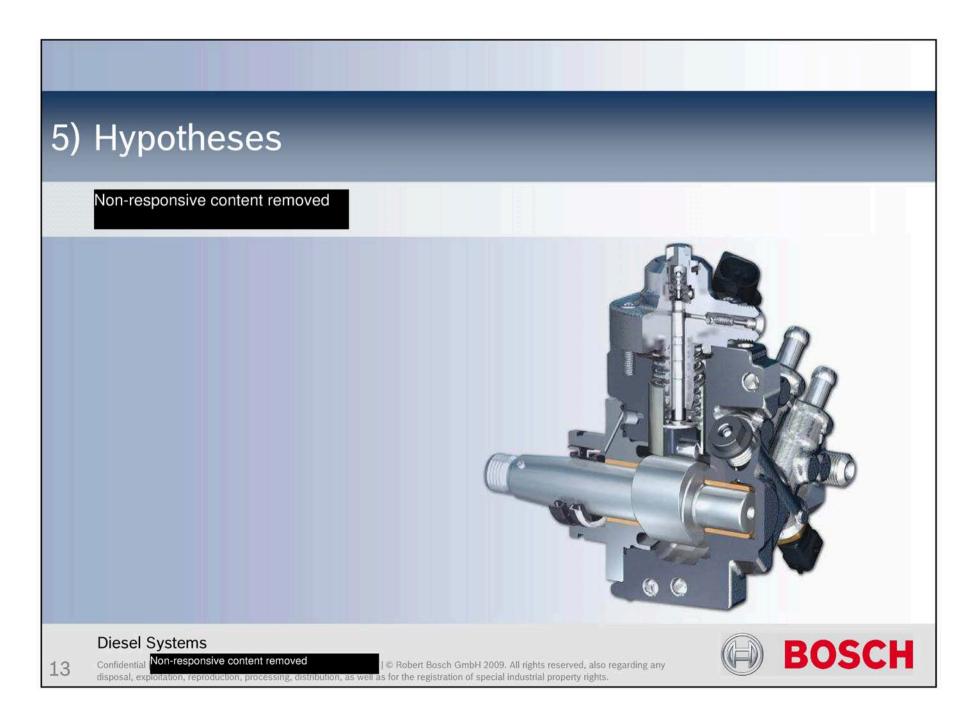
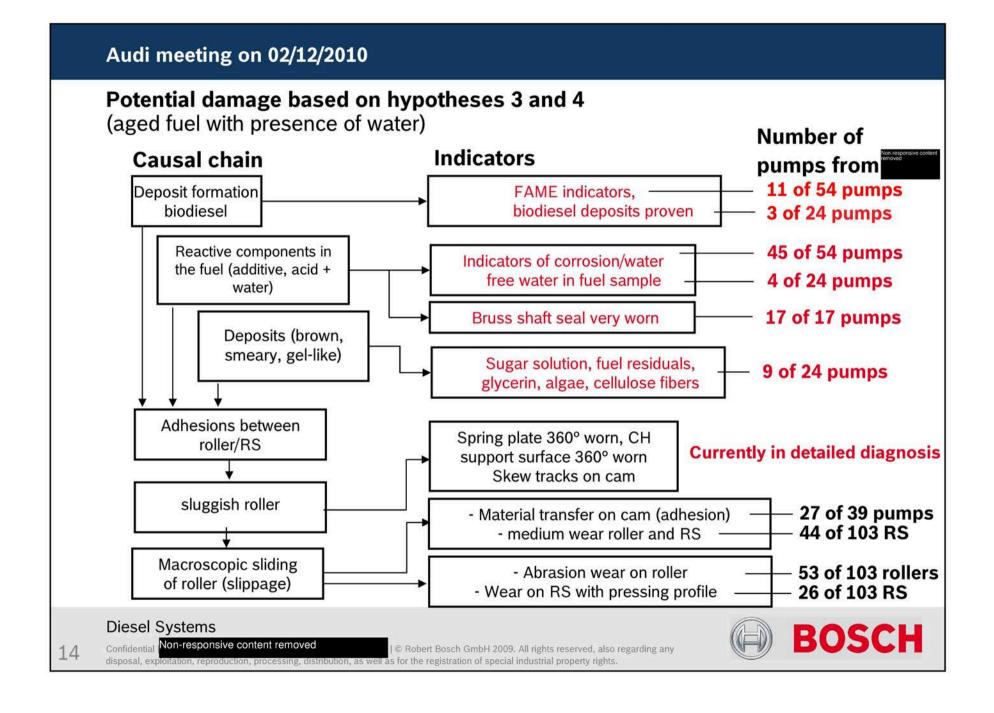
TF AUDI Good pump (2009-CP4_0685)

5,125 km (no failure)

Preliminary damage does not necessarily result in failure (failure primarily due to continued driving with poor fuel).

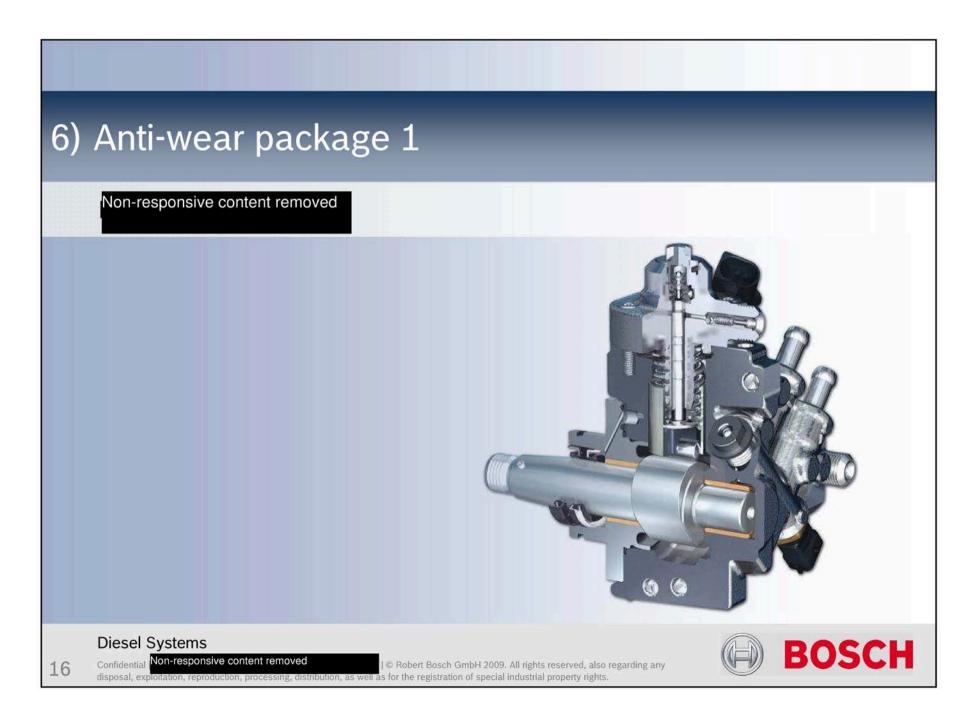
High-speed camera & start-up examinations with poor quality fuel 2/26/2010 Damage case with stopped (seized) roller can be reproduced with reappear test and Arctic Diesel.

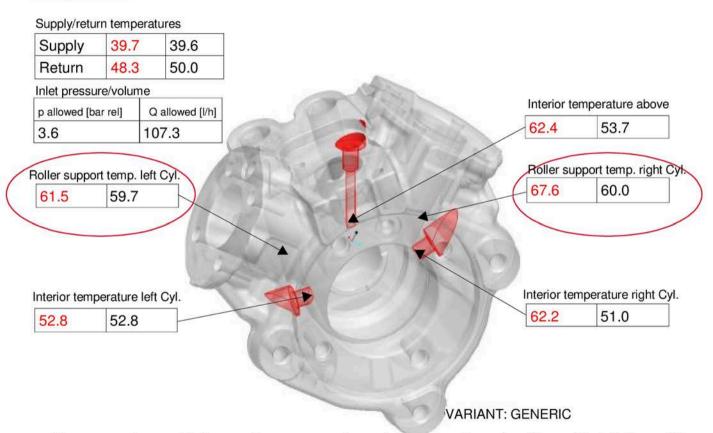
Temperatures CP4.2: Measurement with Arctic diesel, speed: 598 rpm, rail pressure 2,298 bar

Temperature on the roller support surface can be significantly higher. Measuring point 1 mm away from surface. Potential min. 15-20 ° C on the surface

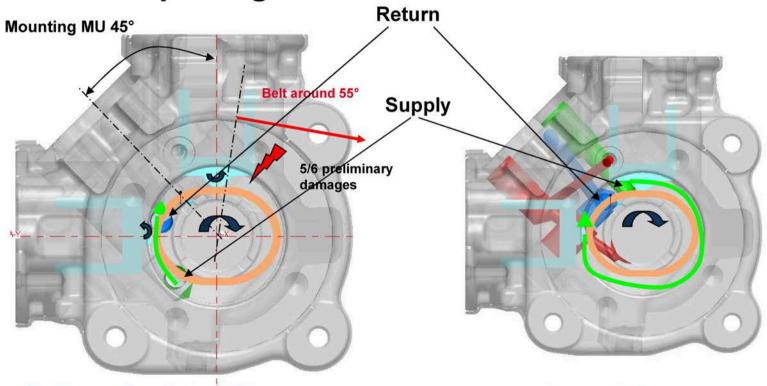
Fuel goes directly to outlet

Anti-wear package 2

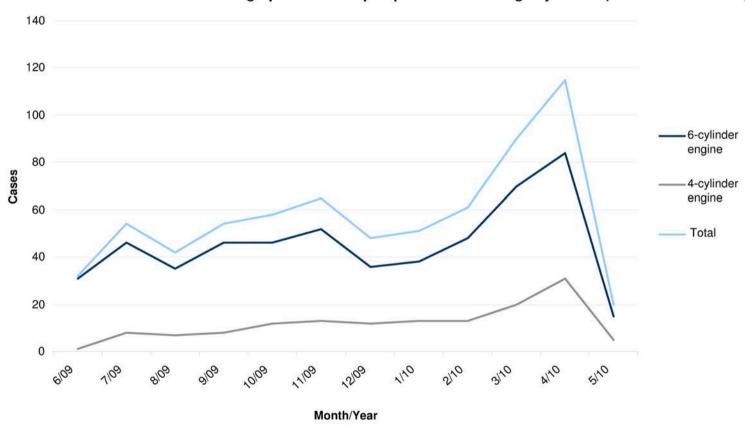
Failure of diesel CR high-pressure fuel pump - cases of damage by month (status: 05/11 WK 18)

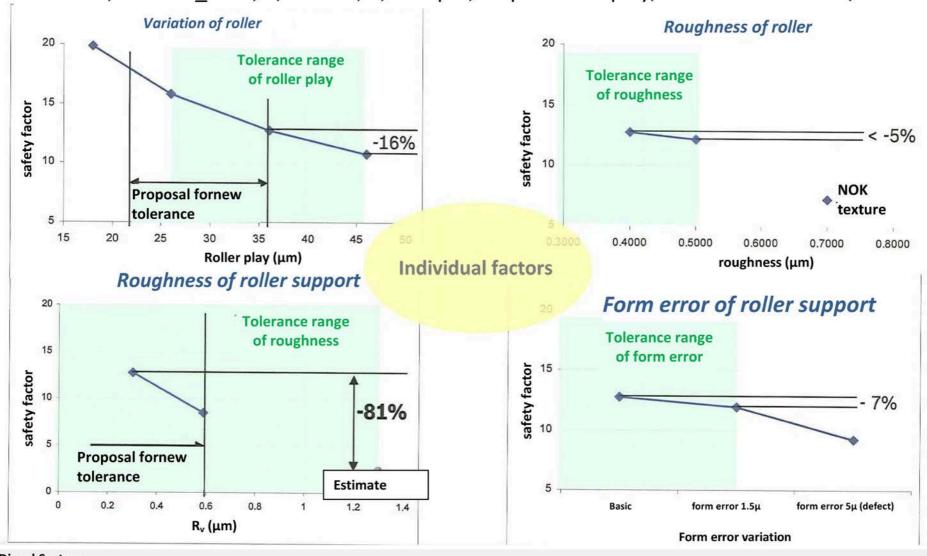
Presentation of safety factor against slip in TDC:

CP4.1, 2 x 5.25_s032, 1,800 bar, 1,000 rpm, 36 μ m Roller play, kin. visc. = 2.7 mm²/s

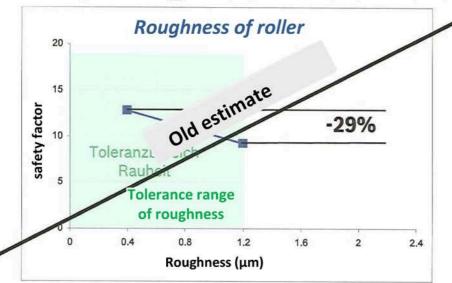
Application safety factor against estimated roughness!

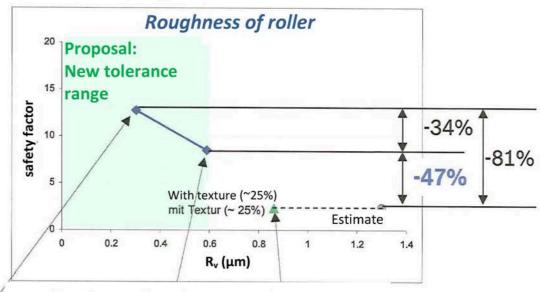
Application safety factor against R_v (tactile measurement)

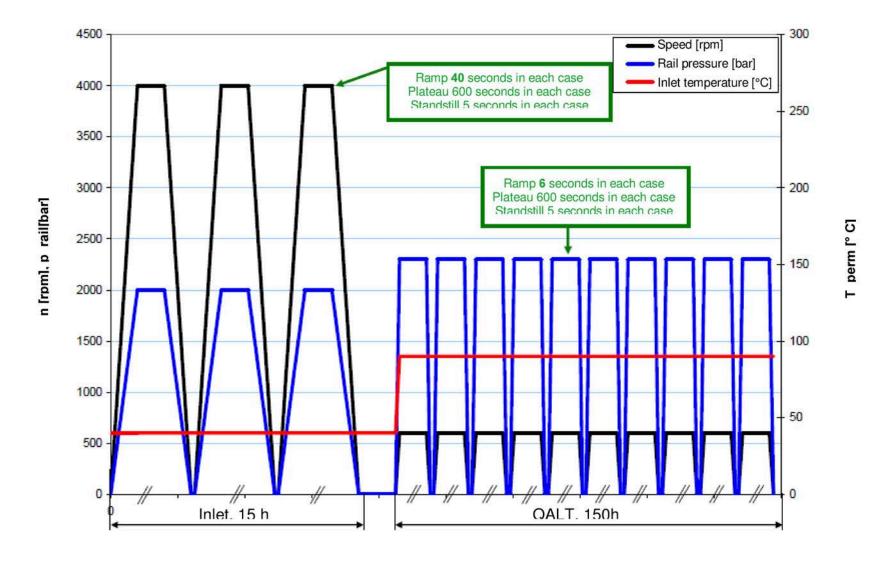
Overload test of drivetrain CP4 LR / RS-QOLD

- → Version 1: Mixed friction at low engine speed
 - Start-up program (15 h, 4,000 rpm, 2,000 bar, 40 °C, Arctic diesel Cl. 4.)
 - Endurance run program (150 h, 600 rpm, 2,300 bar, 90 °C, Arctic diesel Cl. 4.)

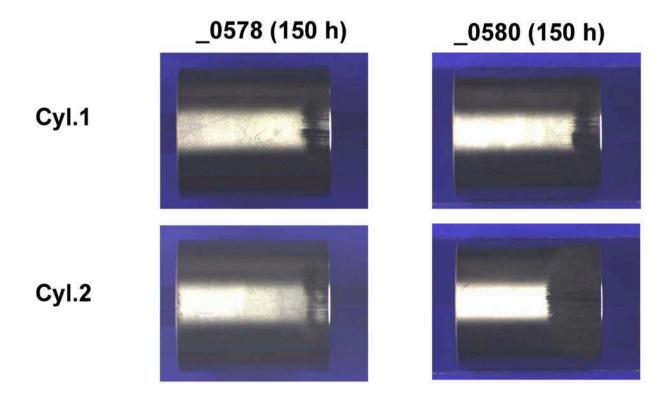
RP1

Aluminum oxide formation (black) as an indicator of elevated temperatures

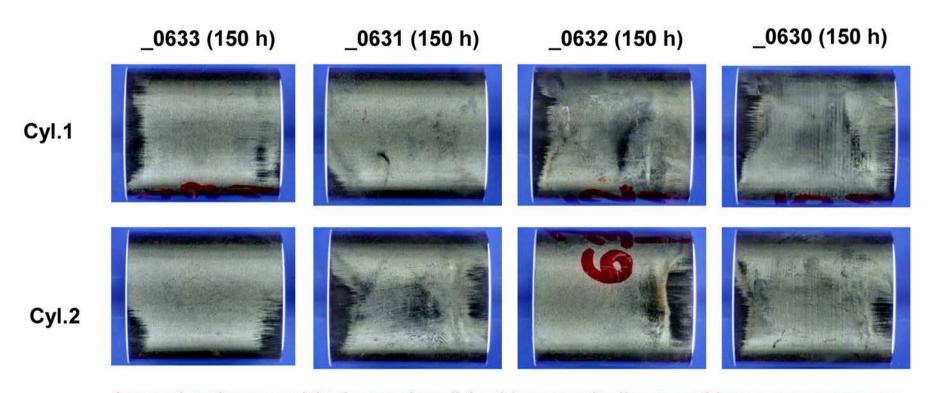
RP2

Low aluminum oxide formation (black) as an indicator of low temperatures

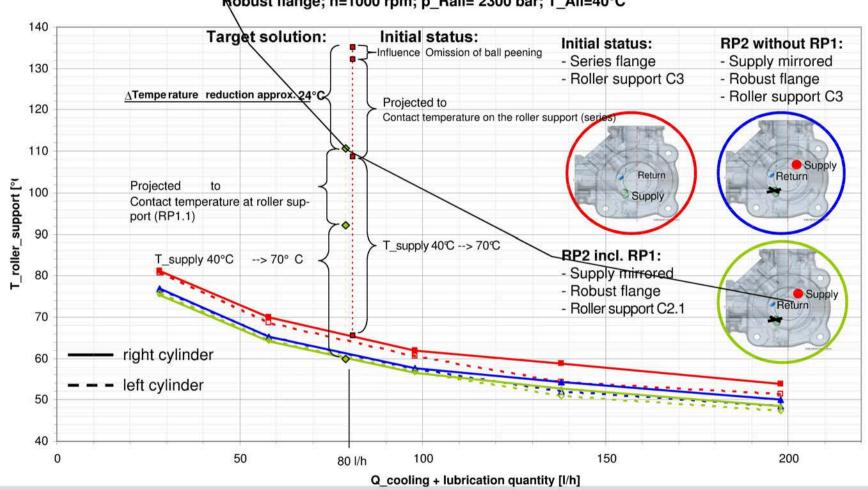
CP4.2 Audi W19: roller support temperature as f (cooling and lubrication quantity)
Robust flange; n=1000 rpm; p Rail= 2300 bar; T All=40°C

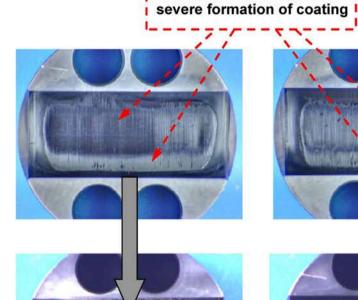
Series after 09.06 C3 coating and unblasted cam shafte

Roller supports from test 2010-CP4_365/366 uncleaned

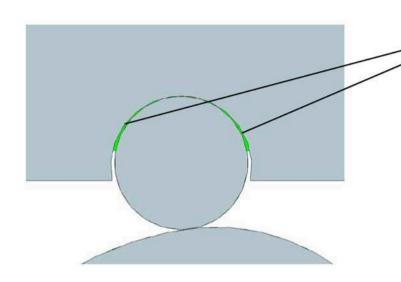
Immobilizer by deposits

Deposit in the roller support prevents starting of running of the roller.

Subsequent pump failure due to

- Turned tapper
- Abrasive wear
- Roller fatigue
 (For very wide flat spots)

Deposits in the roller support prevent the rocking of the roller in the roller support -> no buildup of hydrodynamics -> stationary / stiff roller -> Roller slides on the cam -> preliminary damage (braking flat on the roller).

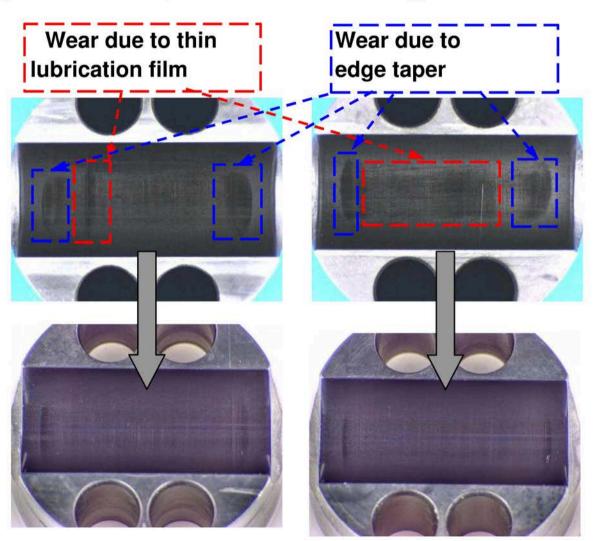
Roller supports from test 2009-CP4_0728 cleaned

Roller supports from test 2010-CP4_0054 cleaned

Anti-wear package RP1

Increasing lubricant film thickness
