Drivetrain damage VW/Audi CP4.1(-507/508) 0 km and field /FD-KW

Drivetrain damage VW/Audi CP4.2 (-611/613) 0 km and field /FD-KW

Task force activities to reduce power train failures

Drivetrain Damage Diesel High-Pressure Fuel Pump CP4.2

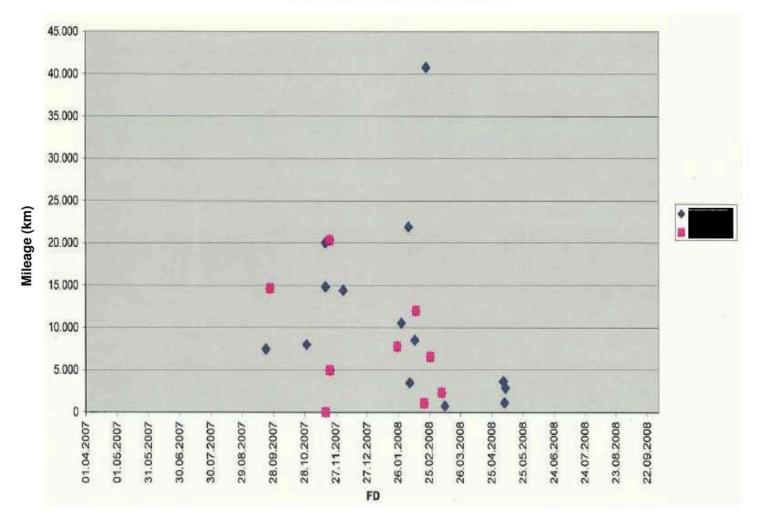
Drivetrain damage CP4.2 VW/Audi

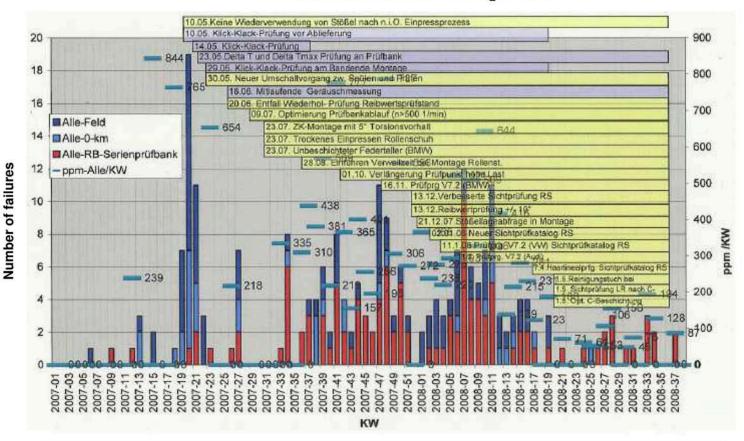
Failures due to drivetrain damage FD-KW

All, field
All, 0 km
All RB series test bench
Ppm all/WK
10.05 No reuse of tappets if not OK Pressing process
10.05 Click-clack test
23.05 Delta T and Delta Tmax test of test

29.05 Click-clack inspection at the end of the assembly conveyor belt
30.05 New switching procedure between flushing and inspection
18.06 Continuous noise measurement

20.06 Repeat inspection on frictional coefficient test bench dropped
09.07 Optimization of test bench process optimized (n>500 1/min)
23.07 CH assembly with 5 ⁰ torsion

23.07 Dry pressing in of roller shoe
23.07 Uncoated spring plate (BMW)
28.08 Introduction of dwell time in assembly, roller
01.10 Extension of checkpoint heavy load

16.11 Inspection V7.2 (BMW)
13.12 Improved visual inspection, RS
13.12 Frictional coefficient check +/- 10 ⁰
12/21/2007 Tappet check in assembly
1/2/2008 New visual test catalog, RS
1/11/2008 Inspection V7.2 (VW) visual test catalog, RS
Inspection V7.2 (Audi)

7.4 Straightedge test CP4.2 visual inspection catalog, RS
1.5 Cleaning cloth with
1.5 Visual inspection LR for C
1.5 Opt. C coating

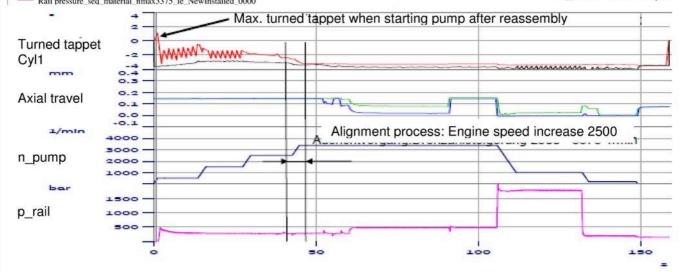
Starting after installation procedure same as factory testing n_max = 3375 rpm

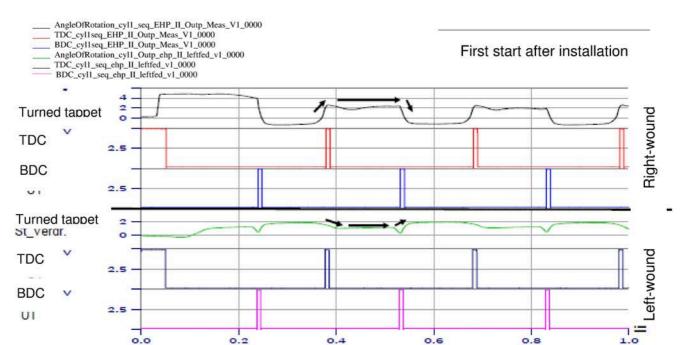
Influencing factor: Coiling direction of the spring

Direction of movement of the tappet at US and LS depends on the spring turn direction

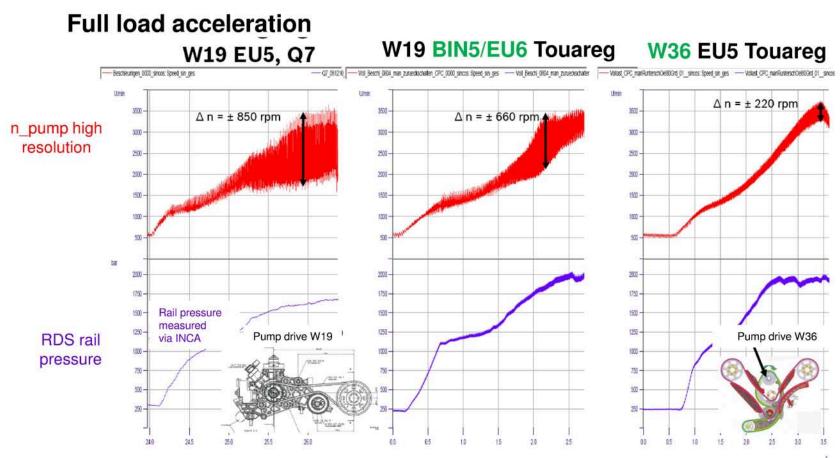
Speed fluctuations V6-TDI engines

Note: Engine speed signal evaluation method is the same for all engine variants.

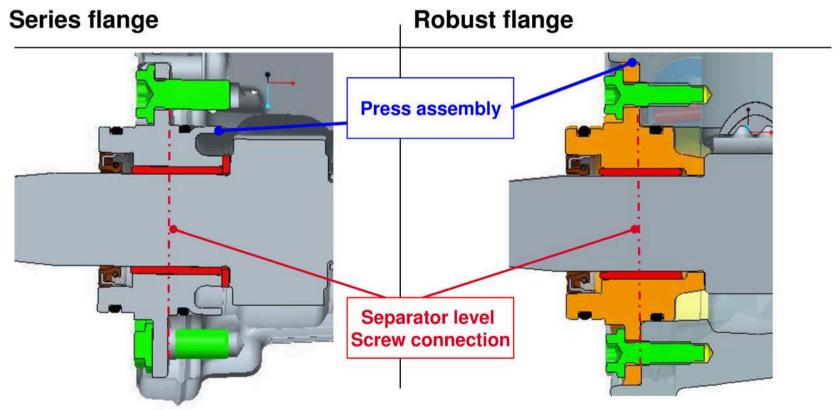
4.1 Press assembly in screw level

Press assembly to support lateral forces moved to outside to separator level of flange/housing components

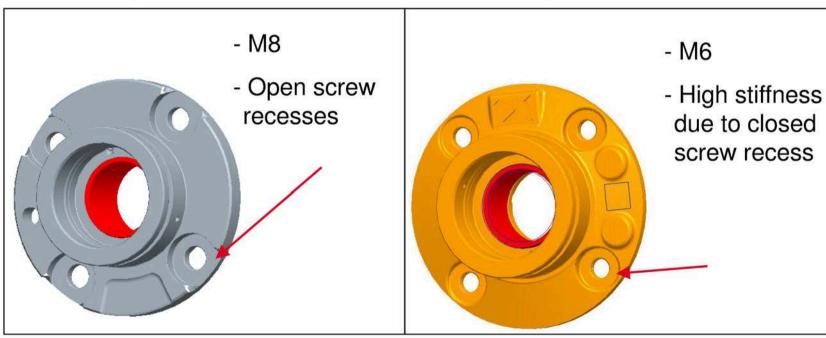
4.2 Screw connection

- Reduction of screw factor possible through changed distribution of force absorption
- Burr formation reduced (CP4 cleanliness initiative)
- Increased stiffness of press assembly through closed screw recesses

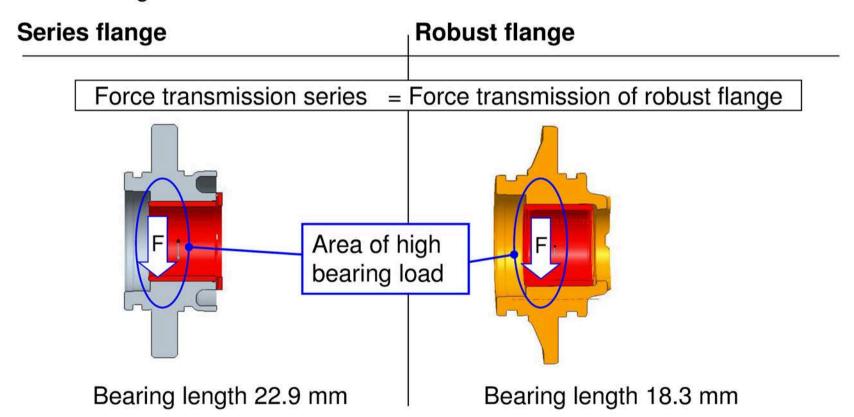
4.4 Bushing

Force transmission through customer drivetrain dominant, bearing largely loaded on customer side, supporting bearing length unchanged

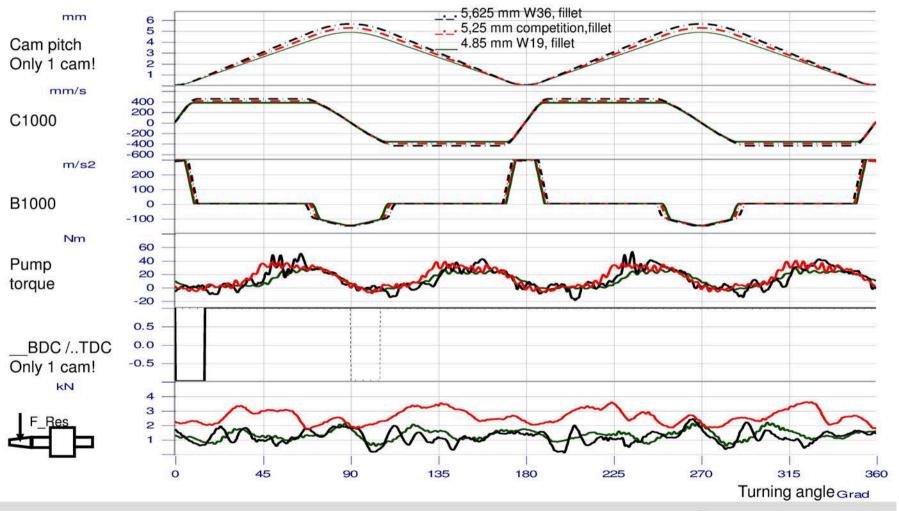
EA110CSE 4.2 Portrayal of cam profiles and torque/forces on the pump

Measurements W19/W36/competition: Cam profile results: 4500 rpm/s, full load

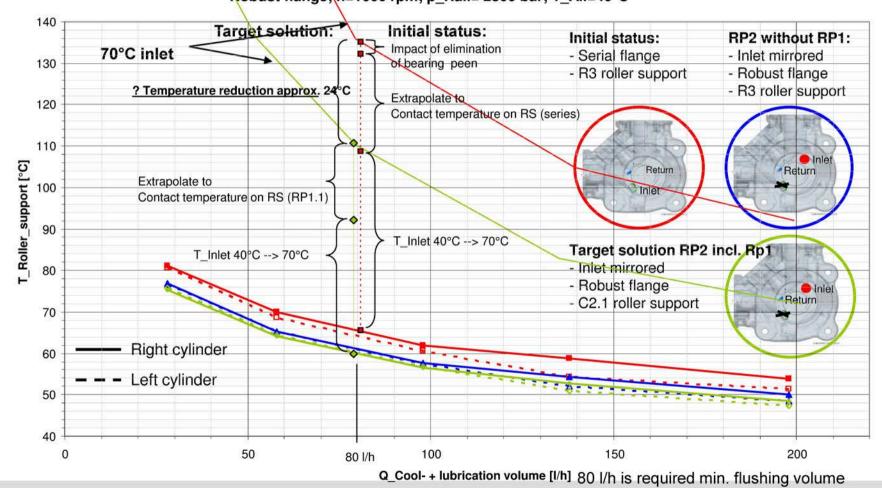
CP4.2 Audi W19: Roller support temperature as f(coolant/lubricant volume) Robust flange, n=1000 rpm; p_Rail= 2300 bar; T_All=40°C

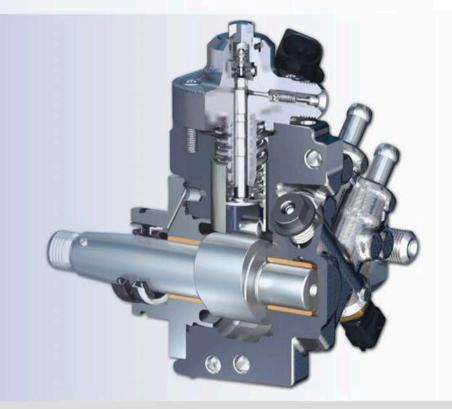
Failed pump field Non-responsive content delivery date unknown

Pump shows typical drivetrain damage
Right roller support destroyed first by abrasive wear
Left roller support killed later (turned tappet)

Abrasive wear matches low viscosity in Non-responsive content re

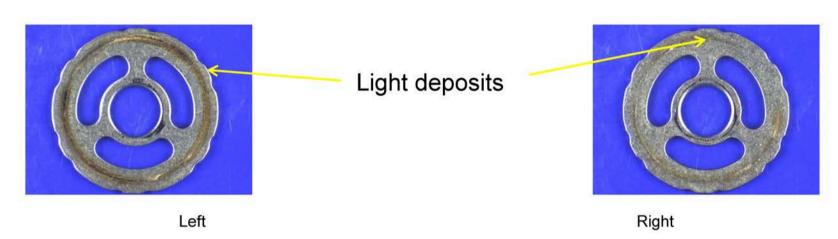
2010-CP4_0643 Non-responsive content rem oved Test RP2 with 43,189km W36 0445 B20 321_01; 000005 BPT 4000; ENT 301 181 KL

Pump with RP2 in very good condition after road test

Best result of all road tests with 6 cyl. (6 CRs evaluated)
