EA11-015

Service Bulletin

SUBJECT: Special Coverage Adjustment - Shift Lever May Not Display Correct Gear

**MODELS: 2007-2008 Saturn AURA
Equipped with 4-Speed Automatic Transmission (ME7/MN5)**

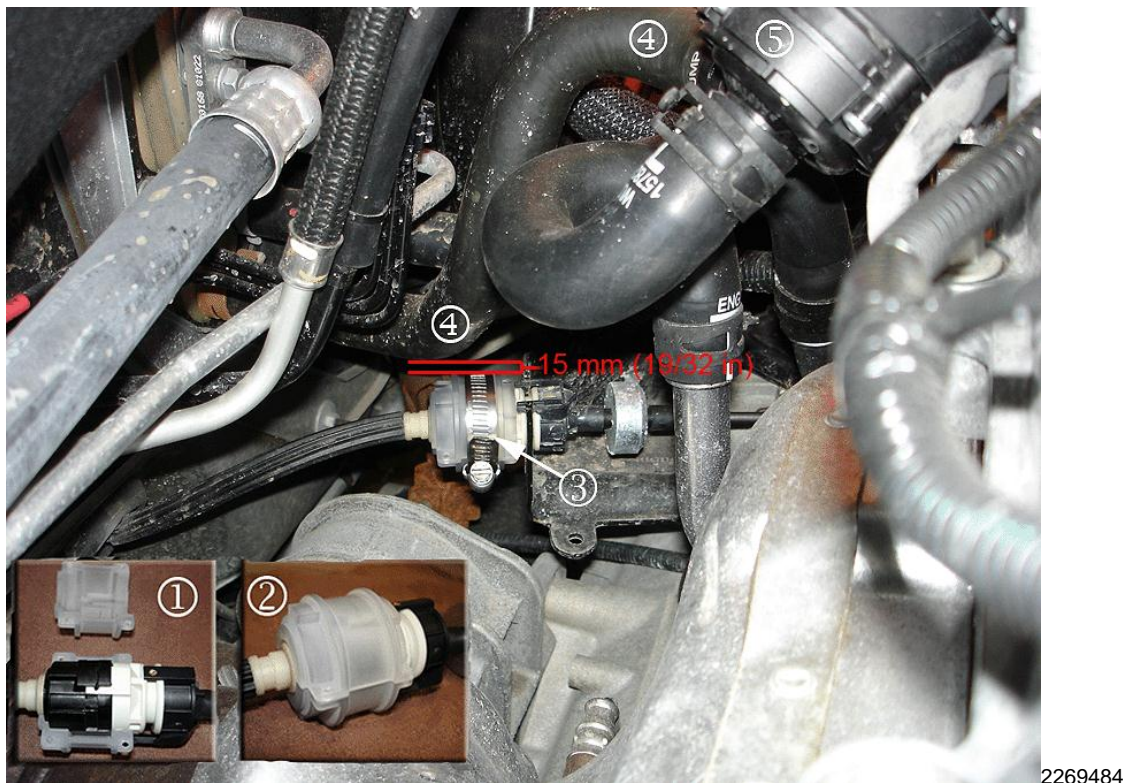
2269484

Hybrid vehicle shown. Combustion engine vehicle is similar.

Caution: Do not kink or damage the inlet coolant hose (4) when repositioning the hose to obtain the 15 mm (19/32 in) clearance. To avoid damaging the hose clamp, use J-38185 or equivalent hose clamp pliers to loosen the hose clamp.

- 7.1. Using J-38185 or equivalent hose clamp pliers, loosen the inlet coolant hose (4) connected to the heater cooler pump (5). Note the location of the clamp on the inlet coolant hose (4).
- 7.2. Rotate the inlet coolant hose (4) clockwise until 15 mm (19/32 in) of clearance between the inlet coolant hose (4) and clam shell (3) is achieved.
- 7.3. Ensure that the inlet coolant hose clamp is secure on the inlet coolant hose (4) in the production location.
- 7.4. Install the generator control module cover. Refer to *Generator Control Module Cover Replacement* in SI.

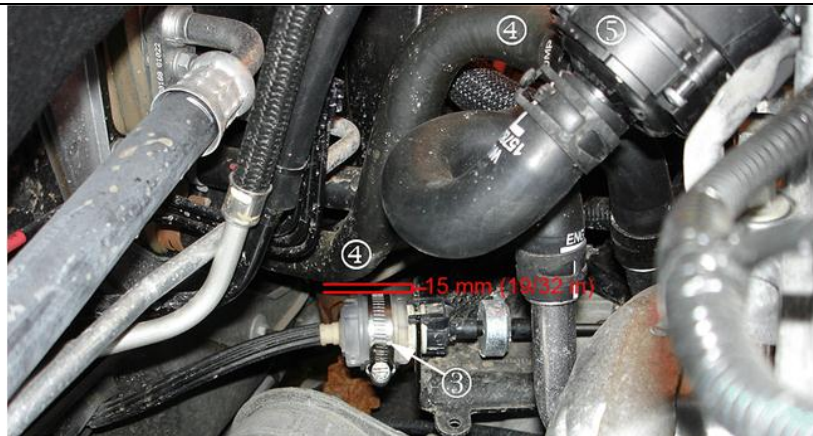
Hybrid vehicle shown. Combustion engine vehicle is similar.
