**RESPONSE TO QUESTION
NO. 9**

Defect Investigation V2010-04	5/1/2010	12/2/2010	Investigate reports of upper bunk side window of the bottom track that attaches to the arms used to open and close the window de-bonding.	Water Bonnet, supplier of the window.

**DEFECT INVESTIGATION
NO. 03-1-1**

SUBJECT: Defect Investigation
03-1-1

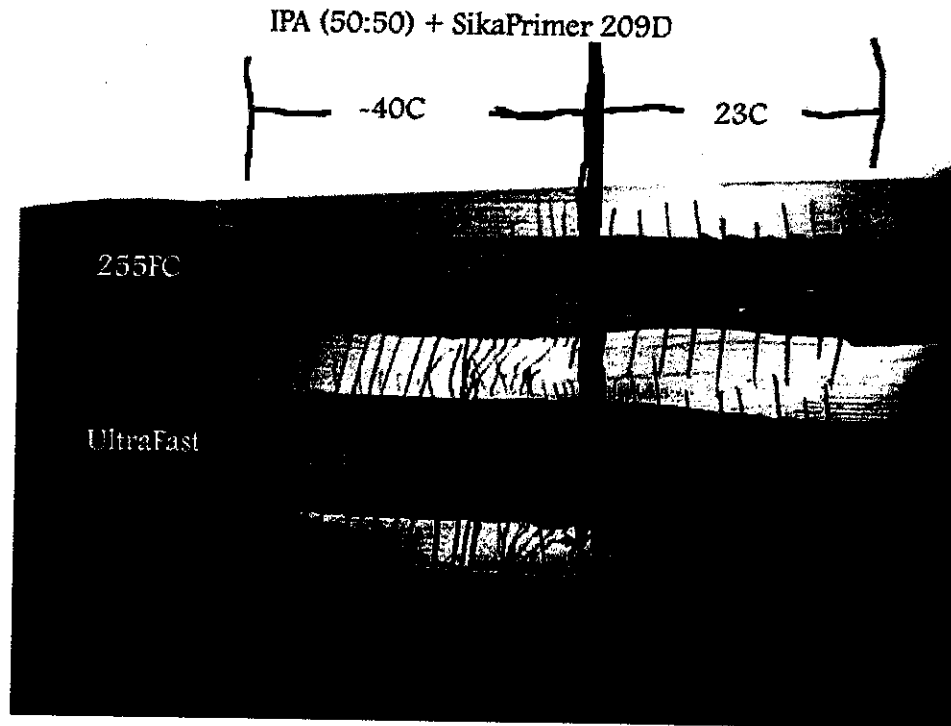
SikaPrimer 209D adhesion test on Xenoy, cold bead adhesion

- No loss of adhesion when tested at -40C in bead adhesion (100% cohesive bond)
- With or without IPA wipe, excellent adhesion with both 255FC and Ultrafast when SikaPrimer 209D is utilized
