November 10, 2011

Mazda's response: NHTSA Inquiry NVS-13cni, PE11-026

Brake fluid Leak from the Master cylinder

Reproduction test result for master cylinder's brake fluid external leakage

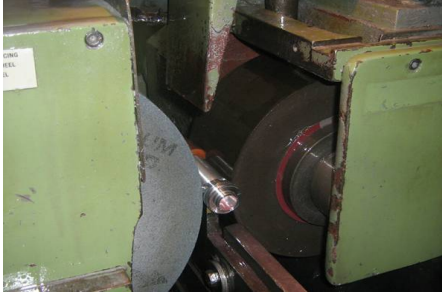
1: Final Grinding Control Wheel Speed Reduced from 40 rpm to 20 rpm 最終研磨工程でのホイールスピードを40 rpm から 20 rpmへ減速						100% presence of components		
2: Coolant filtration system will be reviewed and improved TPM from 6 month to 1 month 研磨機の冷却濾過システムメンテナンス周期(半年に1回から月1回)を見直し

3: Visual inspection of the parts has been introduced after the grinding operation at a frequency of 3/Hour using 10X magnification as per the boundary samples 研磨工程後、サンプルを用いての10X顕微鏡を使用して3時間の視覚的検査を導入。
