U.S. Department
of Transportation
**National Highway
Traffic Safety
Administration**

DOT HS 811 573

January 2012

Chevrolet Volt Battery Incident Overview Report

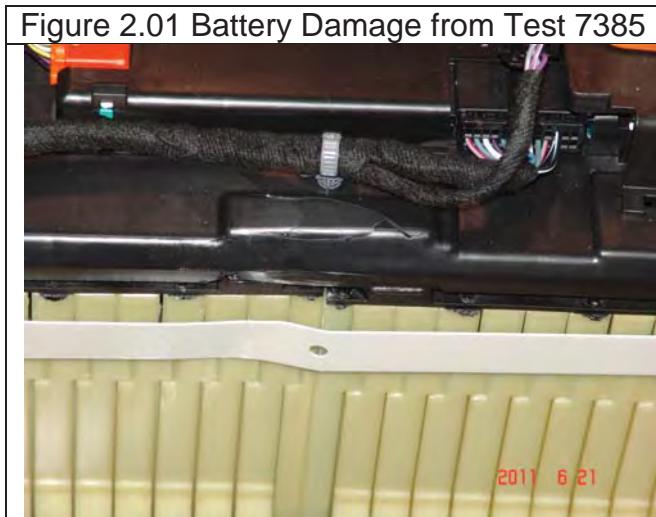
In the test conducted with the 50th percentile male dummy on April 20, 2011, there was minor intrusion into the battery case but little if any damage to the battery and battery cooling system. A photograph of the damage is shown in Figure 2.01. There was no damage to the batteries in either of the next two tests; the side-moving deformable barrier test conducted on May 6, 2011 or the frontal crash test conducted on May 11, 2011. None of the vehicles tested in these first three tests experienced a thermal event at any time during or after the test.

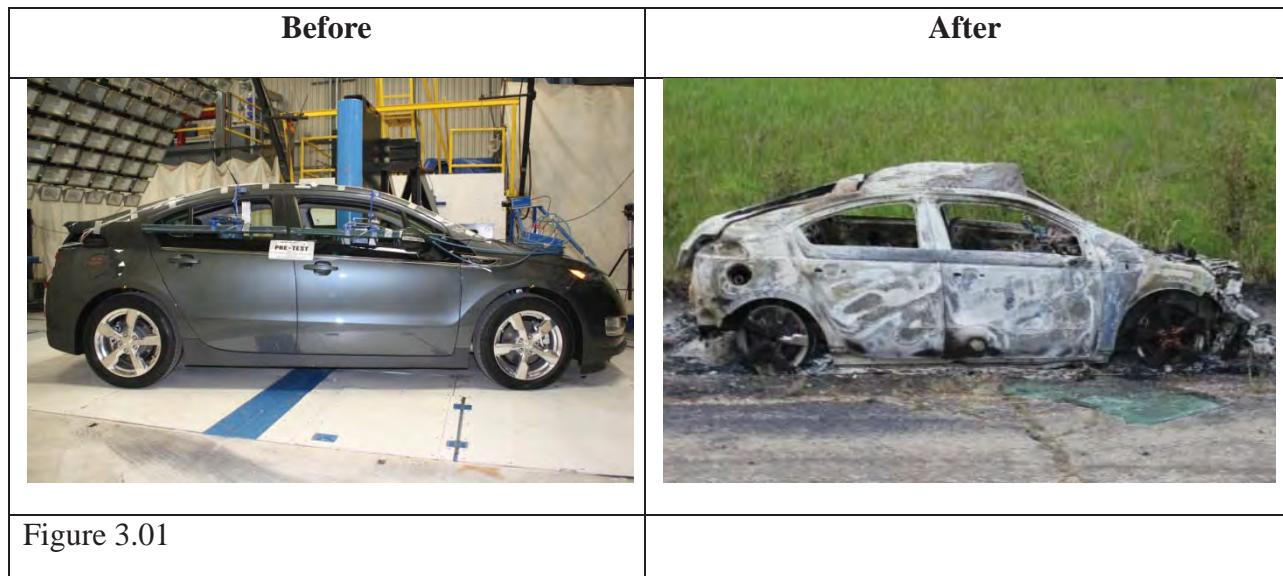
MGA, after informing NHTSA personnel about the fire, notified the local fire authorities who performed an initial scene investigation which primarily focused on identifying any possible arson issues. NHTSA contracted with a battery and fire expert, Hughes Associates, to investigate the origin and cause of the fire. The initial forensic inspection was conducted on June 13-14, 2011 at the MGA facility. In July 2011, Hughes Associates preliminary findings indicated that the fire incident at MGA most likely originated in the Chevrolet Volt and the local fire authorities concurred with that assessment. Figure 3.01 shows pictures of the Chevrolet Volt before and after the fire event. The MGA fire incident report is provided as an attachment.

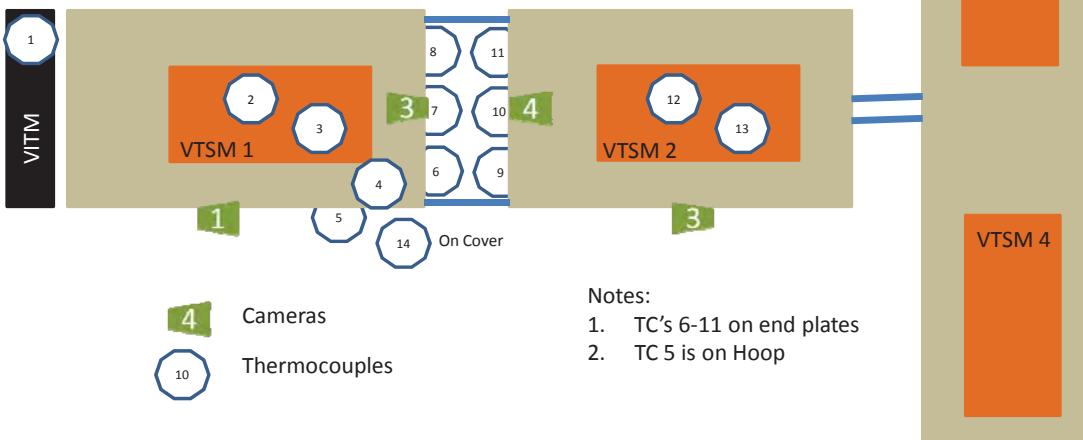
Figure 4.01 Battery Instrumentation

The instrumentation included: (See Figure 4.01)

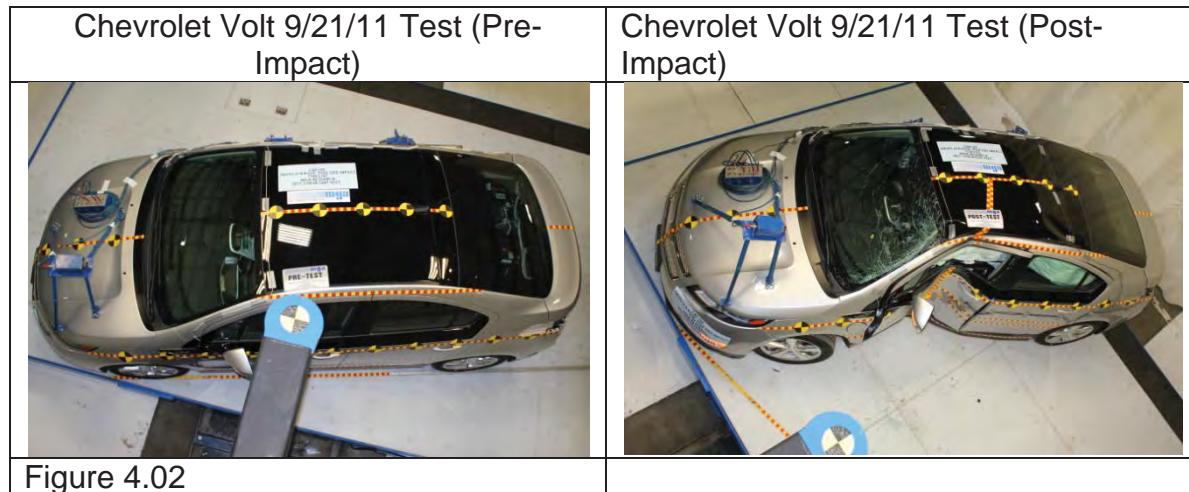
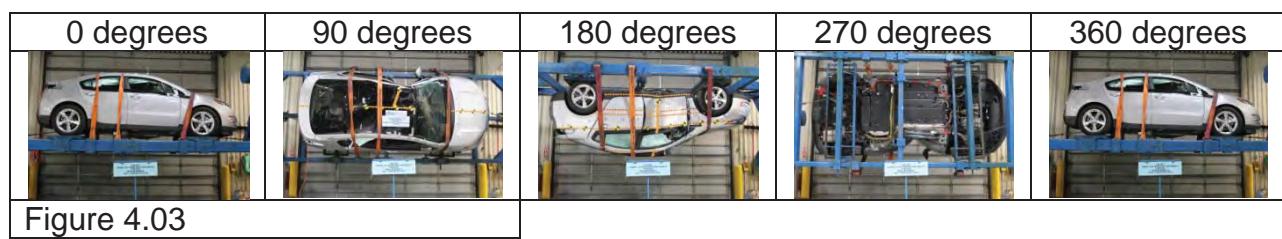
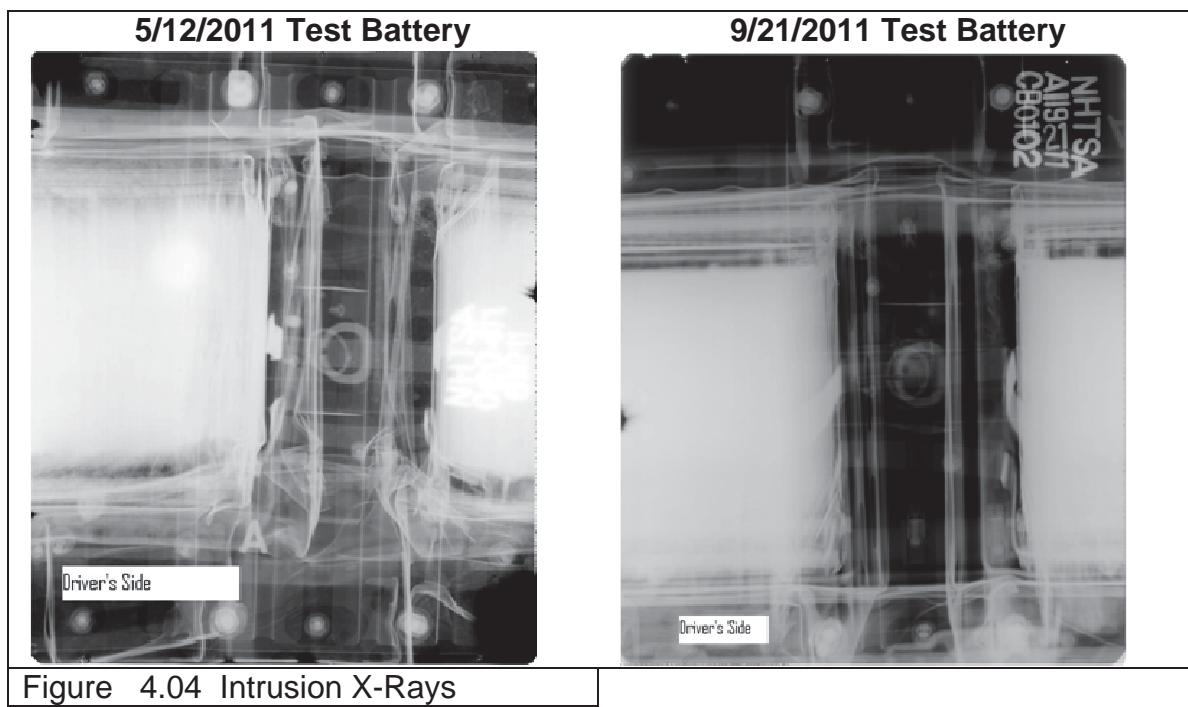
The vehicle was prepared by the test lab and NHTSA engineers outfitted the vehicle battery with the additional instrumentation on September 19th and 20th of 2011. The vehicle was crash tested and the post-crash rollover was performed on September 21, 2011. Figures 4.02 and 4.03. The x-ray of the impact area indicated that the battery did not sustain the level of intrusion observed in the May 12, 2011 test. See Figure 4.04. The vehicle was monitored for three weeks after the impact test and the battery did not experience any thermal or electrical events during the observation period.

No significant battery deformation or intrusion was observed for the September 21, 2011 crash test. There were no signs of coolant leakage during the crash test or the subsequent rollover test as evidenced by the coolant reservoir level post-test. See Figure 4.05. No thermal or electrical activity was observed in the vehicle or the battery immediately after impact or during the three week monitoring period following the test.

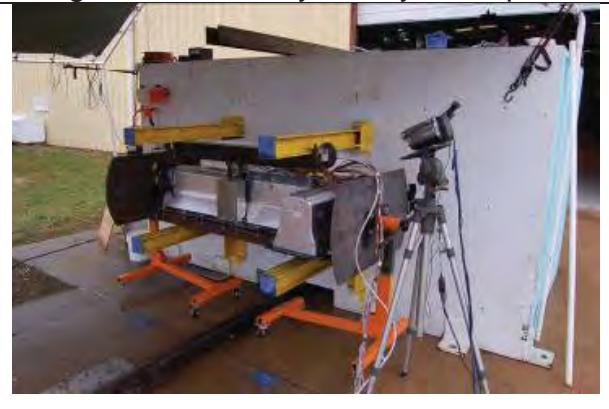
Figure 5.01 Battery Ready for Impact

Voltage monitoring, thermocouples and gas detection instrumentation were connected to the battery and verified for operation. See Figure 5.01.

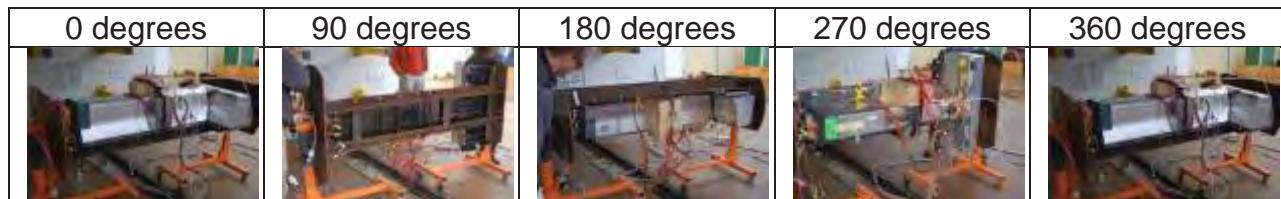
Figure 5.02 Battery Rollover Photographs

The battery remained on the support fixture for approximately one hour while it was being x-rayed. After completion of x-rays the battery/cradle was removed from the support fixture and an FMVSS 305 type rollover was initiated. The battery was manually rolled over, taking approximately one minute to rotate each 90° increment, and held for five minutes at the 90°, 180° and 270° positions. See Figure 5.02

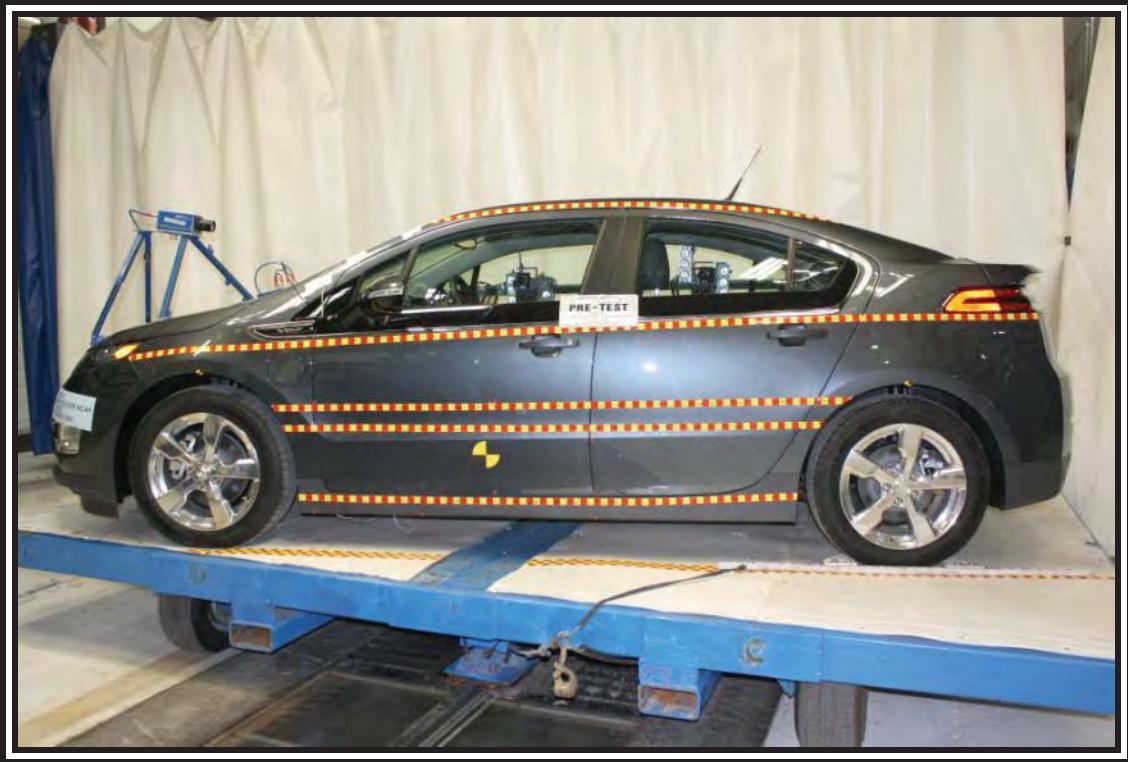
2011 Chevrolet Volt, pre-impact, view from the driver's side

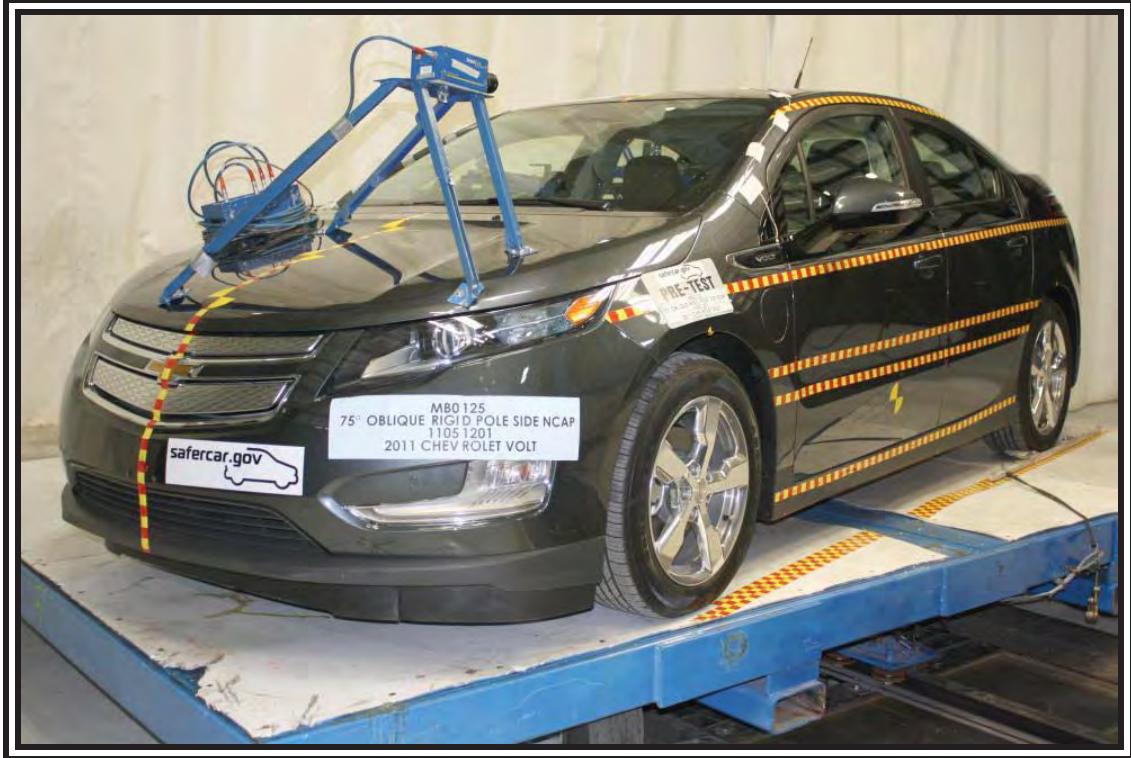
2011 Chevrolet Volt, pre-impact, view from the driver's side front

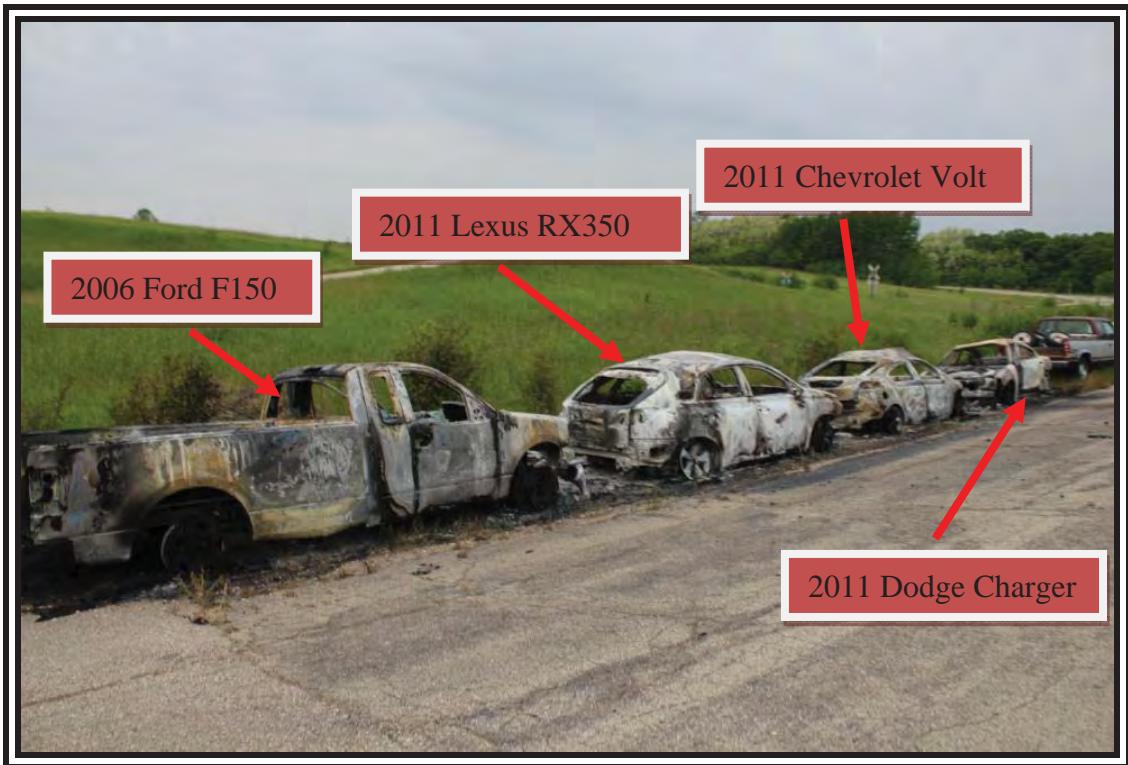
Overall fire scene, view from northeast to southwest.

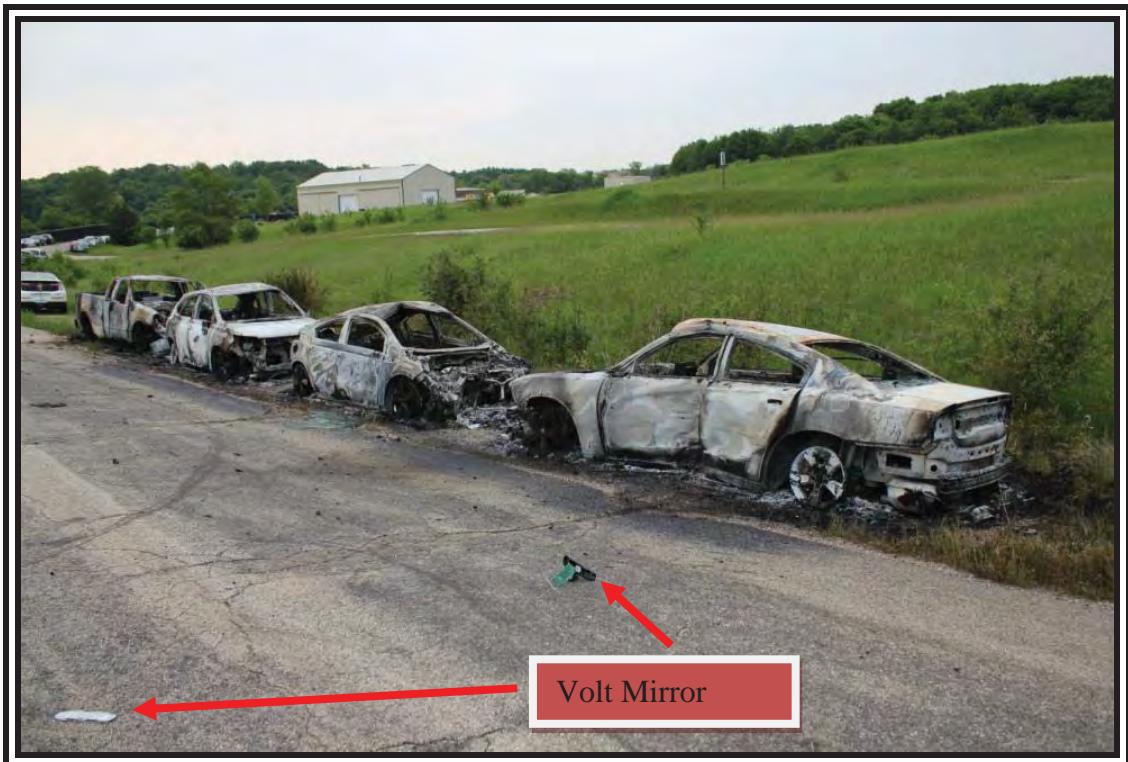
Overall fire scene, view from northwest to southeast

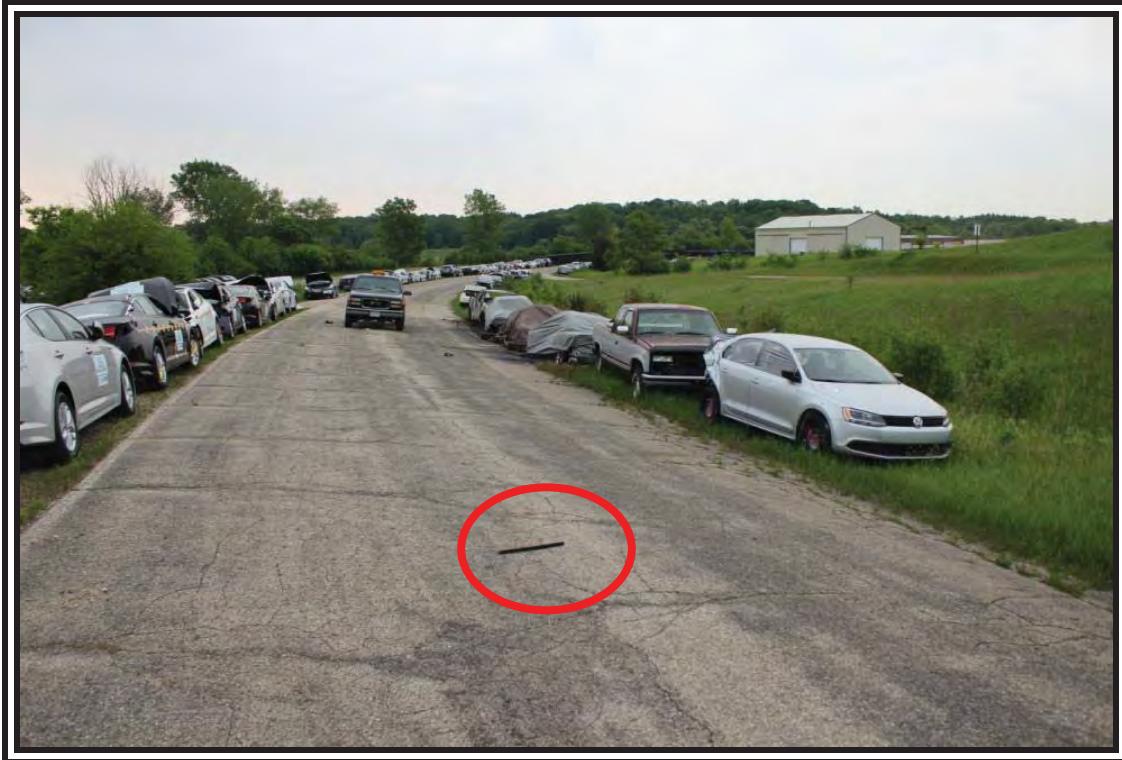
Chevrolet Volt, driver's side, rear lift hatch, pneumatic cylinder

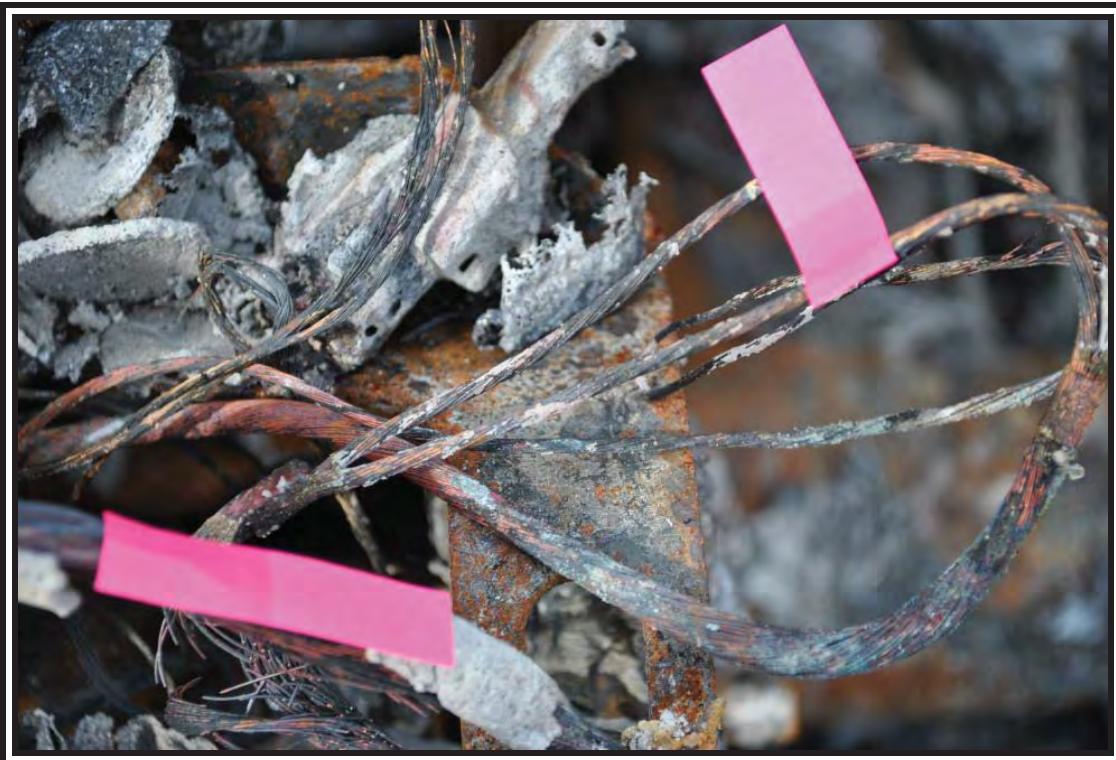
2006 Ford F150, intact fusible links to the alternator

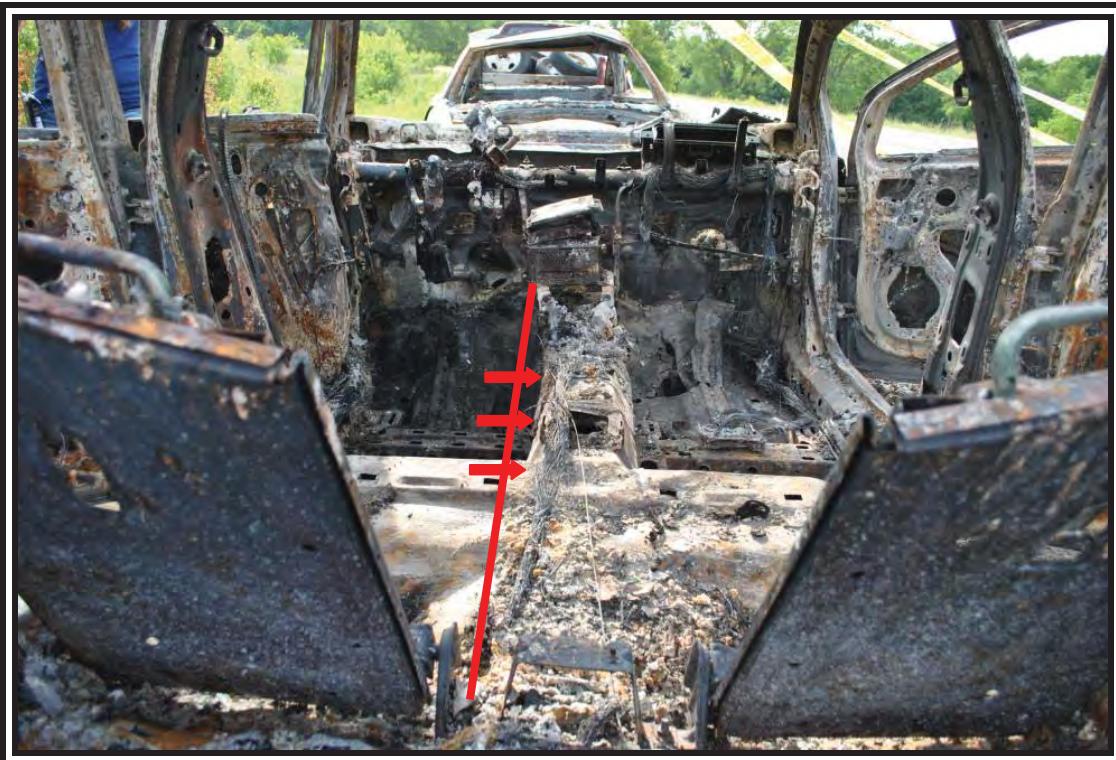
2011 Chevrolet Volt, view from rear after debris removal

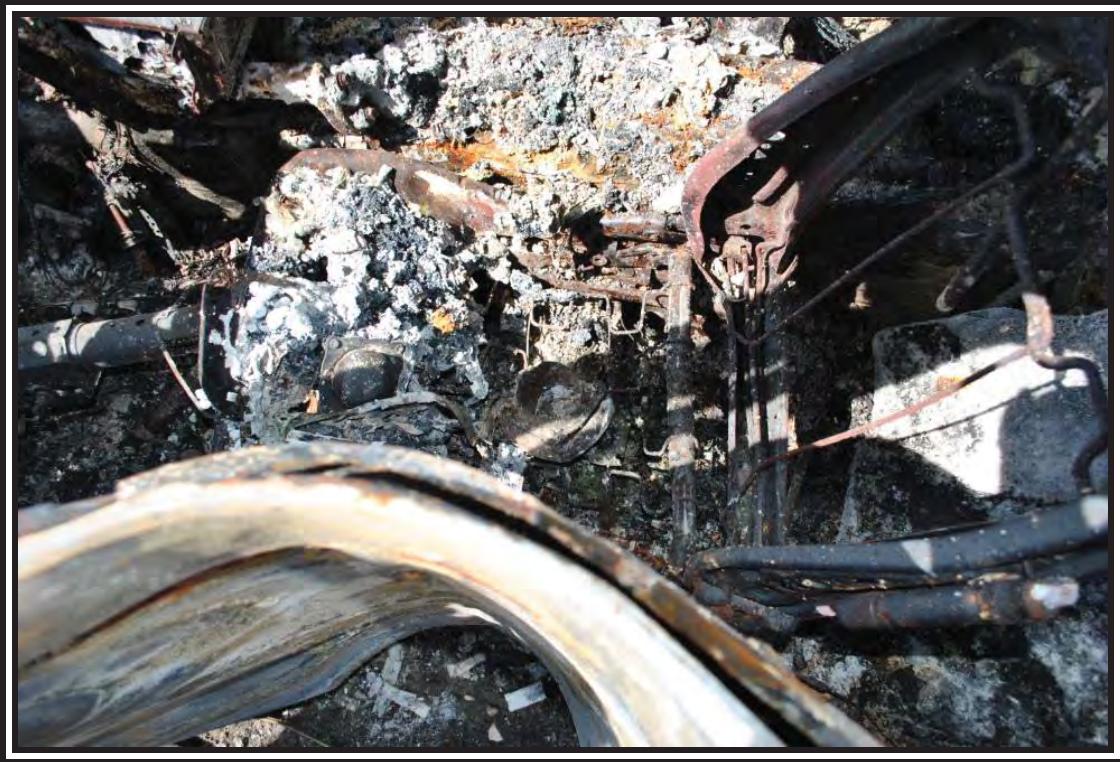
2011 Chevrolet Volt, observable ‘radius’ of the center tunnel

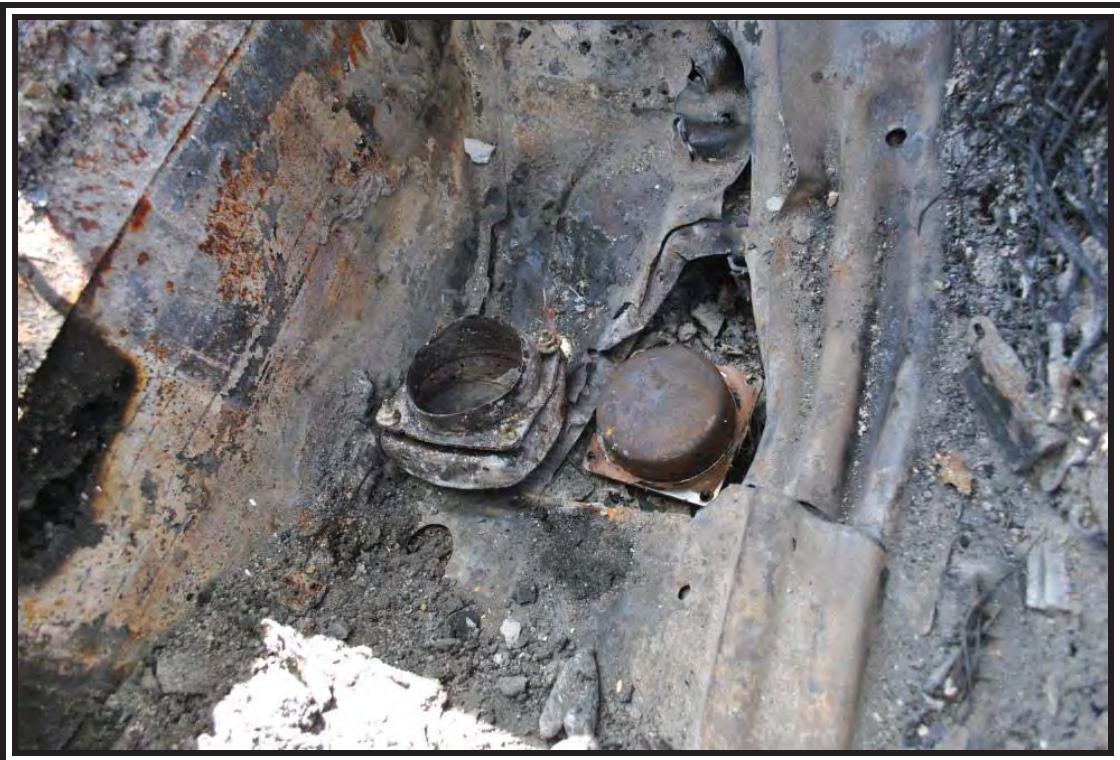
2011 Chevrolet Volt, view of the side impact and intrusion

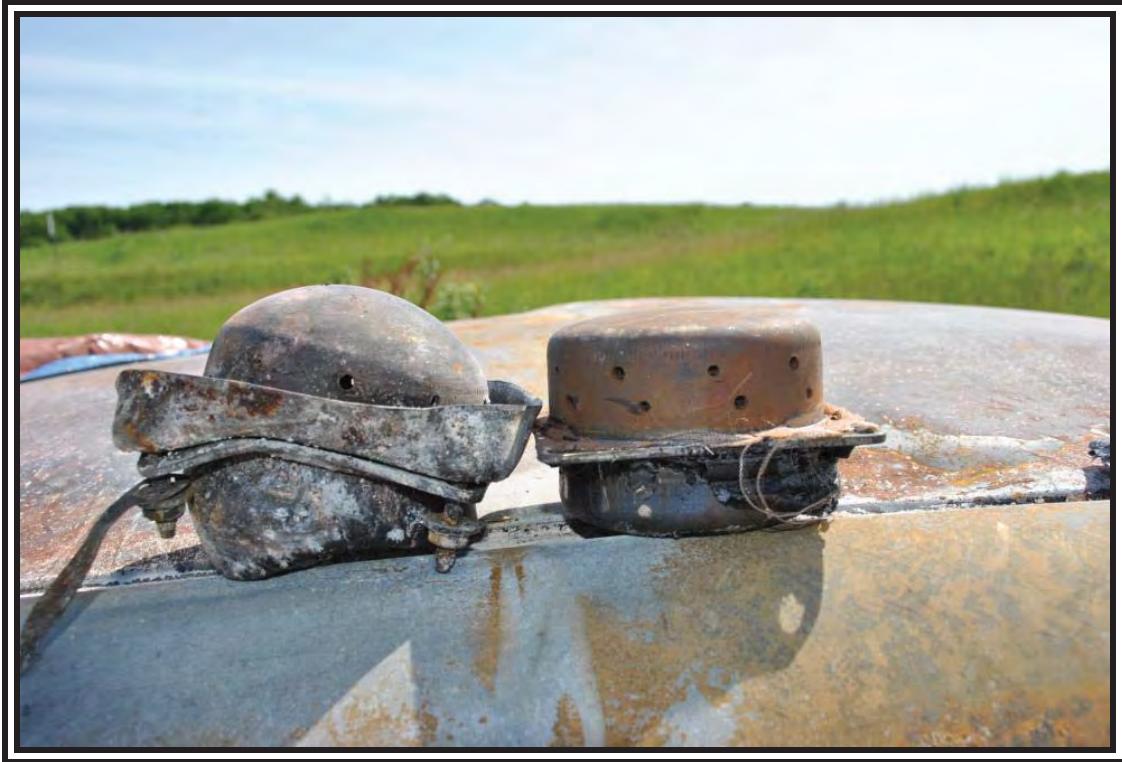
2011 Chevrolet Volt, passenger's side upper airbag module and exemplar module on passenger's side floor

5. The ensuing fire caused the passenger's frontal air bag module to be released from the dash mounting bracket, drop to the passenger's side floor, and remain there until it over-pressurized and mechanically damaged the passenger's side front floor and roof directly over the passenger's side front seat.
6. The fire spread through radiation and convection forward to the 2011 Dodge Charger and further to the 1995 Chevrolet Z71 and rearward to the 2011 Lexus RX350 and further rearward to the 2006 Ford F150.
7. The fire consumed most of the combustible material from the 2006 Ford F150, the 2011 Lexus RX350, the 2011 Chevrolet Volt, and the 2011 Dodge Charger. The 1995 Chevrolet Z71 was superficially damaged.

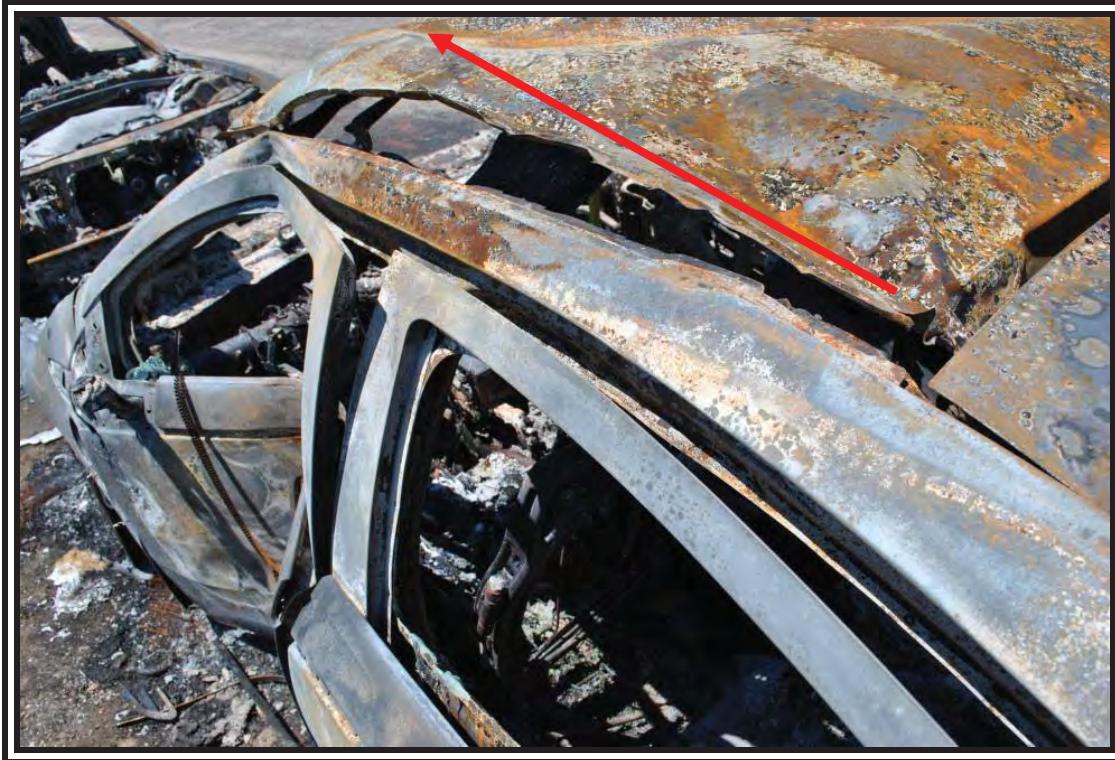
2011 Chevrolet Volt, trajectory illustration of interior rear view mirror components

1. An incipient pressure event occurred within the interior of the Chevrolet Volt. This over-pressure event displaced the vehicle windshield, interior rear-view mirror components, exterior rear-view mirror components, and vehicle trim.
2. After the pressure event, a thermal event occurred within the interior of the Chevrolet Volt.
3. The ensuing fire damaged the driver’s side rear hatch pneumatic cylinder causing it to ‘launch’ from the rear of the vehicle forward, under the roof sheet metal, to its resting place forward and to the passenger’s side of the Chevrolet Volt.
4. The passenger’s side rear hatch pneumatic lift cylinder failed in place causing localized mechanical damage.

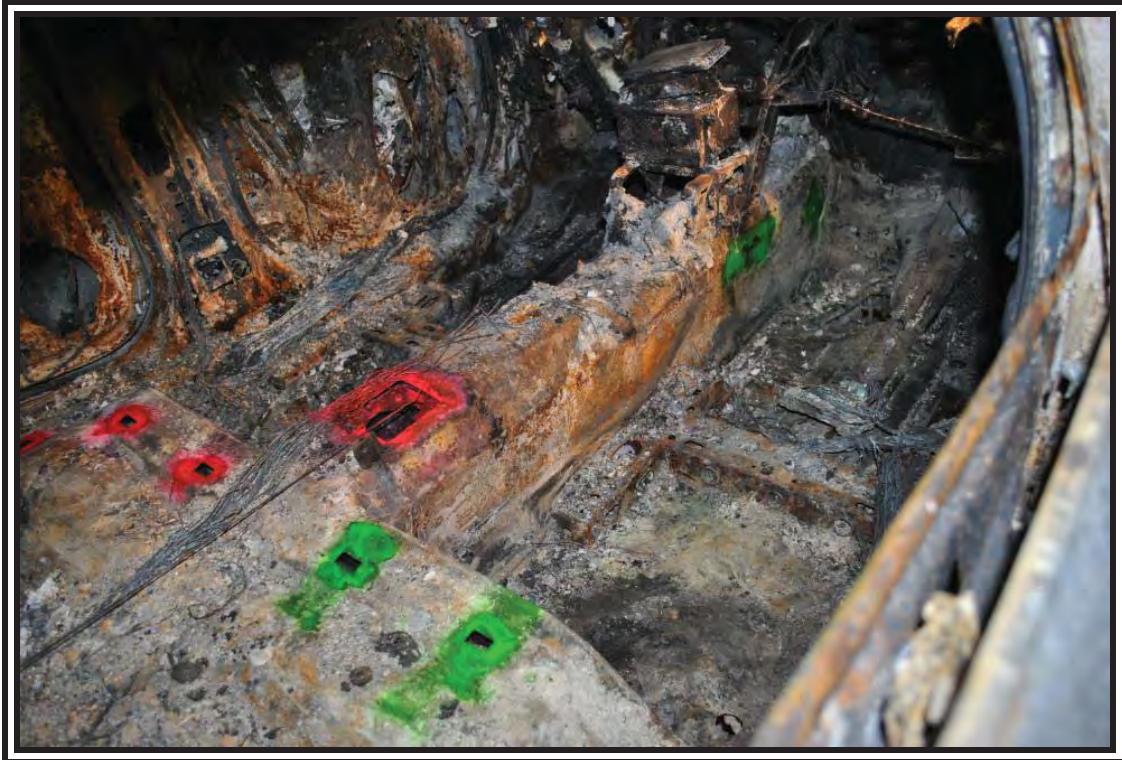
2011 Chevrolet Volt, driver's side interior showing impact intrusion into the center tunnel

An initial inspection of the crash damage to the Volt revealed that the transverse stiffener located under the driver's seat had penetrated the tunnel section of the battery compartment and damaged the lithium battery and the battery's liquid cooling system. For discussion purposes, the battery compartment includes the tunnel section located between the two front seats and the transverse section located under the back seat. It is more likely than not that this damage to the battery, battery compartment, and battery liquid cooling system caused the fire that destroyed the four vehicles at the MGA facility between June 3–6, 2011.

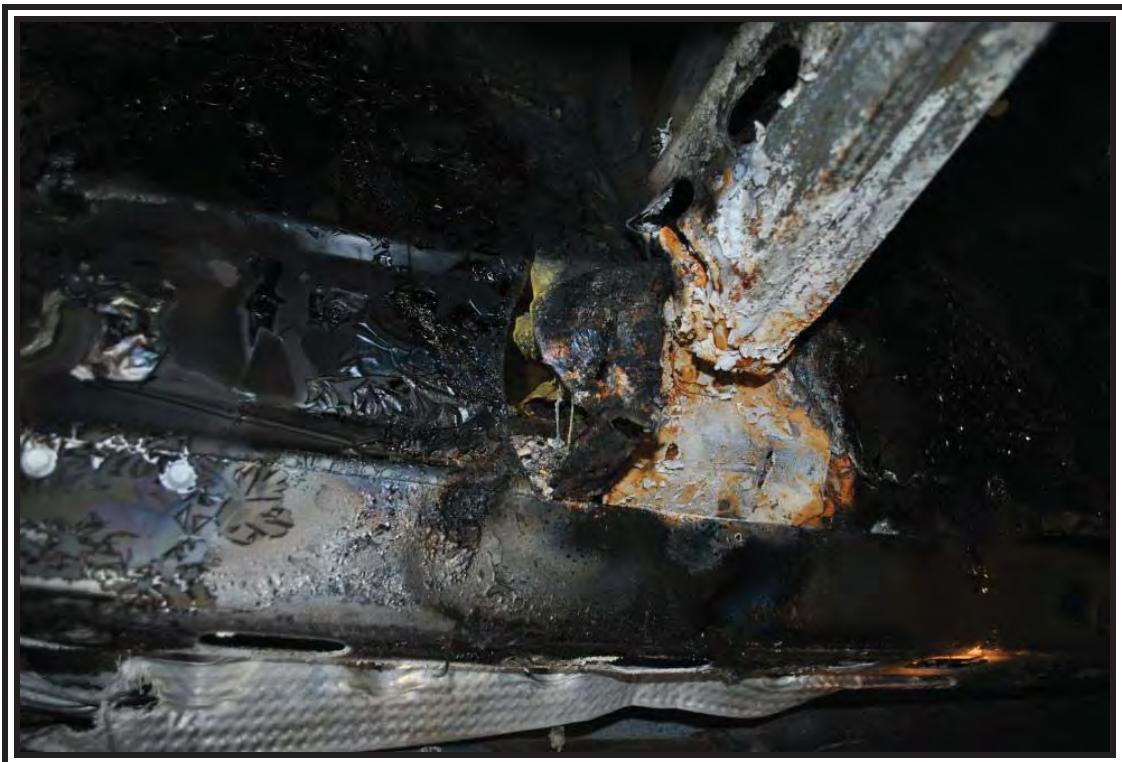
2011 Chevrolet Volt, measurement of intrusion into the battery pack tunnel

The initial inspection revealed that the transverse stiffener located under the driver's seat had penetrated the tunnel section of the battery compartment and damaged the lithium battery. A photograph of the damage to the outside of the tunnel is shown in Figure 3.1-2.

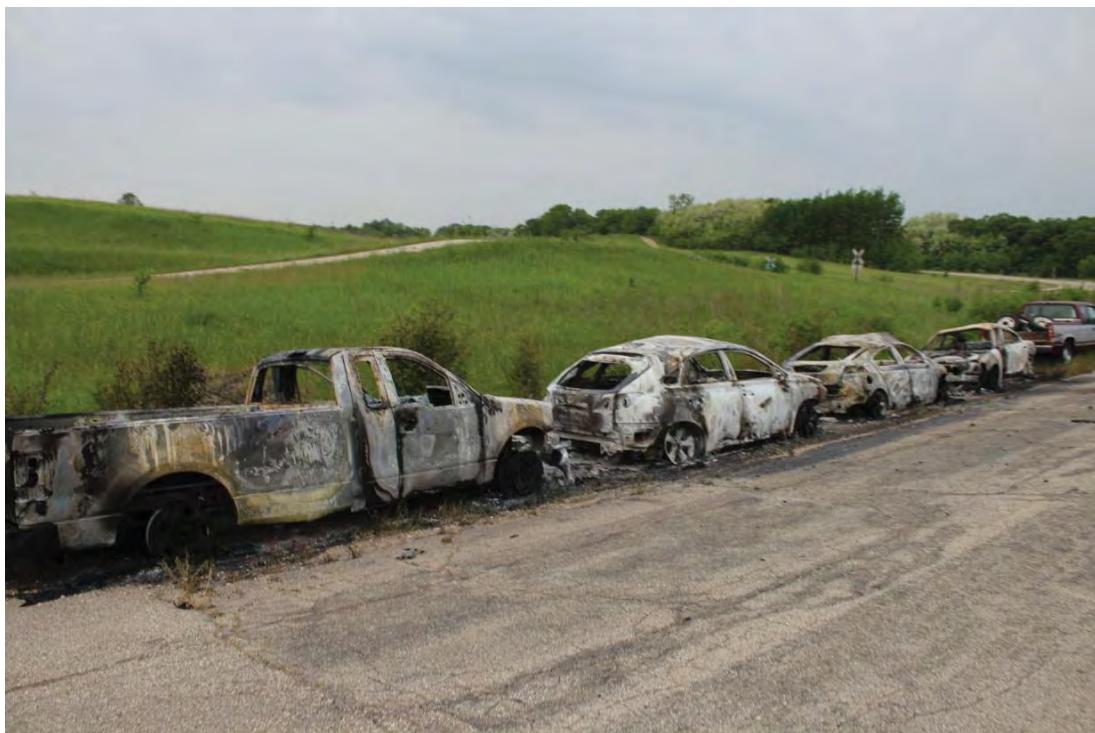
Figure 1.0-1. Fire Scene Photograph

The vehicles were located at the northern portion of the testing facility. The Ford F150, Lexus, and Chevrolet Volt were parked front to back (all three vehicles were parked facing west). The Chevrolet Volt and Dodge Charger were parked front to front (the Charger was parked facing east). The Dodge Charger and the Chevrolet Z71 were parked back to back (the Z71 was parked facing west), all on the southwest side of the roadway. Vehicles were placed there with a forklift after having been crash tested (side impact test on the driver's side). The Ford F150, Lexus RX350, and Chevrolet Volt were crashed 3 weeks prior to the fire and the Ford F150 was tested in February 2011. Per the standard test procedures, the 12V batteries of all four vehicles were fully charged at the time that they were tested. The cars were spaced about 2–3 feet apart. A photograph of these vehicles is provided as Figure 1.0-1.

The initial inspection concluded that the conditions of the adjacent vehicles and the exterior of the Chevrolet Volt are consistent with the fire originating in the Chevrolet Volt [1]. In addition, there were obvious differences in the damage to the Volt when compared to the other vehicles involved in the fire. The most notable was that the windshield and rear view mirror assembly had been blown out of the car and were lying on the street next to the vehicle with little (if any) heat damage to these components. The lack of heat damage suggests that this overpressure event occurred before the occupant compartment of the Volt caught fire. This overpressure event was followed by a fire within the occupant compartment of the Volt that eventually destroyed the four vehicles at the MGA facility between June 3–6, 2011.

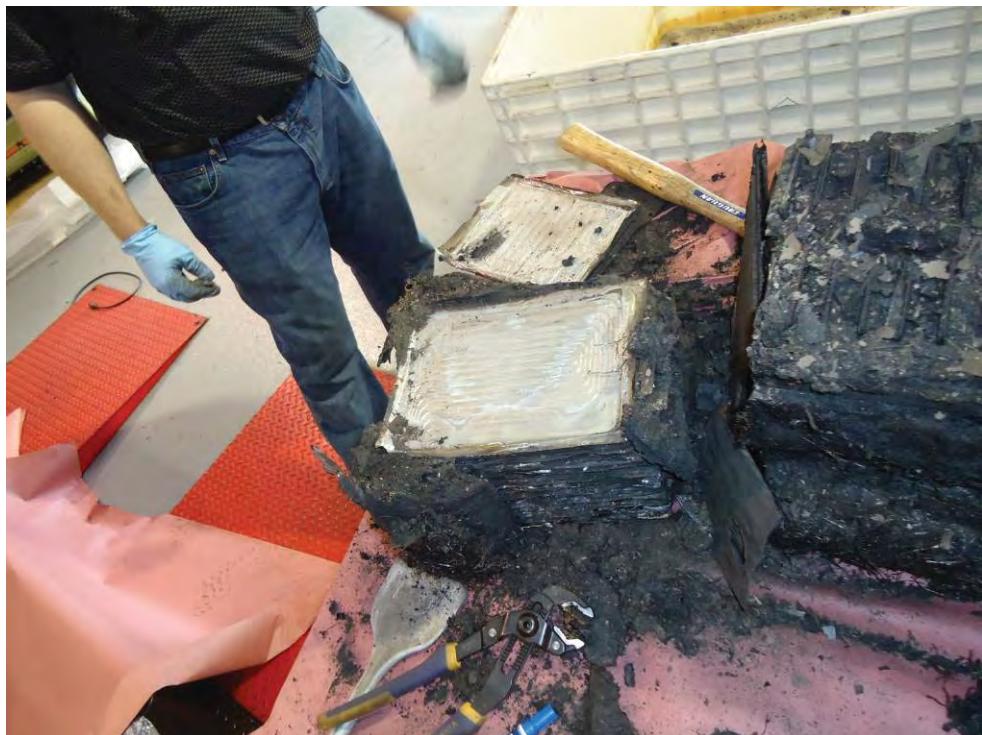
Figure 3.3-4. Overall Battery Condition Photograph

Precautions were taken to prevent additional damage when removing the cells and fins from the module. However, to start the removal process, a saws-all was required to cut away the cooling lines and the support rods that run along the bottom of each module. A photograph showing the disassembly of the battery is provided as Figure 3.3-4.

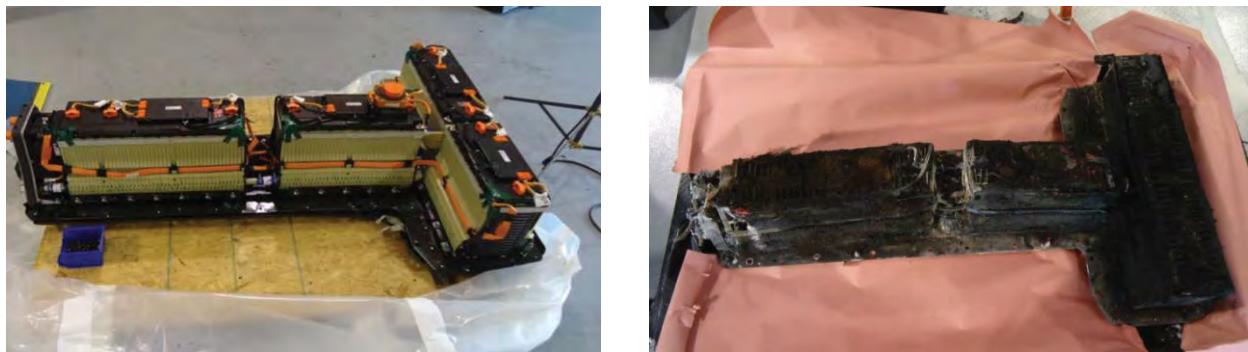
Figure 3.3-5. Overall Battery Condition Photograph

A photograph of the battery after the cover had been removed is shown in Figure 3.3-5 (right photograph). As a reference, an unburned battery is shown in the photograph on the left (Figure 3.3-5). As shown in this figure, the battery was still fairly intact after the fire.

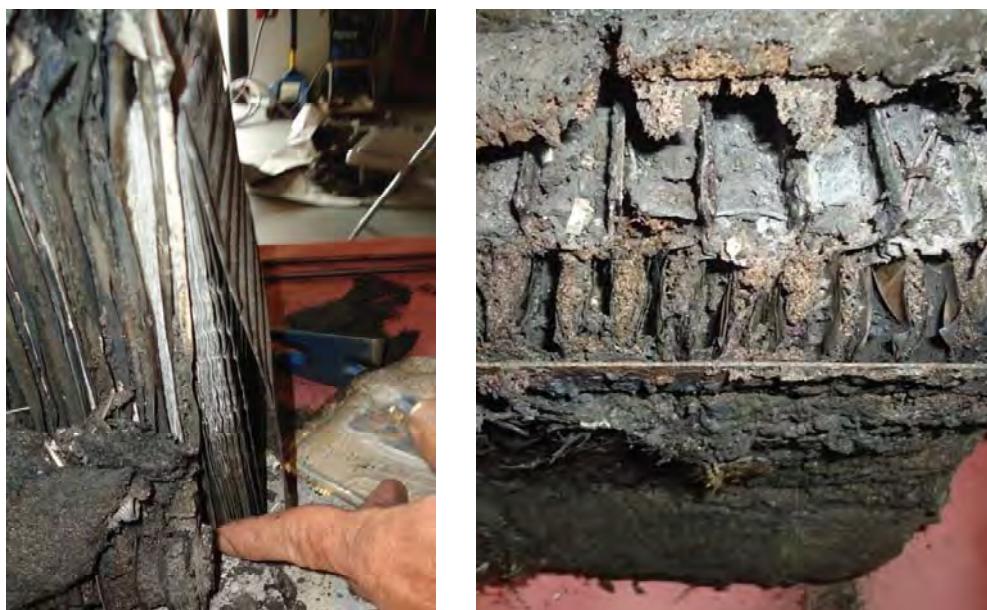
Figure 3.3-7. Typical Cell/Module Remains

The cells at the ends of each module showed significant damage near the top of the cells. There were a few cells at the end of the modules that had vented out of the side and burned a hole through the cooling fin as opposed to venting out of the top of the cell. These end locations have better access to oxygen (due to openings in the tunnel) and as a result, would have been hotter due to increased burning at this location. The increased heating to the end cells may have made them react more violently and/or weakened the cell casings and cooling fins at these locations. Additional discussion of these end cells is provided in Section 3.3.3.

There were at least seven areas where the battery had arced to the inside of the battery compartment during the fire. This arcing was the result of the structural metal bands that run around the top of each module becoming positively charged during the fire. There were multiple areas where the battery leads had shorted and fused to this metal band or module end plates once the insulation on the lead had been consumed by the fire. Figure 3.3-8 (left photograph) shows a positive lead fused to the front plate of Module 2. The right photograph shows the damage to the band produced by the arcing. As stated previously, this arcing typically cut an opening into the side of the battery compartment (i.e., an opening between the battery and occupant compartments). This arcing caused the cells to heat-up adding additional energy the overall event.

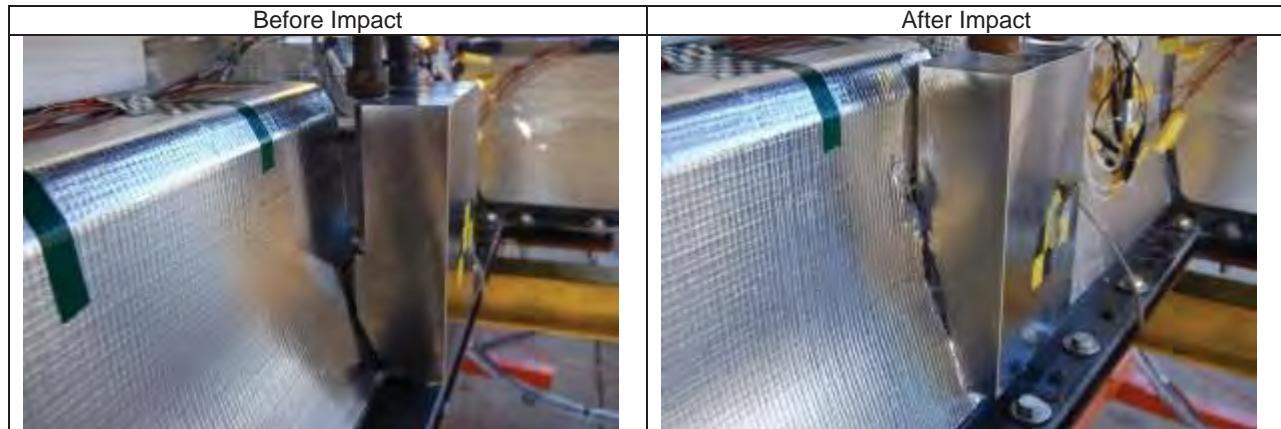
Figure 4.3 Sample Impactor Block Penetration

The impactor block was shaped to simulate the side of the tunnel and stiffener that penetrated the battery during the test at MGA. The impactor block was made of HY100 steel plate. The block was installed on the driver's side of the battery at the junction between Modules 1 and 2. Two 1" diameter rods were connected to the impactor block, run through the opening between the two modules and through a wood block assembly on the opposite side of the battery. Crimp rings were installed on the rods in the center of the wooden block to keep the device in compression after impact. A photograph of the impactor block assembly is shown in Figure 4.2. Photographs of the impactor block in position both before and after impact are shown in Figure 4.3.

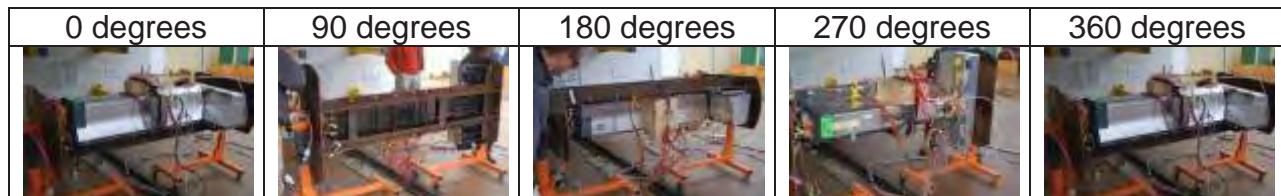
Figure 5.2 Battery Rollover Photographs

For tests that included rollover, the battery was rotated around the longitudinal axis 360 degrees at 90 degree increments as shown in Figure 5.2. The battery was rotated toward the passenger side of the vehicle. Once the battery was rotated each 90 degree increment, the battery was held in that position for five minutes prior to rotating to the next position. This is representative of the post crash procedures used by MGA on the Chevrolet Volt during the test in May 2011.

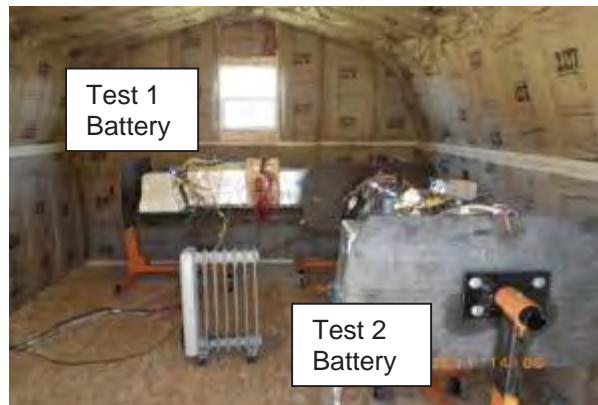
Figure 7.3 – Storage Configuration for Batteries from Tests 1 and 2

The orientation of the two batteries within the shed is shown in Figure 7.3.

The fire occurred in the late afternoon on November 24, 2011 (Thanksgiving Day). There were no indications visually or empirically that a reaction was about to happen up to about an hour before the event. The following is a high level overview of the events that occurred on that day.

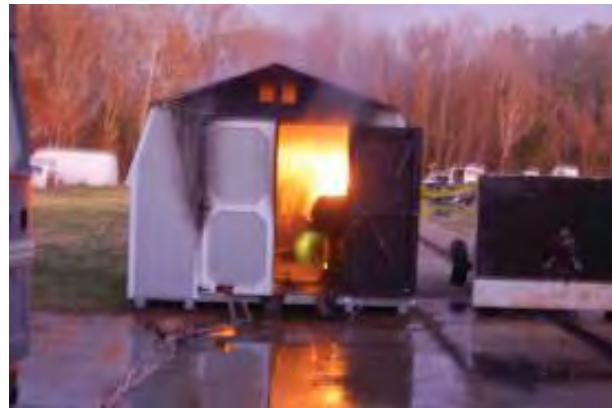
15. Only the Test 2 battery is involved at the time of the initial attack
16. Flames jetting from drivers side end of Module 3 and opening in cover observed at that location

Figure 7.4 – Photograph Showing Early Stage of Fire

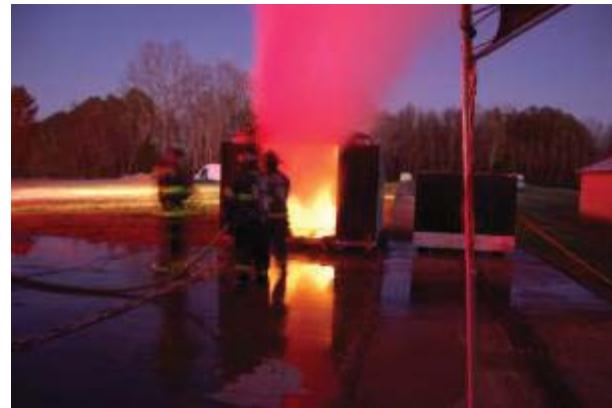
17. Fire spreads to the Test 1 battery
18. Fire is extinguished about 7:30 PM
19. Fire burned for about 2 hours and 30 minutes total

Figure 7.5 – Photograph Showing Final Attack on Fire
