U.S. Department
of Transportation
**National Highway
Traffic Safety
Administration**

DOT HS 811 573

January 2012

Chevrolet Volt Battery Incident Overview Report

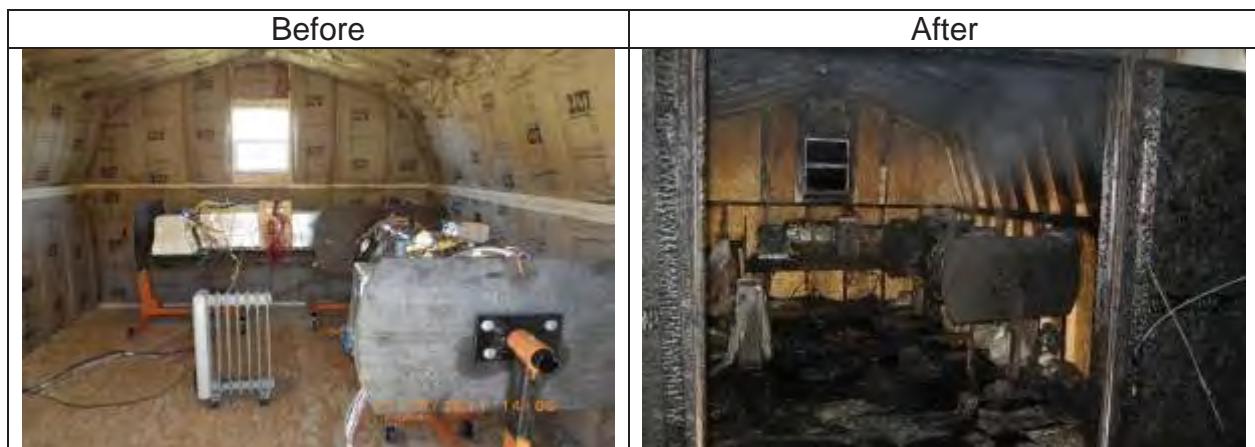
14. Interior of shed significantly charred when door blew open indicating that the fire had been burning for a while prior to the pressure event. Test 2 battery fully involved, Test 1 battery heating but not involved.

Figure 7.6 – Photograph Showing the Contents of the Shed Before and After the Event

The damage is consistent with the following scenario: The fire originated in the Battery in Test 2. The fire then spread to the paper facing on the insulation installed on the inner surfaces of the shed. As the paper facing was consumed, the oxygen concentration in the shed dropped causing the fire to become oxygen limited. The fire then smoldered for about 10 minutes prior to the overpressure that blew open the door.

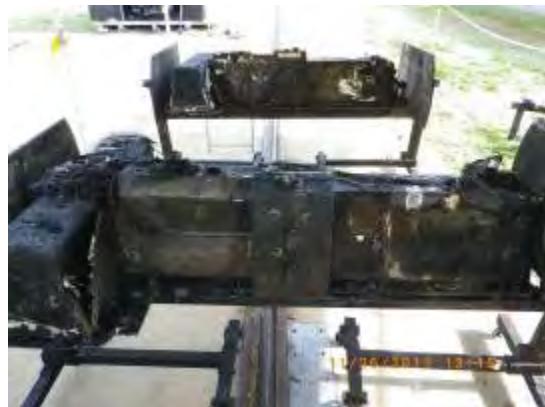
As a general statement, a significant amount of the combustible materials in both batteries were consumed during the fire. A photograph showing two batteries is provided as Figure 7.8.

Figure 7.8 – Photograph of Batteries from Tests 1 and 2 (Battery from Test 2 is closest to the photographer)

The forensic investigation of the battery from Test 2 placed the origin of the fire on the top of the module. However, the exact origin of the fire could not be determined. The electrical shorting caused by the coolant solution that was observed during the other tests conducted during this program suggest that the fire could have originated in any of the circuitry (i.e. VTSM cards and/or cable connections) located on the top of Module 3.

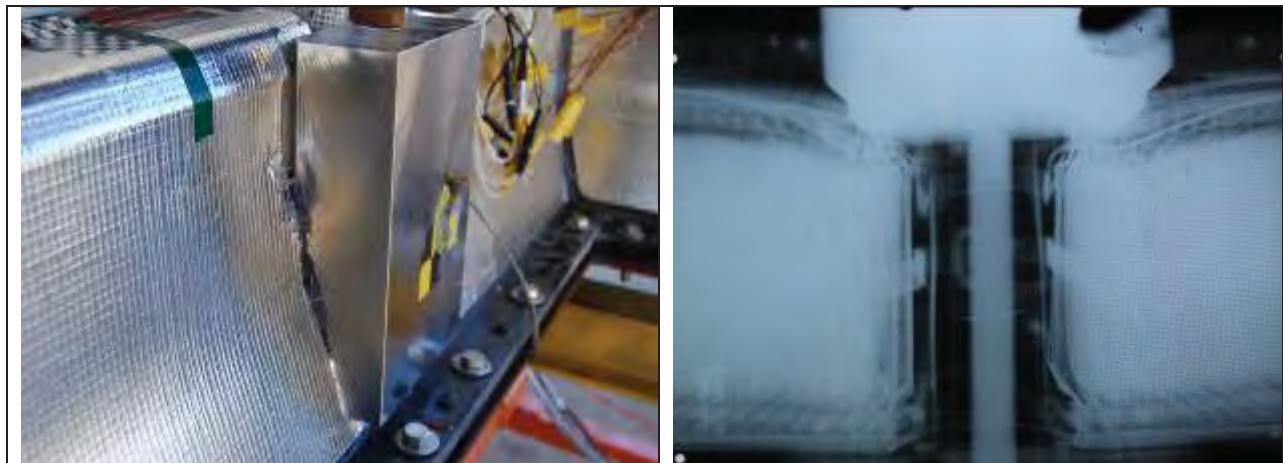
The impact penetration was slightly increased for each test in an attempt to reproduce the damage to the battery produced during the crash test conducted in May at the MGA facility in Wisconsin. The amount of battery coolant (ethylene glycol/water mix 50/50) leaked into the pack was also greater than that leaked during the first two tests. A photograph and an X-ray of the damage for this test is provided in Figures 7.10.

Figure 7.10 – Test 3 Battery Damage and X-Ray

Impact damage looked similar to that of the MGA battery with the back end of Module 1 and the front end of Module 2 slightly crushed and pushed about an inch toward the passenger side of the vehicle. The cooling system was also breached at this location allowing the coolant to flow out of the pack into the battery enclosure.

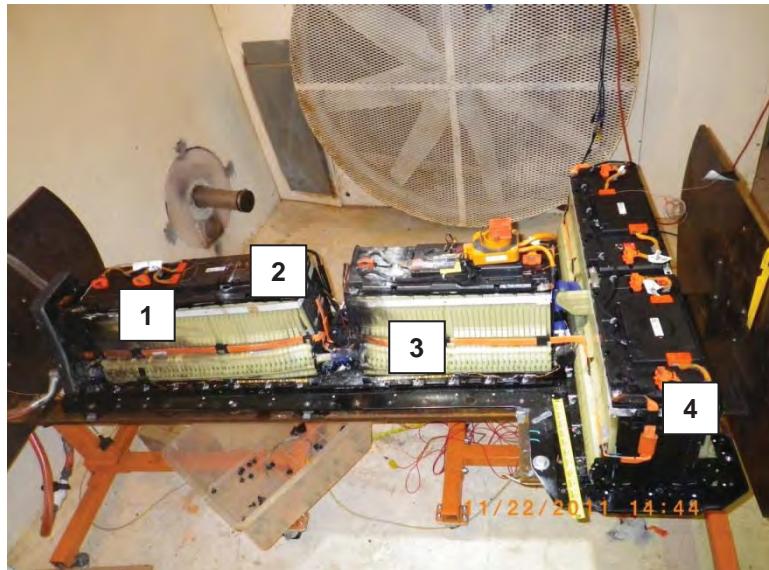
1. In and above the electronics at the front end of Module 1,
2. On VTSM 1 located above the center of Module 1,
3. At the front end of Module 2 near the impact location, and
4. At the negative end of Module 3 (drivers side end).

Figure 7.12 Test 3 Arcing Locations

Generally speaking, the arcing was attributed to both the structural damage to the battery caused by the impact, and the shorting of various components due to the exposure to the electrically conductive coolant solution.

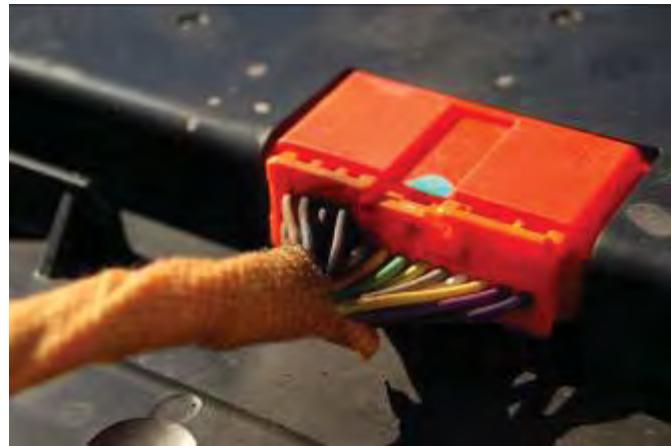
Post test visual inspection of the battery revealed discoloration(brown to black) on the wires and orange jacket leading from the orange connector on the battery to VSTM 3. See photograph at Figure 7.12.

Figure 7.12 Discoloration of wires and orange jacket

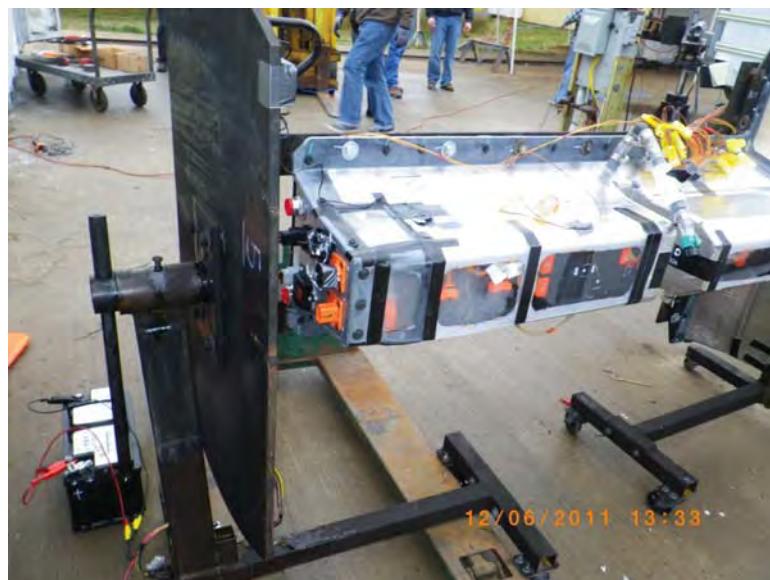
During the rollover portion of the test, between 180 degrees and 270 degrees, the coolant must have submerged the positive and negative terminals located on the driver's side of Module 1 causing rapid electrolysis of the coolant. A vigorous boiling sound could be heard as the battery was rotated through this orientation. The electrolysis abruptly stopped as the battery approached the 270 degree orientation and no other adverse effects were observed. A photograph showing the battery at the 270 degree mark is provided as Figure 7.13. Smoke can still be seen in the area where the shorting and electrolysis is believed to have occurred.

Figure 7.13 Test 5 with the Battery at the 270 degree orientation

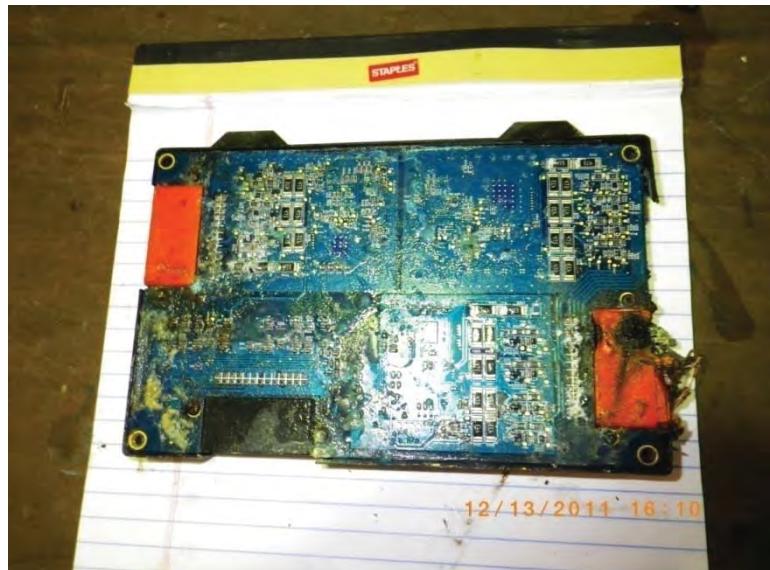
The forensic inspection of the cells was consistent with the fire originating at the connection between the voltage monitoring system bus bar and the cable for VTSM 3. Specifically, there was no damage to any of the cells other than directly under the connector and there was no damage to VTSM 3. A photograph of VTSM 3 is provided as Figure 7.16.

Figure 7.16 VTSM 3 – No Apparent Fire Damage

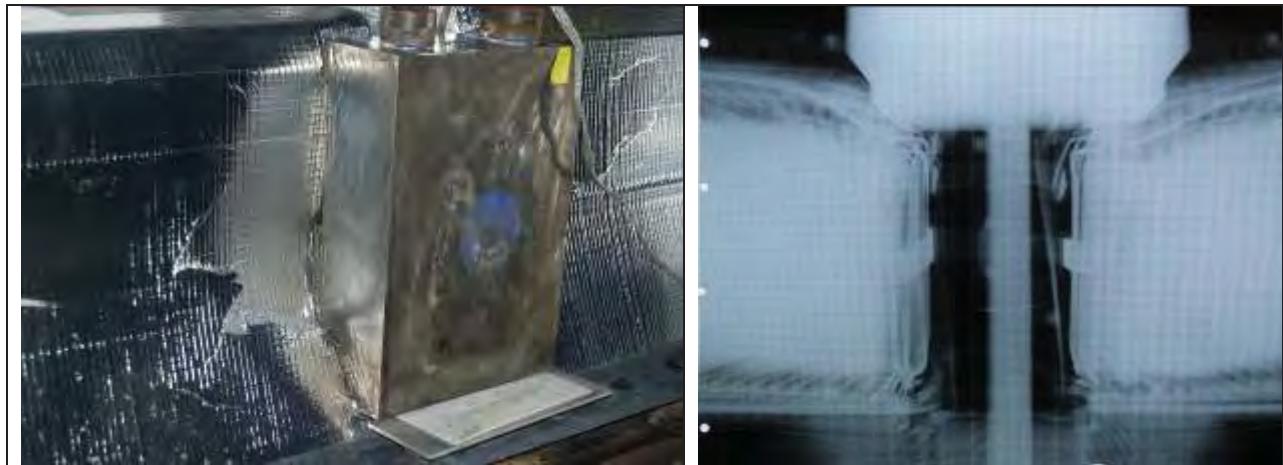
One of the cell groups on the end of Module 1 located in the impact area slowly lost charge during the monitoring period. Voltage at the end of the monitoring period had dropped to 0.21 volts. A photograph and an X-ray of the damage for the test is provided in Figure 7.18.

Figure 7.18 - Test 6 Battery Damage and X-Ray
