# ODI RESUME

**Investigation:** EA 12-007  
**Prompted by:** PE12-007  
**Date Opened:** 09/13/2012  
**Investigator:** Ric Willard  
**Approver:** Frank Borris  
**Subject:** MCI Drive Shaft Safety Loop Failures

**Problem Description:** In the event of a drive shaft failure, the separated drive shaft is not adequately contained and can cause a loss of vehicle control.

## **1992-2012 MCI D-Series Bus Driveshaft Failure**

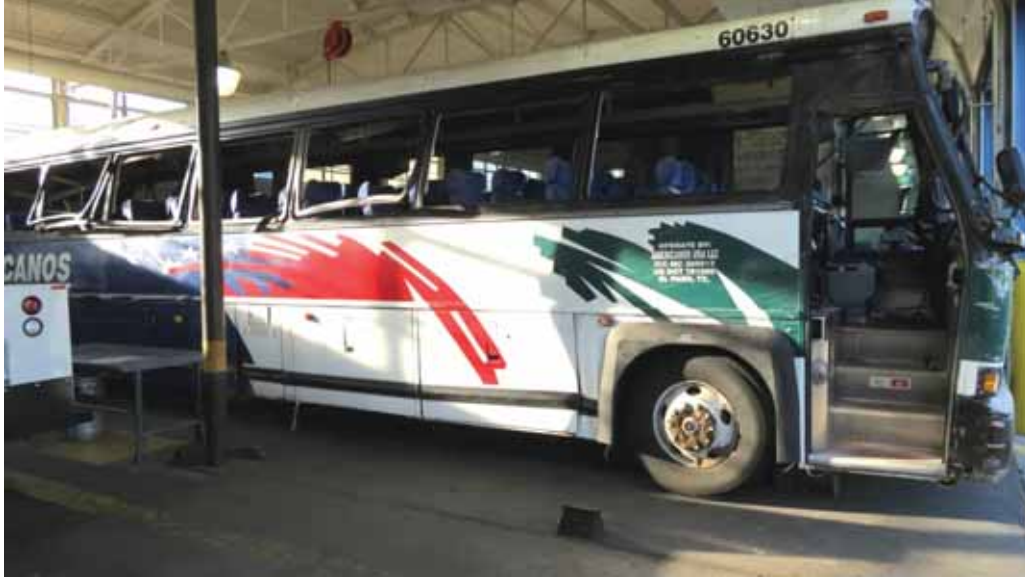
**Figure 28- Americanos 60630 at Inspection Facilities**

The Americanos bus 60630 was inspected by NHTSA at a Greyhound maintenance facility to view crash damage and document forensic evidence. The bus is shown in Figure 28 parked over an inspection pit. The bus had remained in the original condition from the crash, except the damaged tag axle tie rod was straightened to transport the vehicle to the facilities.

The initial tag axle inspection showed damage to multiple areas of the inner structure where the driveshaft passes through, and it revealed considerable impact and bending damage to the caster arms and latching tongue assembly, as shown in Figures 29 and 30. The bent latching tongue clevis in Figure 30 and the witness marks on the safety catch hoop indicate the axle rolled forward into a reversed caster position while in forward travel.

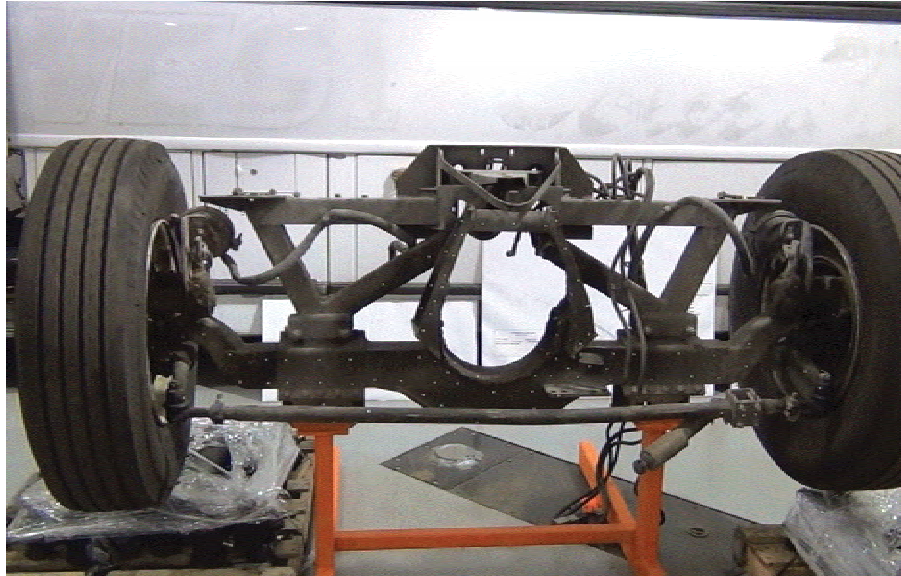
**Figure 34- Americanos 60630 Tag Axle Test Stand**

At VRTC's request, the complete tag axle was removed from the Americanos bus 60630 and sent to VRTC for closer examination of impact damage and quantifying the loss of

mechanical functionality caused by the damage. Figure 34 shows the axle on a test stand after removal from the bus. The damage to the axle components was compared to other subject evidence parts for commonalities.

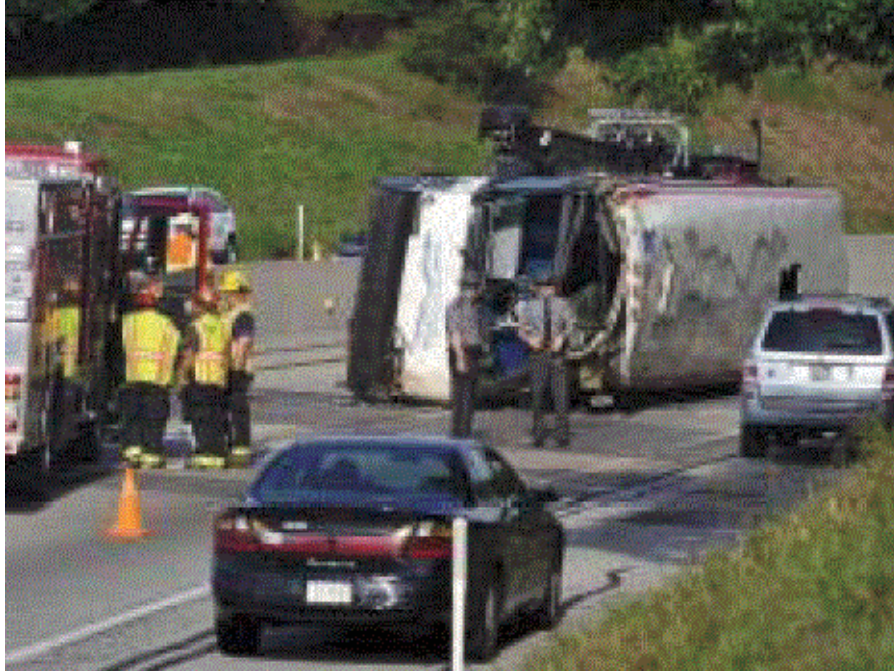
**Figure 35- Greyhound Bus 6352 Crash Scene Press Photo**

The Crash of Greyhound bus 6352 occurred in August of 2011 while the vehicle was traveling westbound in the left hand lane of the I-76 PA Turnpike, near Bowmansville Pennsylvania. The vehicle was traveling approximately 65 mph in a right hand curve when the bus suddenly pulled to the left, and it proceeded to strike and then ride along the concrete Jersey barrier that divides the center median. The driver stated that he applied braking and continuous right-hand corrective steering in an attempt to get the bus off of the barrier as it rode against the concrete wall, flattening the left outside drive axle tire. The vehicle then suddenly reacted sharply to the corrective steering and veered back uncontrollably to the right, crossed the right-hand lane, and exited the roadway. The bus traveled upwards on an earthen embankment adjacent to the shoulder, rolled over onto its left side, then back onto the roadway. The bus continued sliding on its side along the roadway, coming to rest across both lanes, as shown in Figure 35<sup>10</sup>. The crash resulted in multiple injuries sustained to several of the passengers.

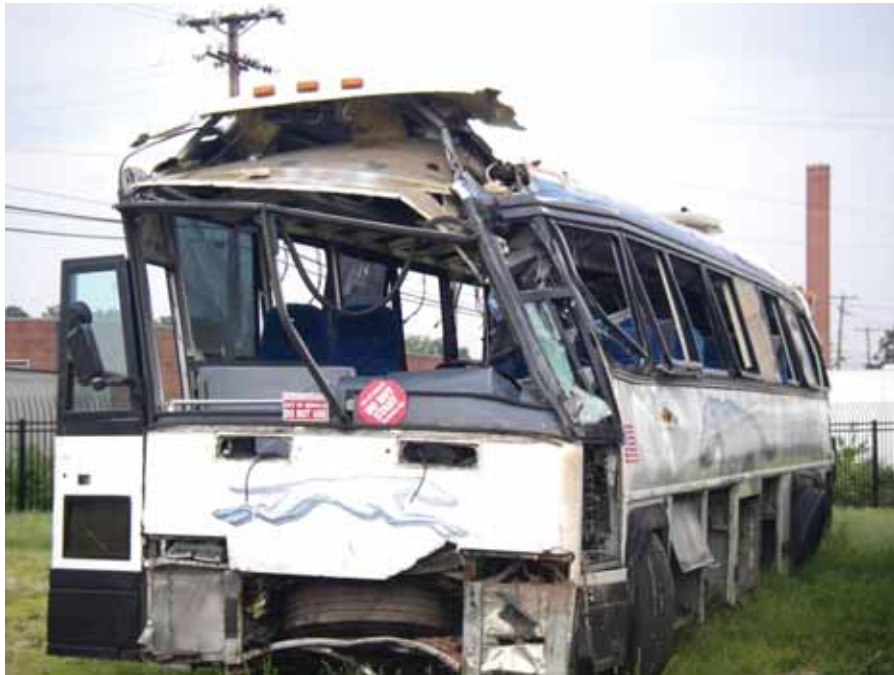
**Figure 36- Greyhound 6352 at Inspection Facilities**

NHTSA was able to conduct an inspection of Greyhound 6352 at a fleet service facility to document crash damage and collect forensic evidence items in support of the investigation. The bus had been salvaged with both the engine and transmission removed, revealing the tag axle structure. The vehicle is shown in Figure 36 parked in a salvage lot at the facility. The bus still had the crash scene tires mounted on both the front and rear drive axles. The tag axle tires had been removed, but the damaged axle assembly remained intact.

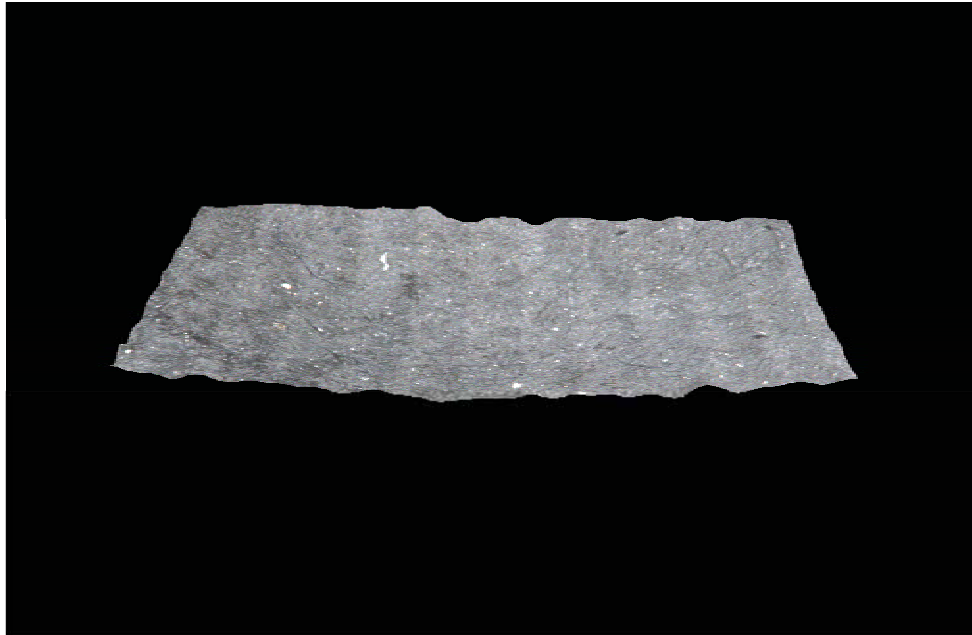
**Figure 43- Exemplar Driveshaft Clay Impression**

A clay impression of an exemplar driveshaft was compared to the impression taken from the Greyhound 6352 tie rod. The impression shown in Figure 43 exhibits a similarly distinct

pattern to that of the tie rod. This similar pattern of the impressions, combined with the radius of the impact that matched the driveshaft tube diameter, demonstrated sufficient evidence that the damage to the tie rod was caused by a driveshaft.

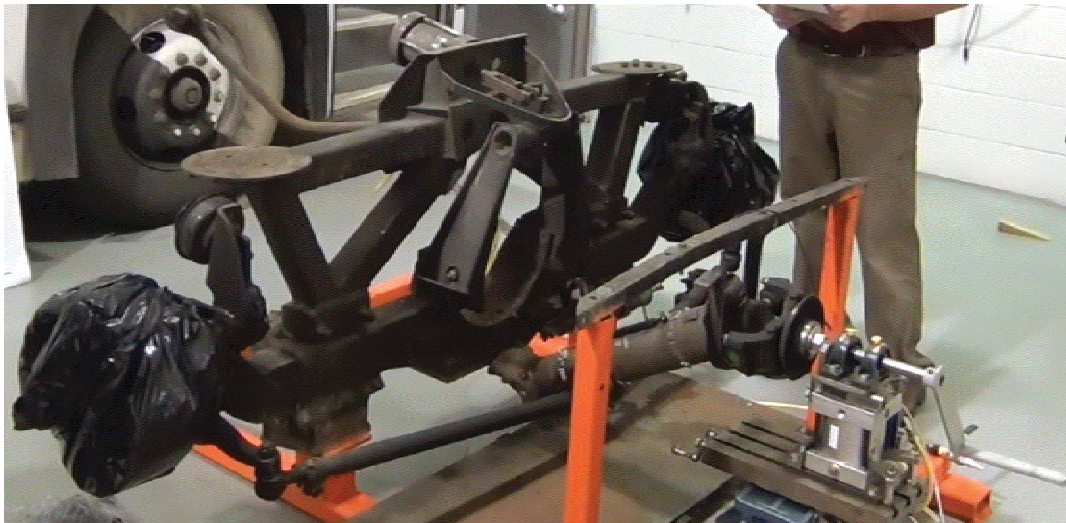
**Figure 44- Greyhound 6352 Reassembled Tag Axle Test Fixture**

Evidence parts retrieved from the Greyhound 6352 crash were reassembled into a working test stand. The complete tag axle assembly with tie rod was mounted vertically, and a drive axle hub assembly was positioned on the fixture allowing the driveshaft to be connected at the hub and remain free to rotate within the tag axle structure. The fixture can be seen in Figure 44 showing the escaped driveshaft at the impact point on the tie rod.

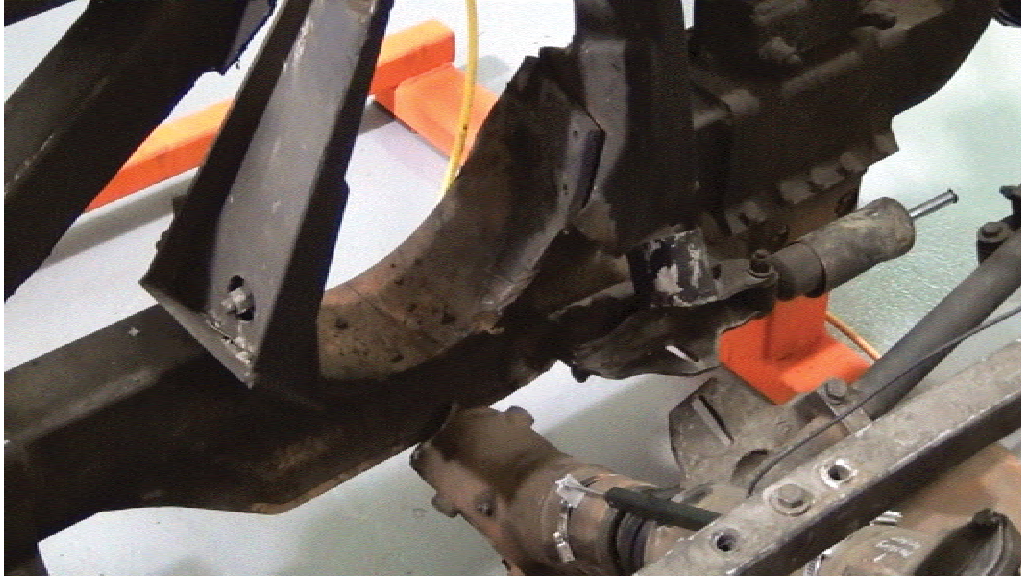
**Figure 45- Greyhound 6352 Escaped Driveshaft on Test Fixture**

The fixture shows the driveshaft can escape from the pass-through opening of the axle, as seen in Figure 45. The image also shows the impact damage to the tie rod latching cylinder base and latch plate clamp block. The driveshaft matched the gouging marks on the lip and face of the axle beam caused as the shaft escaped the mouth of the pass-through.

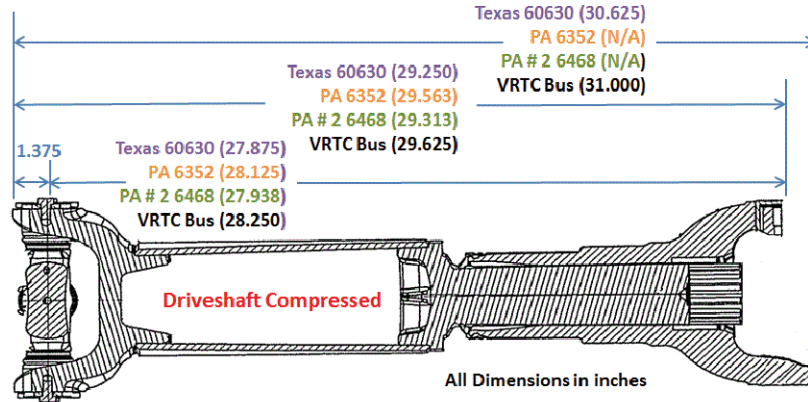
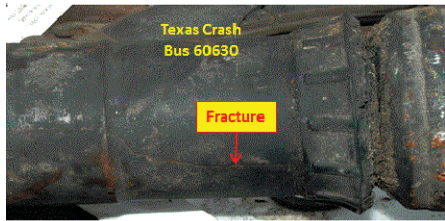
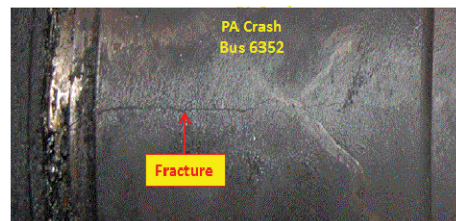
Figure 50- Compressed Driveshaft Dimensions

Measurements were taken on evidence and exemplar parts to determine whether a driveshaft can escape the tag axle pass-through. These measurements were compared to the manufacturer's specifications. The measurements reflect the shortest compressive lengths of the driveshafts. These measurements were used to establish overall lengths and clearances at the tag axle pass-through. Figure 50 shows each driveshaft's dimensions and images of the column fracturing caused by over-compression, which further reduced the overall length. The measurements were compiled into a table that showed the interference and length inconsistencies between actual measured parts and the manufacturer provided specification drawings. The table is in Figure 51, and measurements are listed from all three collected driveshafts and an exemplar driveshaft from the VRTC test vehicle.

Conical shape loading produces column fracturing

Overcompression limited by tube integrity, but conical design can fracture tube and further shorten shaft.

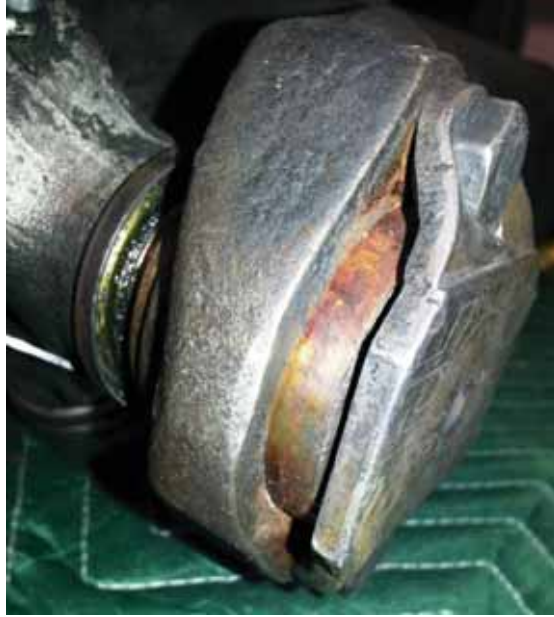
**Figure 53- Greyhound 6352 Deformed Bearing Retainer Plate**

The driveshafts also revealed that the remaining U-joint on the drive axle end of the shaft was in good working condition with little or no visible wear. The remaining bearings gave good representation of the condition of the driveshaft U-joints at the time of the failure. This evidence further supported that the root cause of the failure was the fracturing of the cast journal ear rather than a bearing failure that might have been caused by wear or lack of maintenance. The U-joint also showed distortion of the journal bearing cap retainer plates, shown in Figures 52 and 53, while grease was still present in the bearing. The distortion indicates a mechanical overload levering of the joint that occurred as the freed end of the driveshaft wedged against the tag axle face as it escaped the pass-through opening. This is likely when over-compression of the driveshaft occurred.

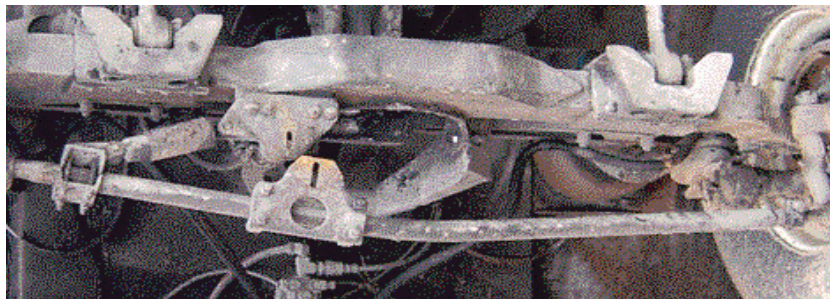
**Figure 54- Americanos 60630 Signature Bent Tie Rod**

The tag axle tie rods from both crashes have a unique similar V-shaped bend on the right-hand side of the latching plate clamp block. This common V-shaped, signature bend is shown on the Americanos bus 60630 in Figure 54 and on the Greyhound bus 6352 tie rod in Figure 55.

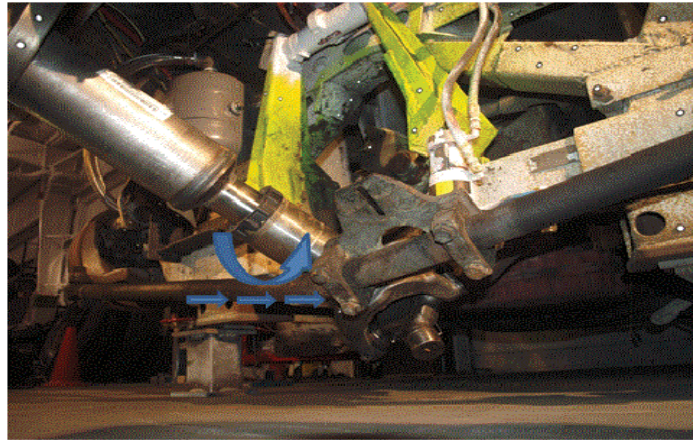
**Figure 56- Driveshaft Impacting on Tie Rod Illustration**

The Greyhound 6352 tie rod was installed on the VRTC test bus to illustrate and confirm that the impact markings on the tie rod could be caused by contact from a freed, rotating driveshaft. Figure 56 illustrates the rotational impact to the tie rod and the forced directional movement of the tie rod to the left as it strikes the latching plate assembly.

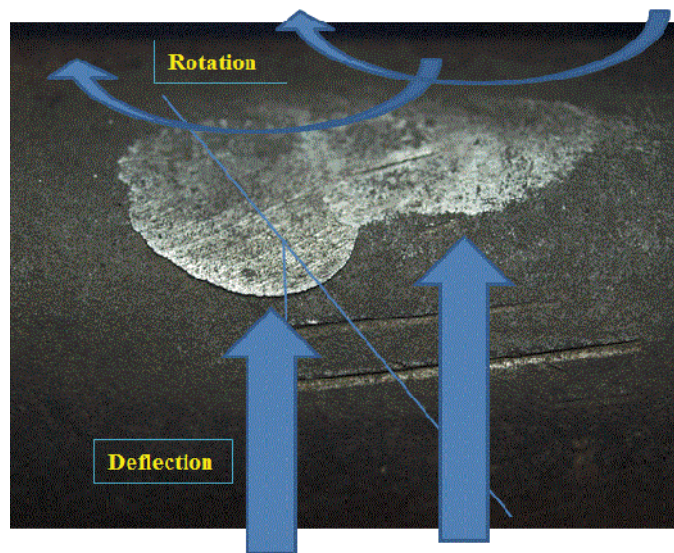
**Figure 57- Greyhound 6352 Tie Rod Illustrated Impact Force Axis**

The impact marks on the Greyhound 6352 tie rod are shown in Figure 57, with the line of force and deflection axis illustrated in reference to the blows delivered by the freed driveshaft. Note once again the rotational markings embedded in the impact indentations.

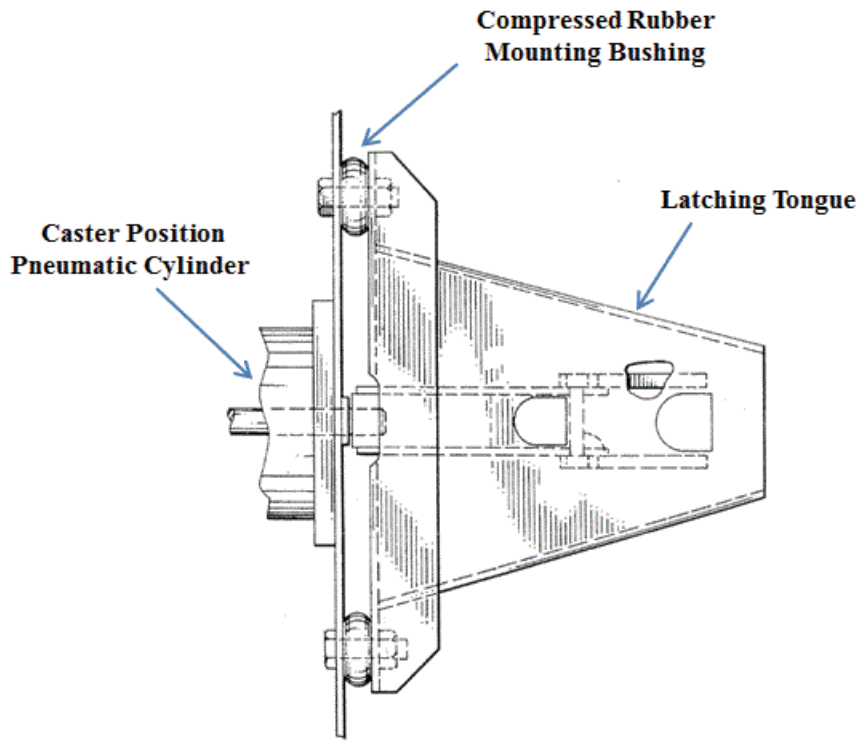
**Figure 60- Mechanical Illustration of Caster Latching Tongue and Bushings**

Figure 60 is a top view mechanical illustration showing the caster latching tongue mounting through the rubber bushings. The perpendicular mounts use rubber bushings that allow upward deflection of the tongue when the cylinder extends into a ramp feature on the bottom of the tongue. This action forces the tongue upward to the unlocked caster position. When the cylinder retracts, the elastic feature of the bushings, as well as gravity, bring the tongue back down to a locked position. The elasticity of these bushings provides the uncontrolled mobility of the tongue when it is transitively impacted by the axle structure.

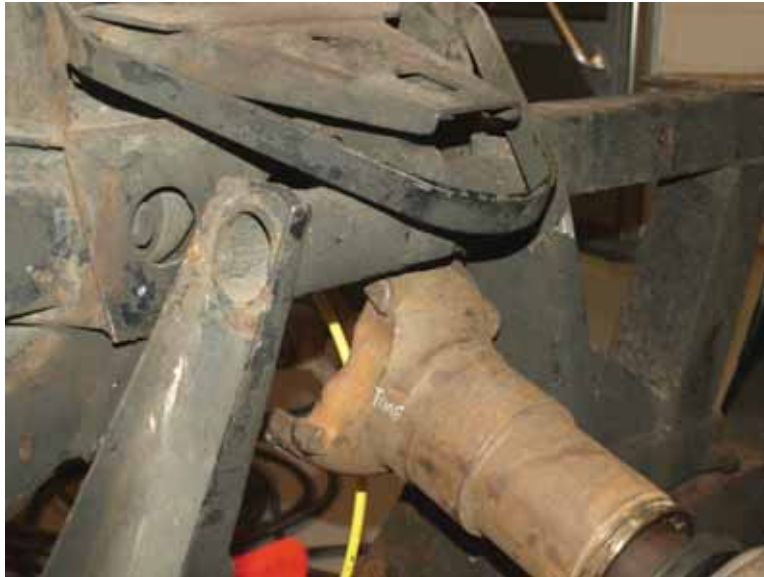
**Figure 61- Greyhound 6352 Arrangement of Components that Affect Latching Tongue**

This photo of Greyhound 6352 in Figure 61 also shows the impact path into the caster arm assembly that occurred during the crash. The tag axle will continue to perform as a fixed axle if the tie rod is still intact; however both the tie rod and the caster control were damaged in the studied crashes. When a freely steering axle is combined with negative caster, it can destabilize tracking.

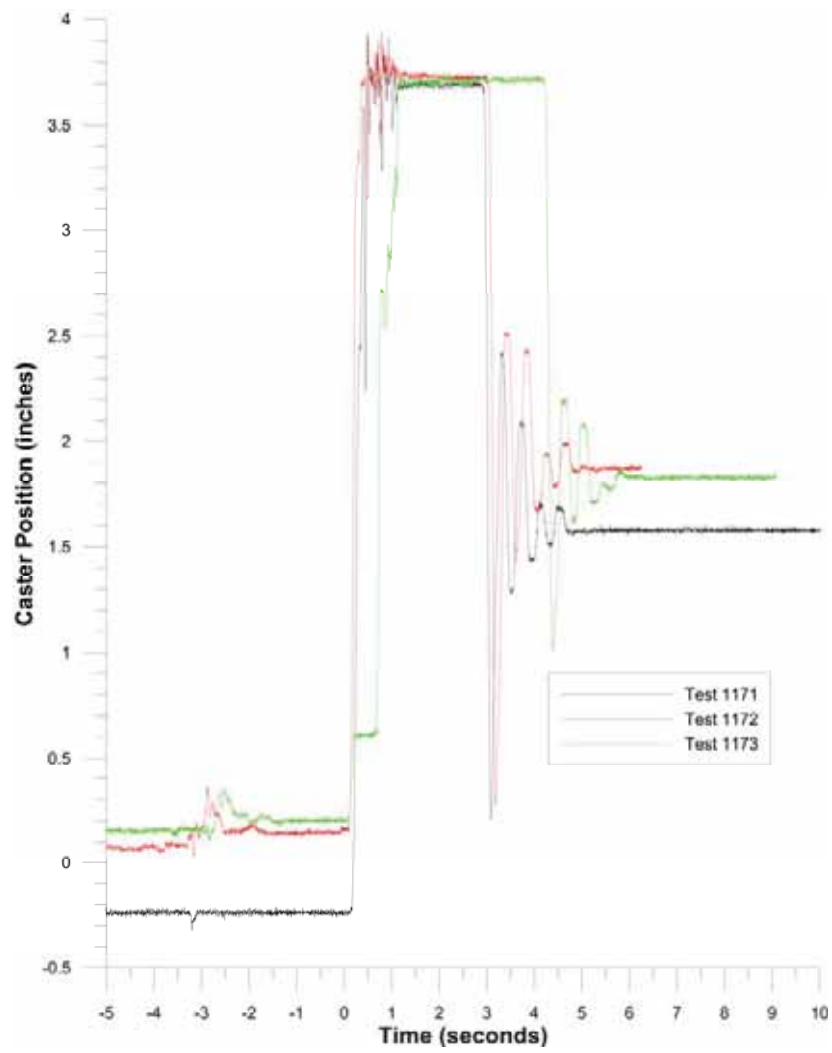
Figure 63- Impact Transmitted Caster Latch Failure Test Graph

A series of dynamic vehicle tests were conducted that showed that common perturbations such as potholes and railroad crossings were adequate to bounce the latching tongue into an unlatched condition, rolling the axle forward into a negative caster if adequate brake force was also applied. With the tongue unlatched, the pullback force of the pneumatic caster position cylinder is insufficient to overcome the brake torque produced by the tag axle brakes. Figure 63 shows three test runs overlaid where a brake application was performed while driving over a simulated railroad crossing at VRTC's test facility. The graph clearly shows the tag axle caster position changed due to the tongue unlatching, while brake torque successfully rotated the axle forward into a negative caster position.

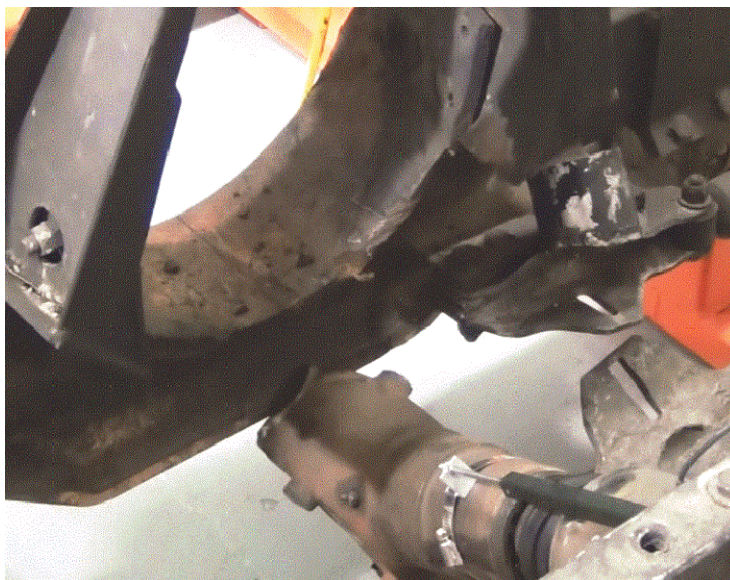
**Figure 65- Greyhound 6352 Illustrating Driveshaft Levering Against Axle Face**

The examination of all subject evidence driveshafts indicated an over-compressed condition of the splined tubes. This over-compression made driveshaft escape easier because it effectively shortened its overall length. As the flailing shaft impacted the surfaces around the

opening, it displaced metal by gouging and levering against the structure. This damage is seen in Figure 65 at the upper and leading edges of the opening. As the driveshaft escaped, it also levered against the face of the main axle beam, as shown in the Figure 65. Column fracturing occurred to the outer tube as the conical shape of the inner tube's mating end acted as a conical wedge that split the outer tube and allowed excessive shortening of the driveshaft. The compressive lengths of the failed driveshafts examined were inadequate to be retained properly by the designed D-Series tag axle structure of the subject class vehicles.

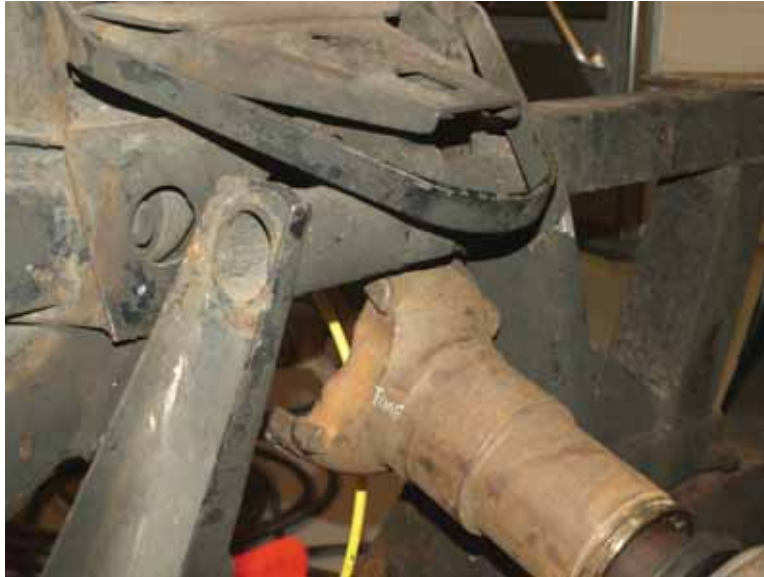
**Figure 67- Greyhound 6352 Illustrating Impacting Caster Latch Arm Assembly**

Several conditions can be created when a driveshaft decouples from the transmission that can lead to a compromise of the functionality of the tag axle caster position latching mechanism. Impacts to the caster latch arm assembly, as shown in Figure 67, can produce resonating forces through the structure causing the latching tongue to bounce. The axle can roll into a negative caster under moderate braking if the latch is defeated. The pneumatic position cylinder has inadequate force to keep the axle in the retracted home position under moderate braking if unlatching occurs. In the case of the Americanos 60630 crash, evidence showed the caster latch arm assembly was levered forward as the driveshaft wedged in behind the arms. The wedge forced the caster arms to roll forward into an extreme negative caster position, compounding the existing loss of stability of the steering knuckles. Damage and deformation of the tongue latching components and torn metal on the left caster arm are evidence of the levering caused by the driveshaft on the latch arm assembly.

Also, the caster latch tongue can be defeated without a driveshaft failure by resonating impact forces from common roadway perturbations under moderate braking conditions. This caster change can occur if the roadway impact is coincident with a firm brake application. If the tie rod is still latched in a non-steered condition in this scenario, there is little effect on the vehicle dynamics. If the tie rod is also released, which could occur from damage resulting from a broken driveshaft, the steering knuckles are able to react to the caster angle changes. In both the

Americanos 60630 and the Greyhound 6352 crashes, a caster change occurred during the course of the event resulting from impacting damage from the driveshaft. This unintentional caster change contributed as a dynamic function to the loss of control of the tag axle steering knuckles in both crashes.

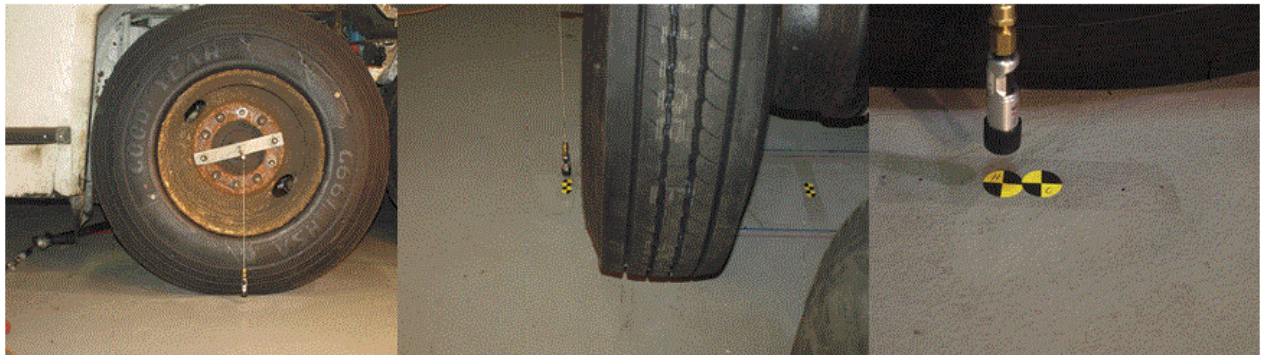
**Figure 68- Measuring Caster Angle Change on VRTC Bus Using Lasers**

Verification of the 6° tag axle caster change and axle roll was measured using machinist alignment lasers. Lasers were mounted to the center hub axis and through the center line of steering knuckle king pin. The laser positions were projected on a level floor recording both the home and reverse caster locations of the axle and the tire roll as the axle changed positions. The caster measurement using the lasers is shown in Figure 68.

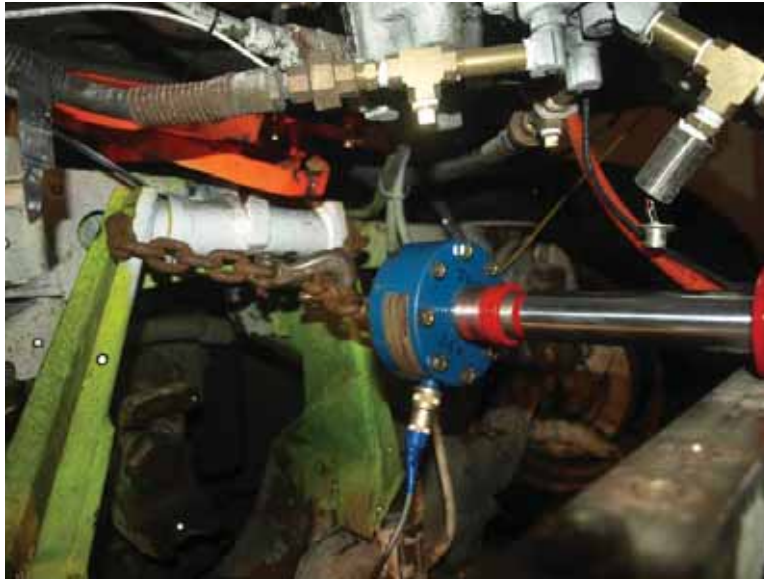
**Figure 69- Pulling Caster Arms to Safety Catch on VRTC Bus**

A hydraulic ram and load cell were applied to the tag axle caster arm structure, as shown in Figure 69, to measure the pull-back force the caster position cylinder produced. The caster latch was unlatched and the axle was pulled into the reverse caster position until it reached the safety catch. The test was used to determine the amount of brake torque that would be required to overcome the position cylinder if the latch was defeated and rotate the axle into a negative caster position.

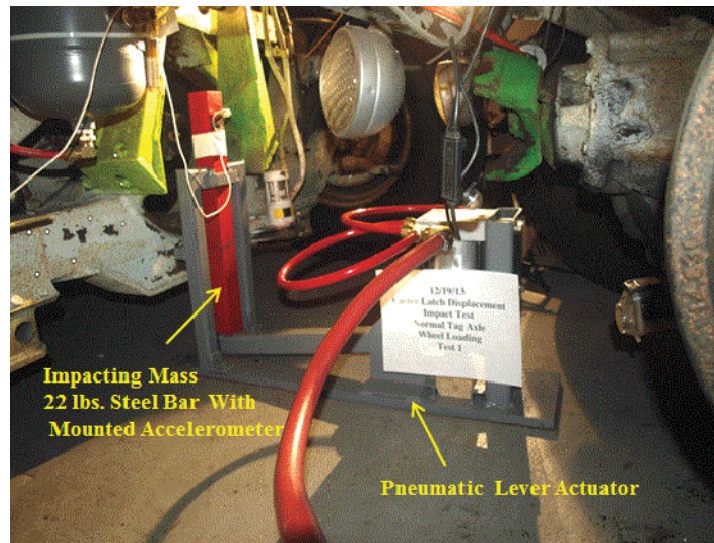
Figure 70- Caster Latch Arm Assembly Impacting Test Fixture

A pneumatic impacting fixture was constructed and applied to the VRTC test bus to confirm that when a driveshaft strikes the caster arms, the force can be transmitted through the arms and into the latching plate and cause it to release the caster lock. A solid steel bar was projected by a pneumatic lever actuator into the cross tie tube of the caster arms directly under the latching tongue. This impact point matches the damage area found on the evidence axles. High speed video cameras recorded the event and captured the bouncing of the latching tongue as the forces transmitted easily through the structure when impacted. Figure 70 and 71 show the test fixture in place under the tag axle caster latch arm assembly. An accelerometer was attached to the accelerated 22-pound mass to calculate impacting forces.

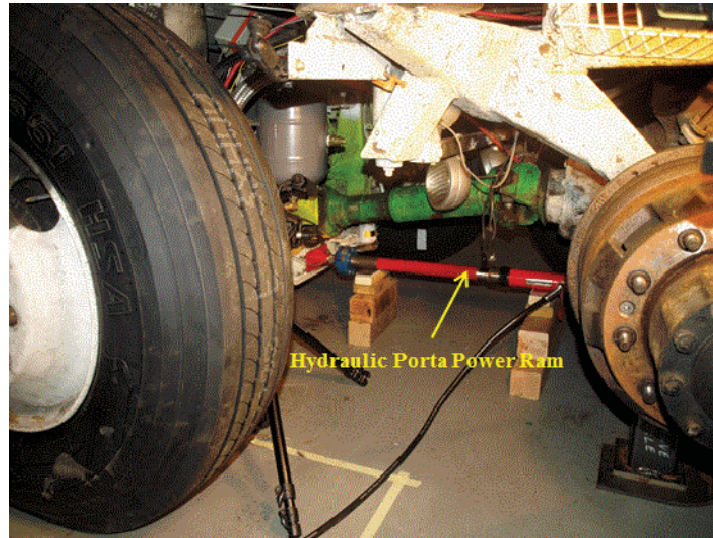
**Figure 72- Loading Axles on VRTC Bus with Hydraulic Ram**

To measure the compliance of the tag axle radius rods and the drive axle mounting links, a hydraulic ram and load cell was positioned between the two axles as shown in Figure 72. Force was applied to yield all bushing compliance of the rods and mounting links on both axles. The displacement is shown being measured in Figure 73. This displacement can occur when the driveshaft lever off the face of the tag axle as it escapes. There was minimal difference found between the bushing compliance of both new and used radius rods tested on the tag axle.

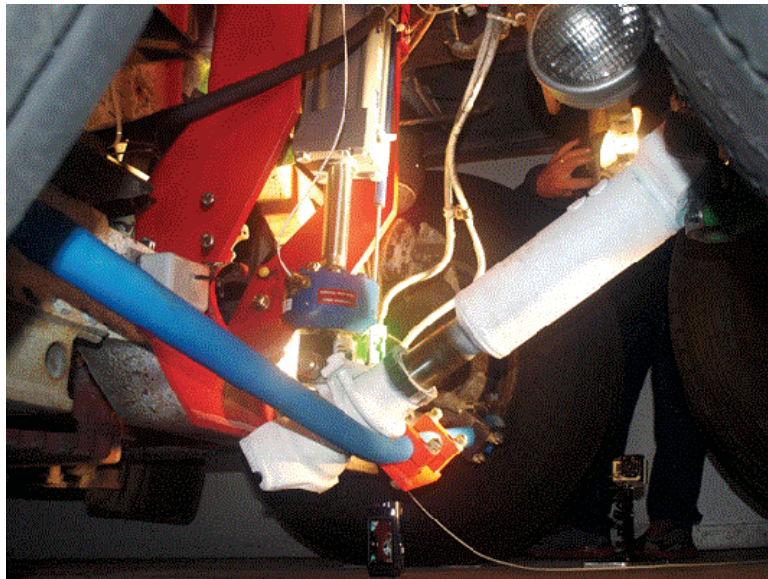
**Figure 74- Signature Bending of Tie Rod with Hydraulic Ram on VRTC Bus**

A test was conducted to replicate the signature V-shaped tension bend found on tie rods from both the Americanos 60630 and the Greyhound 6352 crashes. A hydraulic cylinder was positioned to apply force in the same axis as the freed driveshaft. The driveshaft contacted the tie rod at the same location as the strike points located on the evidence tie rods. The ram assembly and load cell is shown bending the tie rod with the freed driveshaft in Figure 74. A slow continuous rate of force was applied using a hand pump while instrumentation data and video was collected.

The forces required to displace the tie rod were significantly below predicted striking forces from an approximately 90 pound driveshaft rotating at 2,000 RPM. Even without direct impact damage to the latching cylinder and mounting block, the cantilevered latching plates were easily defeated by leverage as the tie rod bent to the signature shape. Figure 75 shows the deformed lower latch late that was levered downward by the tie rod plate as the bending progressed. The test also confirmed that only the right tag axle tire toes inward during the initial bending of the tie rod. The wheel remains toed in with the left wheel still straight ahead until the tie rod latch is defeated. This was the same tire orientation that produced the single tire mark in testing (see section 7.3) and most likely at the beginning of the Americanos 60630 crash.

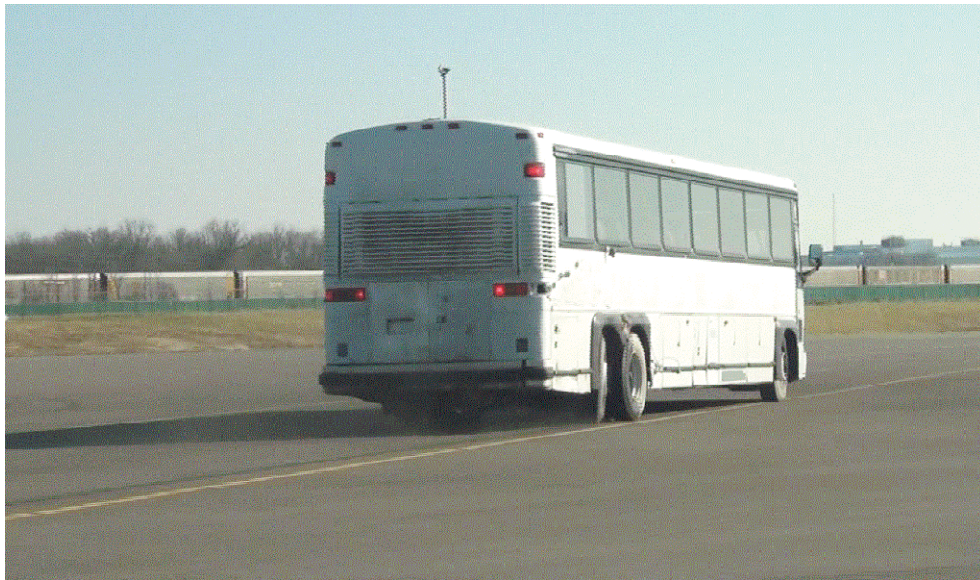
**Figure 76- VRTC Bus Forced Tag Axle Steering Trial Testing**

Vehicle dynamic testing started with low speed trials and learning maneuvers to develop an understanding of tag axle performance. Since the conditions of the accidents were unique due to a steerable tag axle possibly influencing loss of control, there was no prior testing or research available for reference. Figure 76 shows a forced steer condition test using the pneumatic tie rod push cylinders that were shown in Section 4 of the report. This type of test was used to determine whether the steerable tag axle had the capability to steer the back of the bus under different caster positions and pavement conditions.

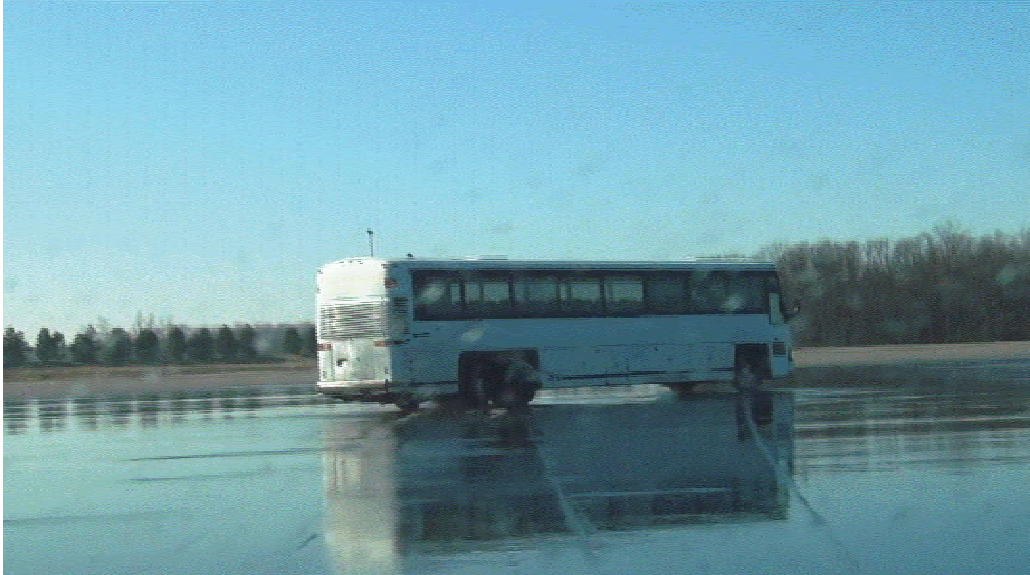
**Figure 77- VRTC Bus Tag Axle Steering with Reversed Caster Test**

Other trial tests included low speed releasing of the tie rod with different caster positions applied to the tag axle. These tests established the stability of the steering knuckles of the tag axle when the tie rod is unlatched. Additional tests were conducted using low coefficient surfaces so reduced speeds could be used for safe testing. Figure 77 shows the test unit being steered into a 90° yaw by the tag axle on a low-friction wet surface. The drive wheels ahead of the tag axle wheels were able to lock easily and thus reduced rear lateral stability. When the tag axle tie rod was released with a reversed caster position, the steering knuckles swung violently into their stop bolts, and the back of the bus yawed uncontrollably. Additional trial tests confirmed the importance of maintaining a positive caster for stability of the steering knuckles of the tag axle when the tie rod was unlatched.

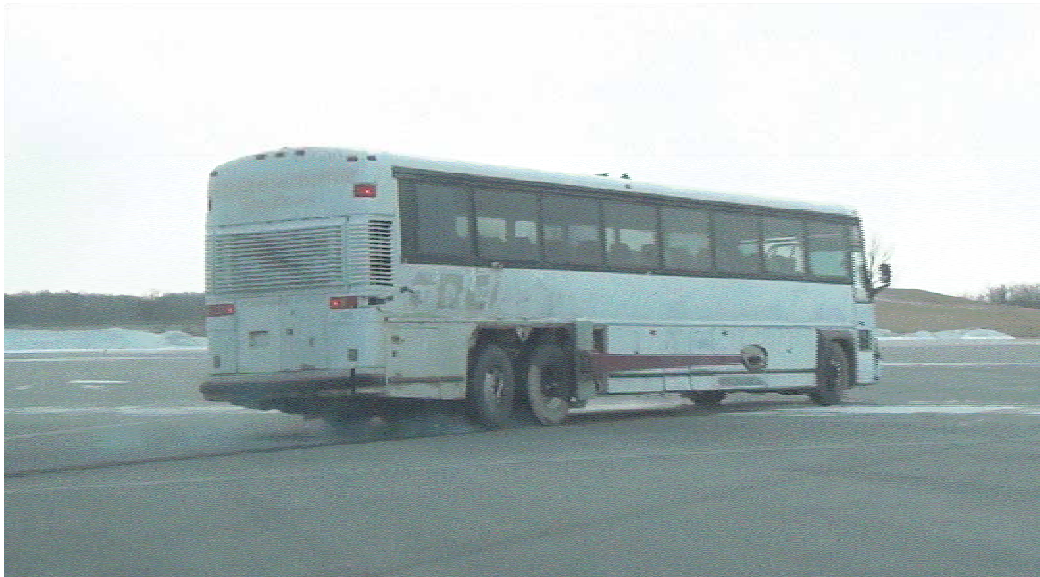
**Figure 78- VRTC Test Vehicle Performing Aggressive Failure Test**

This more aggressive level of testing demonstrated that the effects of the tag axle failures could produce yawing that resulted in lane departure. The severity of compromise to steering control of the bus was also influenced by other causative factors. Vehicle speed and pavement conditions were elements that could increase the degree of loss of control and reduce recoverability by the driver. This series of tests also confirmed that when the positive caster position of the tag axle was being forced into a negative position while in forward motion, the stability of the steering knuckles was reduced when the tie rod was unlatched. Improper caster position is one of the key elements necessary for compromise of steering control if the tie rod is released during a failure event.

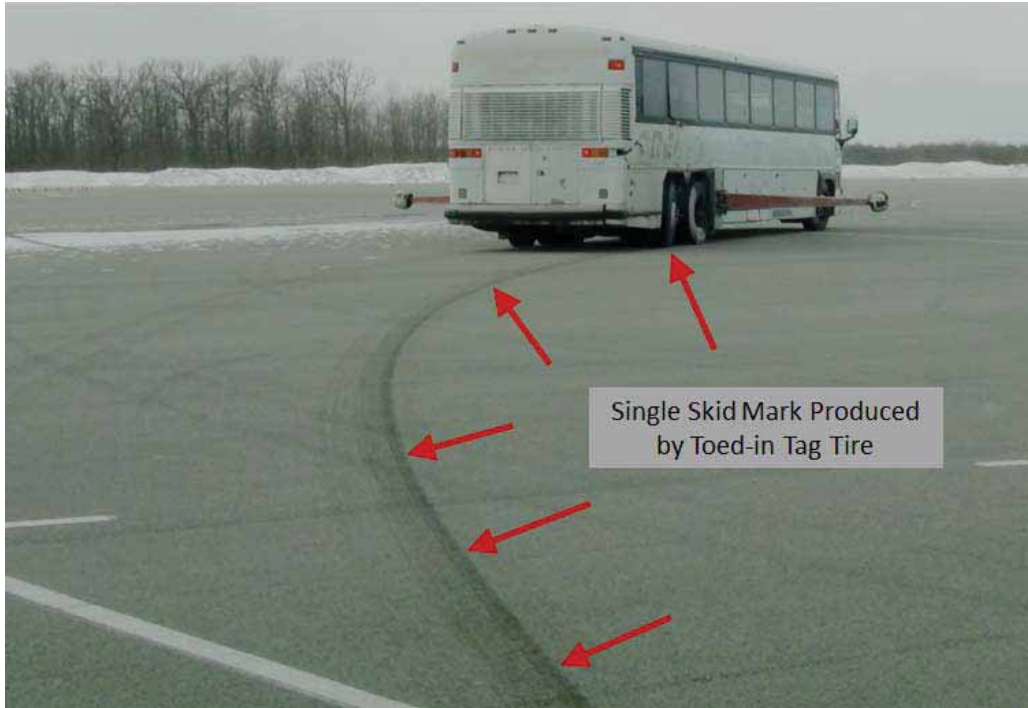
**Figure 79- VRTC Test Vehicle Replicating Accident Single Tire Marking**

Other evidence findings were tested, such as the inadvertent release of the caster latch tongue using both evidence and exemplar parts. These tests demonstrated the ability for the latch tongue to fail under certain conditions, and that the failure is another element needed to achieve an unstable steering condition of the tag axle. This failure of the tongue latch allows the axle to have the ability to rotate into a negative caster during an unstable steering condition event. The effects of braking and counter-steering during failure events were also tested to confirm that locking of the tandem drive wheels without locking the tag axle wheels is possible and will provide increased steering authority to the tag axle.

VRTC's testing also successfully reproduced critical crash evidence findings such as the single tire marking of the Americanos 60630 scene and the signature tension bending of the tie rod that matched the Greyhound 6352 evidence. The results of these tests substantiated the theorized damage created to the tag axle and the resulting adverse effects that were produced by the decoupled driveshafts of the crash accidents. This testing also identified previously unknown performance problems of critical components, such as the caster position latch tongue function and the ability for brake torque to overcome the pullback force of the positon pneumatic cylinder allowing the caster of the axle to change.
