**From:** Neff, Joshua (NHTSA)  
**Sent:** Tuesday, September 18, 2012 12:42 PM  
**To:** Howell, Rosa (NHTSA)  
**Subject:** FW: Southern Honda Powersports (a/k/a Big Red Powersports, LLC),

**From:** Carlos Smith [<mailto:ccsmith@millermartin.com>]  
**Sent:** Tuesday, June 19, 2012 5:06 PM  
**To:** Borris, Frank (NHTSA)  
**Cc:** Piazza, John (NHTSA); Kyle Eiselstein  
**Subject:** Southern Honda Powersports (a/k/a Big Red Powersports, LLC), - Confidential - Privileged and/or Work Product

### 2002-2005 VFR800/A Wire Harness Replacement

### 2006-2007 VT600C/CD Fuel Valve Diaphragm Replacement

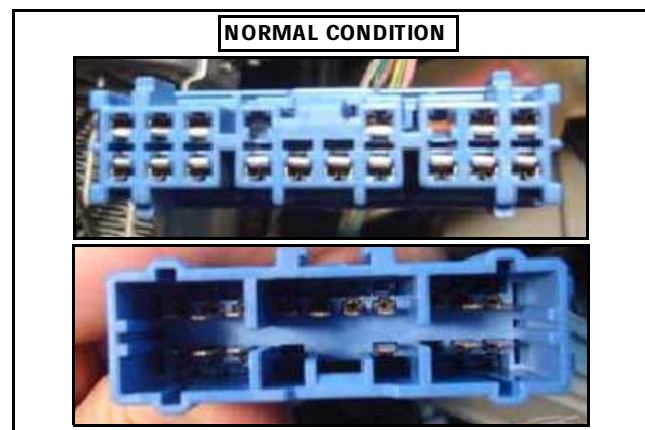
Inspect the 18P connector (light blue) inside the protective sleeve for any burnt, melted, or discolored condition.

If the condition of the 18P (light blue) connector is normal, proceed with the FRONT SUB-HARNESS REPLACEMENT.

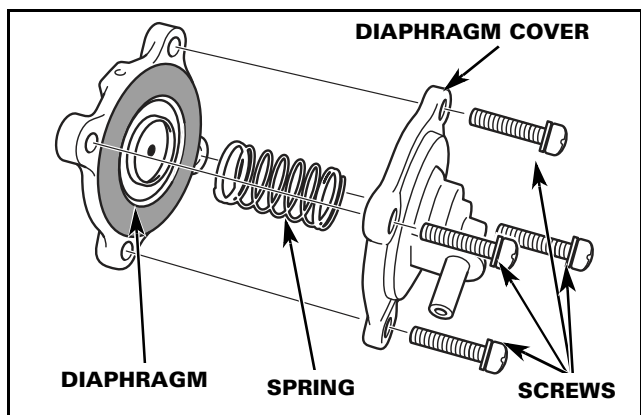
**NOTE:** The countermeasure part has a paint mark near the air vent hole.

8 Replace the diaphragm, spring, cover, and screws with new parts included in the kit.

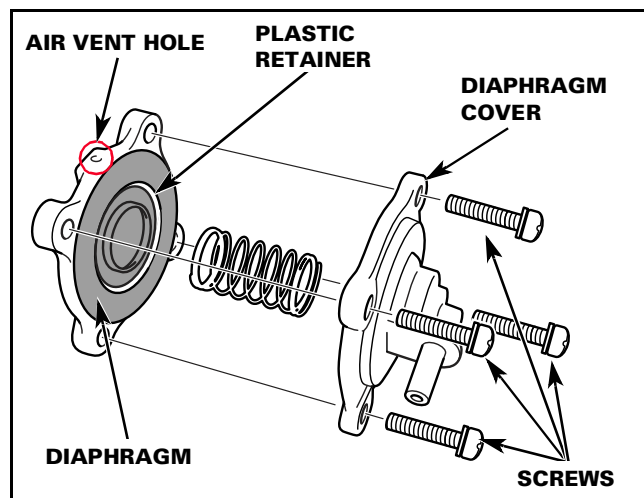
**NOTE:** The diaphragm cover is under spring pressure. The countermeasure part has a paint mark near the air vent hole.

4. Replace the diaphragm, spring, cover, and screws with new parts included in the kit. Install the new diaphragm with the plastic retainer facing the diaphragm cover.

**NOTE:** Make sure the air vent hole is facing downward towards the ground.

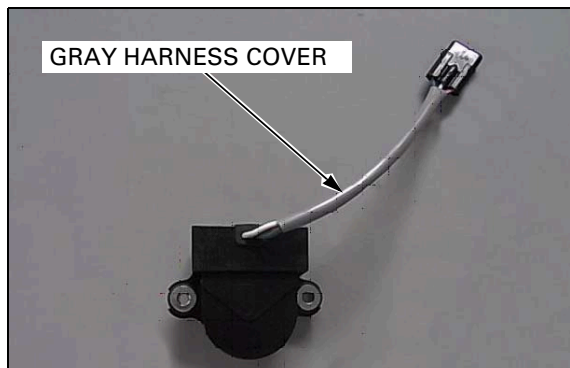
The update part has a gray harness cover.

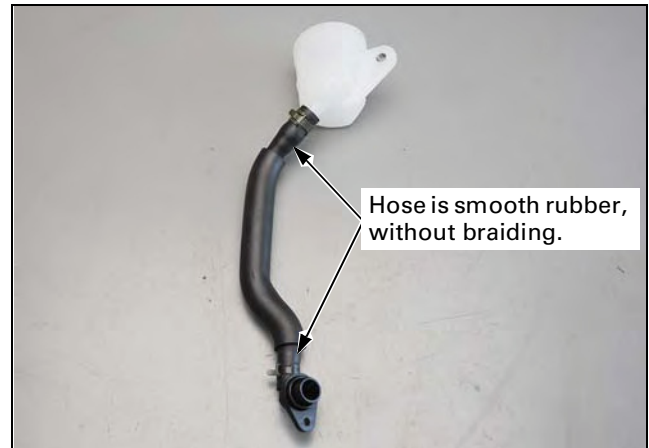
The hose portion of the update part is smooth rubber, without braiding.

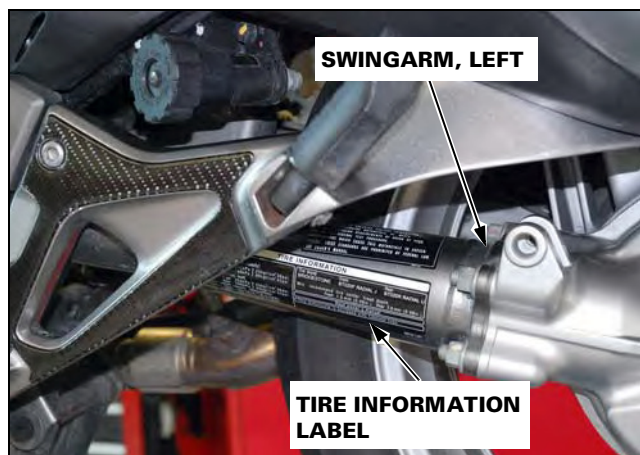
Examine the tire *model* information on the label and compare it to the correct information shown in the IDENTIFICATION section of this bulletin.

- If the tire *model* information is correct:
  - No further action is necessary.
- If the tire *model* information is incorrect (anything other than shown):
  - Proceed with the remaining steps of the repair procedure.

2. Remove the incorrect tire information label from the swingarm by peeling it up from the corner.

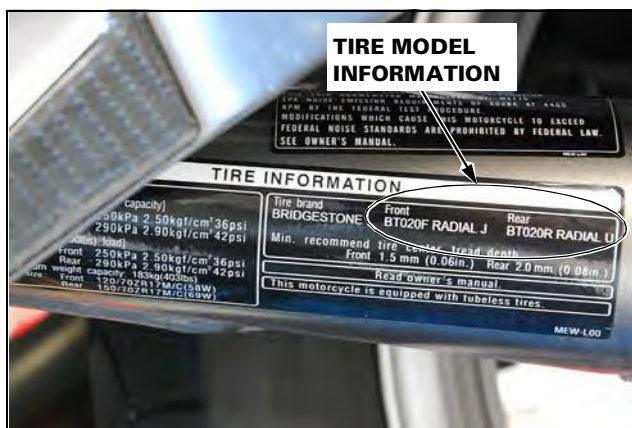
A correct Tire Information Label can be identified by the *tire model* information on the label. The correct information is:

Front	Rear
BT020F RADIAL J	BT020R RADIAL U

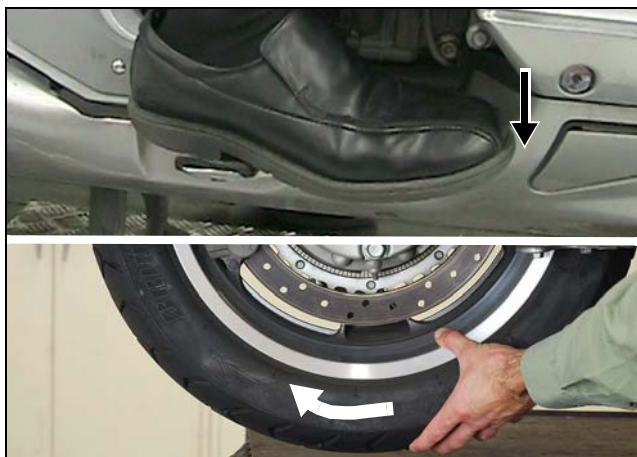
10. Firmly depress and slowly release the brake pedal five times, then release the brake pedal, wait five seconds, then try to rotate the rear wheel as shown.

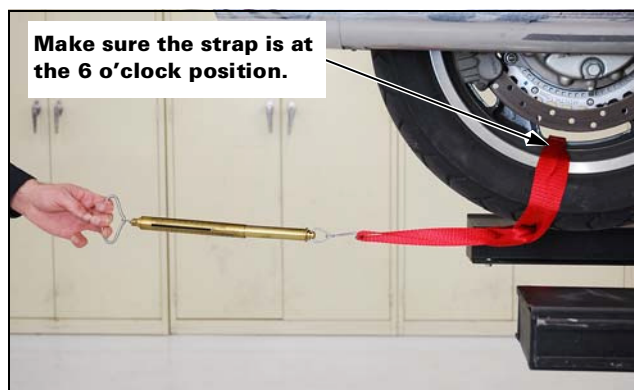
- If the rear wheel rotates freely, the secondary master cylinder is OK. Proceed to Step 11.
- If the rear wheel is locked (does not rotate), the secondary master cylinder must be replaced. Proceed to the REPAIR PROCEDURE section of this bulletin.
- If the wheel is not locked, but feels like it has more drag than noted in Step 2, check the drag as shown with a spring scale (T/N: SAMIN12MRP). The rear wheel drag should be no more than:  
**50 N (5.1 kgf, 11.2 lbf)**

If the wheel drag is greater than specified, the secondary master cylinder must be replaced. Proceed to the REPAIR PROCEDURE section of this bulletin.

If the wheel drag is less than specified, the secondary master cylinder is OK; proceed to Step 11.

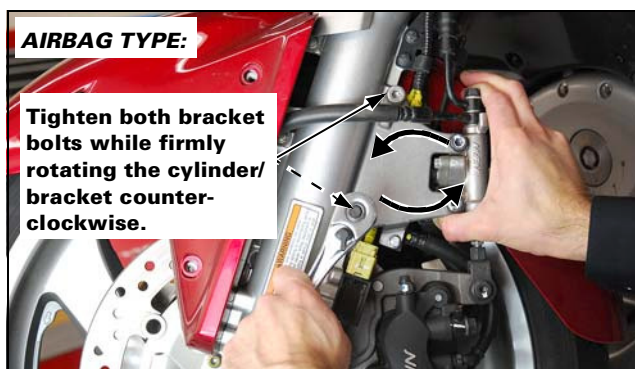
12. *Airbag type only:* If the secondary master cylinder passed the inspection, loosen both secondary master cylinder bracket bolts.

Grasp the secondary master cylinder with one hand as shown and firmly rotate the cylinder/bracket in a *counter-clockwise* direction and tighten the bolts to the specified torque.

**TORQUE: 30 N·m (3.1 kgf·m, 22 lbf·ft)**
