Subject: ACTION: PE12-028 Memo to Public File

On November 14, 2012, ODI held a meeting with representatives of Honda at the Vehicle Research and Testing Center (VRTC) in East Liberty, Ohio to discuss PE12-028. A redacted copy of the presentation by Honda is attached. Confidentiality for the redacted portions was requested by Honda.

NHTSA ODI Meeting: 05M PILOT VSA

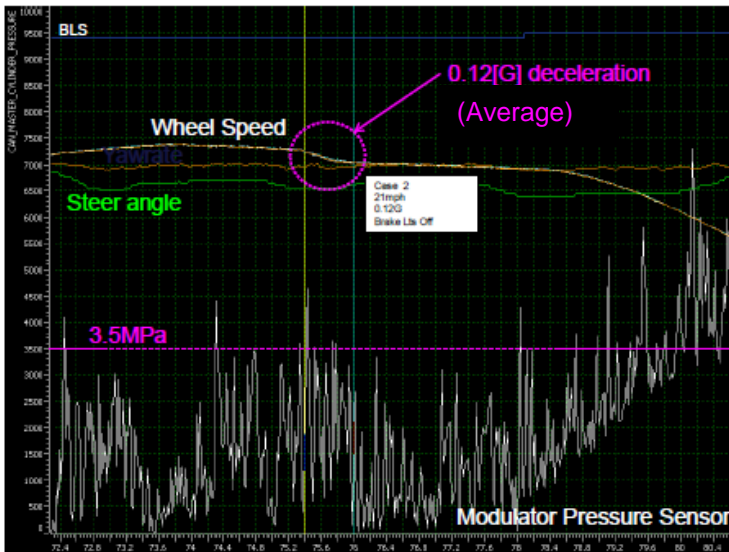
【Without Brake Applied by Driver】

- Customer contention of “Car braked on its own” is confirmed.
- Modulator pressure sensor has a high level of noise.
- Occurrence Rate and Severity
 - Sensor noise can occur at any time & speed, causing low G braking
 - This can occur with or without brake pedal application
 - High decelerations only occurs with braking and stops when the brake pedal is released (200 ms delay)

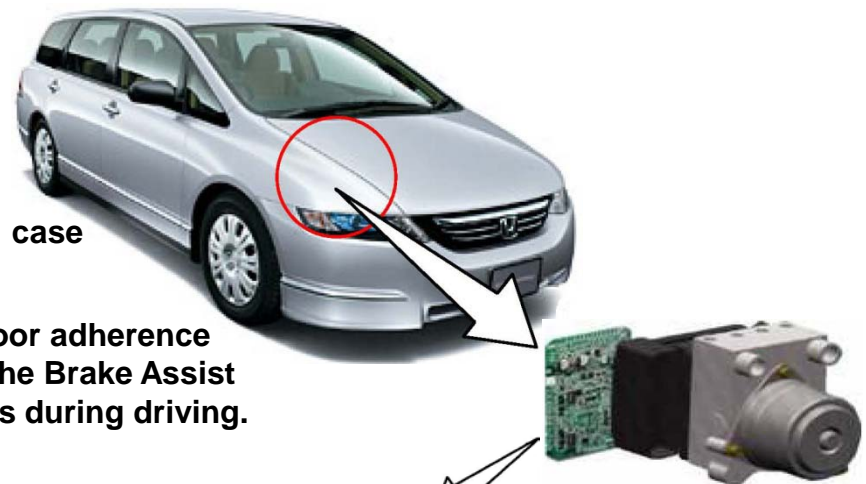
Tantalum capacitor

Our confirmation found that ESR exceeded standard (should be less than 1.2Ω).

It was found that ESR rose between capacitor element (-) and capacitor frame.

From this, we determined that an abnormality is found between the capacitor element and negative pole frame.

Abnormal resistance value inside tantalum capacitor are assumed to have caused the problem. We are continuing to study this phenomenon.

Melted Sn plating was found on peeled surface of negative pole frame.

① If reflow furnace temperature setting exceeded target level during ECU manufacturing it could cause the capacitor frame Sn plating to melt

Manufacturer's Program for Remediying the Noncompliance:
 Dealers in Japan will replace the VSA modulator board on all vehicles.

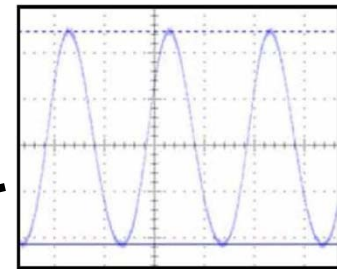
Internal pressure sensor

Abnormality

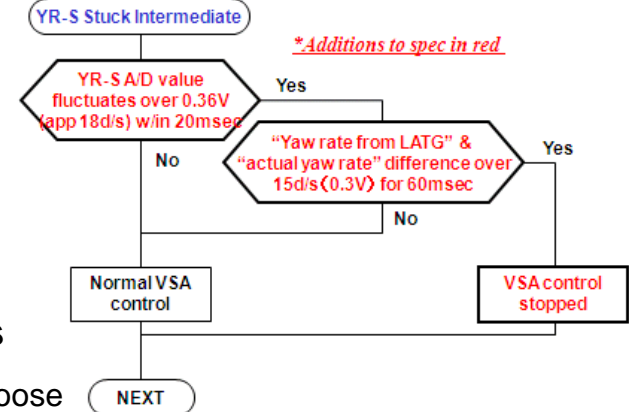
C/M Spec: Logic for confirming yaw sensor output value within normal voltage range (under 4.7V, Over 0.3V)

- After initial startup (IG-ON), VSA will activate during diagnostic check at 15 Km/h VSA MIL illuminates, L/Fr brake (Loose G302).

- When G302 GND resistance is high (due to a loose G302), VSA modulator activates (initial check, control etc) and current flows, sending up SGND electric potential.

- HM – Addition of 2nd torque check & marker check for G302 (HMA: March 7, 2005, HCM: Feb 5,2004)
- VSA Modulator Failsafe Software C/M : Control specification added to prevent activation if YAWR-S change is over 18deg/s in 20msec, if there is output over 15deg/s for 60msec continuous, VSA operation is stopped. (06M Software C/M)
