**CRA ON-SITE AIR BAG DEPLOYMENT CRASH INVESTIGATION  
SCI CASE NO.: CR13006**

**OFFICE OF DEFECTS INVESTIGATION**

**VEHICLE: 2013 HYUNDAI ELANTRA**

**LOCATION: FLORIDA**

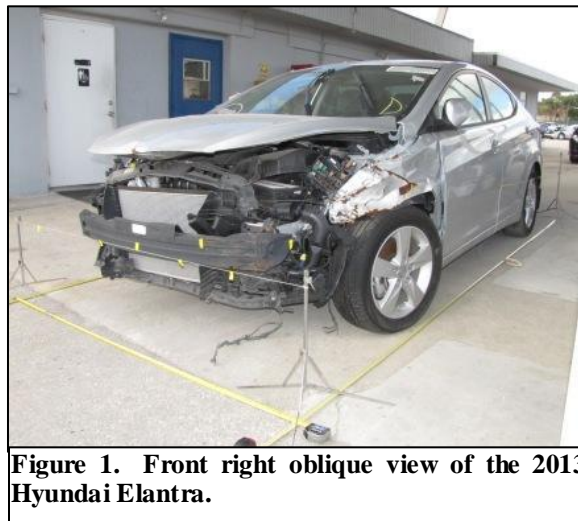
This on-site investigation focused on the deployment of the left Inflatable Curtain (IC) air bag and the partial separation of a sheet metal reinforcement to the headliner in a 2013 Hyundai Elantra (**Figure 1**). This component protruded into the driver compartment on the inner aspect of the deployed IC air bag.

**Figure 1. Front right oblique view of the 2013 Hyundai Elantra.**
