GM 12-14-2012 ATTACHMENT Q_09 2006-7 GMT360_370 DDM Function Historian 4-19-12-p

Driver Door Module Short Circuit

2006-2007 GMT360/370 DDM CA Warranty Labor Op N2117

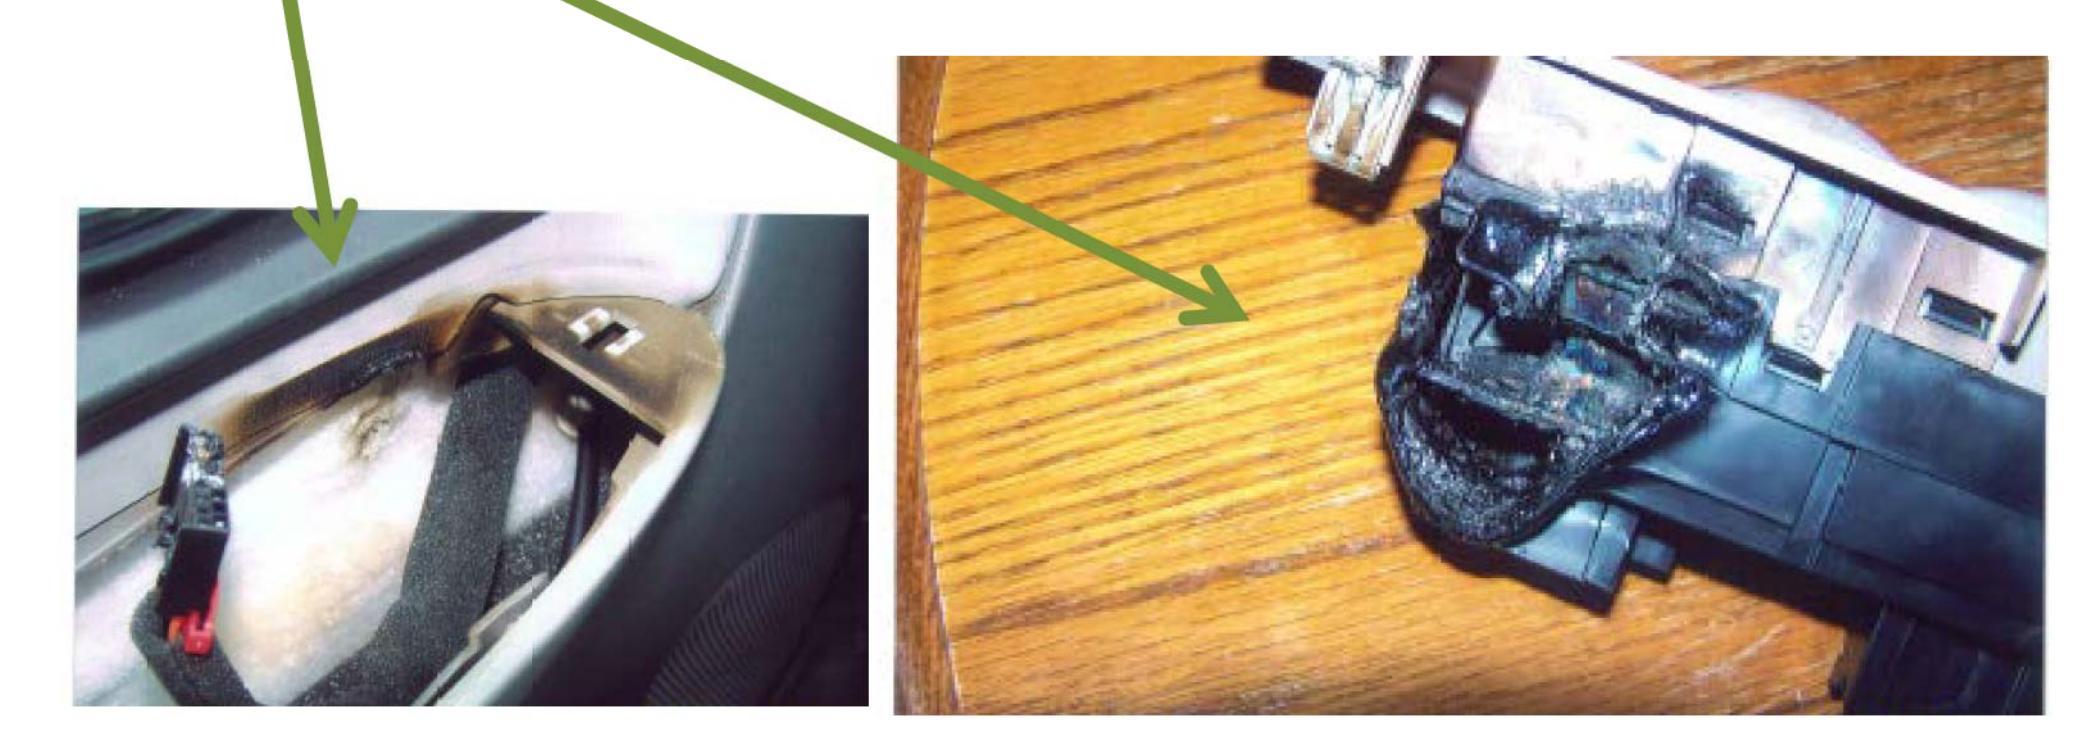
1GNDT13S872 - 727454): Incident date: 3-5-2011; Estimated mileage: 50,000 miles; Fire in driver door while the s/v was parked and unattended.

1GNDT13S072 1000 - 1000 (725483); Incident date: 2-27-2011; 63,000 miles; Fire in driver front door while the s/v was parked and unattended.

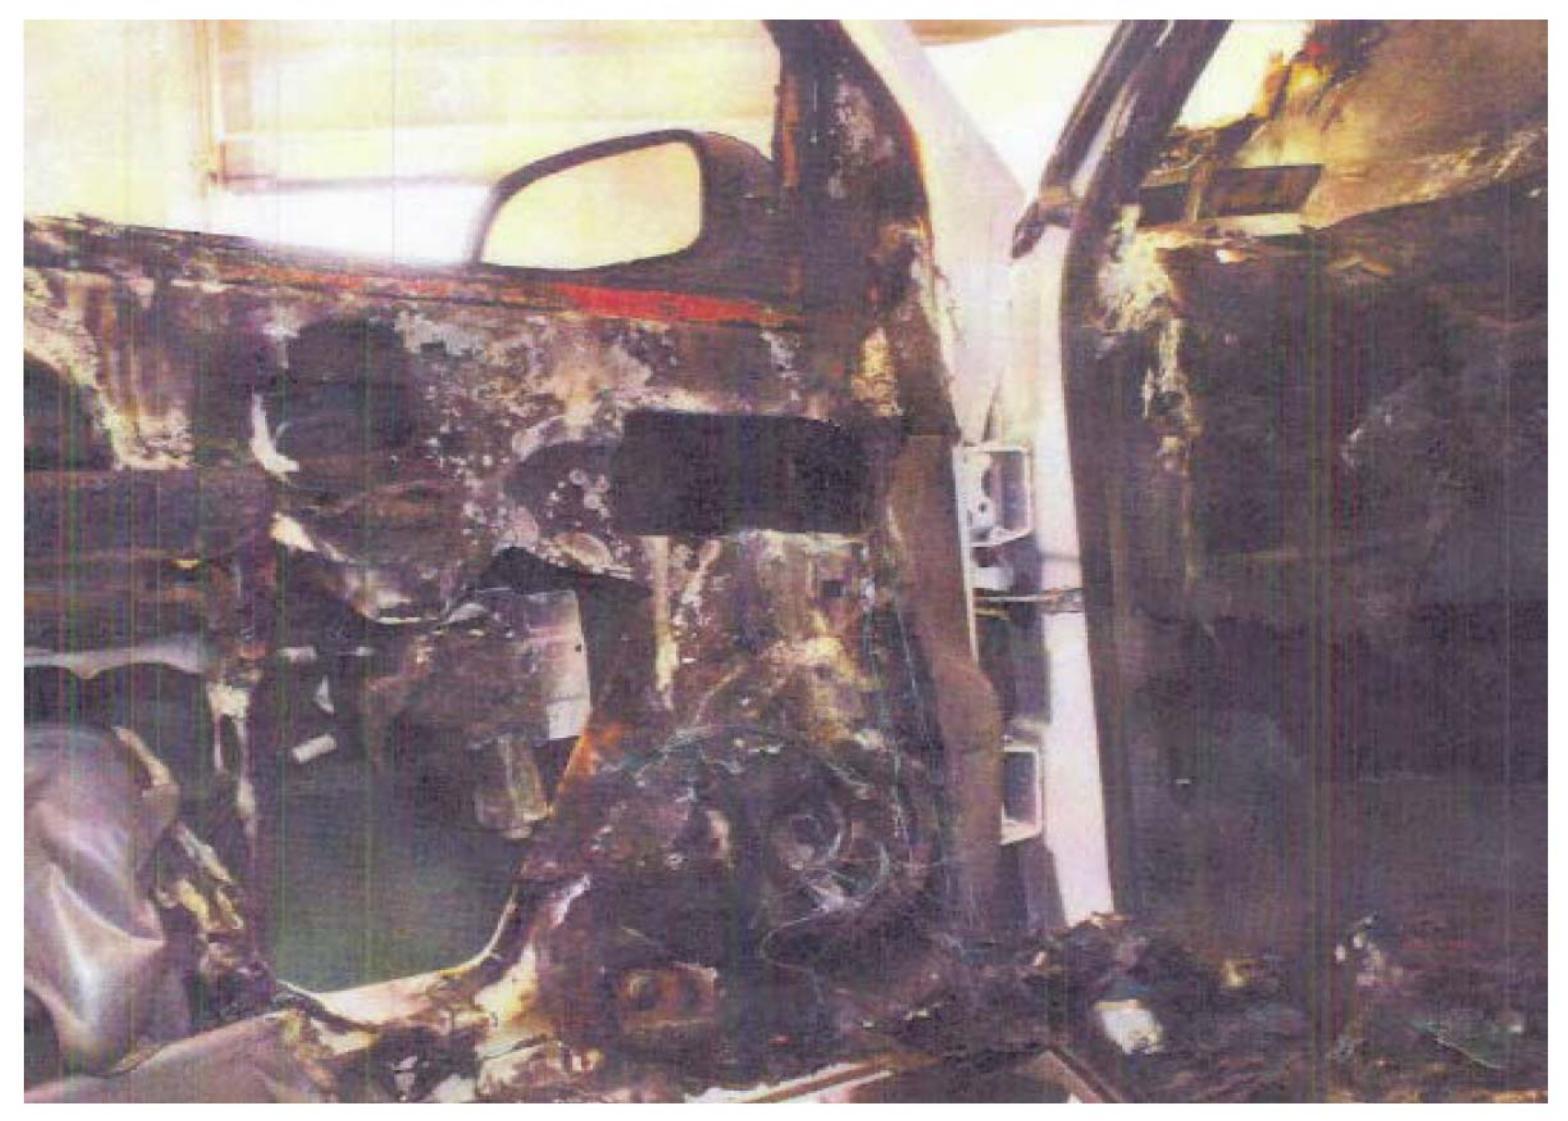
Inspections/Investigations

1GNDT13S362 - 663106) Incident date: 10-29-2008; Estimated mileage: 50,000 miles; Fire in driver door while the s/v was parked and unattended.

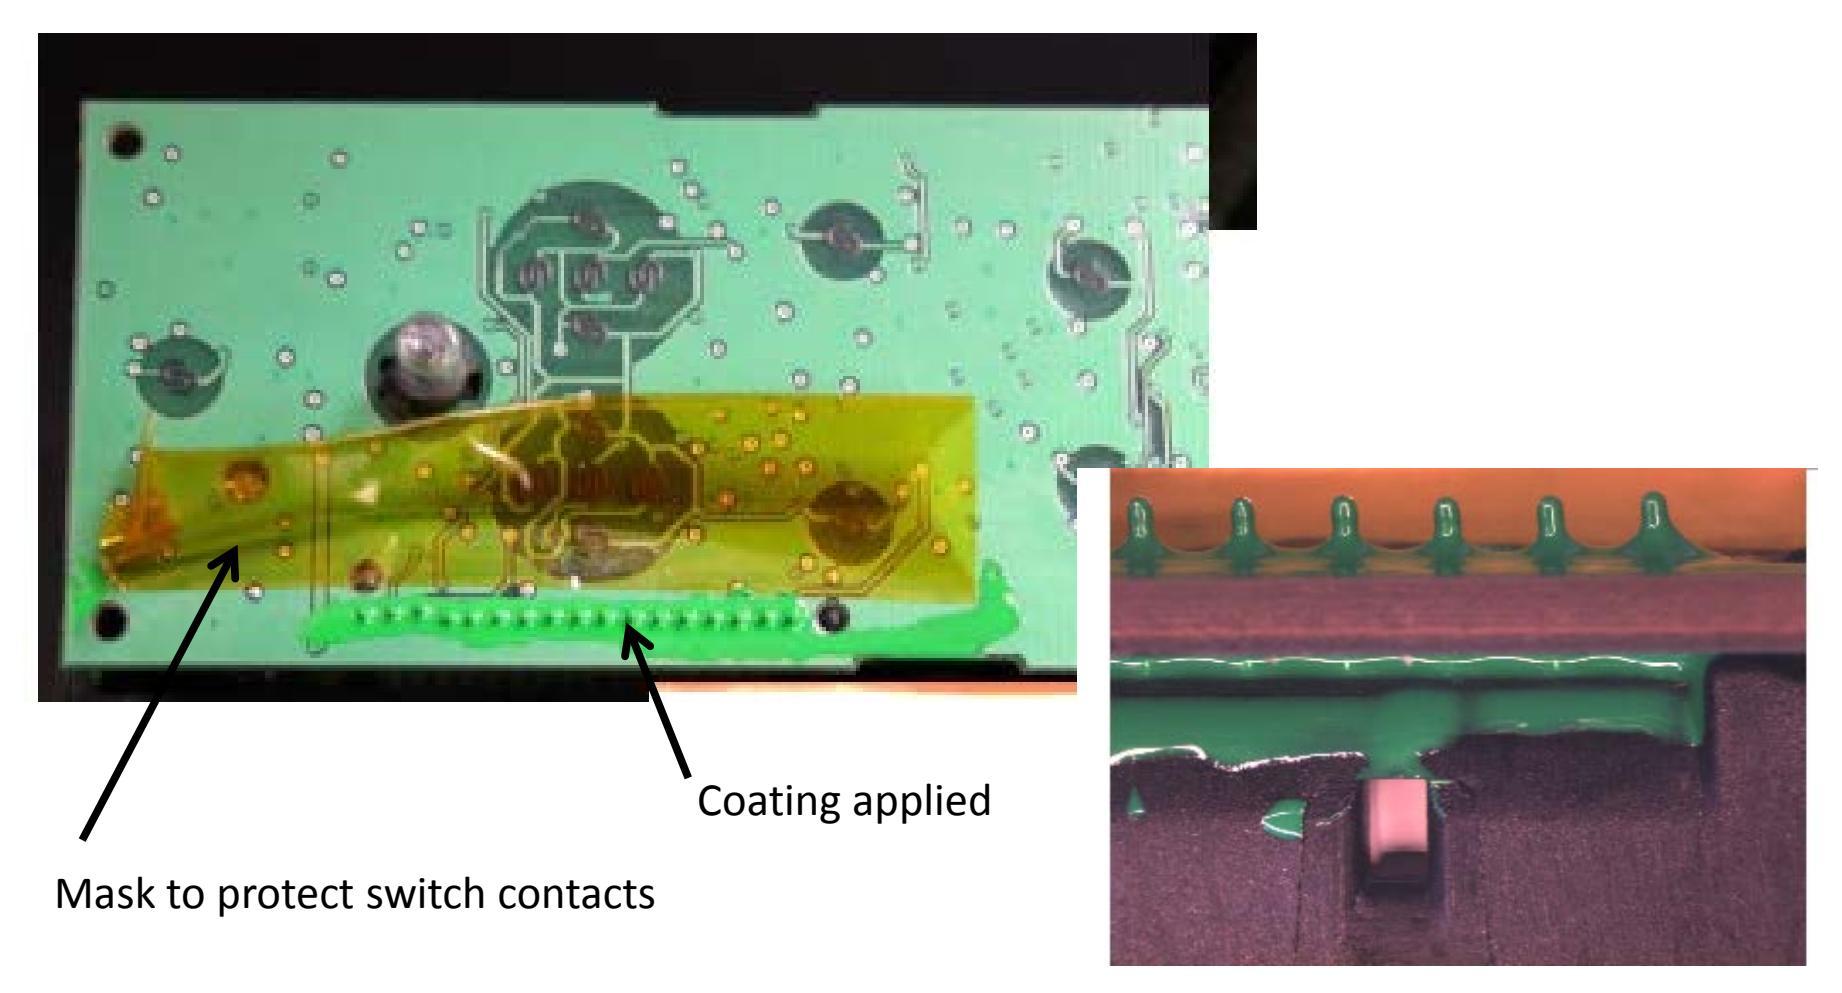
GMT3XX DDM Proposed PCB Treatment

Close-up of PCB edge coating

Potential Field Remedy: Treat DDM to prevent short circuits (not currently validated) or replace DDM.

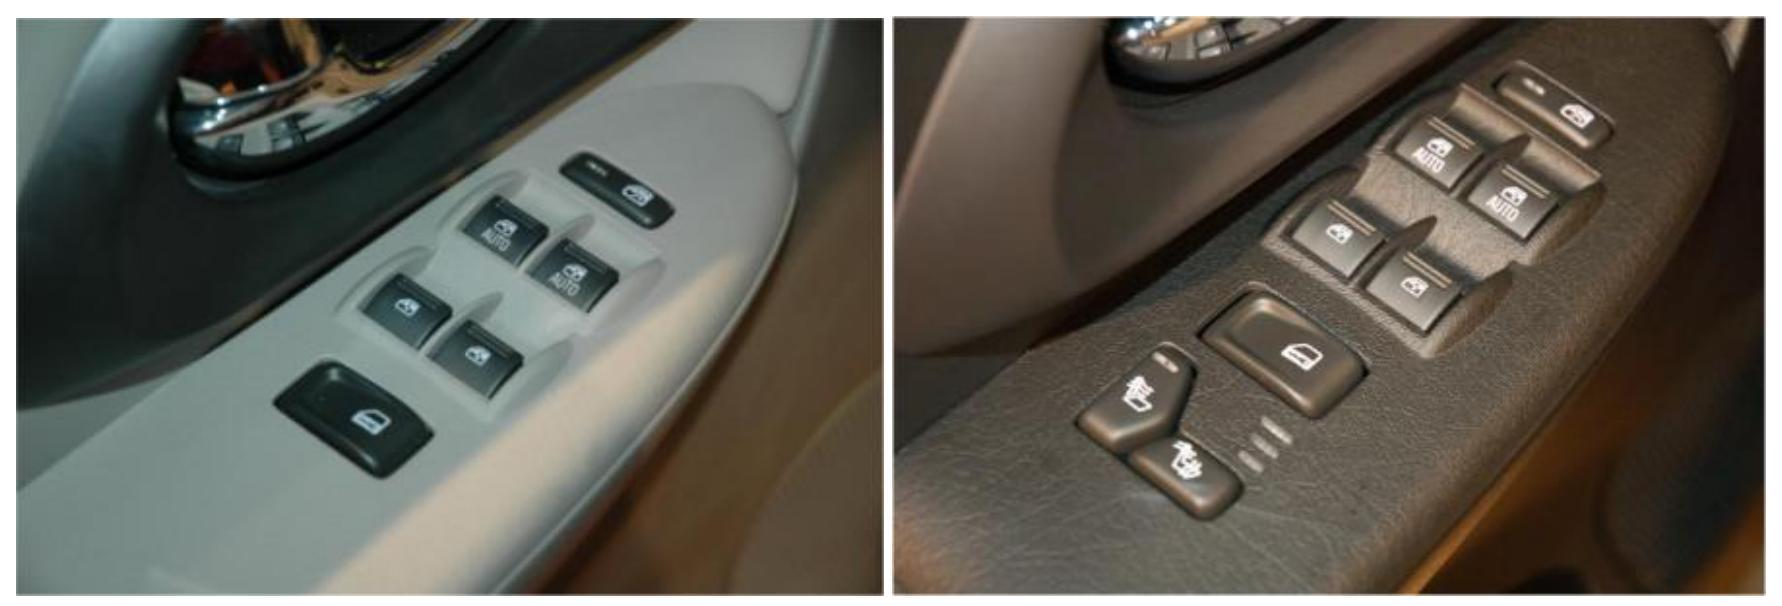
Internal investigation opened 5/26/11 after review of TREAD data and VOQs. Root cause is fluid contacting DDM printed circuit board and shorting between power and ground.

Moisture will tend to collect at the forward left corner of the module, and depending upon the amount and type of liquid intrusion into the DDM, corrosion of the printed circuit board traces may occur and current flow may be compromised.

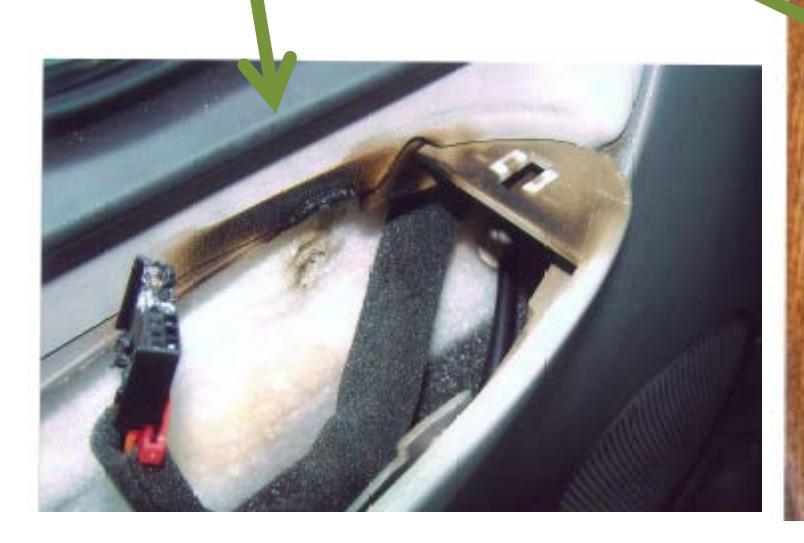
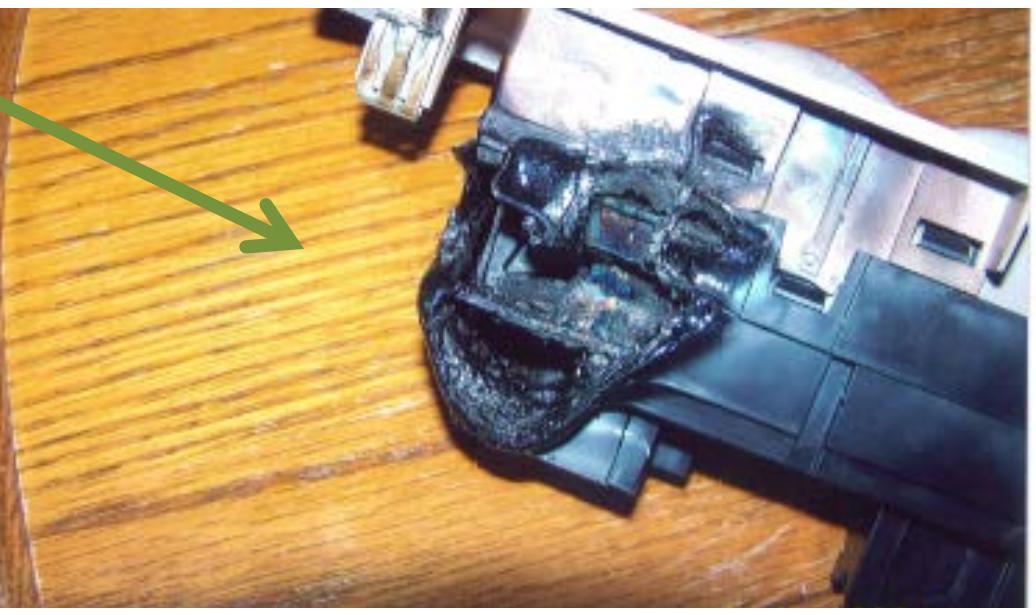
1GNDT13S872 - (727454): Incident date: 3-5-2011; Estimated mileage: 50,000 miles; Fire in driver door while the s/v was parked and unattended.

1GNDT13S072 1000 - 1000 (725483); Incident date: 2-27-2011; 63,000 miles; Fire in driver front door while the s/v was parked and unattended.

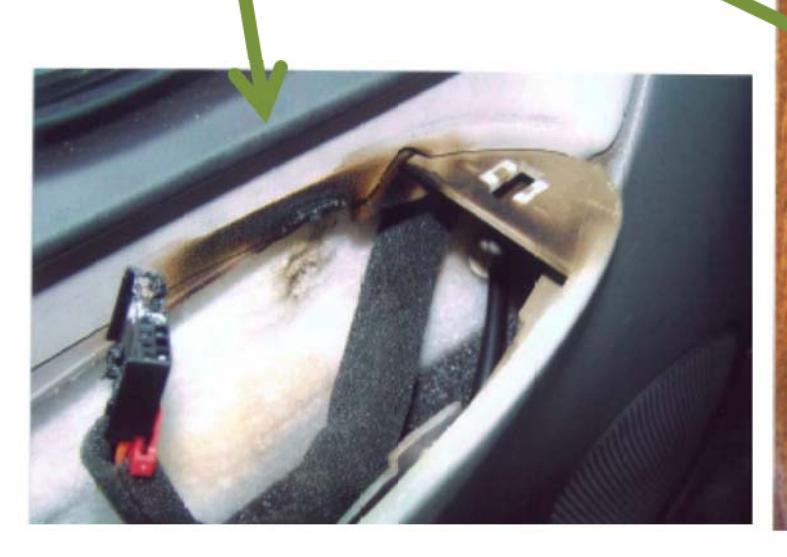
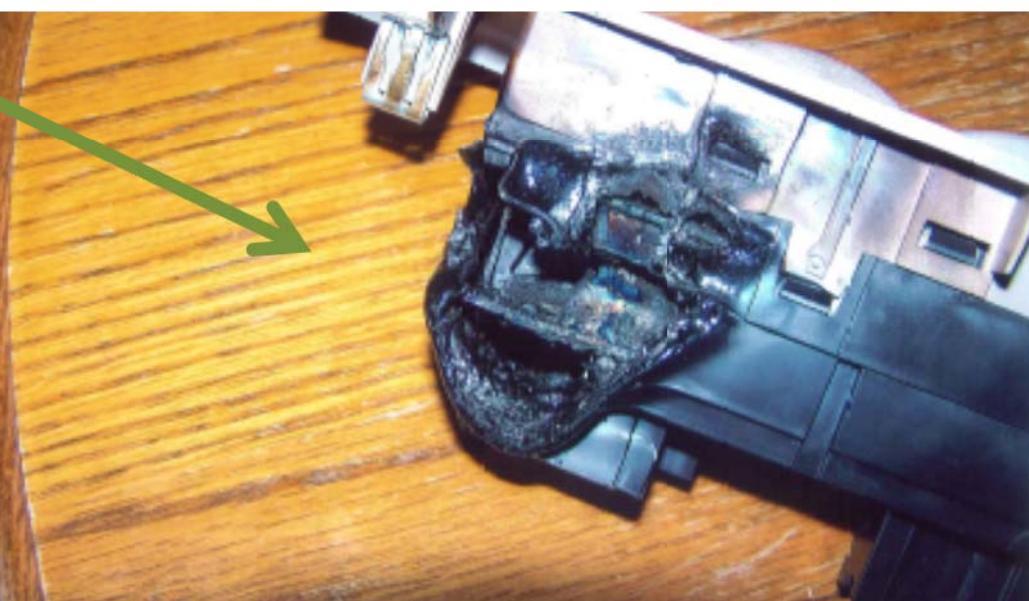
1GNDT13S872 - Control (727454): Incident date: 3-5-2011; Estimated mileage: 50,000 miles; Fire in driver door while the s/v was parked and unattended.

(725483); Incident date: 2-27-2011; 63,000 miles; Fire in driver from door while the s/v was parked and unattended.

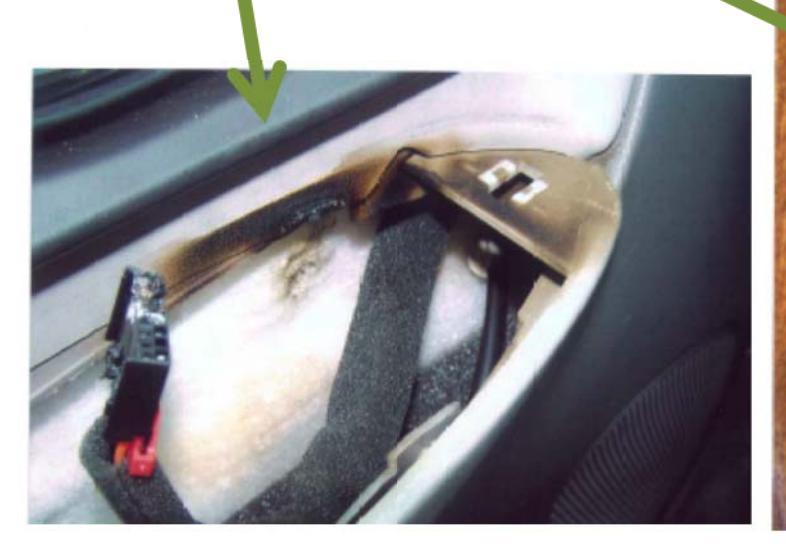
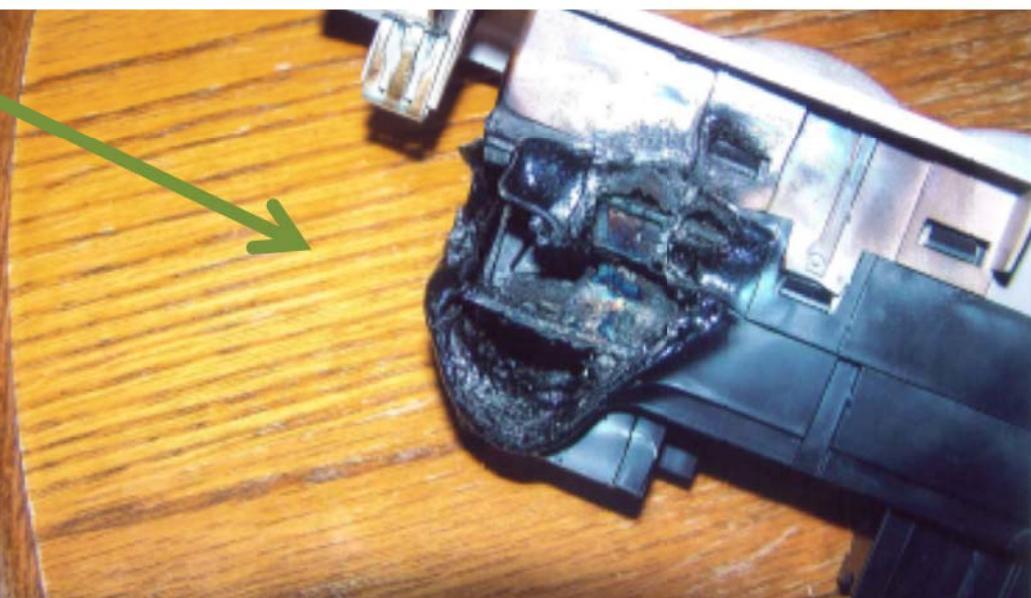
1GNDT13S872 - (727454): Incident date: 3-5-2011; Estimated mileage: 50,000 miles; Fire in driver door while the s/v was parked and unattended.

(725483); Incident date: 2-27-2011; 63,000 miles; Fire in driver from door while the s/v was parked and unattended.

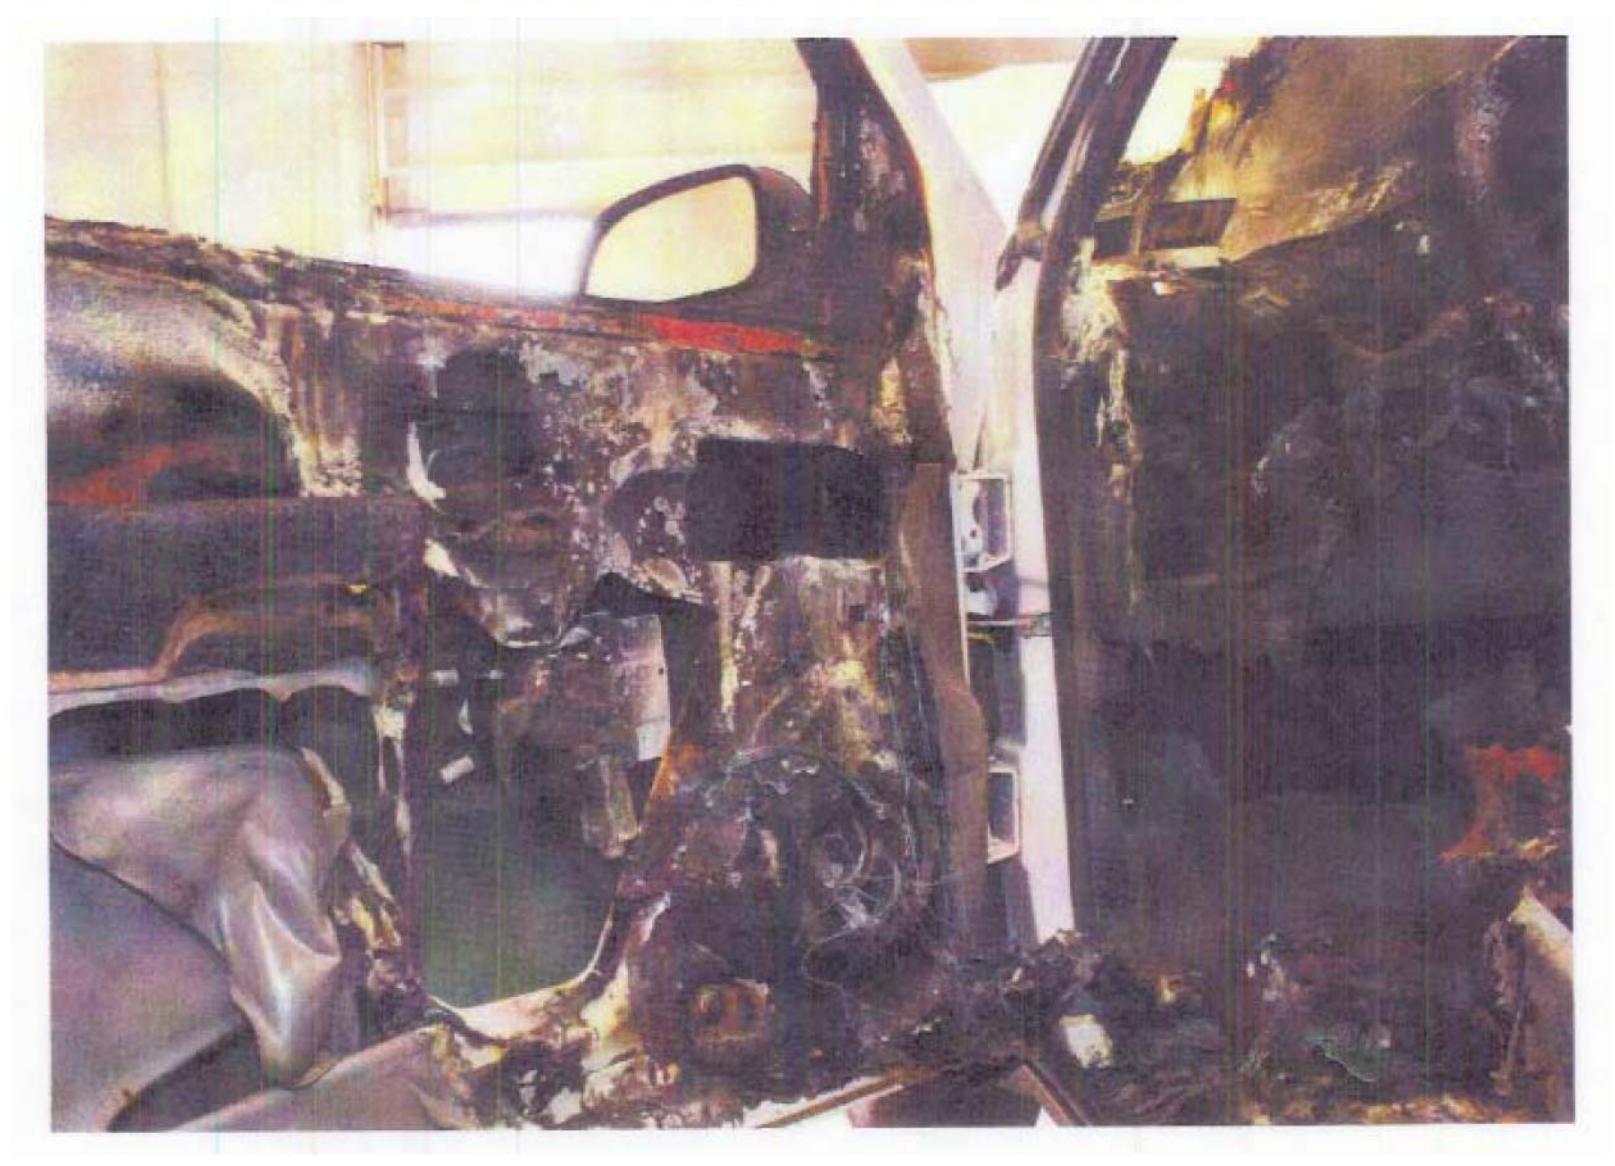
1GNDT13S362 (663106) Incident date: 10-29-2008; Estimated mileage: 50,000 miles; Fire in driver door while the s/v was parked and unattended.

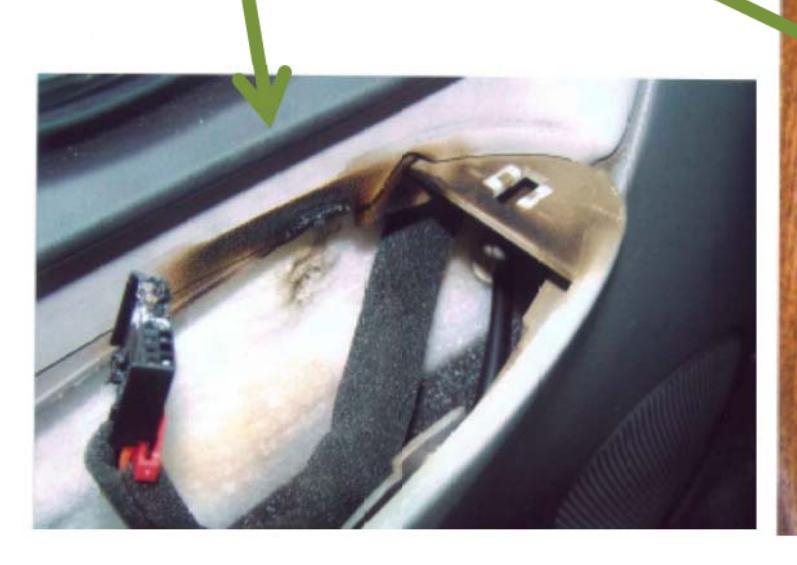
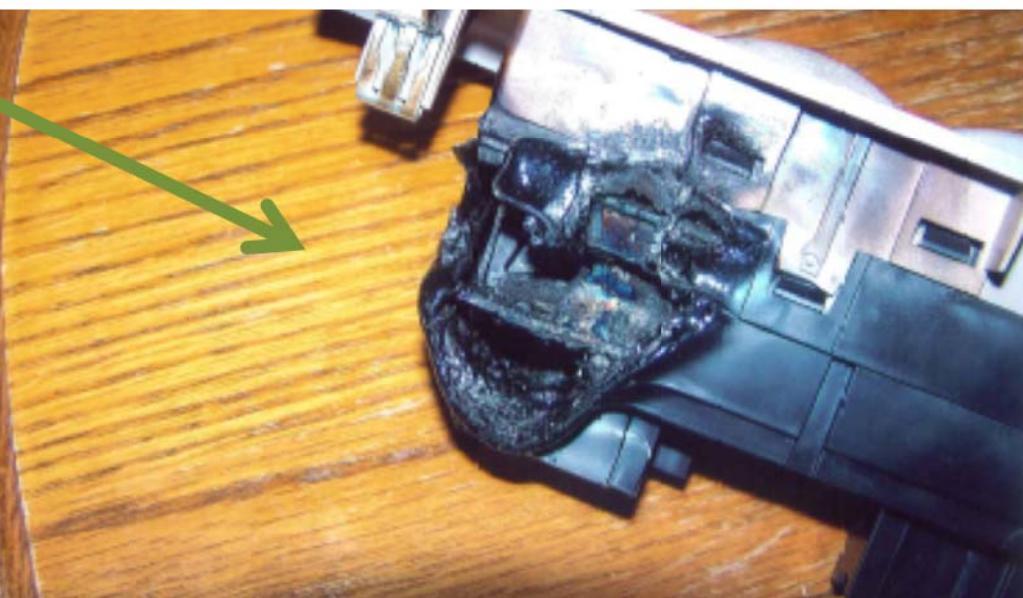
1GNDT13S872 - (727454): Incident date: 3-5-2011; Estimated mileage: 50,000 miles; Fire in driver door while the s/v was parked and unattended.

(725483); Incident date: 2-27-2011; 63,000 miles; Fire in driver from door while the s/v was parked and unattended.

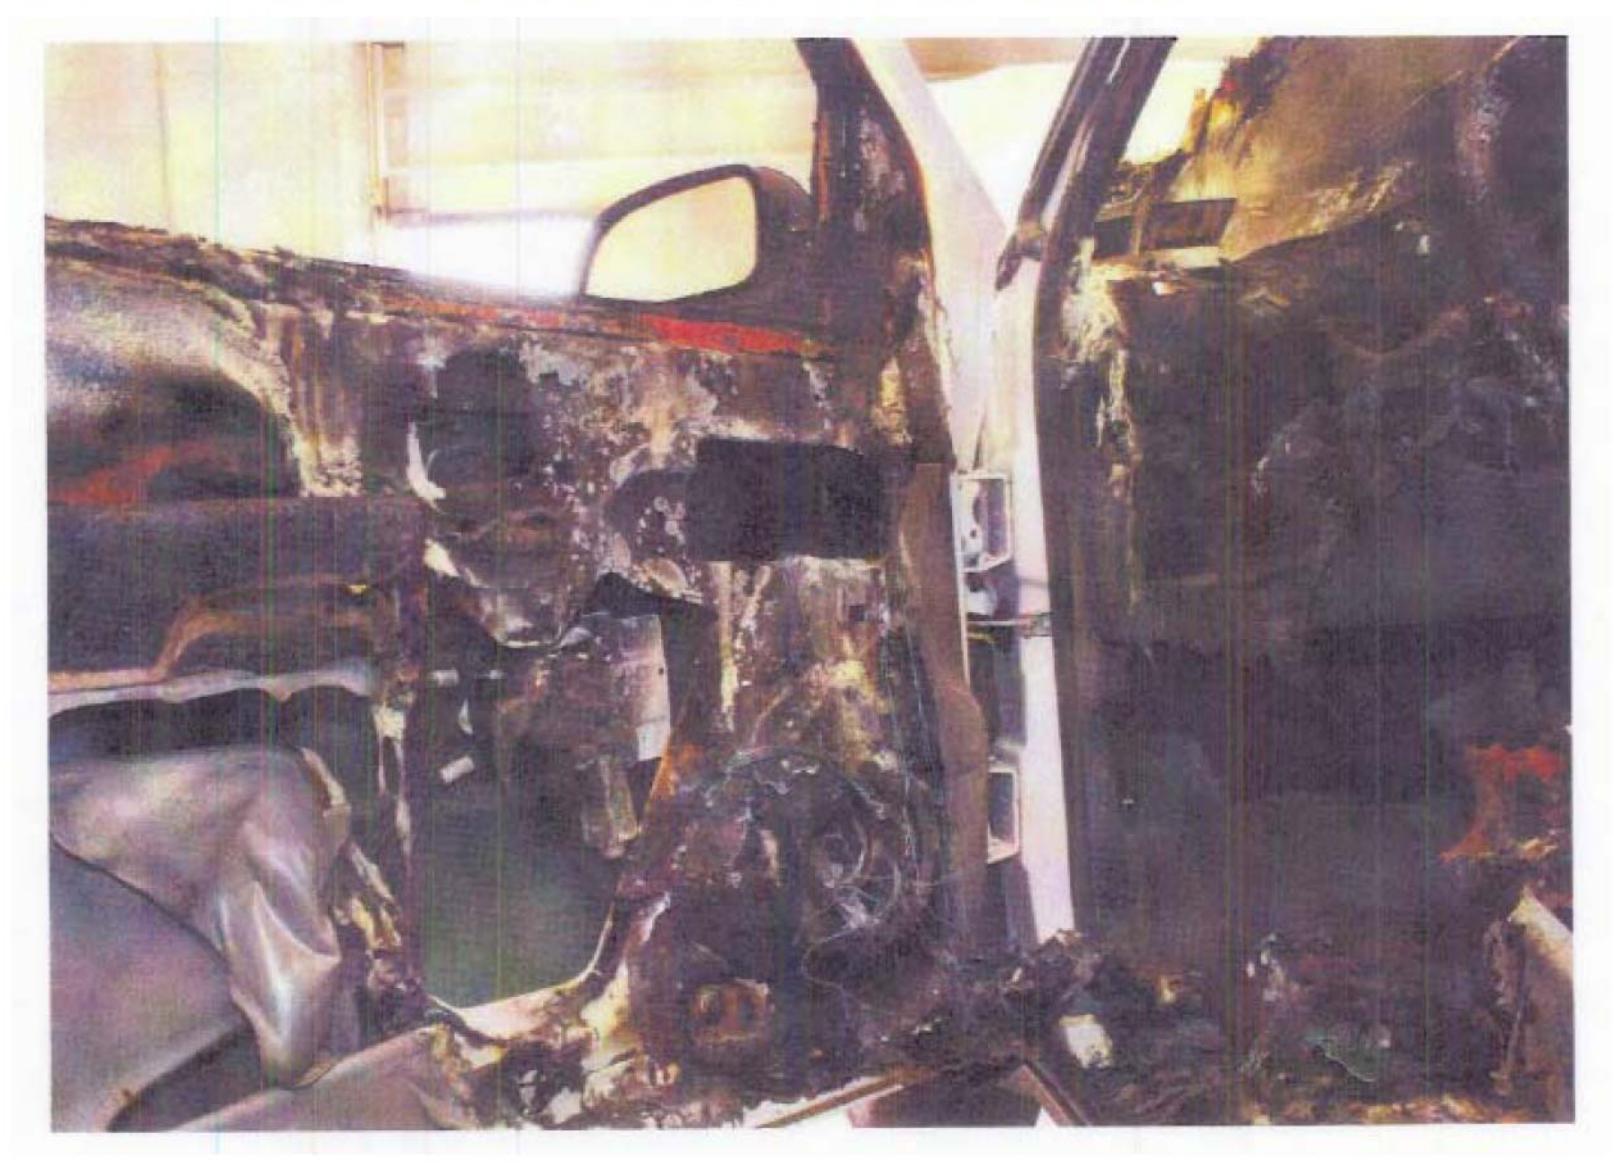
1GNDT13S362 (663106) Incident date: 10-29-2008; Estimated mileage: 50,000 miles; Fire in driver door while the s/v was parked and unattended.

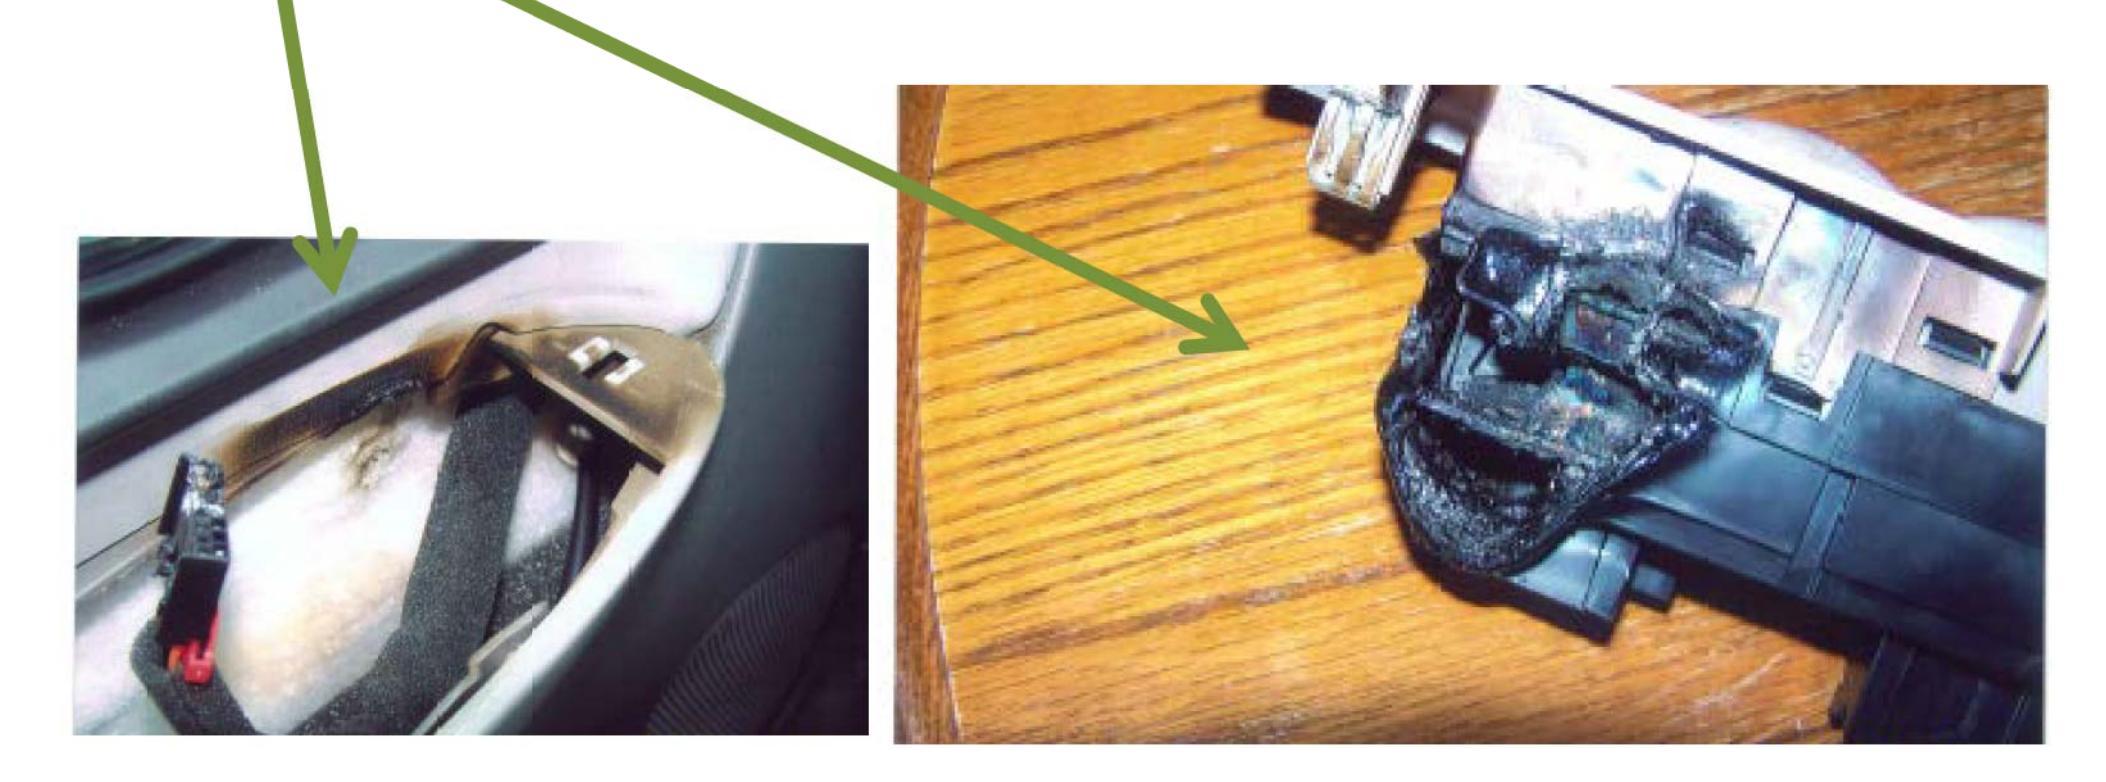
1GNDT13S072 1000 - 1000 (725483); Incident date: 2-27-2011; 63,000 miles; Fire in driver front door while the s/v was parked and unattended.

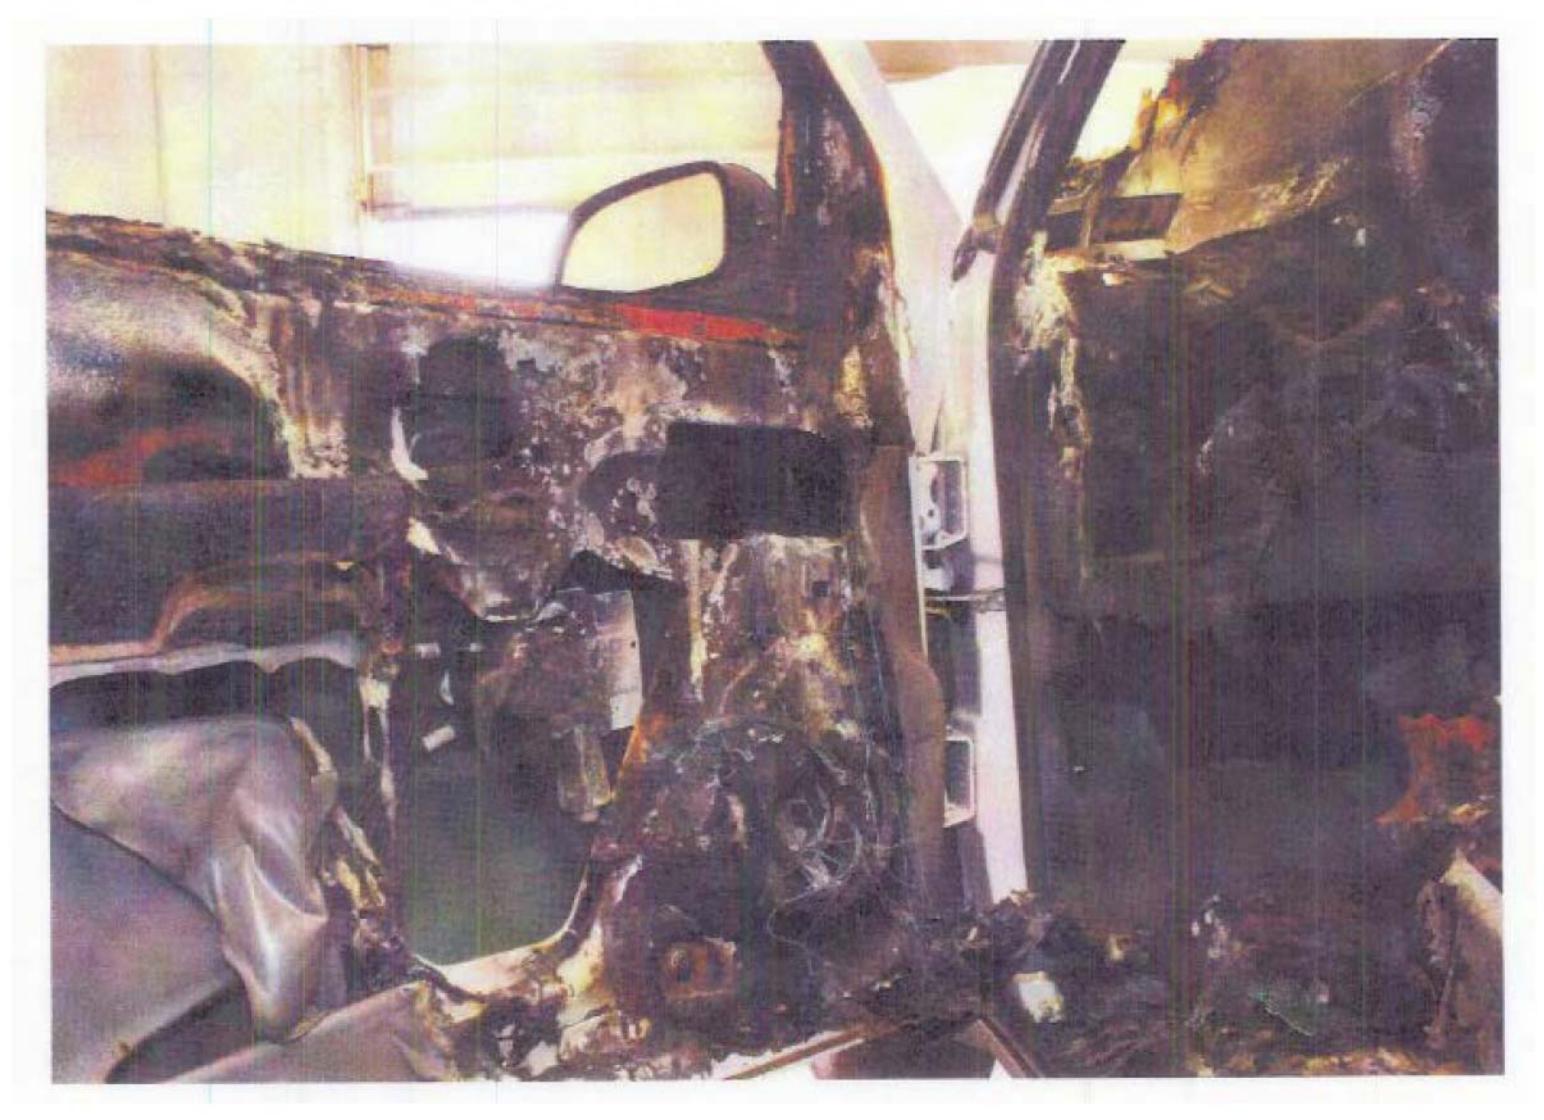
Inspections/Investigations

1GNDT13S362 (663106) Incident date: 10-29-2008; Estimated mileage: 50,000 miles; Fire in driver door while the s/v was parked and unattended.

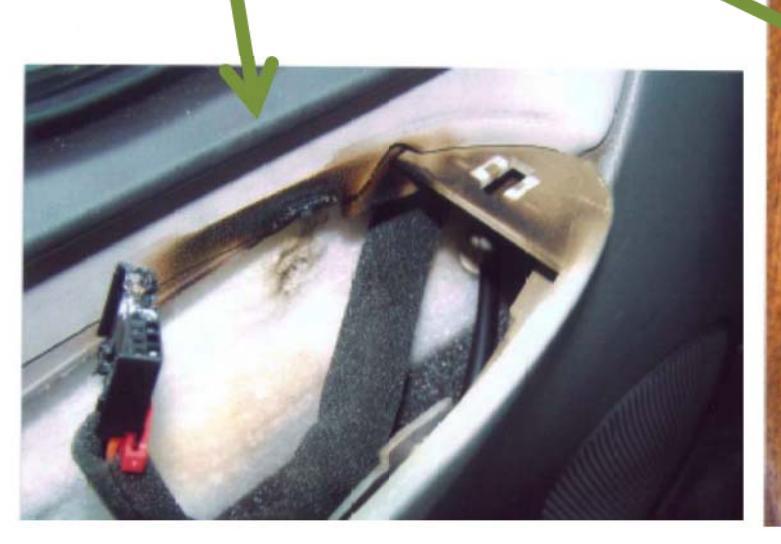
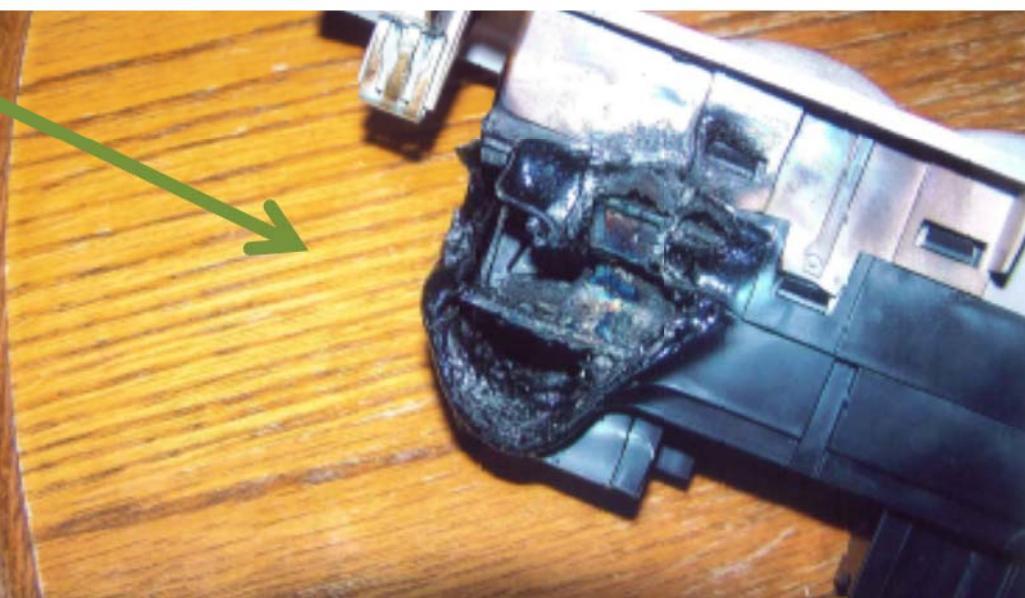
1GNDT13S872 - (727454): Incident date: 3-5-2011; Estimated mileage: 50,000 miles; Fire in driver door while the s/v was parked and unattended.

(725483); Incident date: 2-27-2011; 63,000 miles; Fire in driver from door while the s/v was parked and unattended.

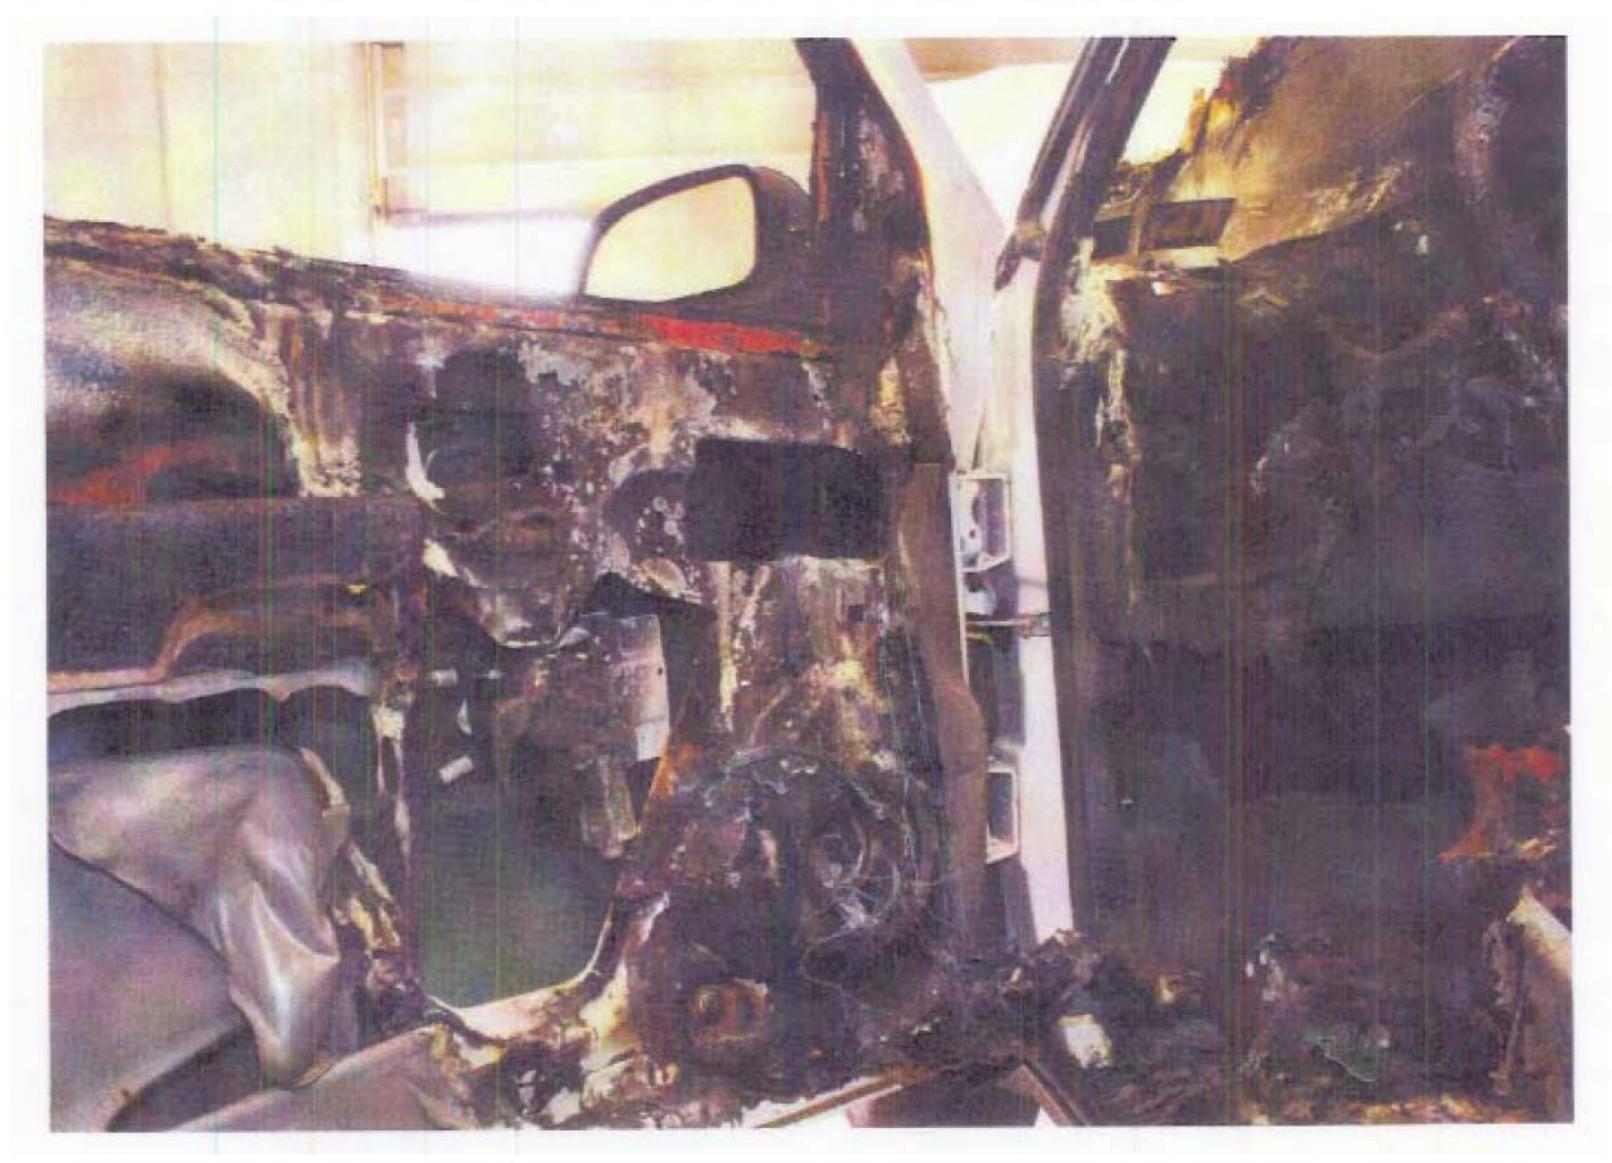
1GNDT13S362 (663106) Incident date: 10-29-2008; Estimated mileage: 50,000 miles; Fire in driver door while the s/v was parked and unattended.

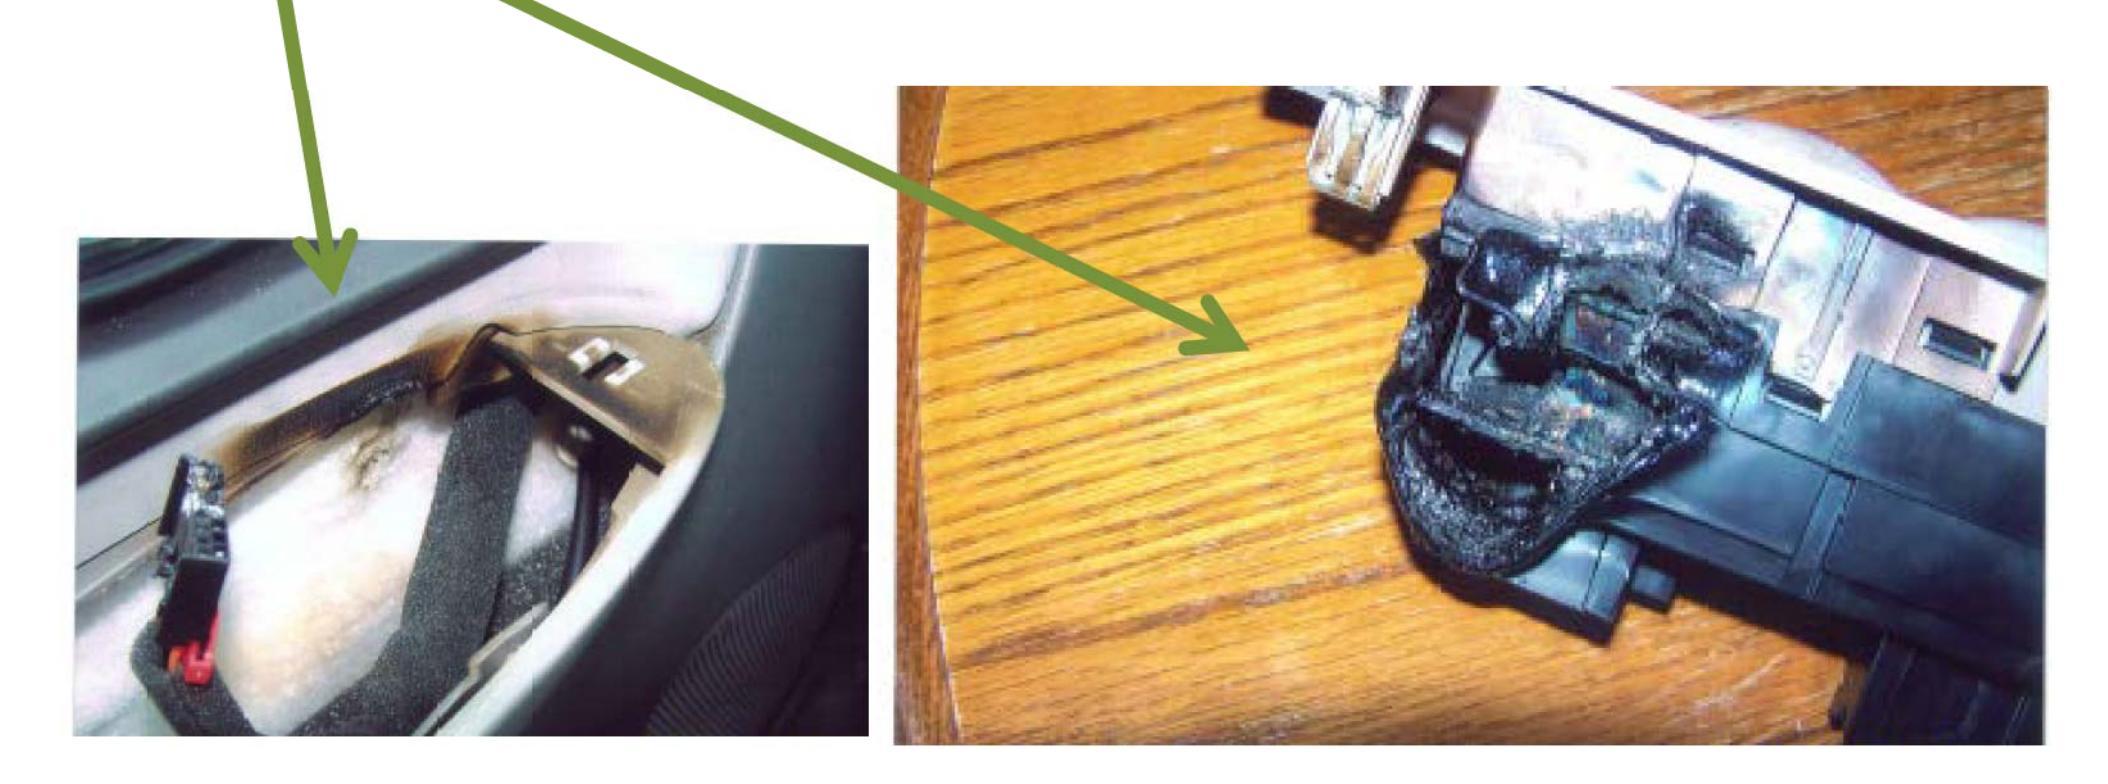
1GNDT13S872 - 77454): Incident date: 3-5-2011; Estimated mileage: 50,000 miles; Fire in driver door while the s/v was parked and unattended.

1GNDT13S072 - Control (725483); Incident date: 2-27-2011; 63,000 miles; Fire in driver front door while the s/v was parked and unattended.
