GM 12-14-2012 ATTACHMENT Q_09 2006-7 GMT360_370 DDM Function Historian 4-19-12-p

Driver Door Module Short Circuit

2006-2007 GMT360/370 DDM CA Warranty Labor Op N2117

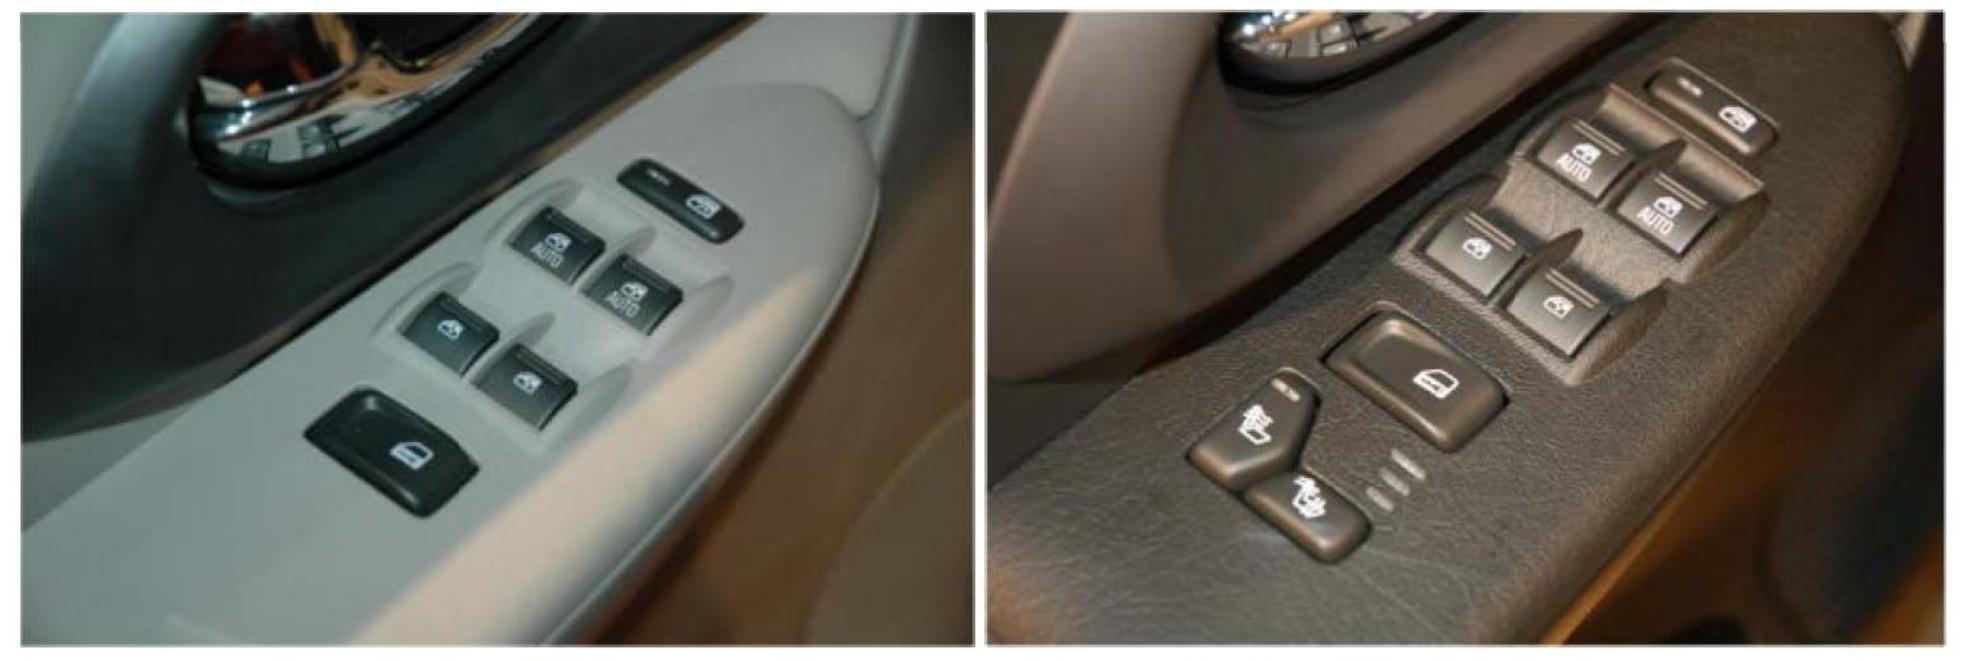
Base Switch Package

Uplevel Switch Package

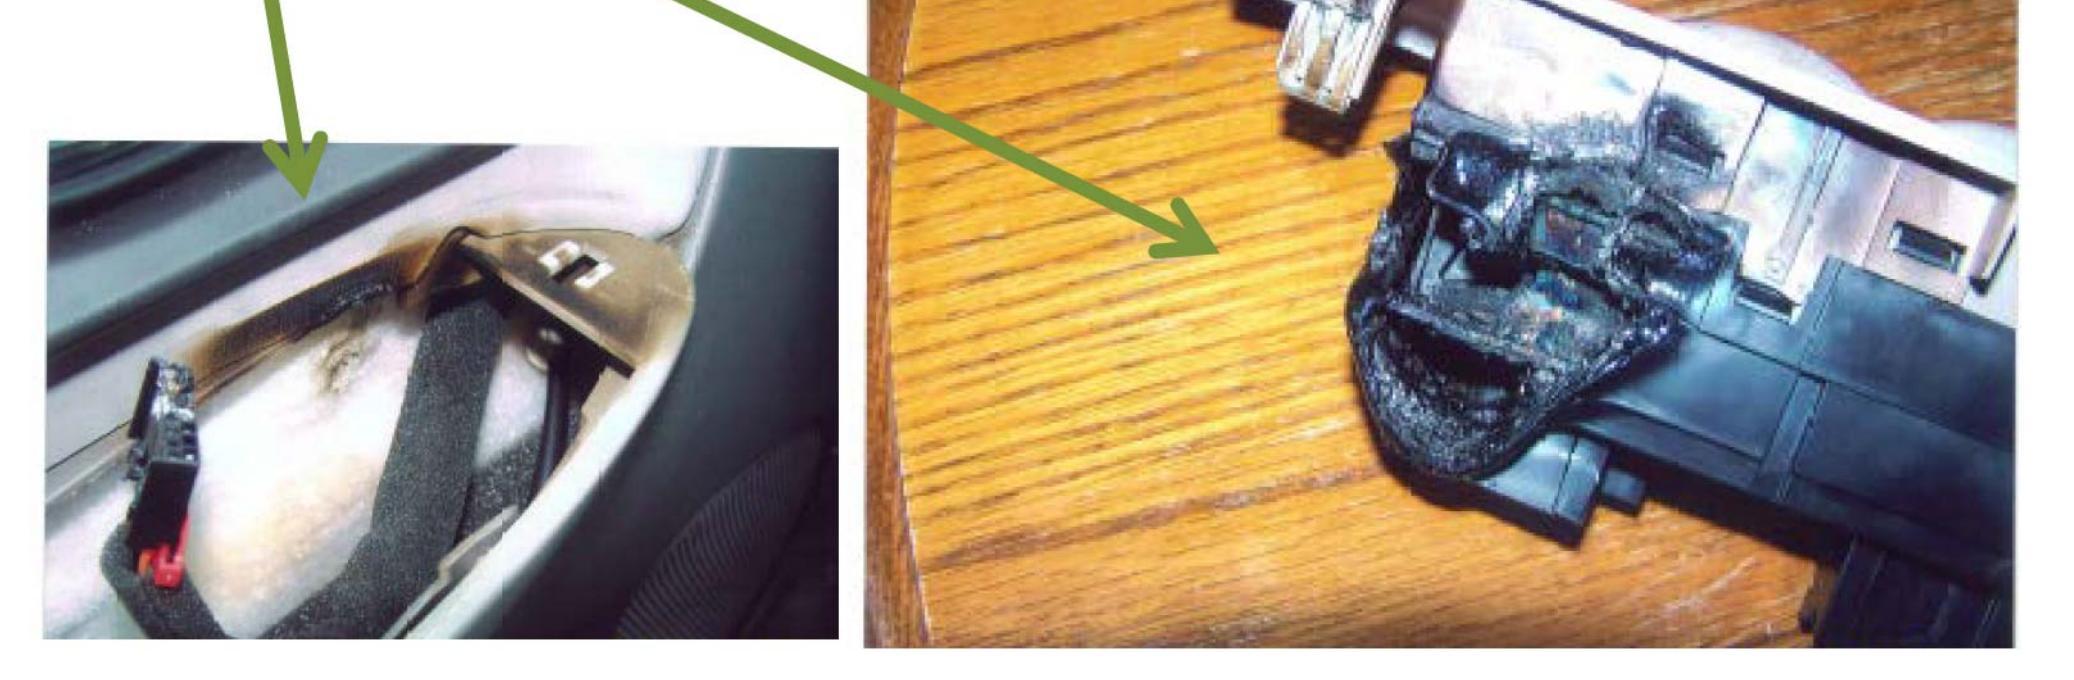
Inspections/Investigations

1GNDT13S362 (663106) Incident date: 10-29-2008; Estimated mileage: 50,000 miles; Fire in driver door while the s/v was parked and unattended.

1GKET63M4622 - (723759) Incident date: 12-16-2010; Lawpack (no details on circumstances of incident, but damage is consistent with DDM)

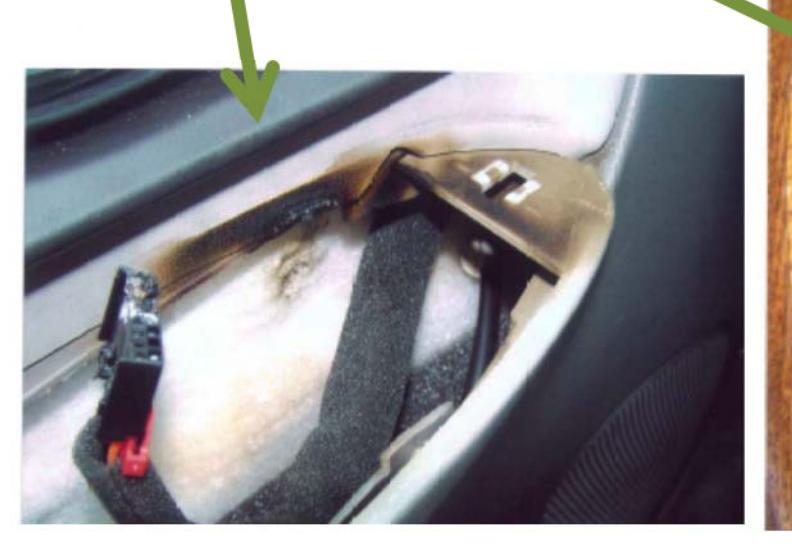
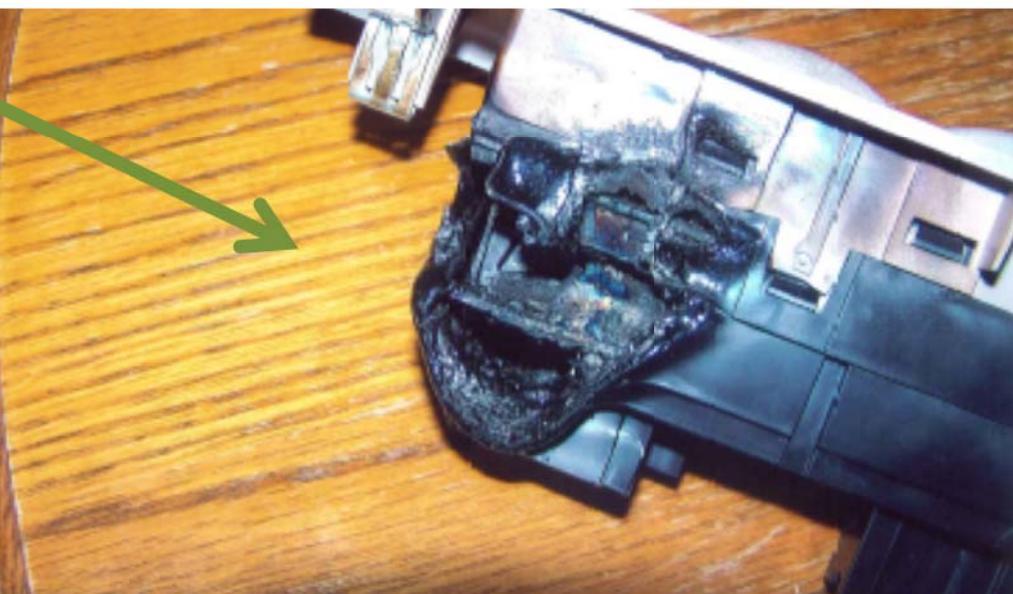
1GNDT13S872 - (727454): Incident date: 3-5-2011; Estimated mileage: 50,000 miles; Fire in driver door while the s/v was parked and unattended.

(725483); Incident date: 2-27-2011; 63,000 miles; Fire in driver from door while the s/v was parked and unattended.

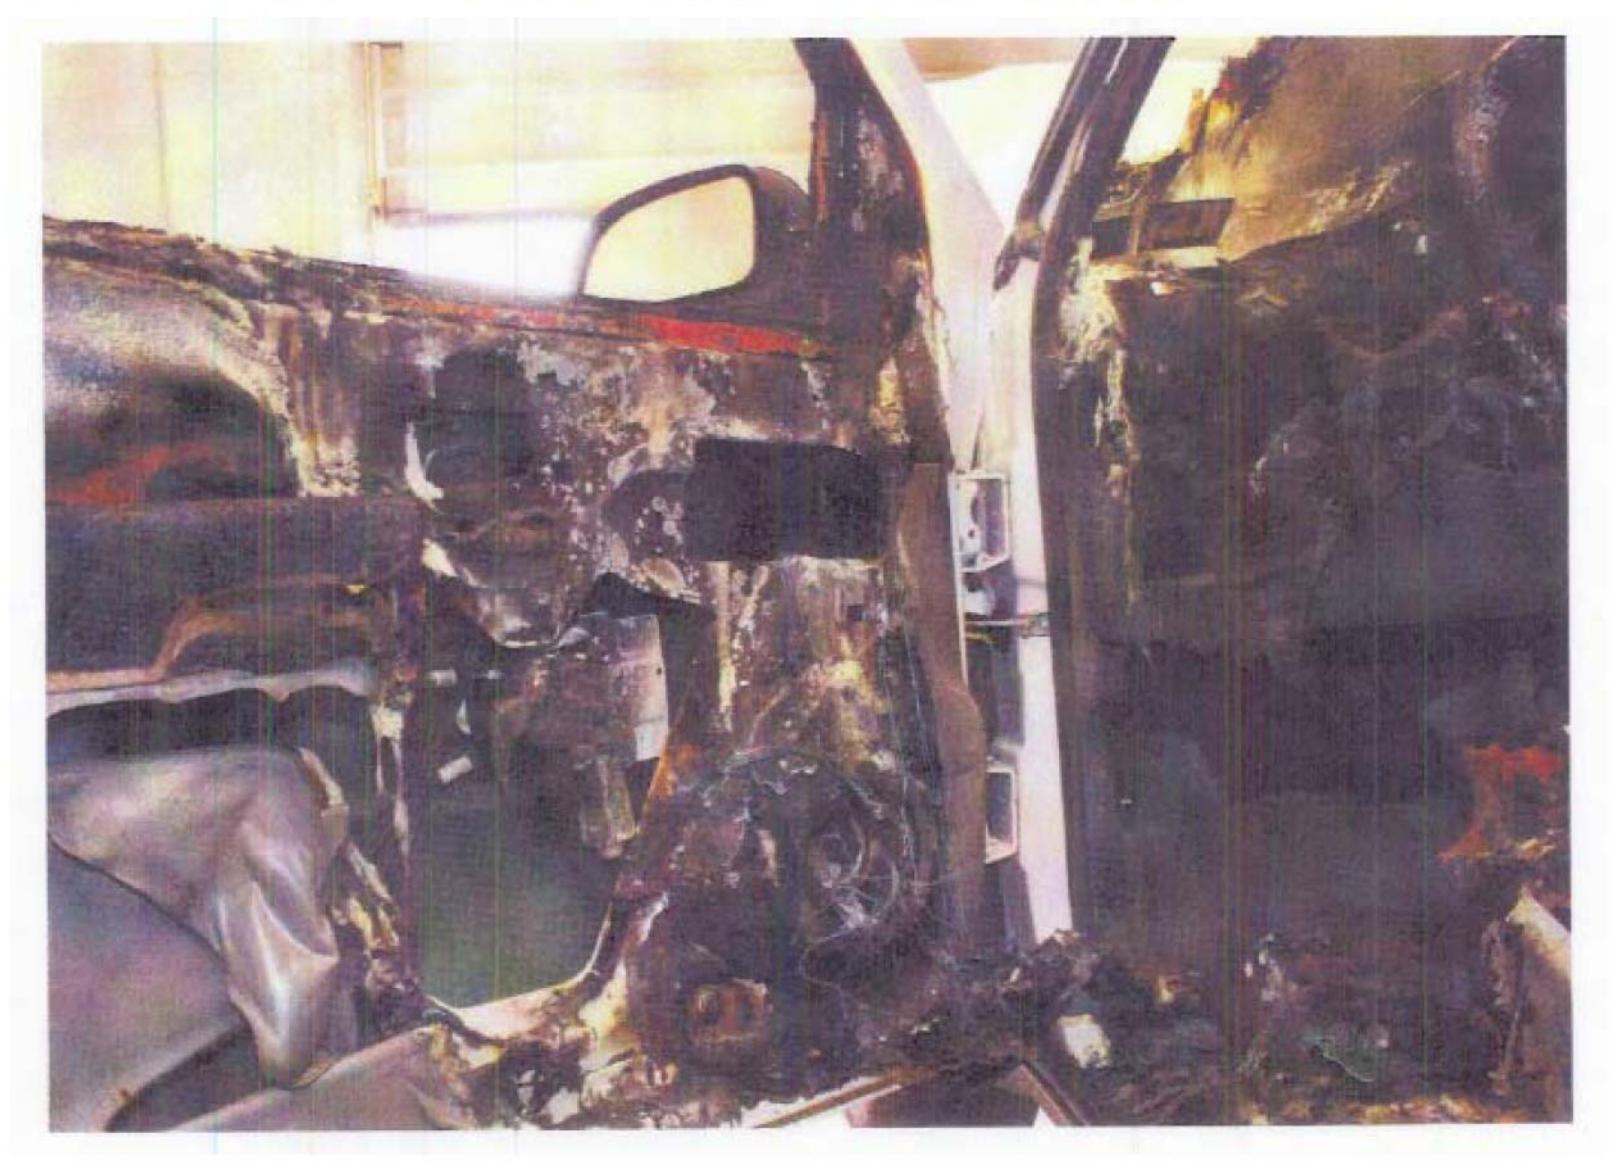
1GNDT13S362 (663106) Incident date: 10-29-2008; Estimated mileage: 50,000 miles; Fire in driver door while the s/v was parked and unattended.

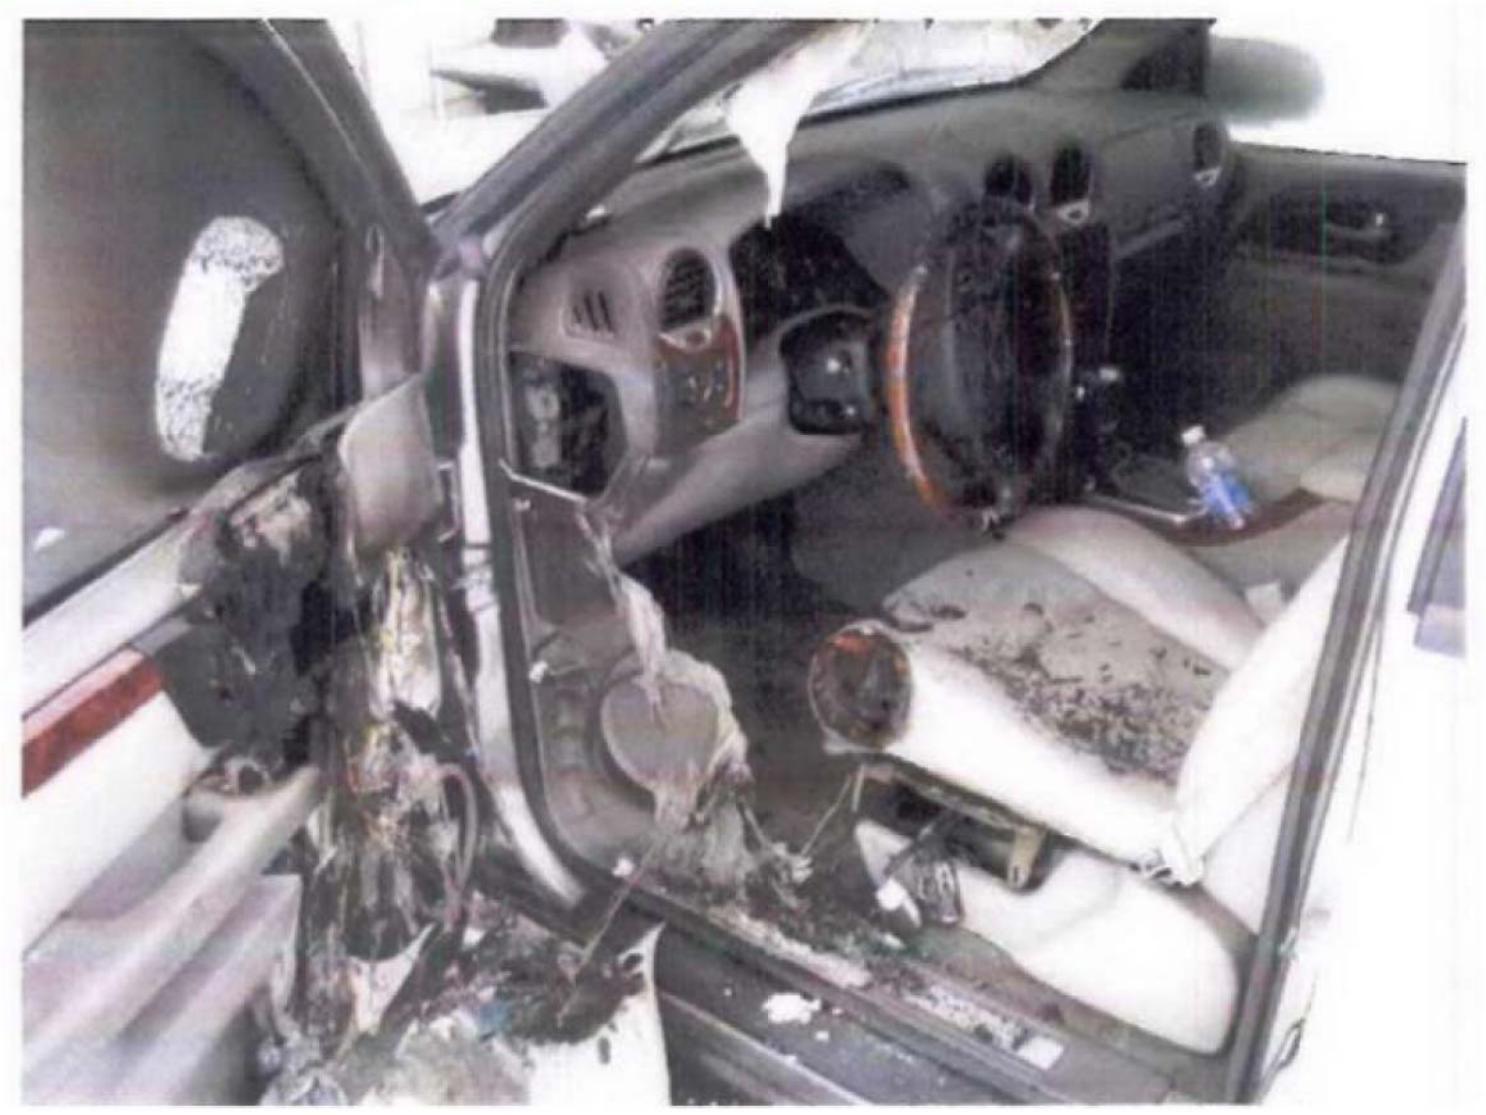
1GKET63M462 (no details on circumstances of incident, but damage is consistent with DDM)

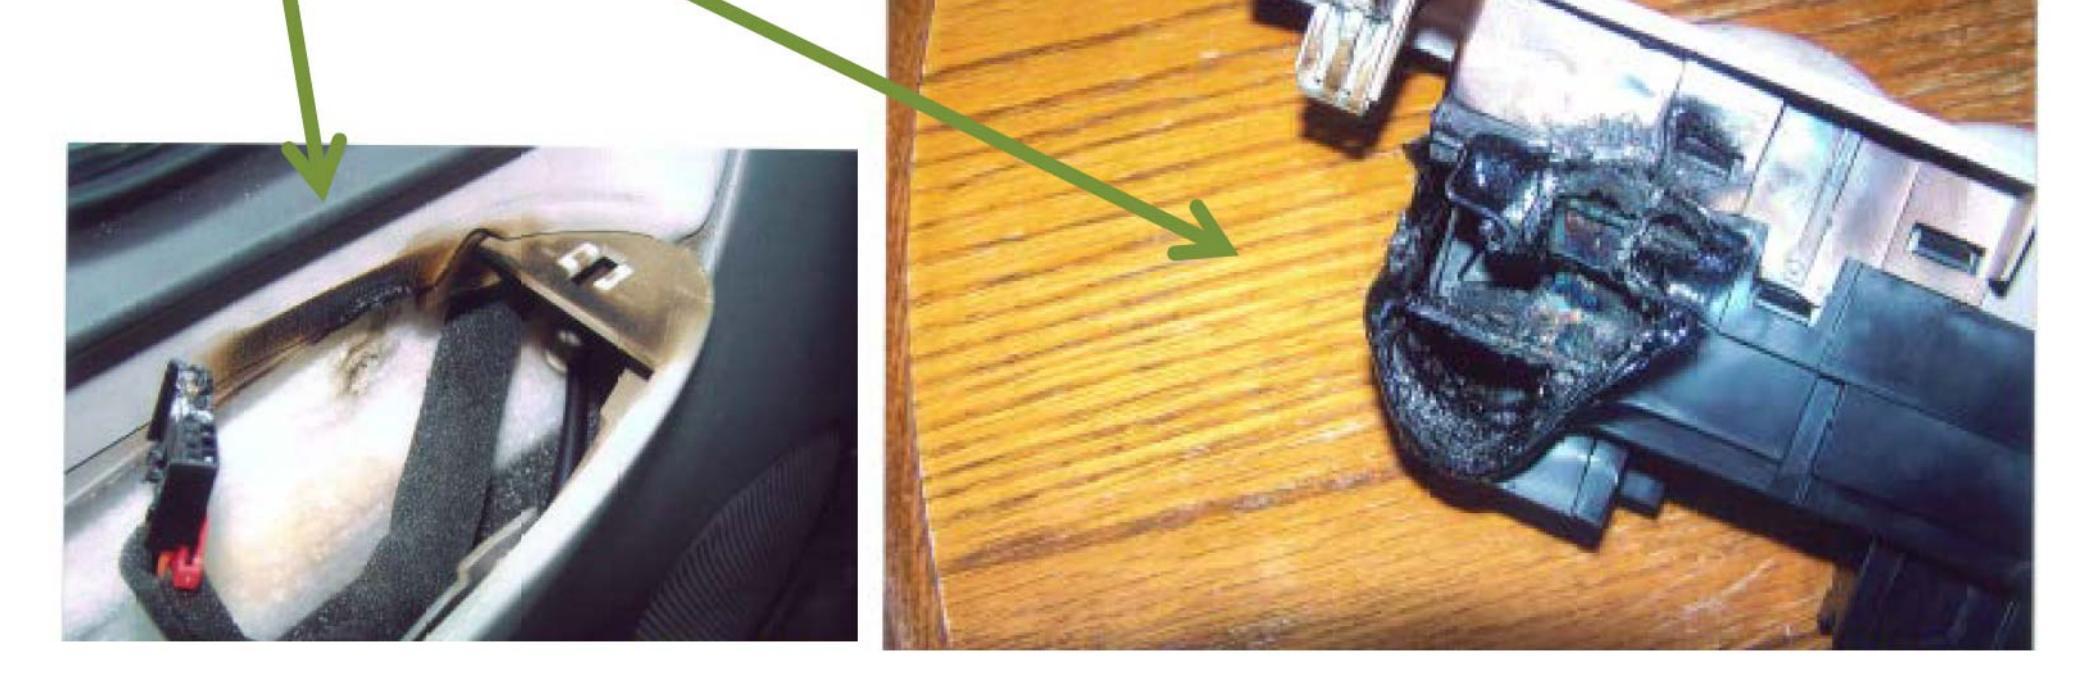
1GNDT13S072 - Control (725483); Incident date: 2-27-2011; 63,000 miles; Fire in driver front door while the s/v was parked and unattended.

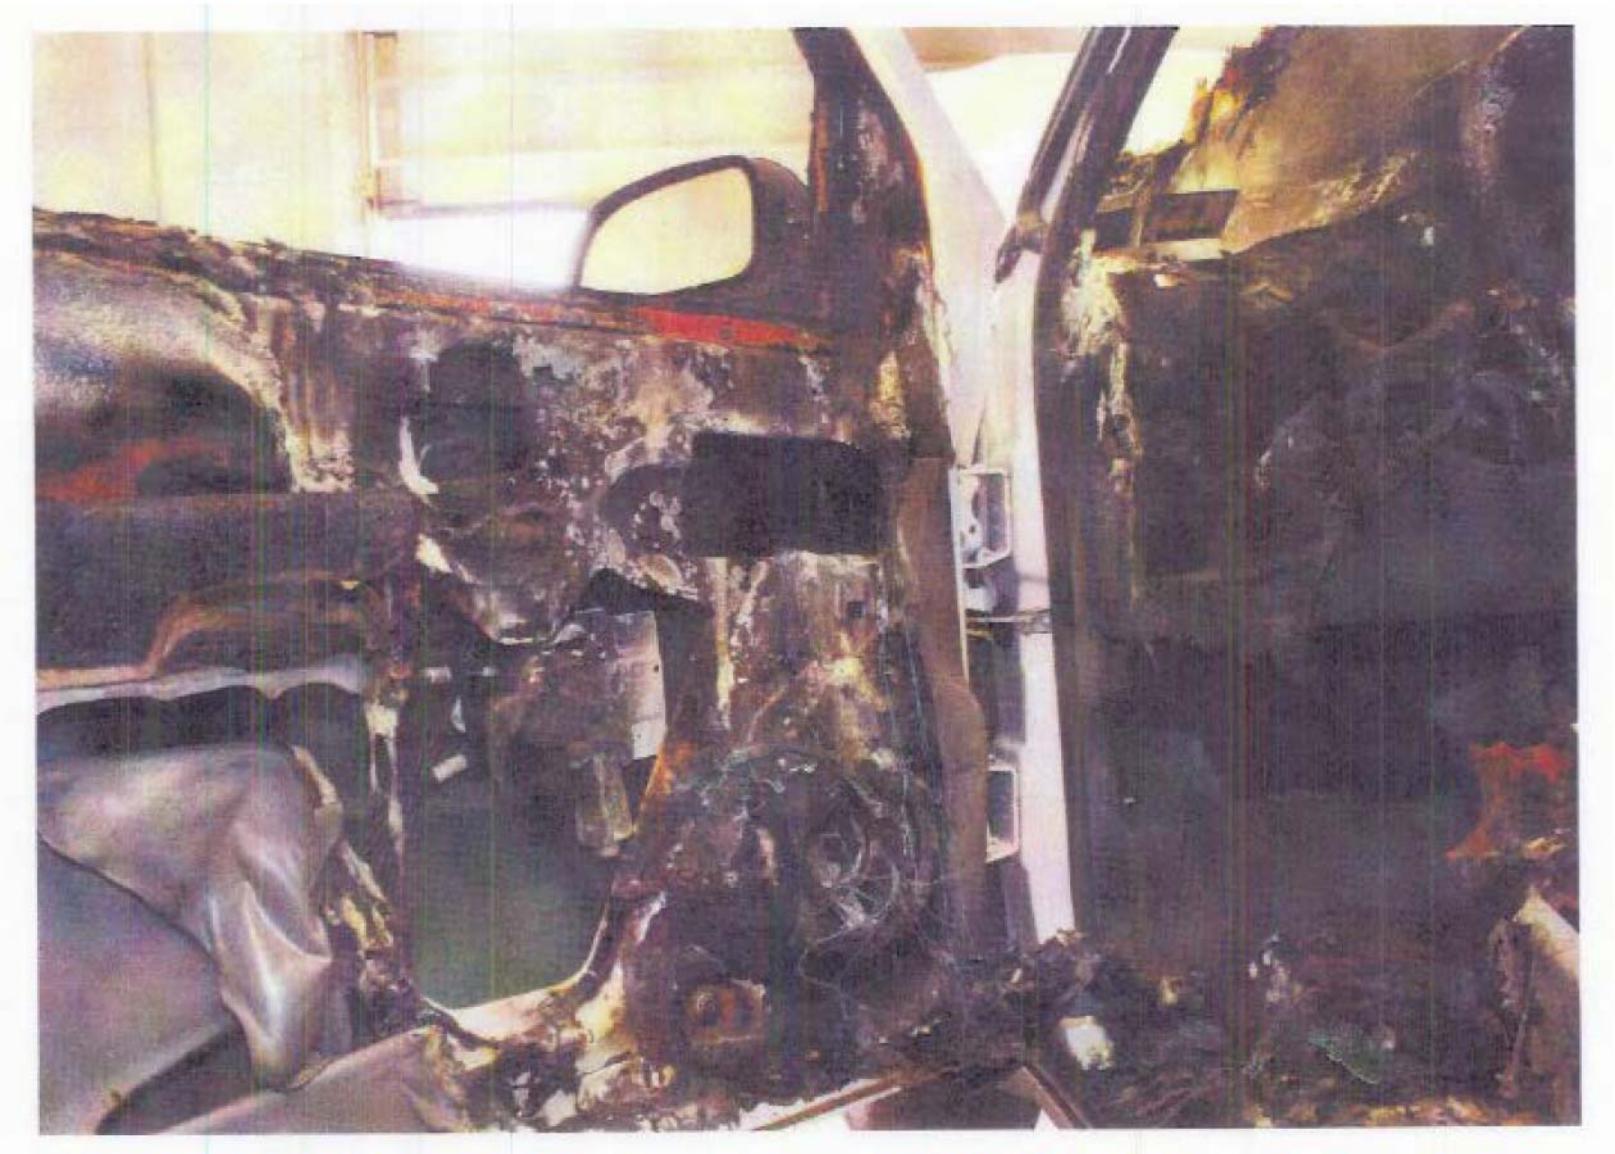
1GNDT13S362120309 - Stevens (663106) Incident date: 10-29-2008; Estimated mileage: 50,000 miles; Fire in driver door while the s/v was parked and unattended.

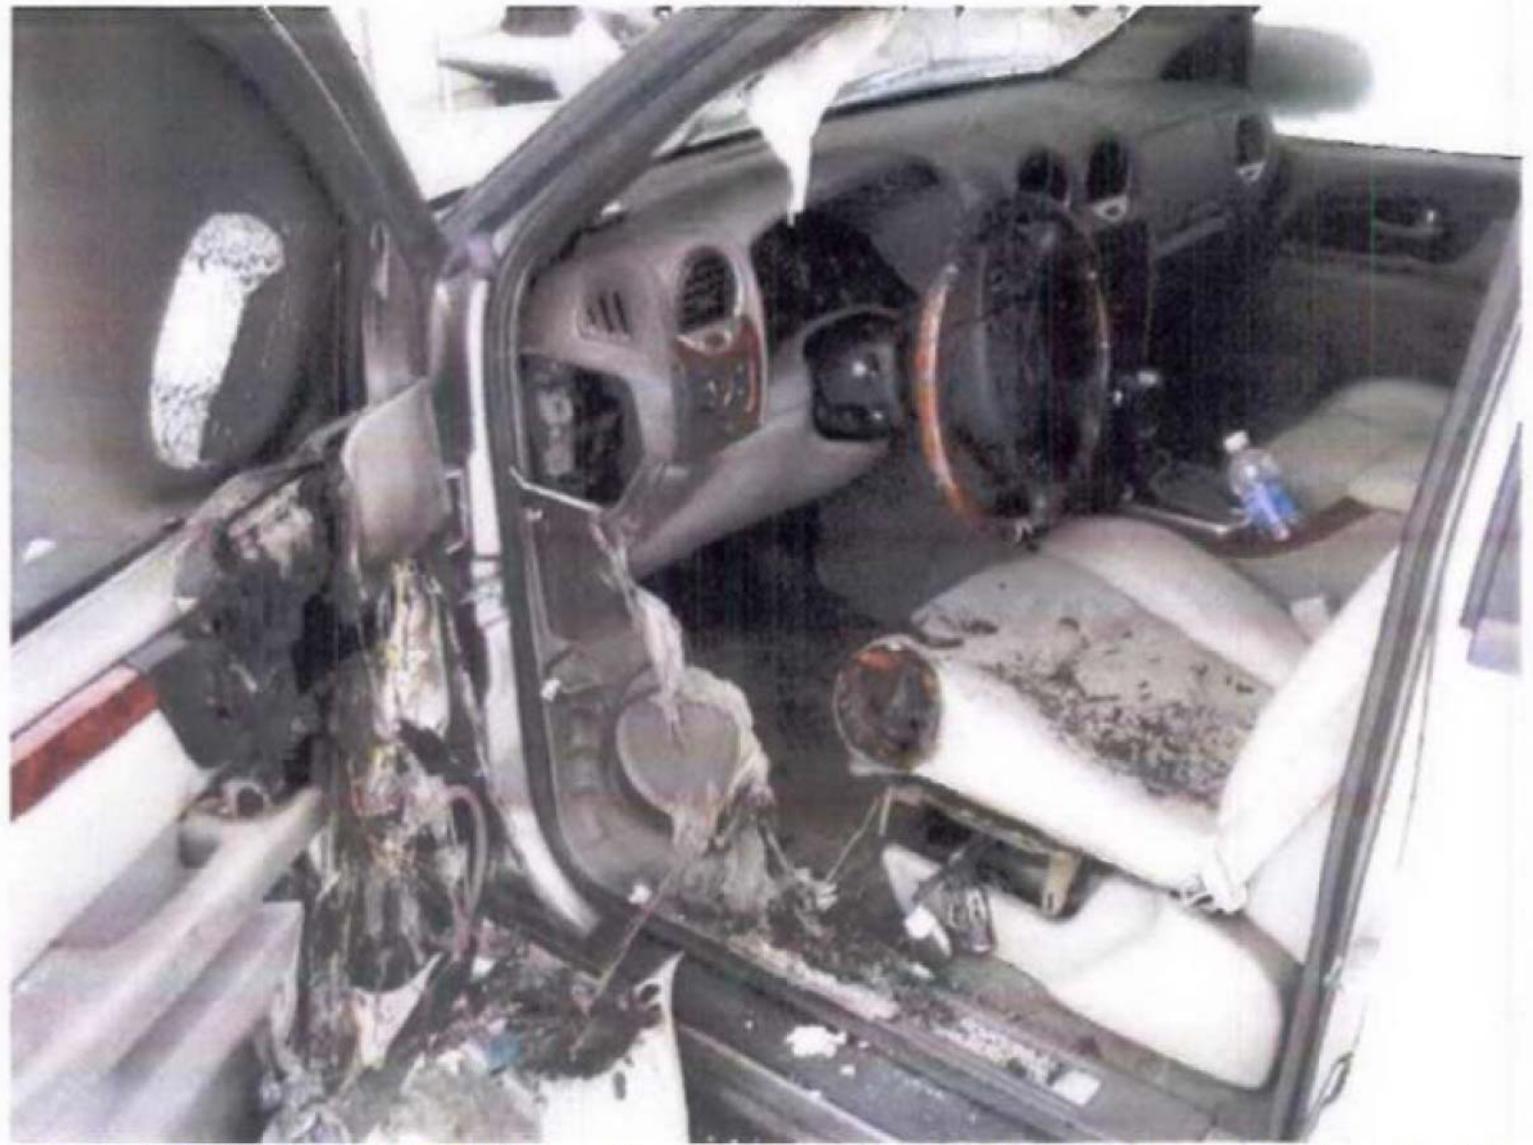
1GKET63M462 - (723759) Incident date: 12-16-2010; Lawpack (no details on circumstances of incident, but damage is consistent with DDM)

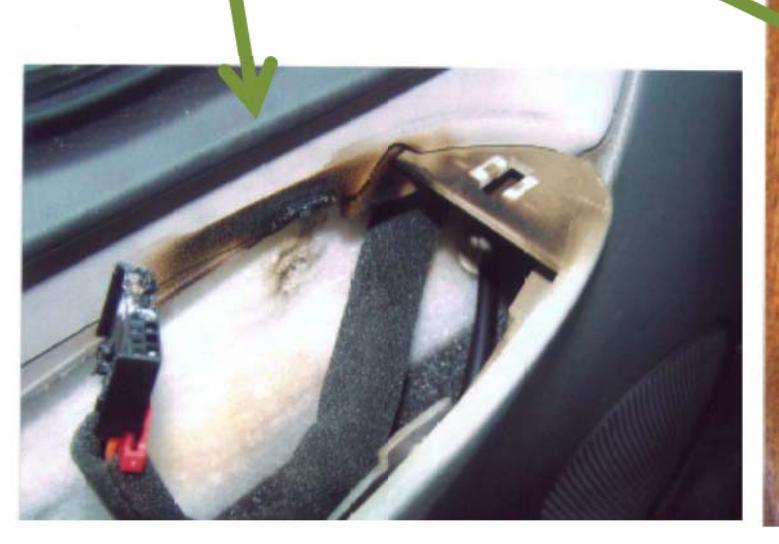
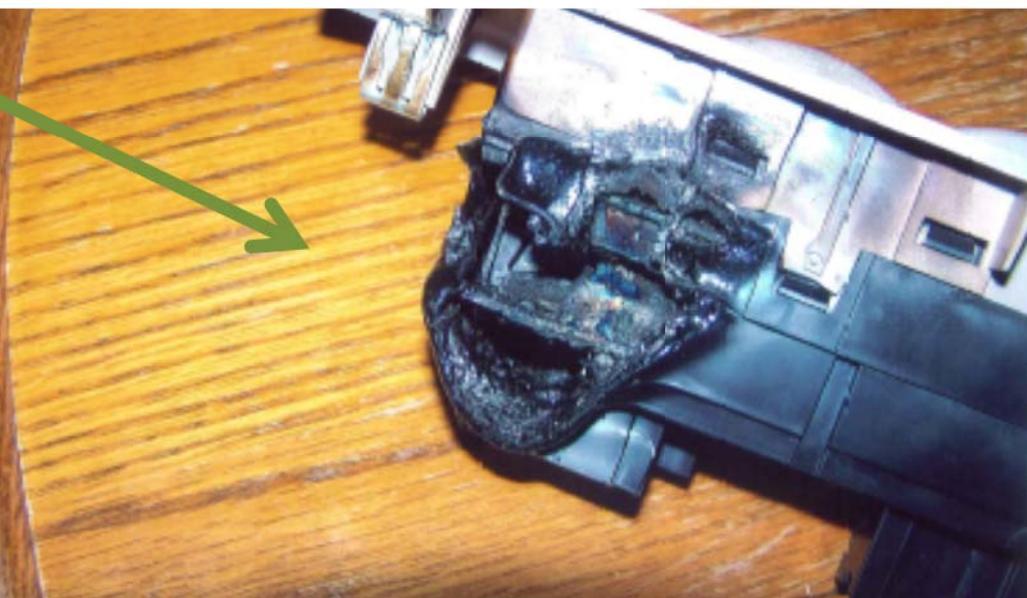
1GNDT13S872 - (727454): Incident date: 3-5-2011; Estimated mileage: 50,000 miles; Fire in driver door while the s/v was parked and unattended.

(725483); Incident date: 2-27-2011; 63,000 miles; Fire in driver from door while the s/v was parked and unattended.

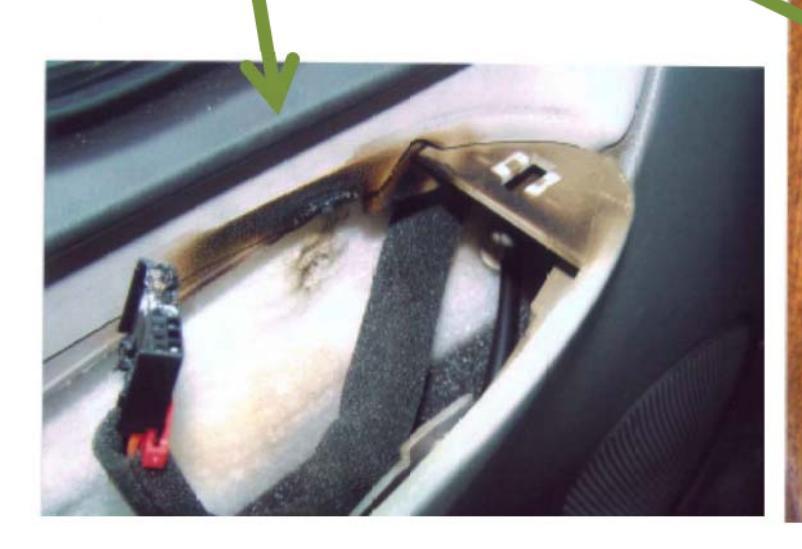
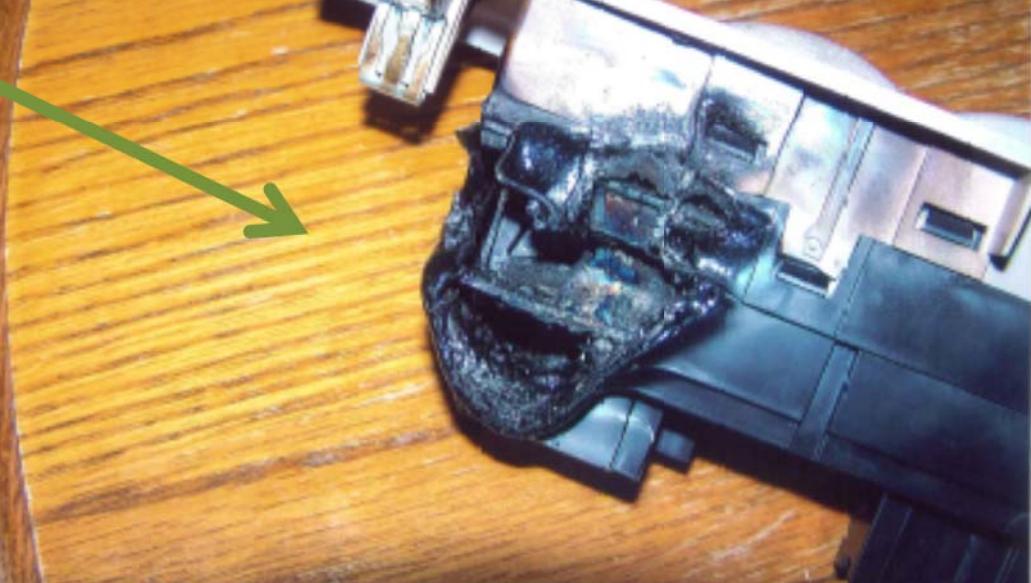
1GNDT13S872 - (727454): Incident date: 3-5-2011; Estimated mileage: 50,000 miles; Fire in driver door while the s/v was parked and unattended.

(725483); Incident date: 2-27-2011; 63,000 miles; Fire in driver from door while the s/v was parked and unattended.

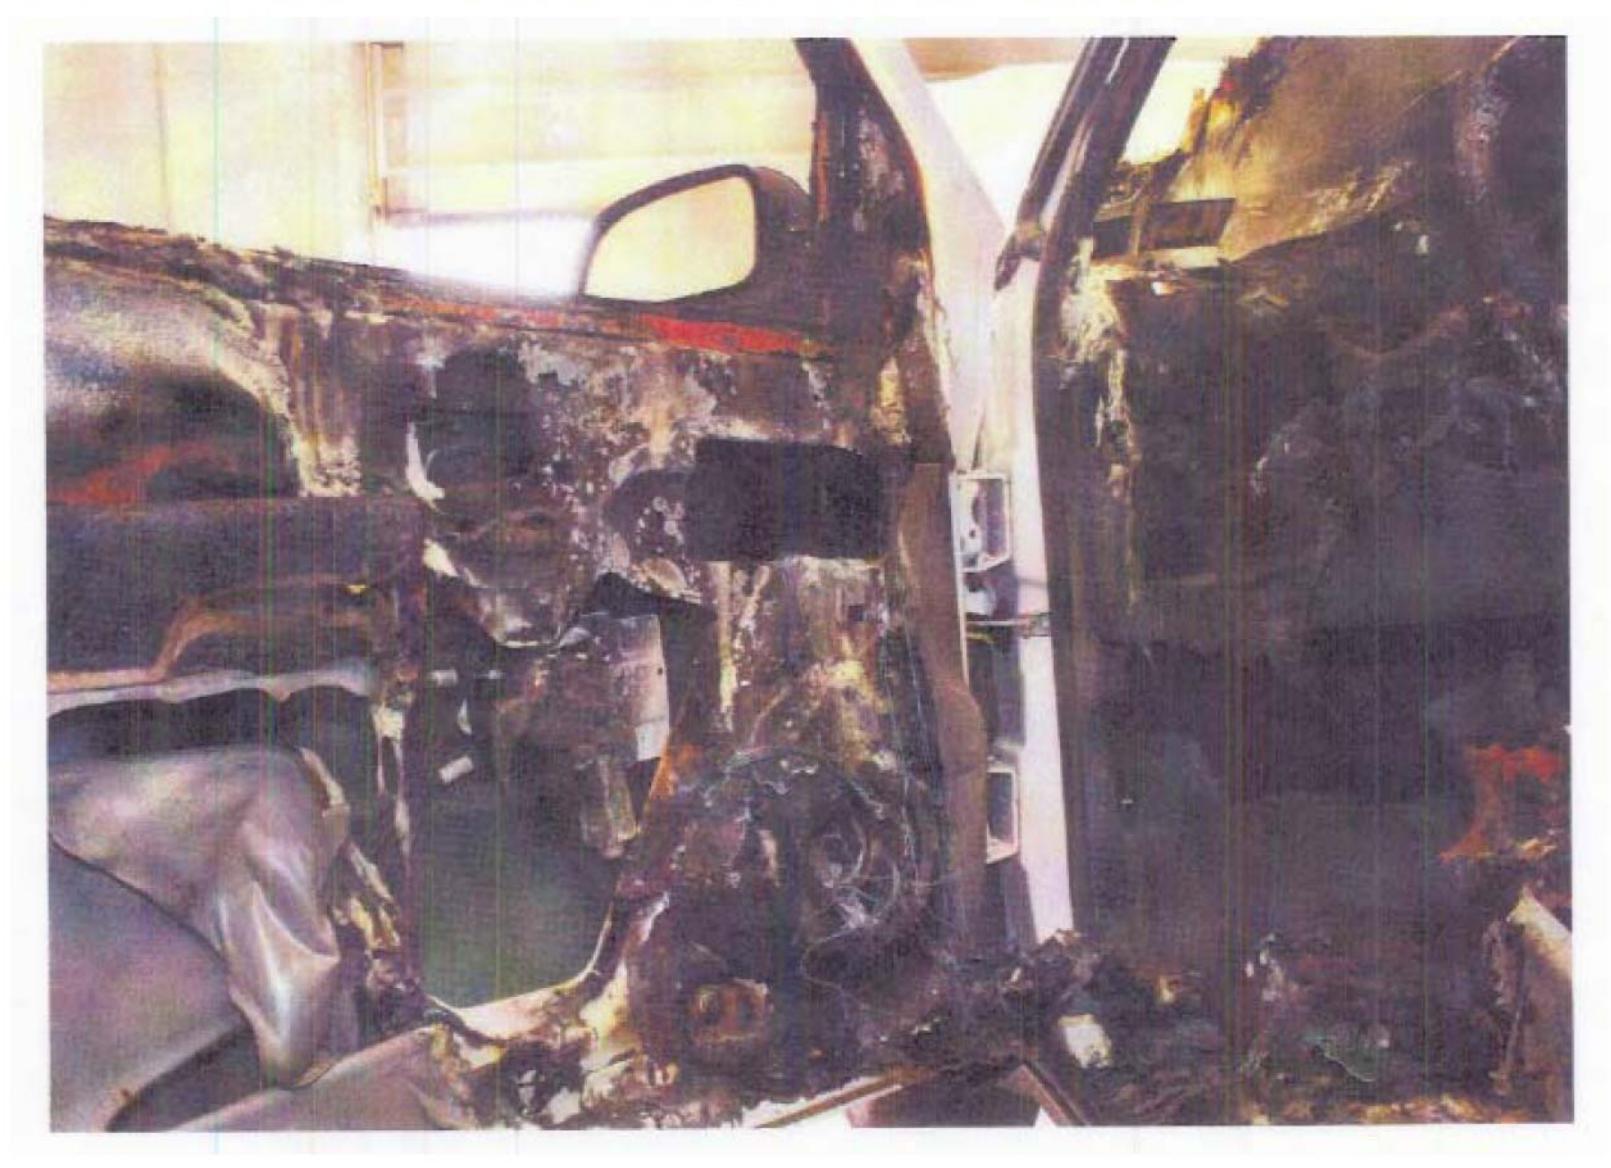
1GNDT13S362 (663106) Incident date: 10-29-2008; Estimated mileage: 50,000 miles; Fire in driver door while the s/v was parked and unattended.

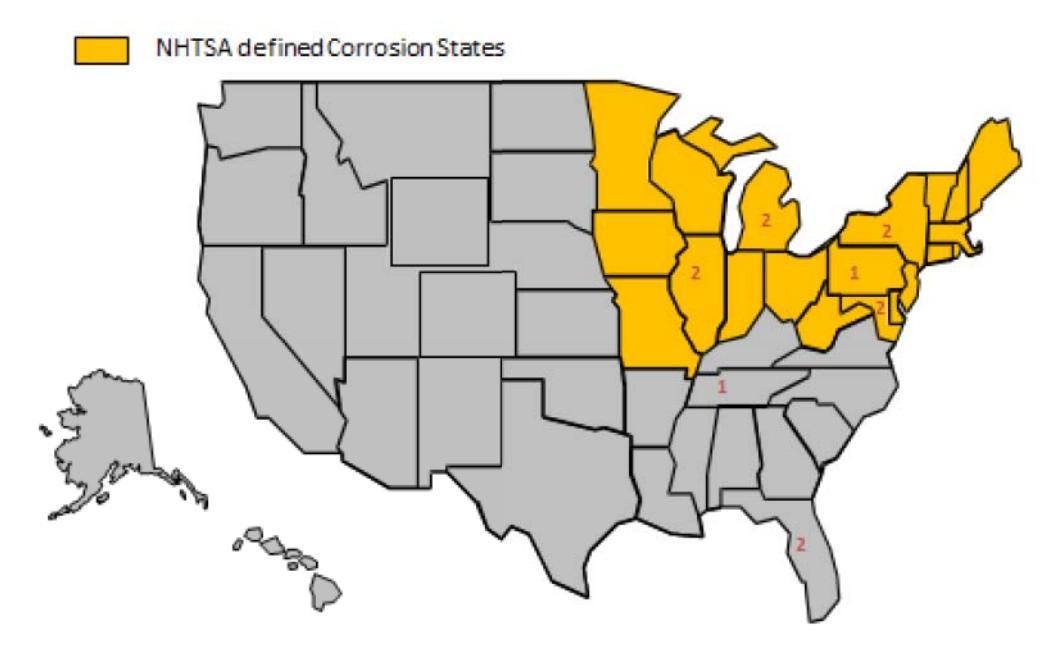
Figure 8 – VOQs from PE12-003 plotted by state (Trailblazer ONLY)

The VOQs show a bias to the NHTSA corrosion states. 9 of the 12 VOQs were in one of the NHTSA defined corrosion states. It is hypothesized that in these states, use of road salt result in accumulation of salt on the exterior of vehicles. When vehicles covered with snow have a window rolled down or door open, some of this snow may drop onto the DDM. The combination of snow and salt may melt and migrate through the window switch openings and wick onto the PCB and begin the corrosion process.

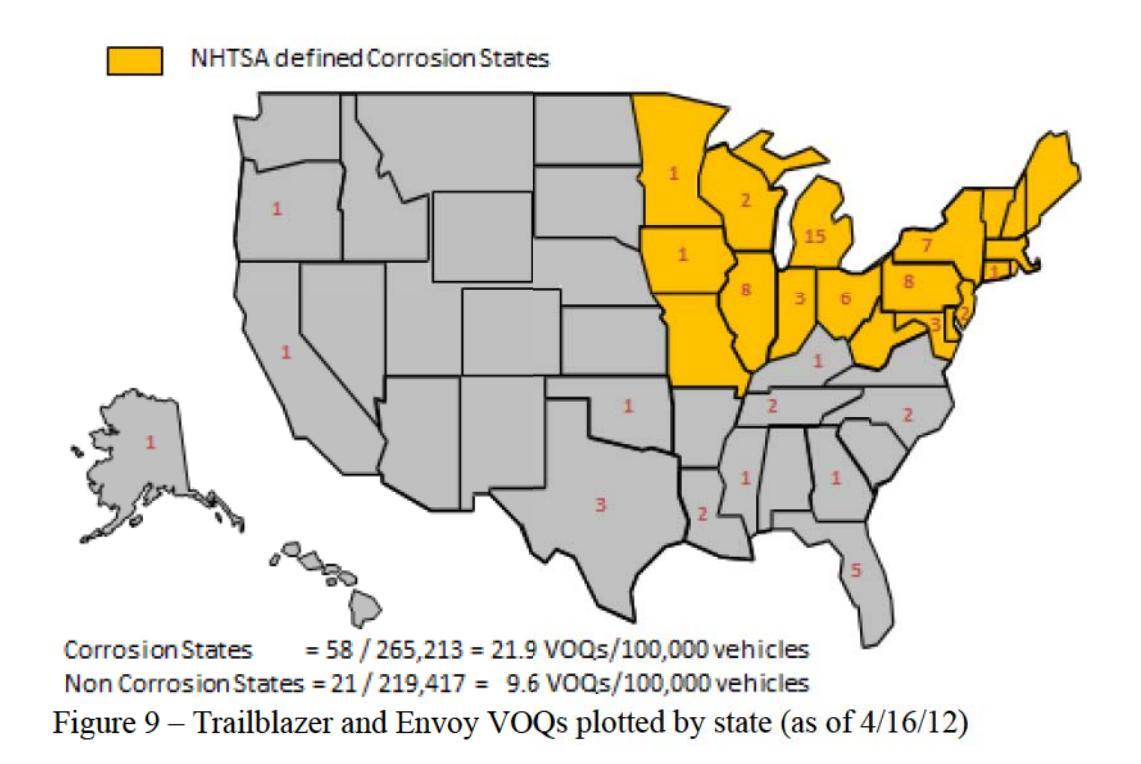
The corrosion state bias still exists. The VOQ rate in corrosion states is more than double the rate in non-corrosion states. While the NHTSA opening resume for PE12-003 listed complaints of melting, smoke and fire, after the investigation was listed in the media, there have been 16 function only VOQs.

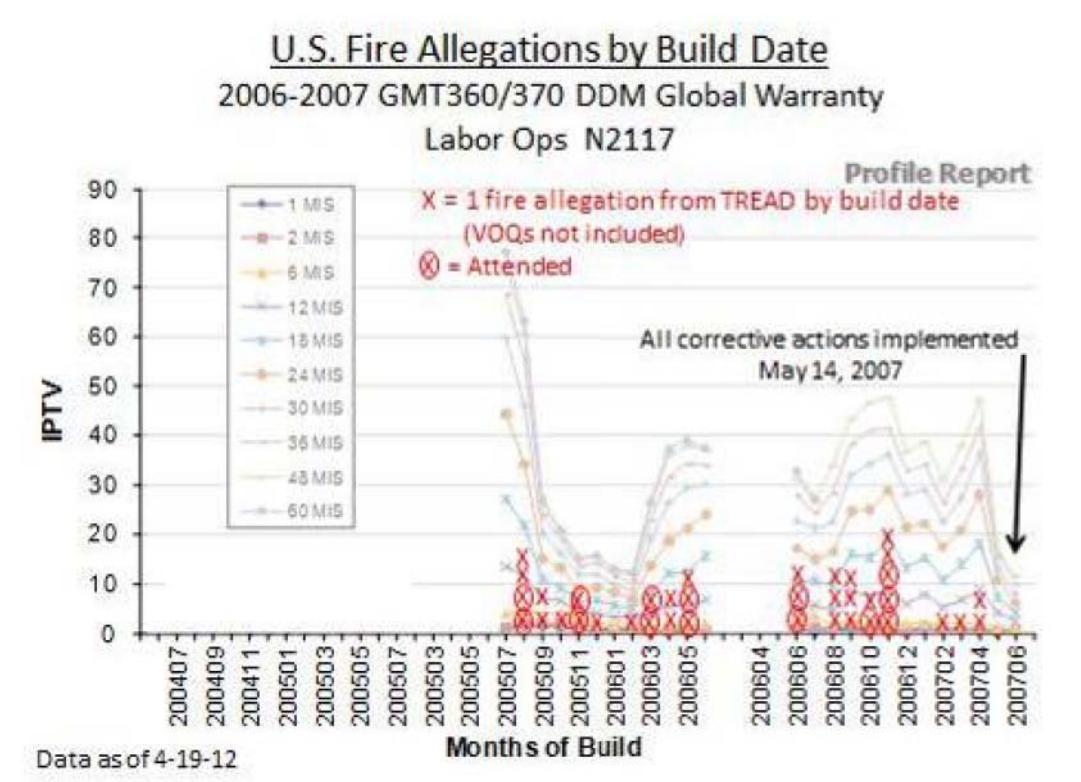
For data pulled through April 19, 2012, plots of the TREAD incidents by vehicle build date are shown in Figure 10. The same incidents were also plotted by state in Figure 11 where the DDM warranty rate by state is also shown. Of the 37 allegations of fires found in TREAD, only 5 are reported outside of the Corrosion States. In researching the history of those 5 vehicles, 3 were found to have been originally sold in New York or Michigan which are corrosion states.

Figure 10 - Reports of fires by vehicle build date. A circle around the X indicates the incident was attended. There are no known fires after the DDM PCB change 5/14/07.

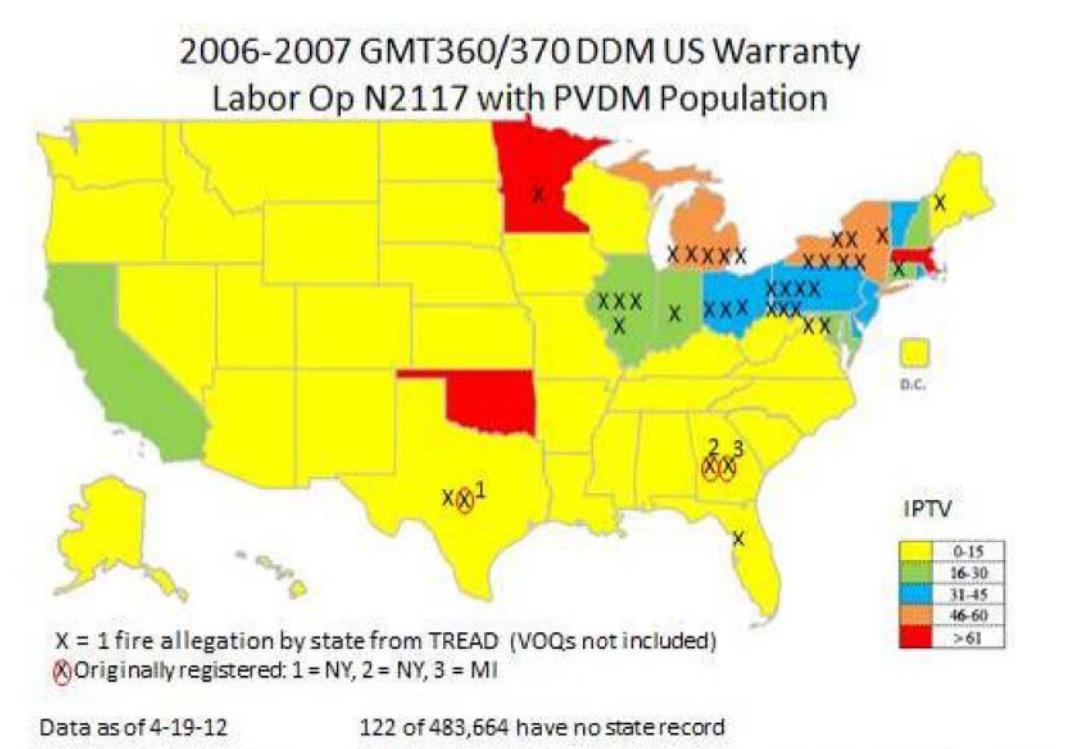
Figure 11 TREAD reports of fires by state on a plot of warranty IPTV for DDM replacement by state.

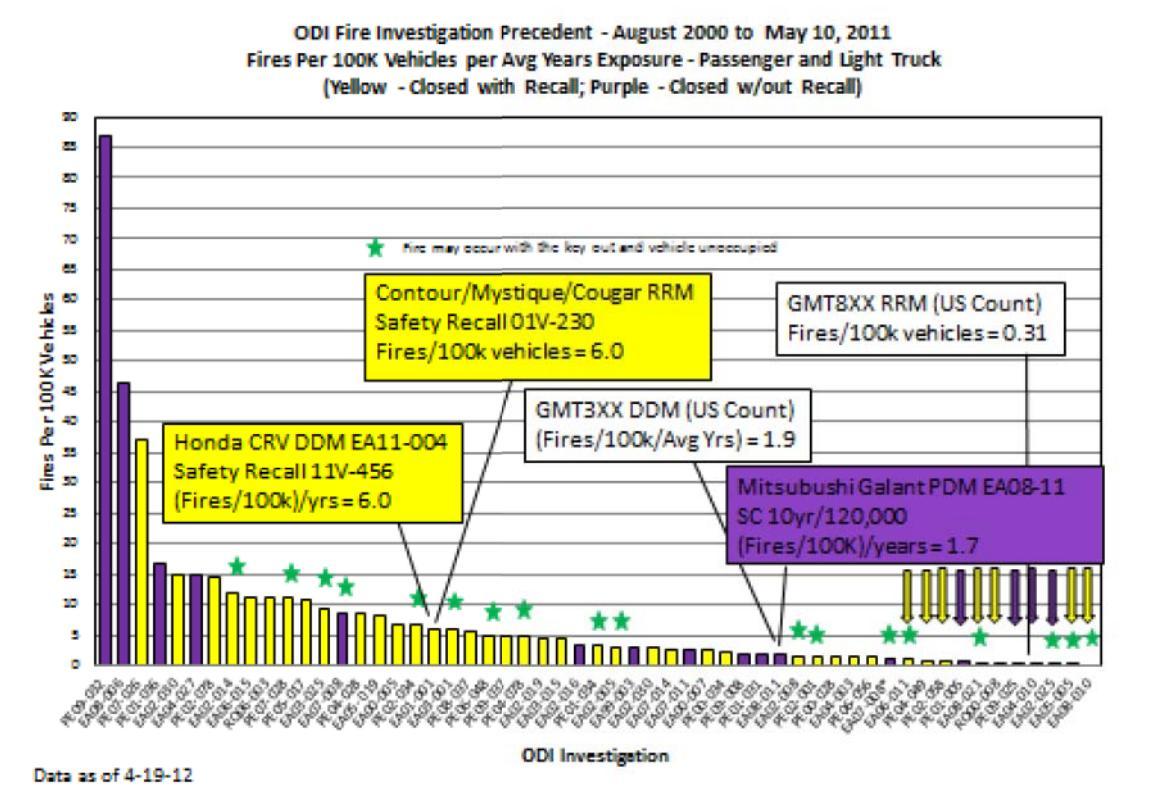
Figure 11 – Historian comparison, GMT3XX comparison to other NHTSA investigations.

The Honda CRV had a safety recall on an incident rate of 6.0 fires/100K/avg yrs exposed. The Mitsubishi Galant had the NHTSA investigation EA08-11 closed without action, but Mitsubishi agreed to provide 10 yr /120,000 mile special coverage for those vehicles. When that investigation was closed, the rate was 1.6 fires/100K/avg yrs exposed.
