PE12-008

NAVISTOR TRUCK GROUP

Request 2 & 3

MC Unit 5218

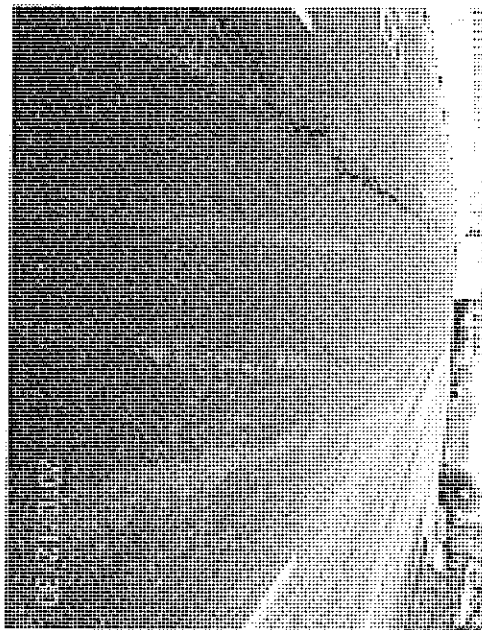
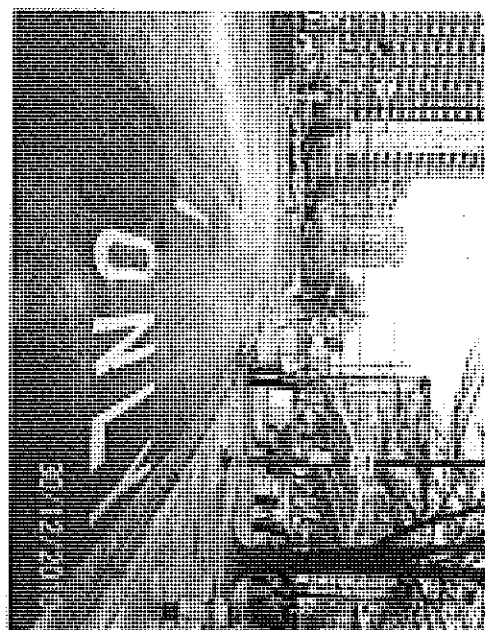
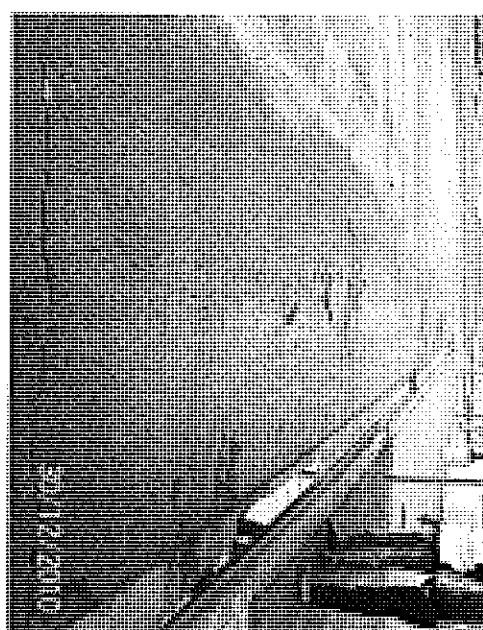
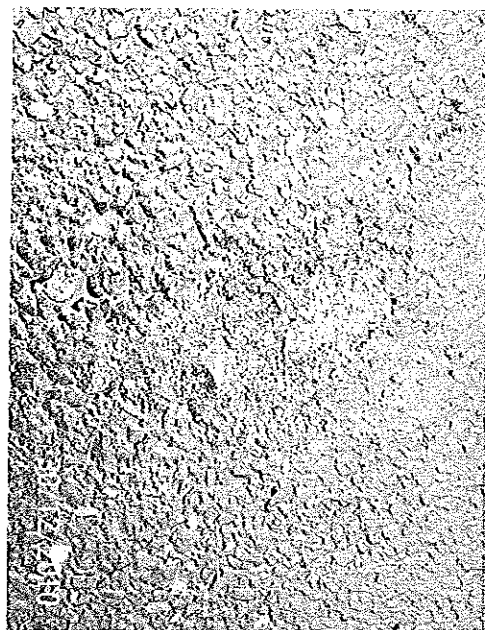
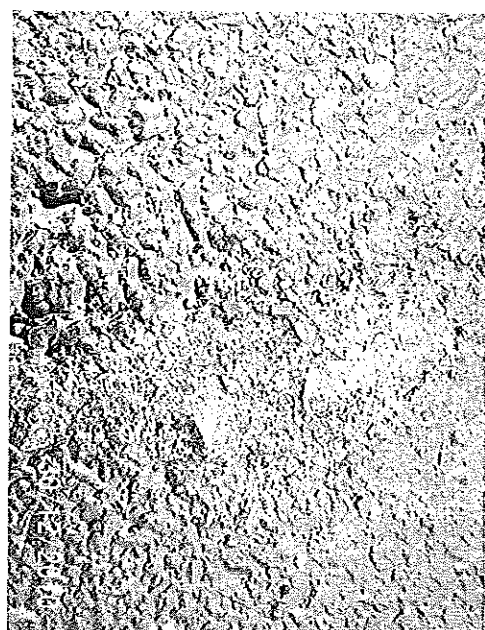
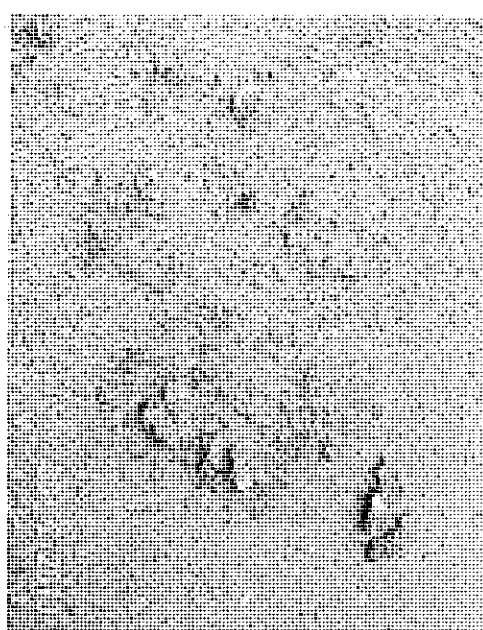
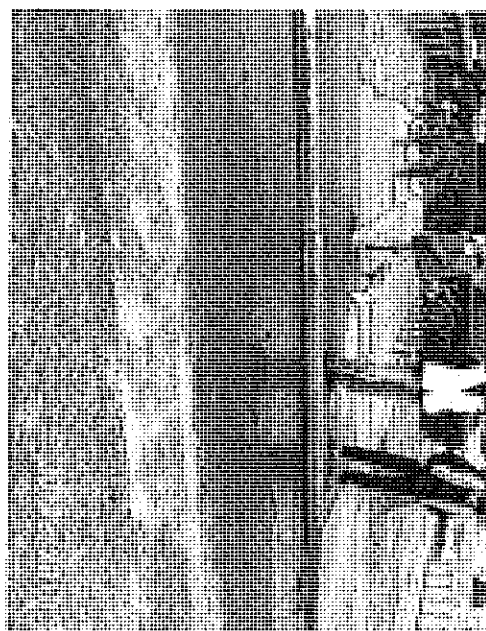
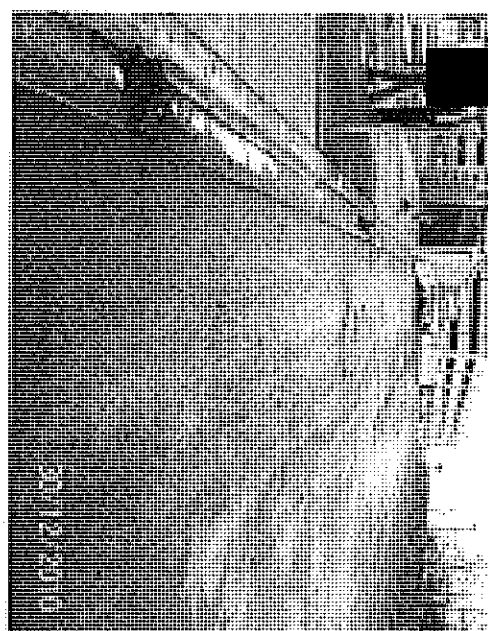
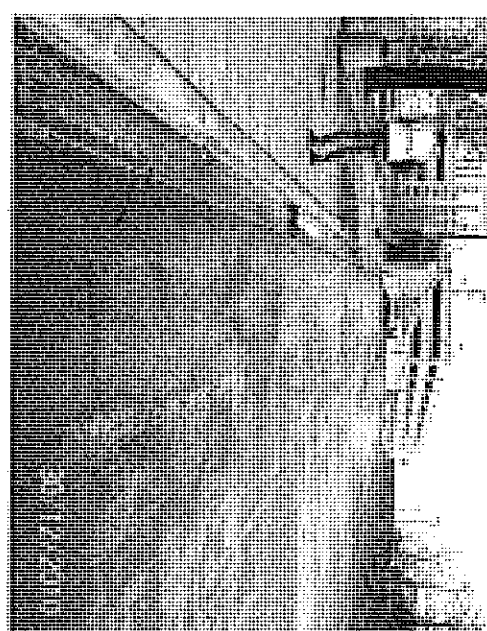
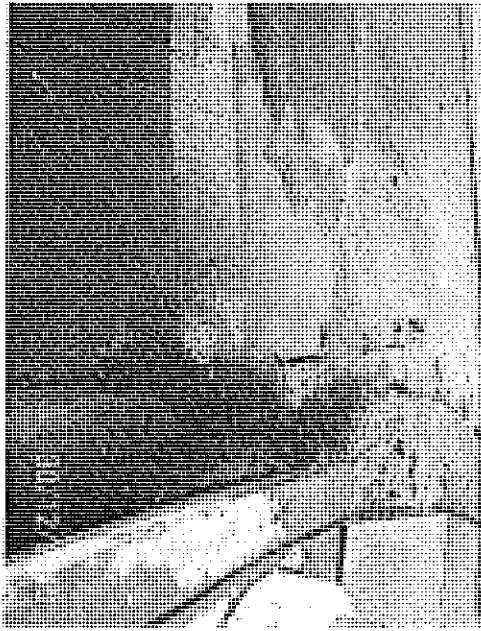
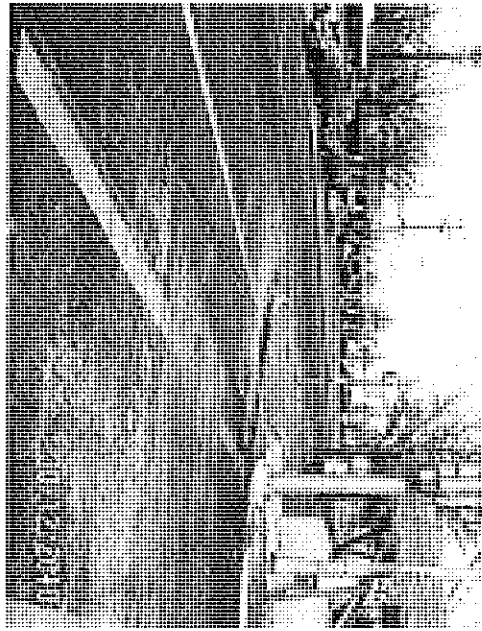
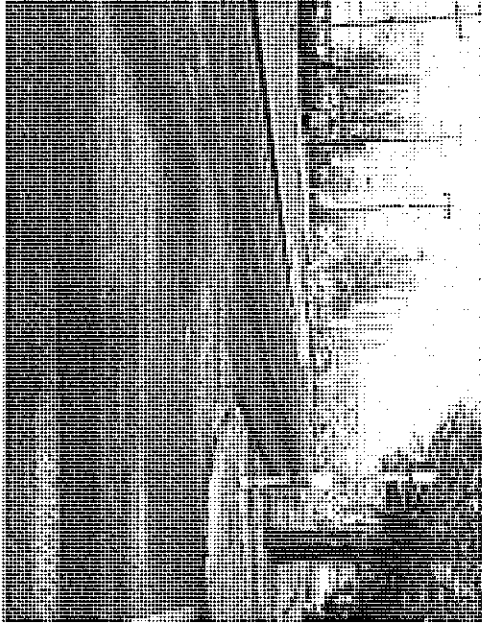
Fire pictures 2

MC Unit 5218

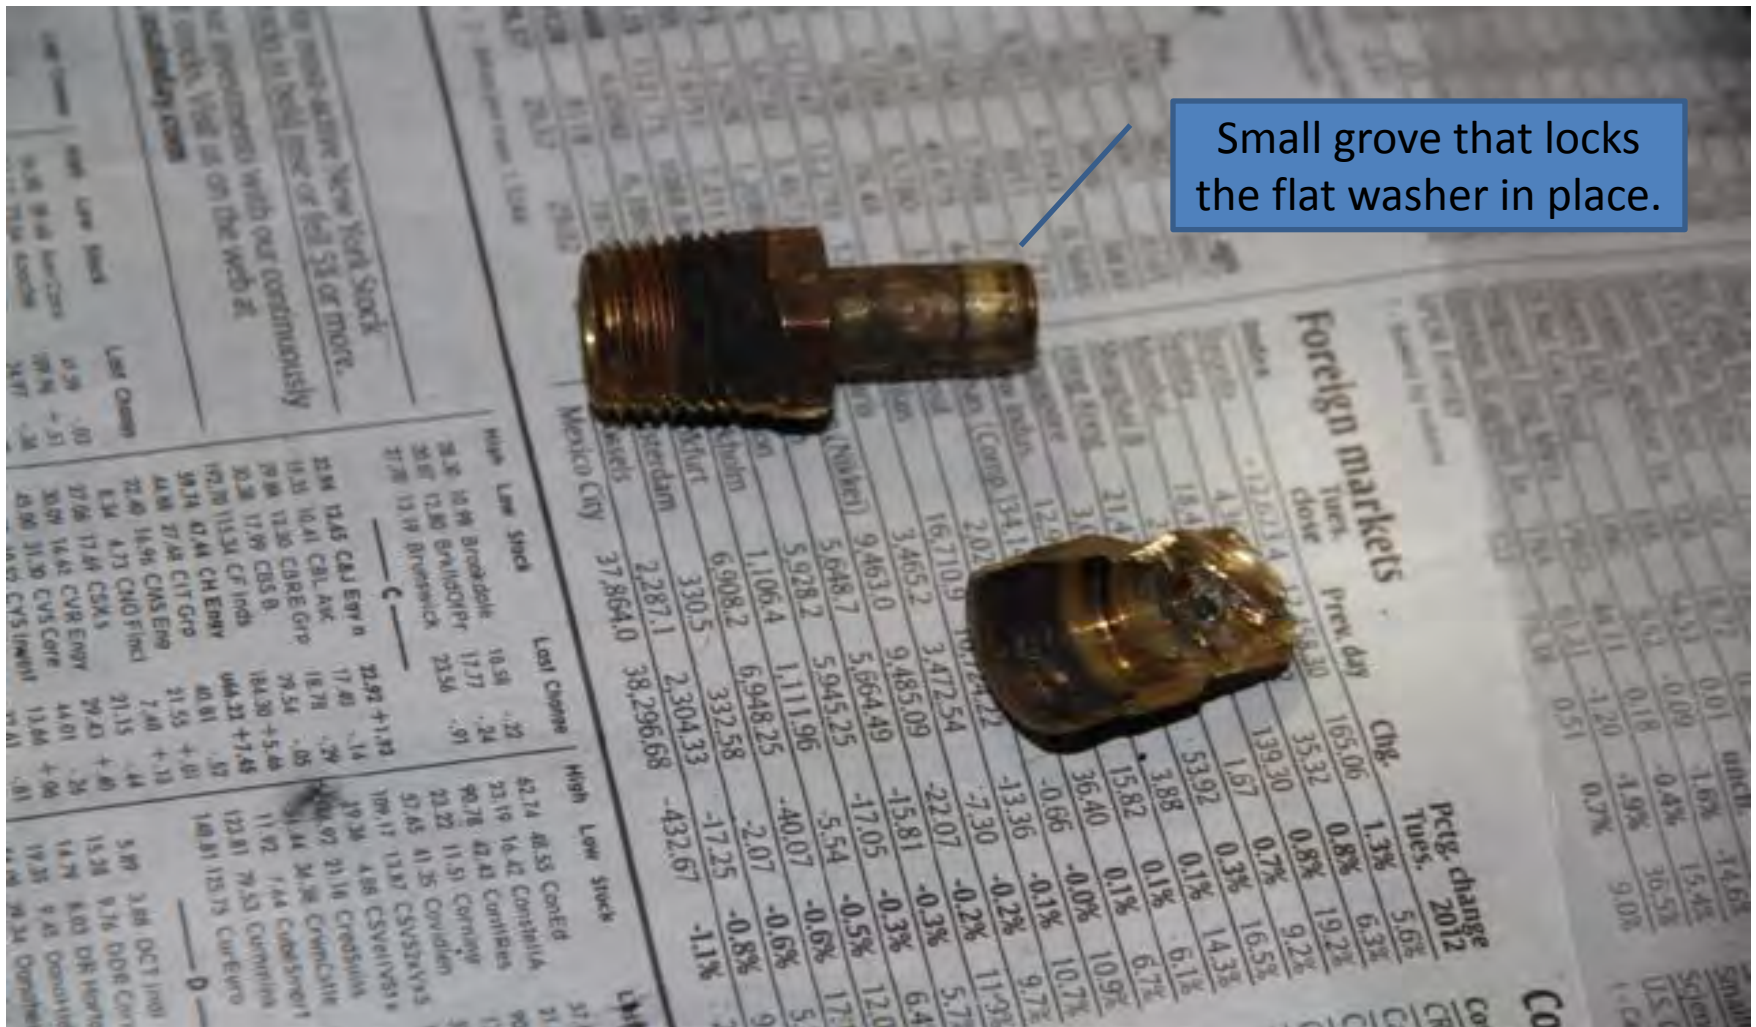
# Cut away view of the swivel fitting

If you look at the end of the nipple you see a small groove. This is where the flat snap washer locks into.
