PE12-012

2011 NA Cruze Washington DC Issue

Fire Origin and Cause Analysis

DC Clutch System Analysis

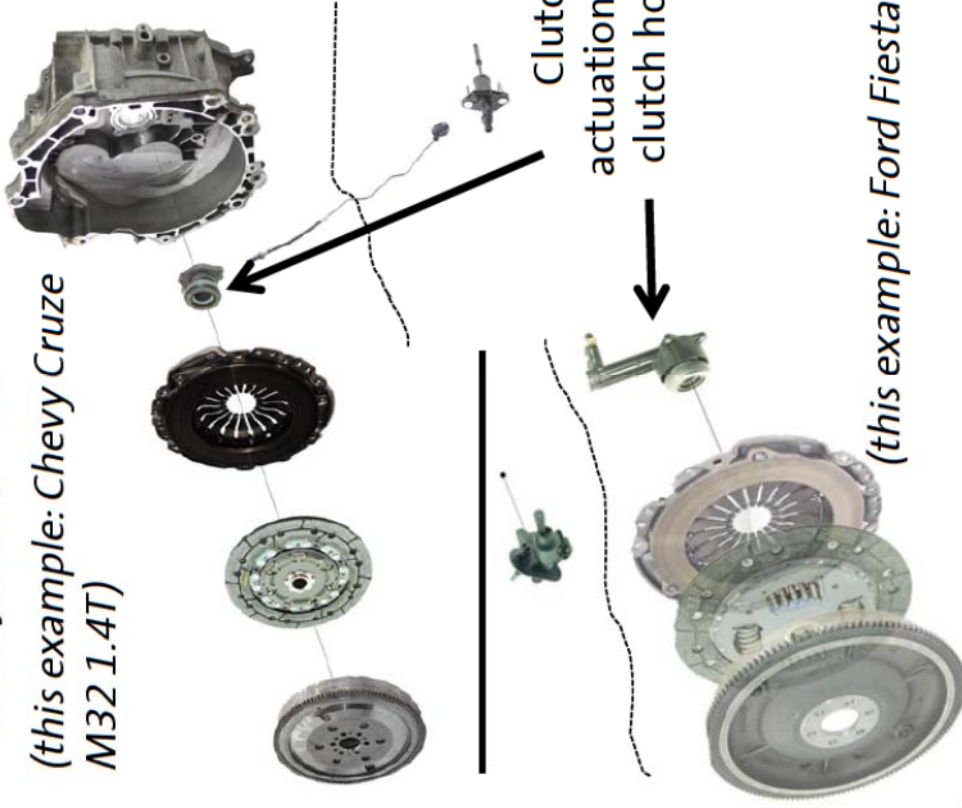
(this example: Chevy Cruze M32 1.4T)

Slave Cylinder) = **internal clutch actuation**

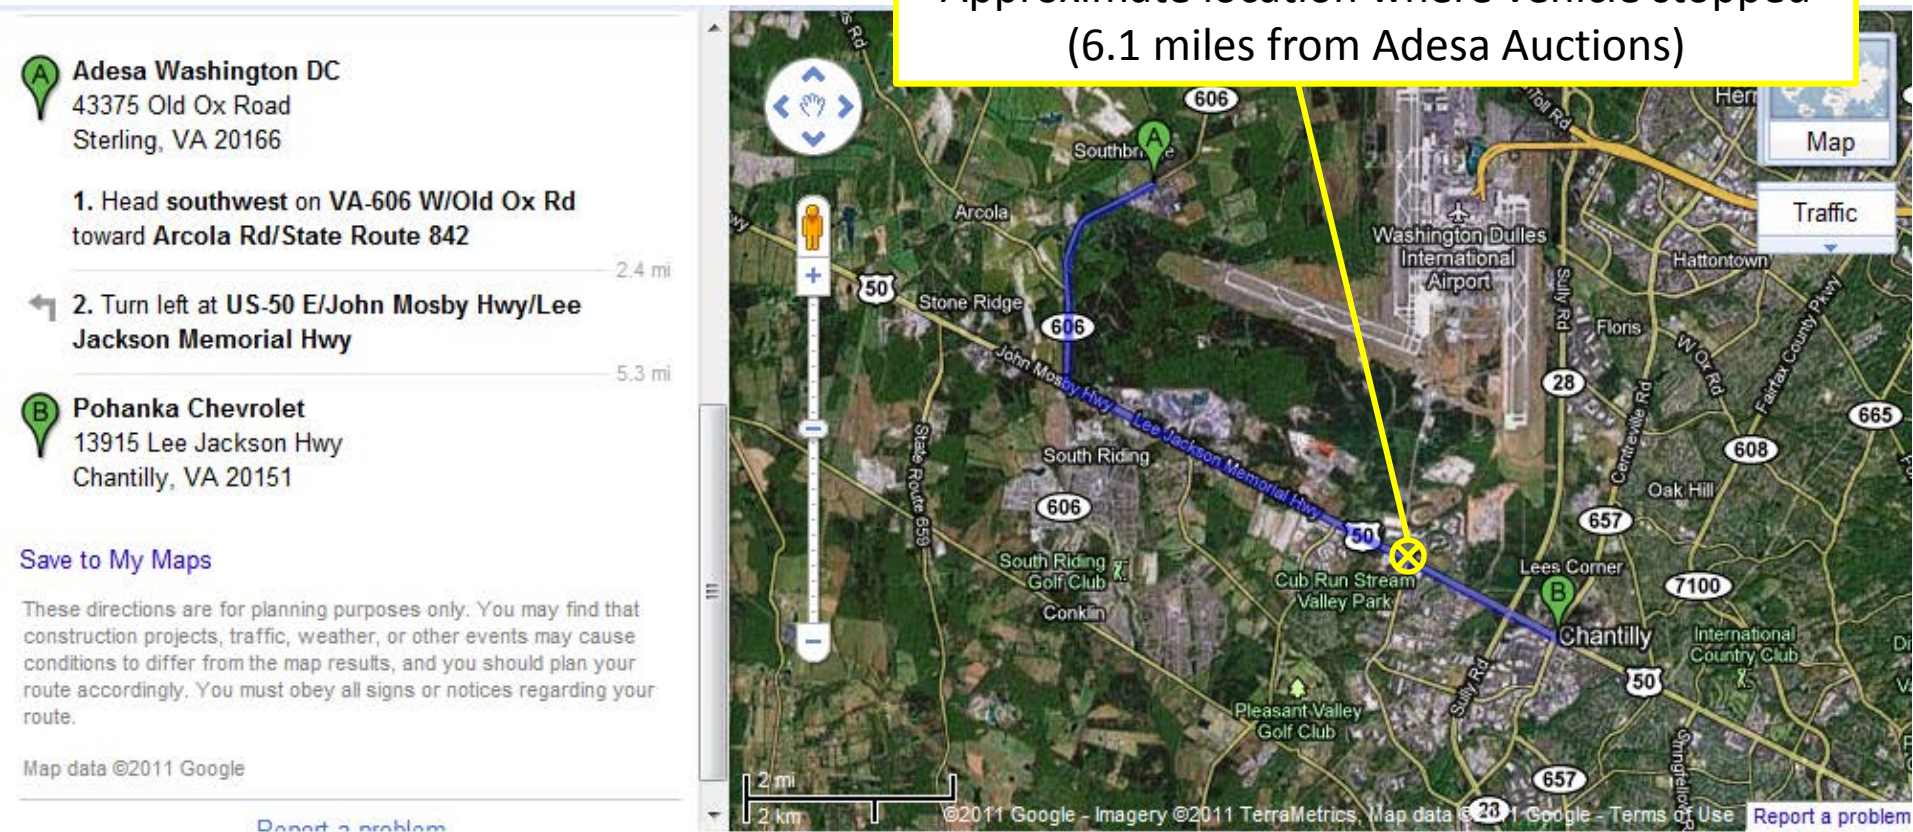
Approximate location where vehicle stopped
(6.1 miles from Adesa Auctions)

Adesa, Washington DC to Pohanka Chevrolet, Chantilly, VA 7.7 miles

Per Adesa personnel roads generally flat

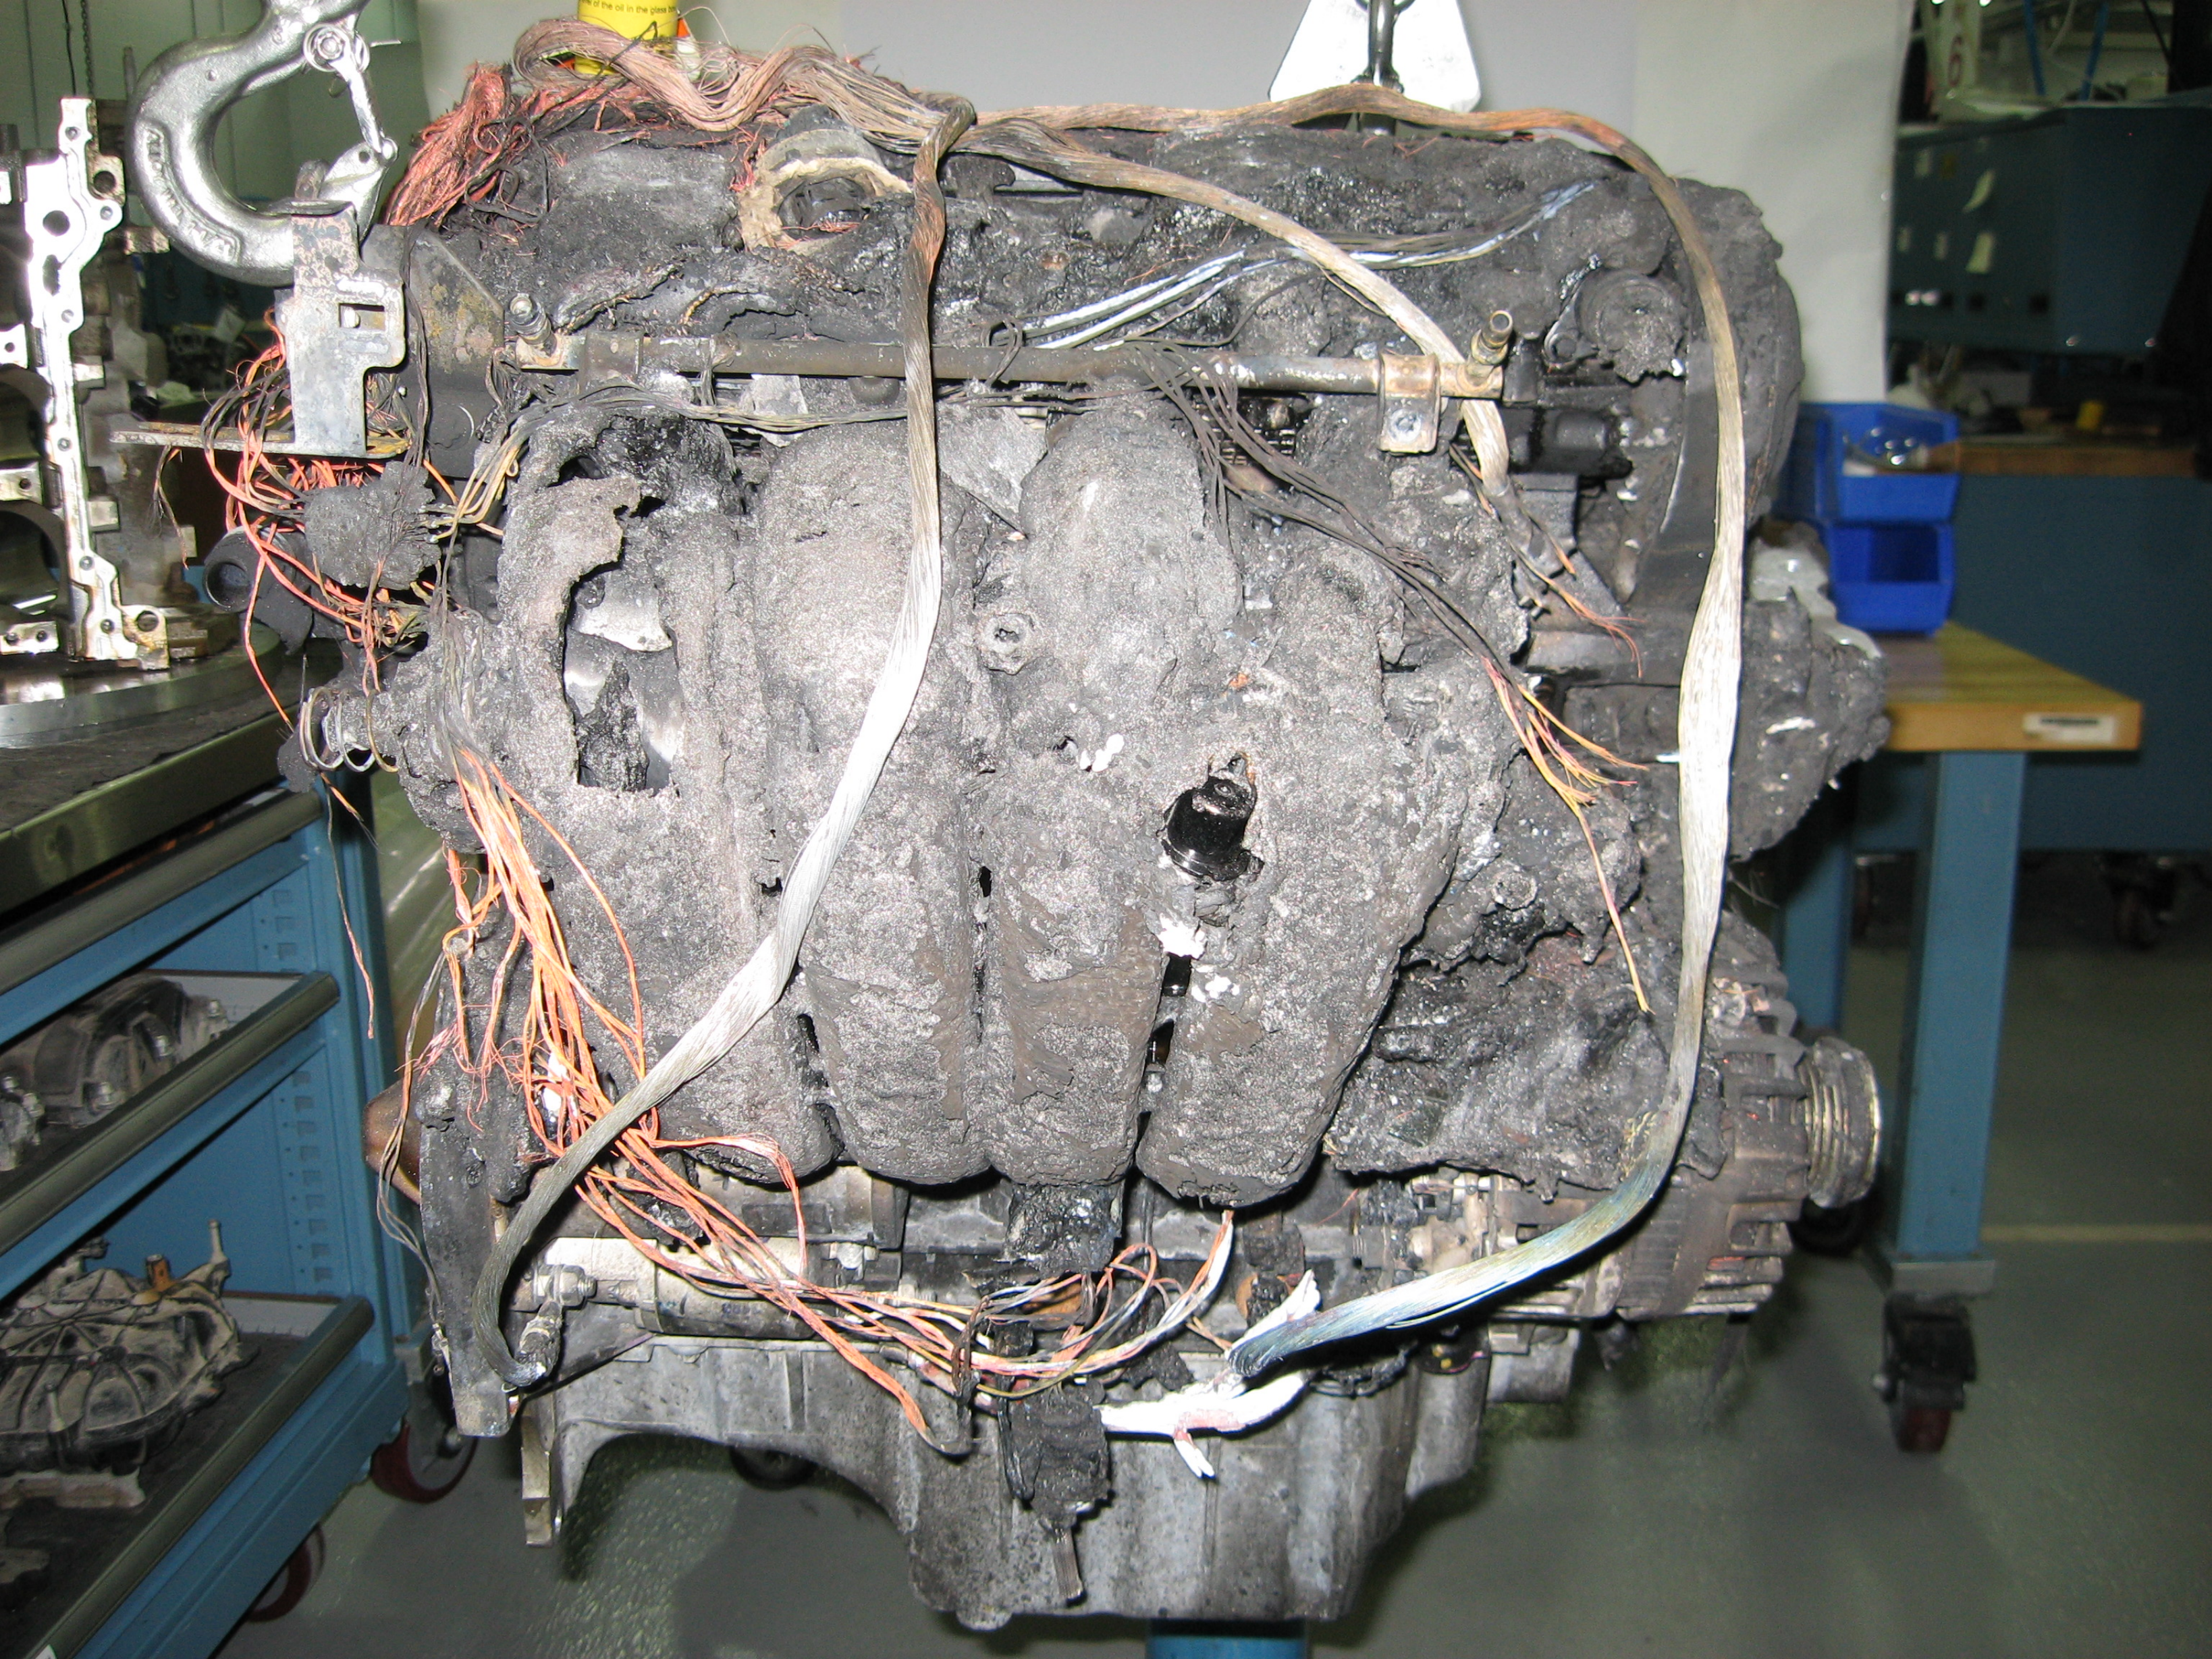
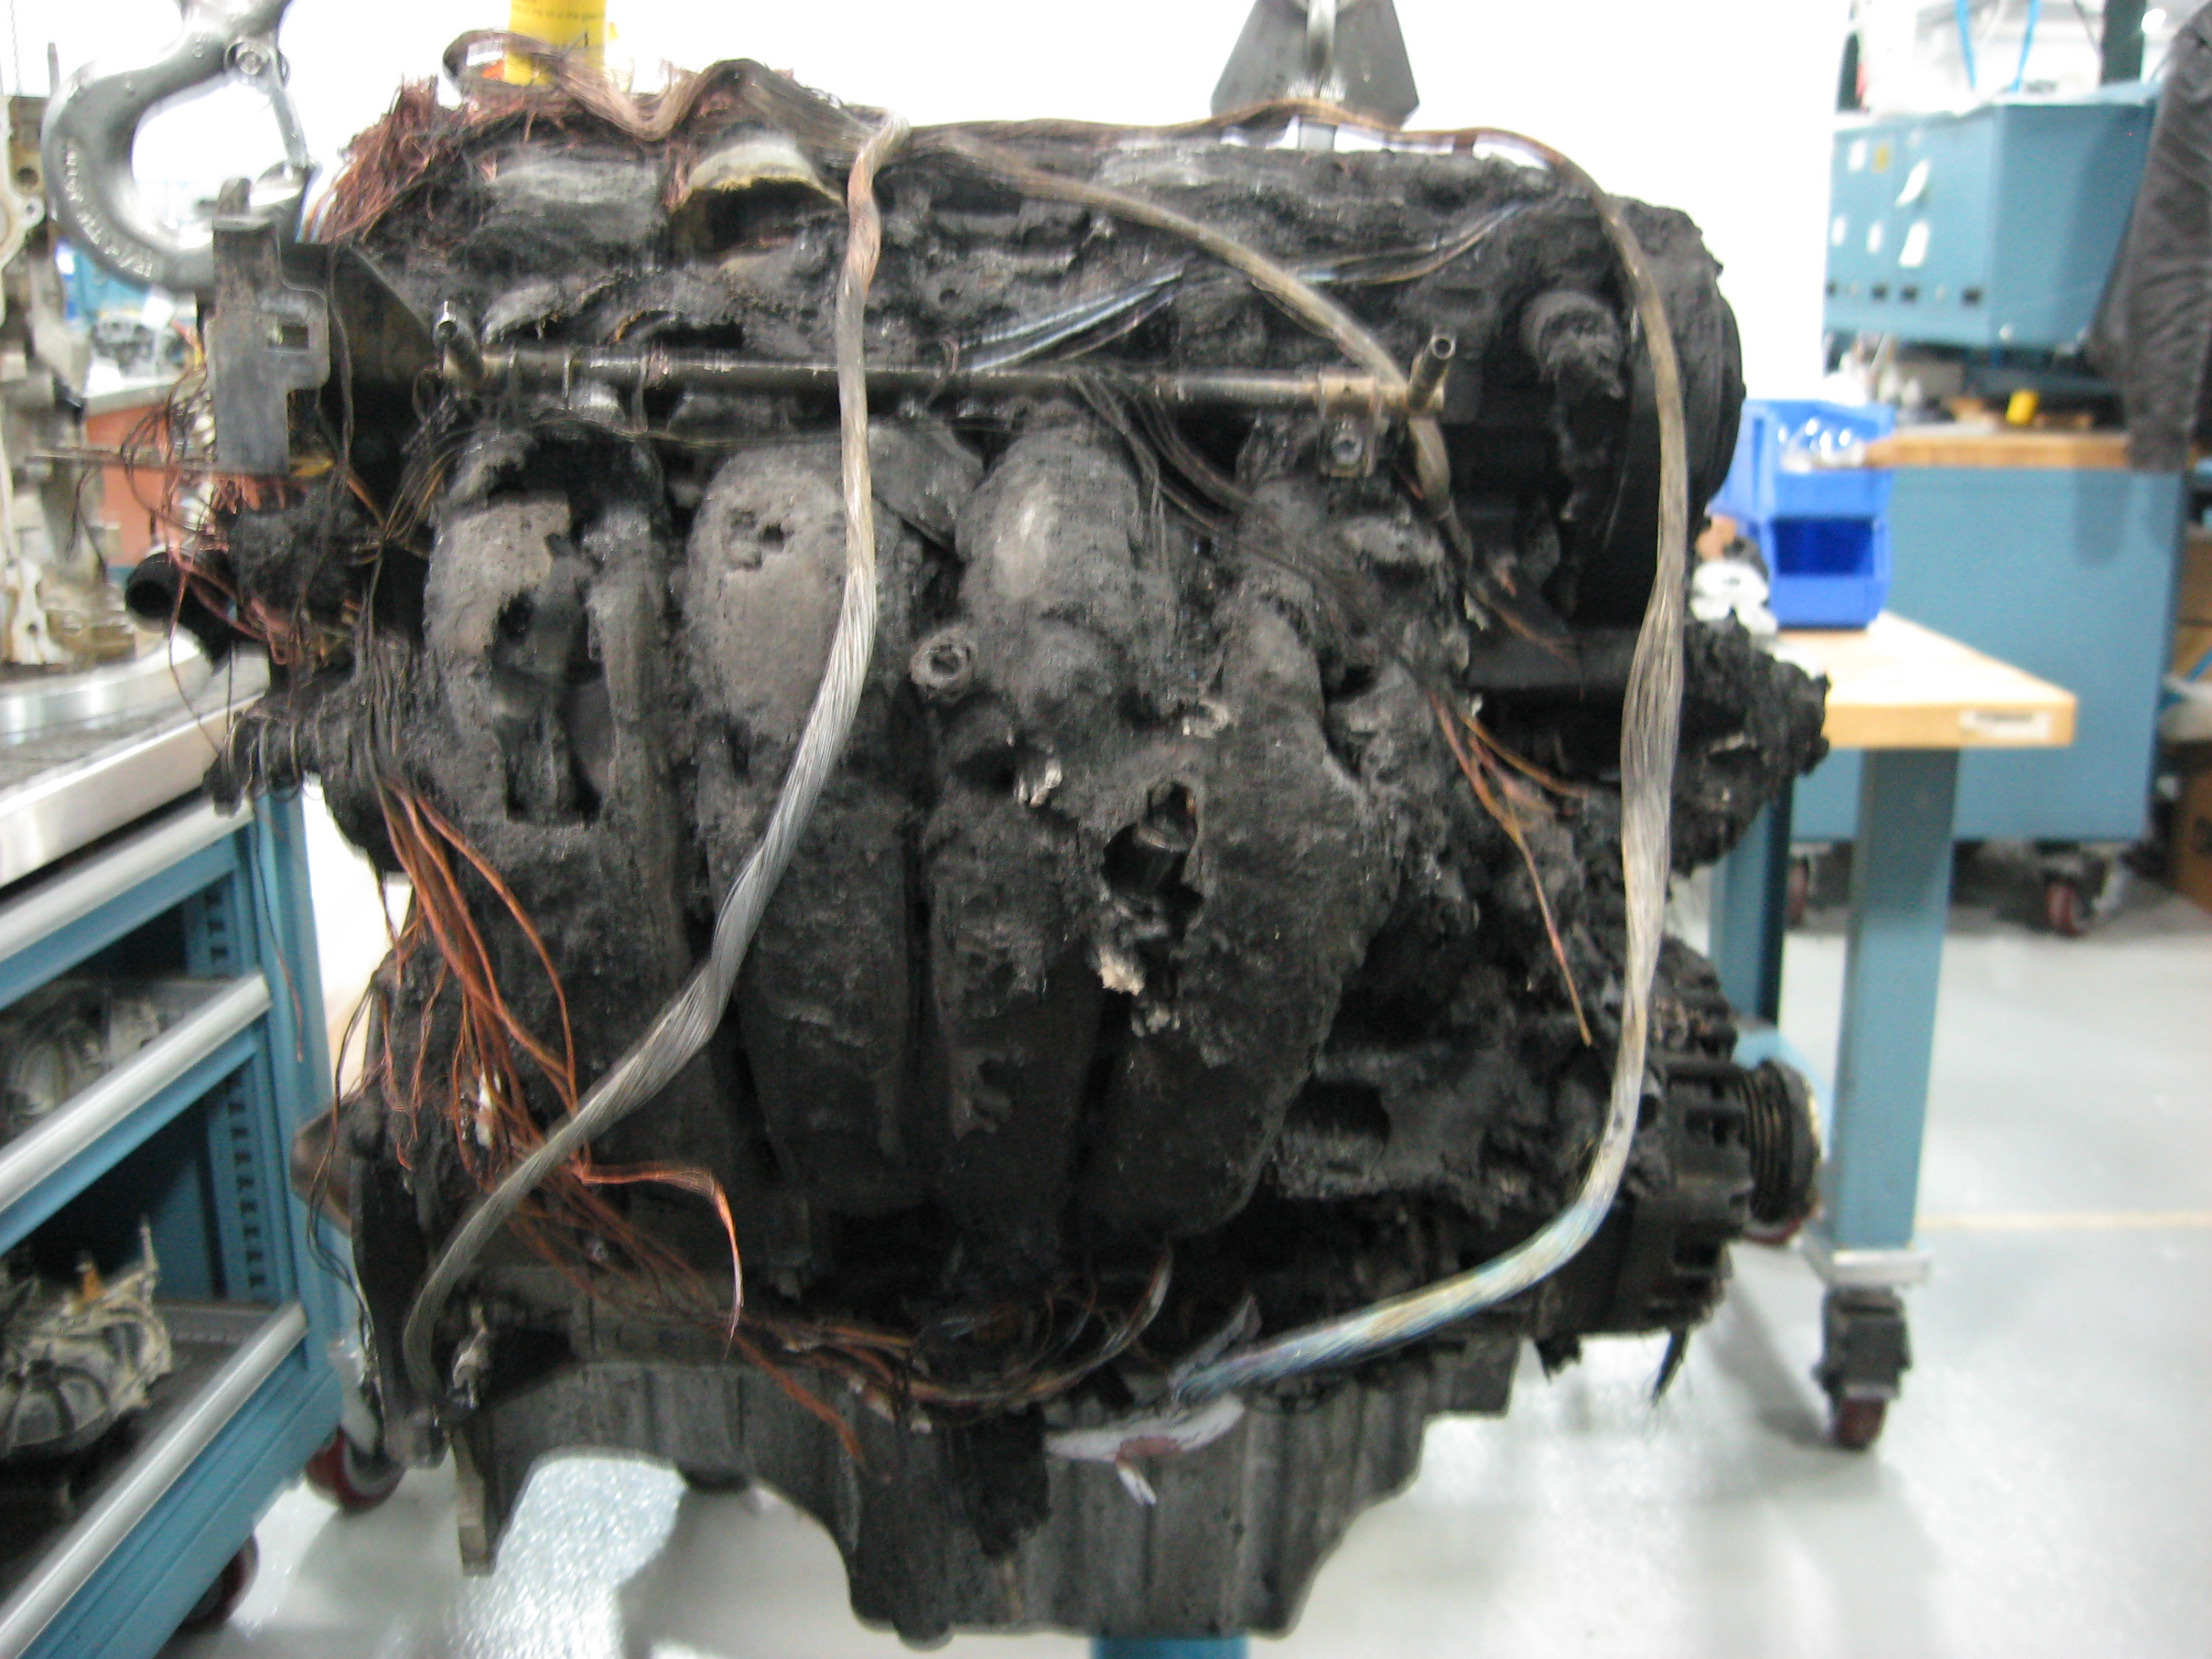
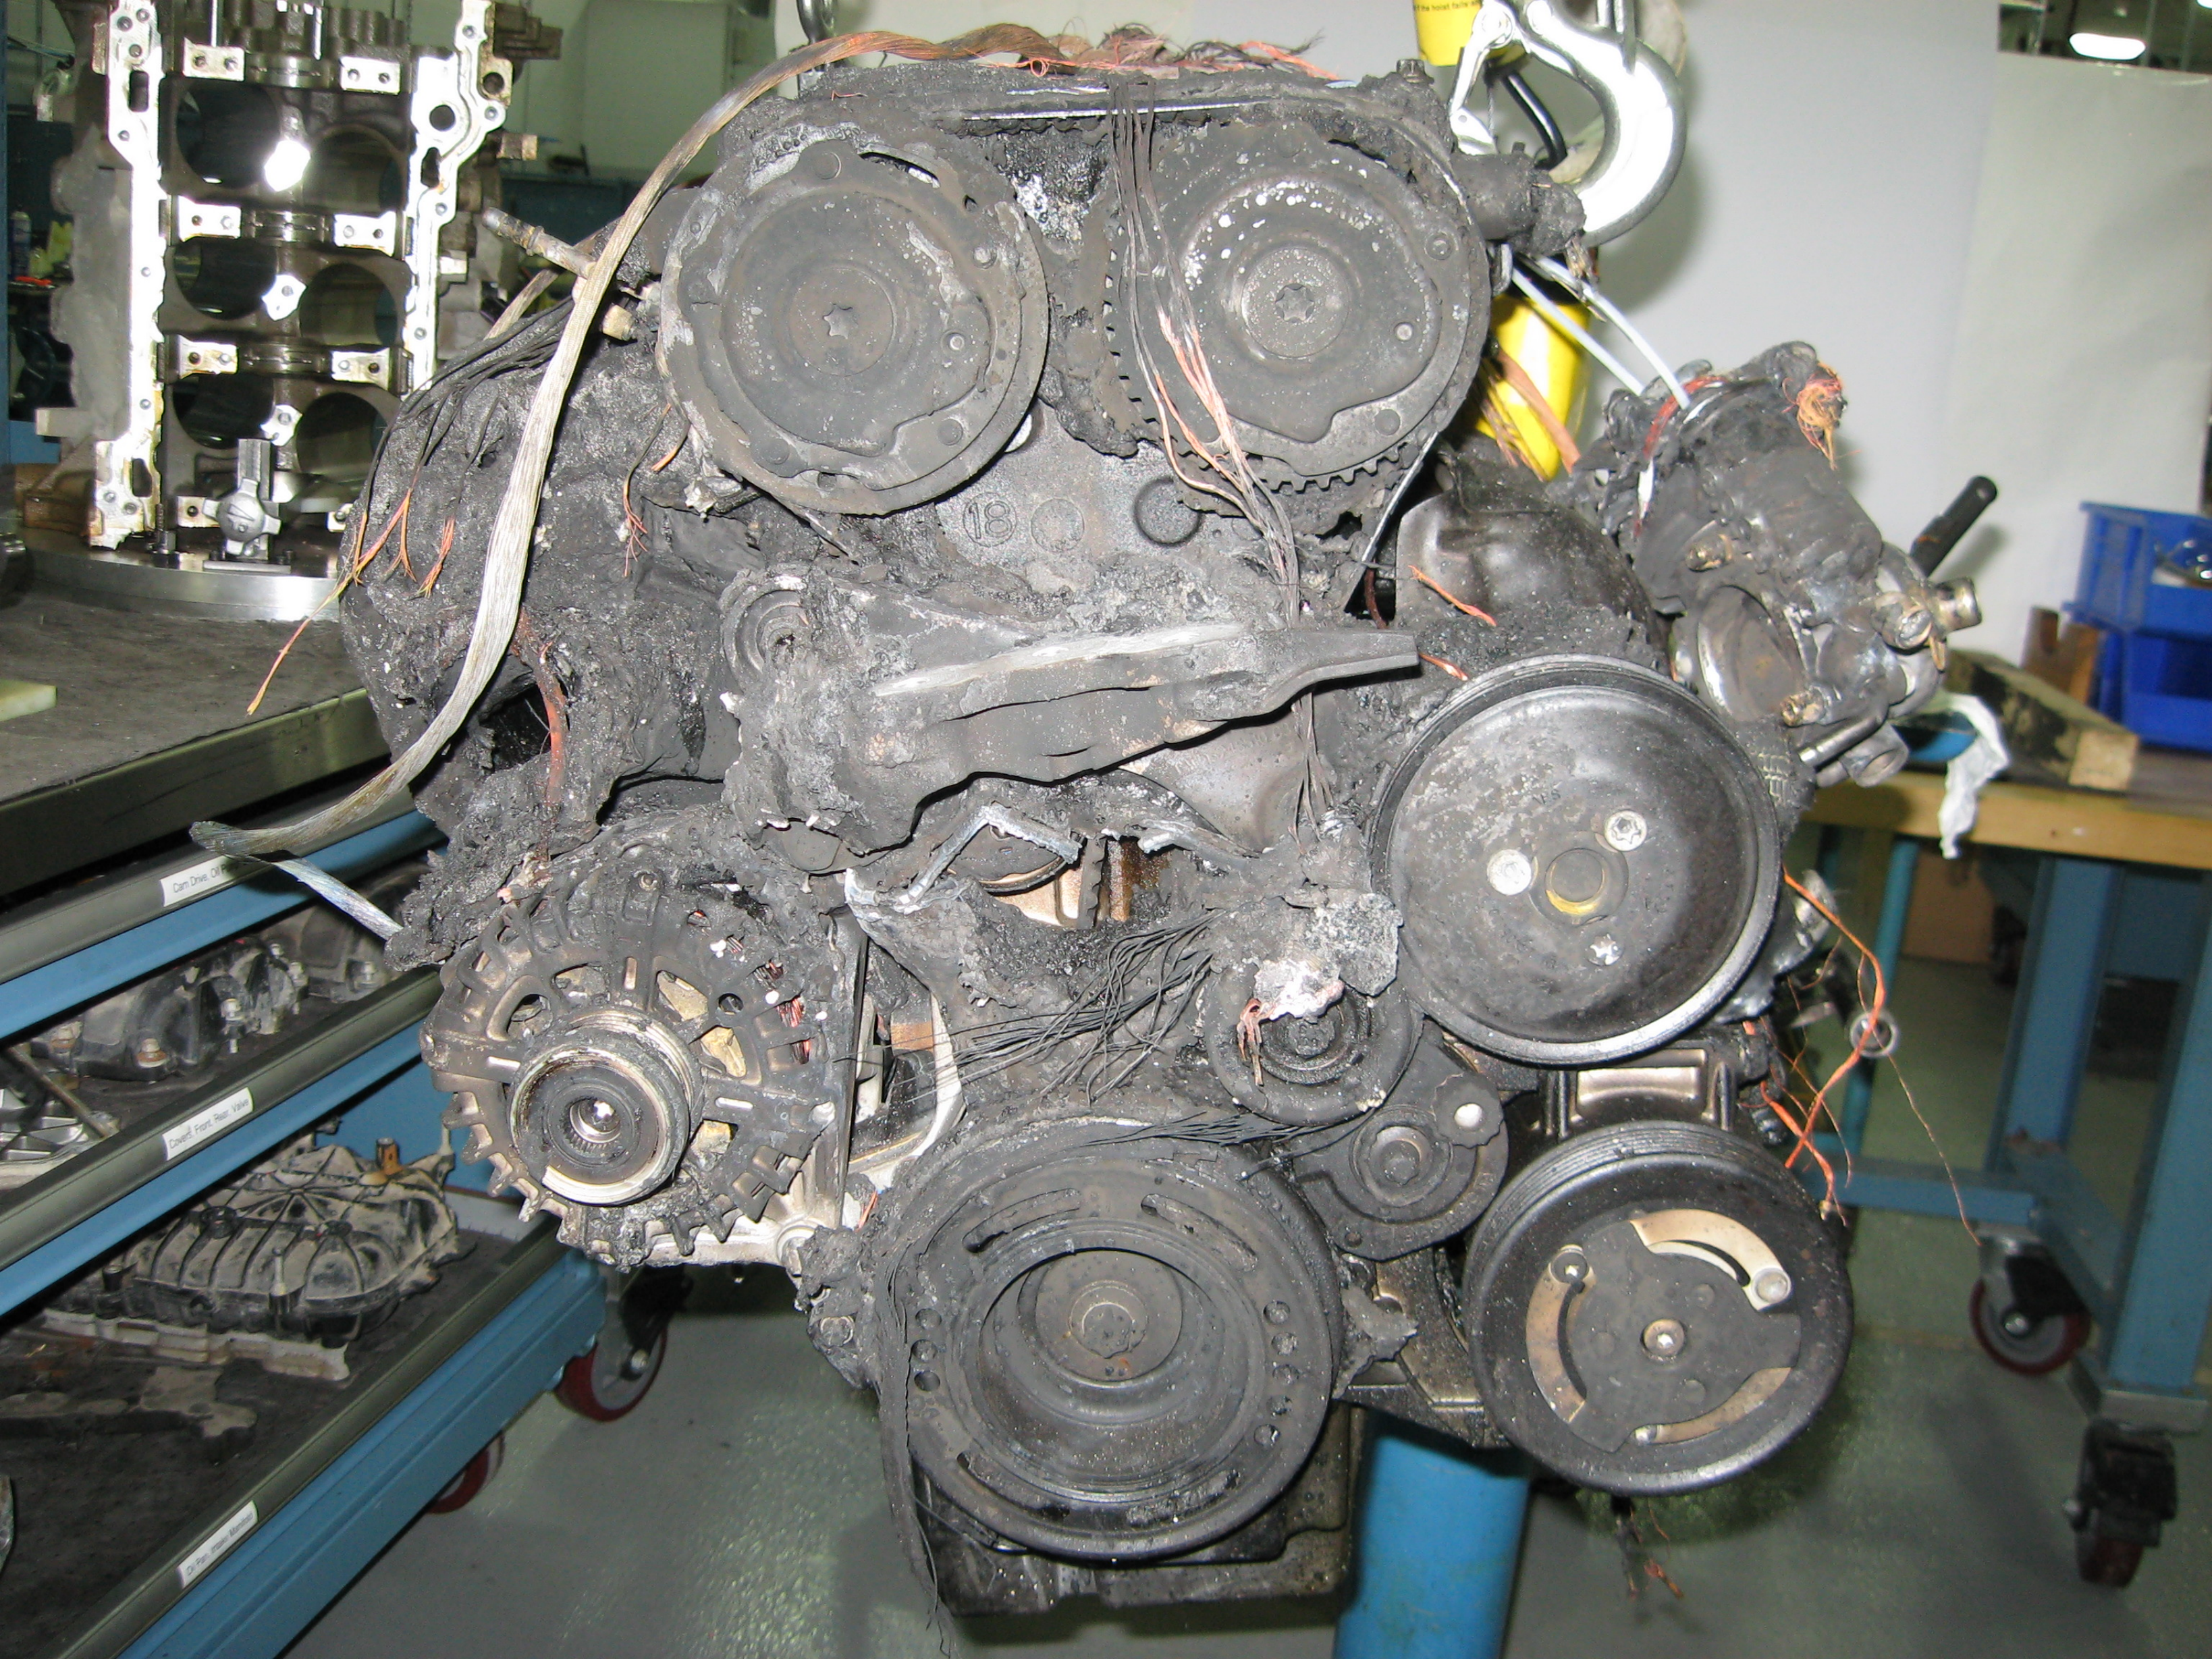
Cam Drive Oil

Oil Pan (from Engine)
