## Claim Detail Report

Vehicle Line: T/UB-EXPLORER [11-12]

**DEFECT DEFINITION for Y (Objective Metric):**  
Within the TRW EPAS electronics, there is a motor relay and a link relay. Failure of the motor relay primarily results in the TRW code B3A and failure of the link relay primarily results in the code B43.

**PROBLEM STATEMENT, SCOPE, AND GOAL**  
Find root causes of relay failures and implement corrective actions to eliminate this issue.  has highest repair rate at 0.35 R/1000 and problem will be scoped to it.

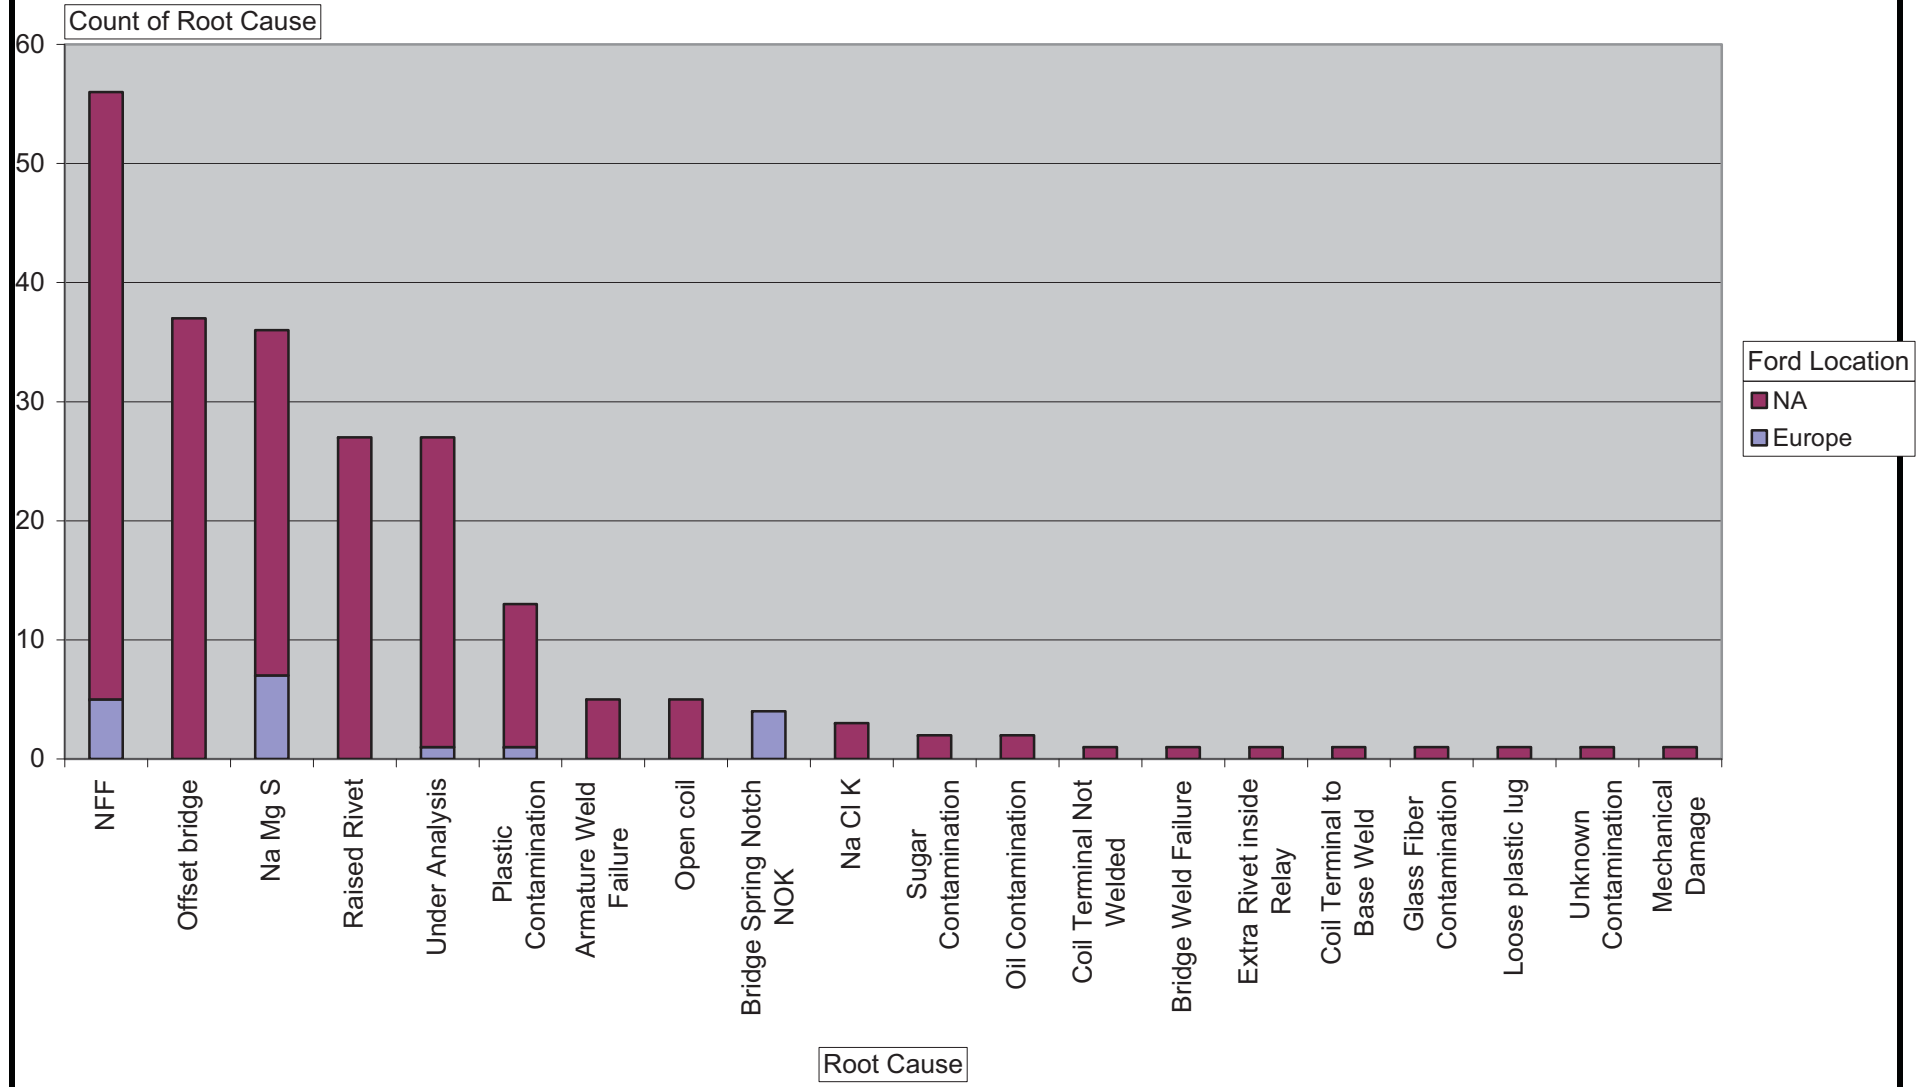
## Root Causes

- Sugar contamination 2
- Mechanical damage 3
- Extra rivet inside relay 1
- Coil terminal not welded 1
- Plastic contamination 1
- Unknown contamination 1
- Scratches on contact 2
- CuS 4
- Initial report NFF 4

Multiple root causes so focus on largest failure mode which is currently CuS contamination.

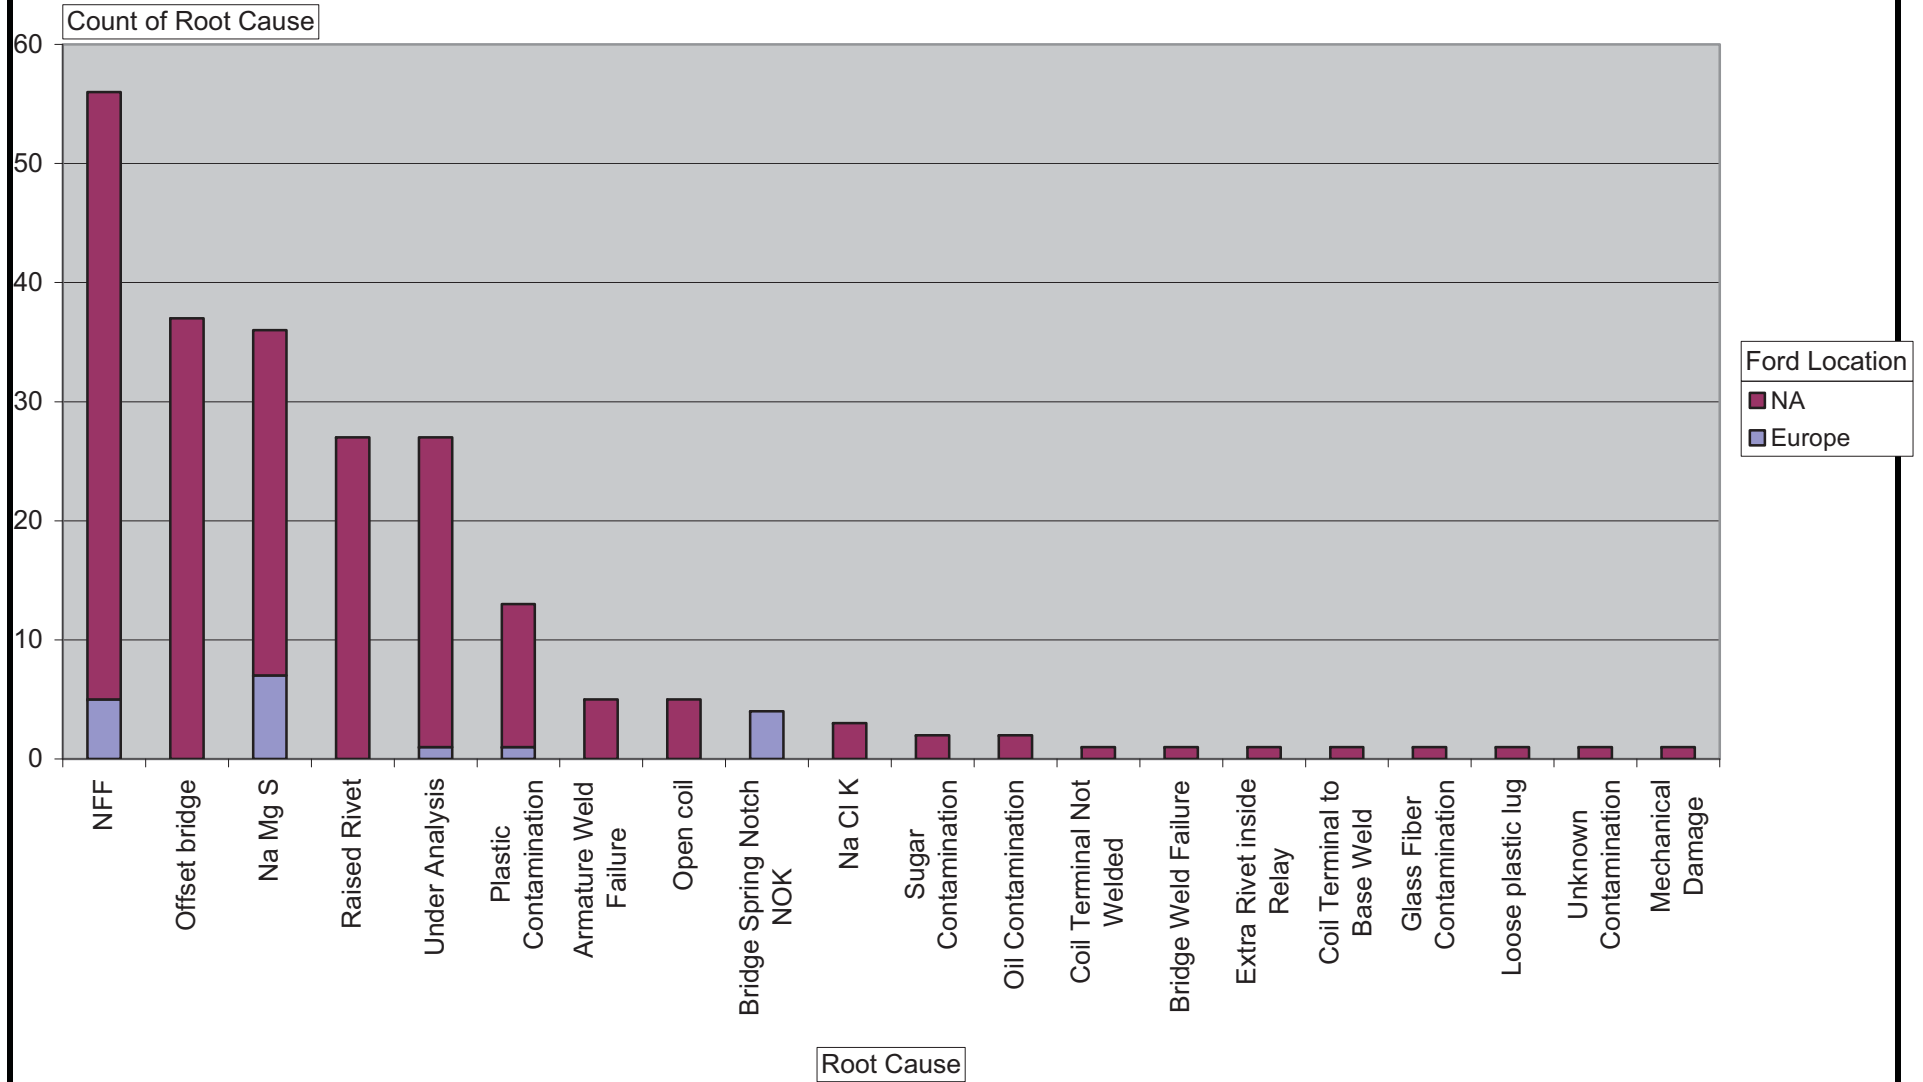
## Root Causes

- Cu S 45
- Mechanical damage 8
- Melted plastic 6
- Plastic contamination 4
- Scratches on Contact 2
- Unknown contamination 2
- Na Cl K 2
- Sugar contamination 2
- Extra Rivet inside Relay 1
- Coil Terminal Not Welded 1

Multiple root causes so focus on largest failure mode which is currently CuS contamination.

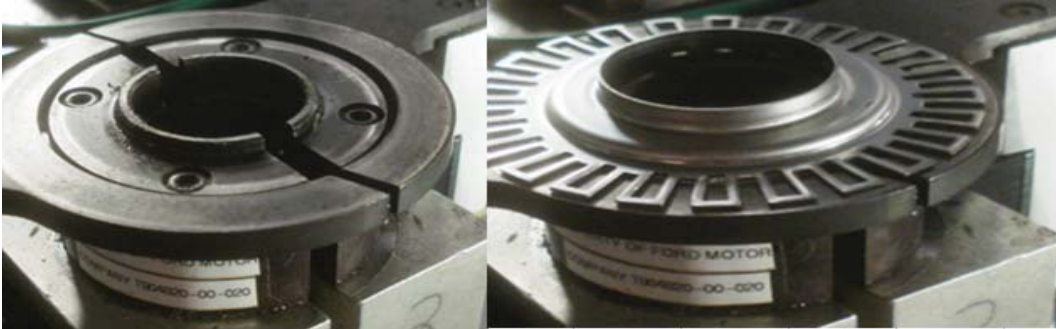
Yes, but it would take a specially bent vane (in the shape of an "L") for this to happen.

Are you saying the half moon closes so the only way a finger can be bent and pass the MP tooling station is if the finger is bent so it is vertical and sits inside the ID of the tool parallel to the shaft? Yes, the only way that a bent finger could actually fit into the gap of the half moon is to be bent so that it is vertical and sitting inside the ID of the tool. Please see the pictures below. We will take a look at the tooling and see if we can reduce the gap to eliminate this possibility.

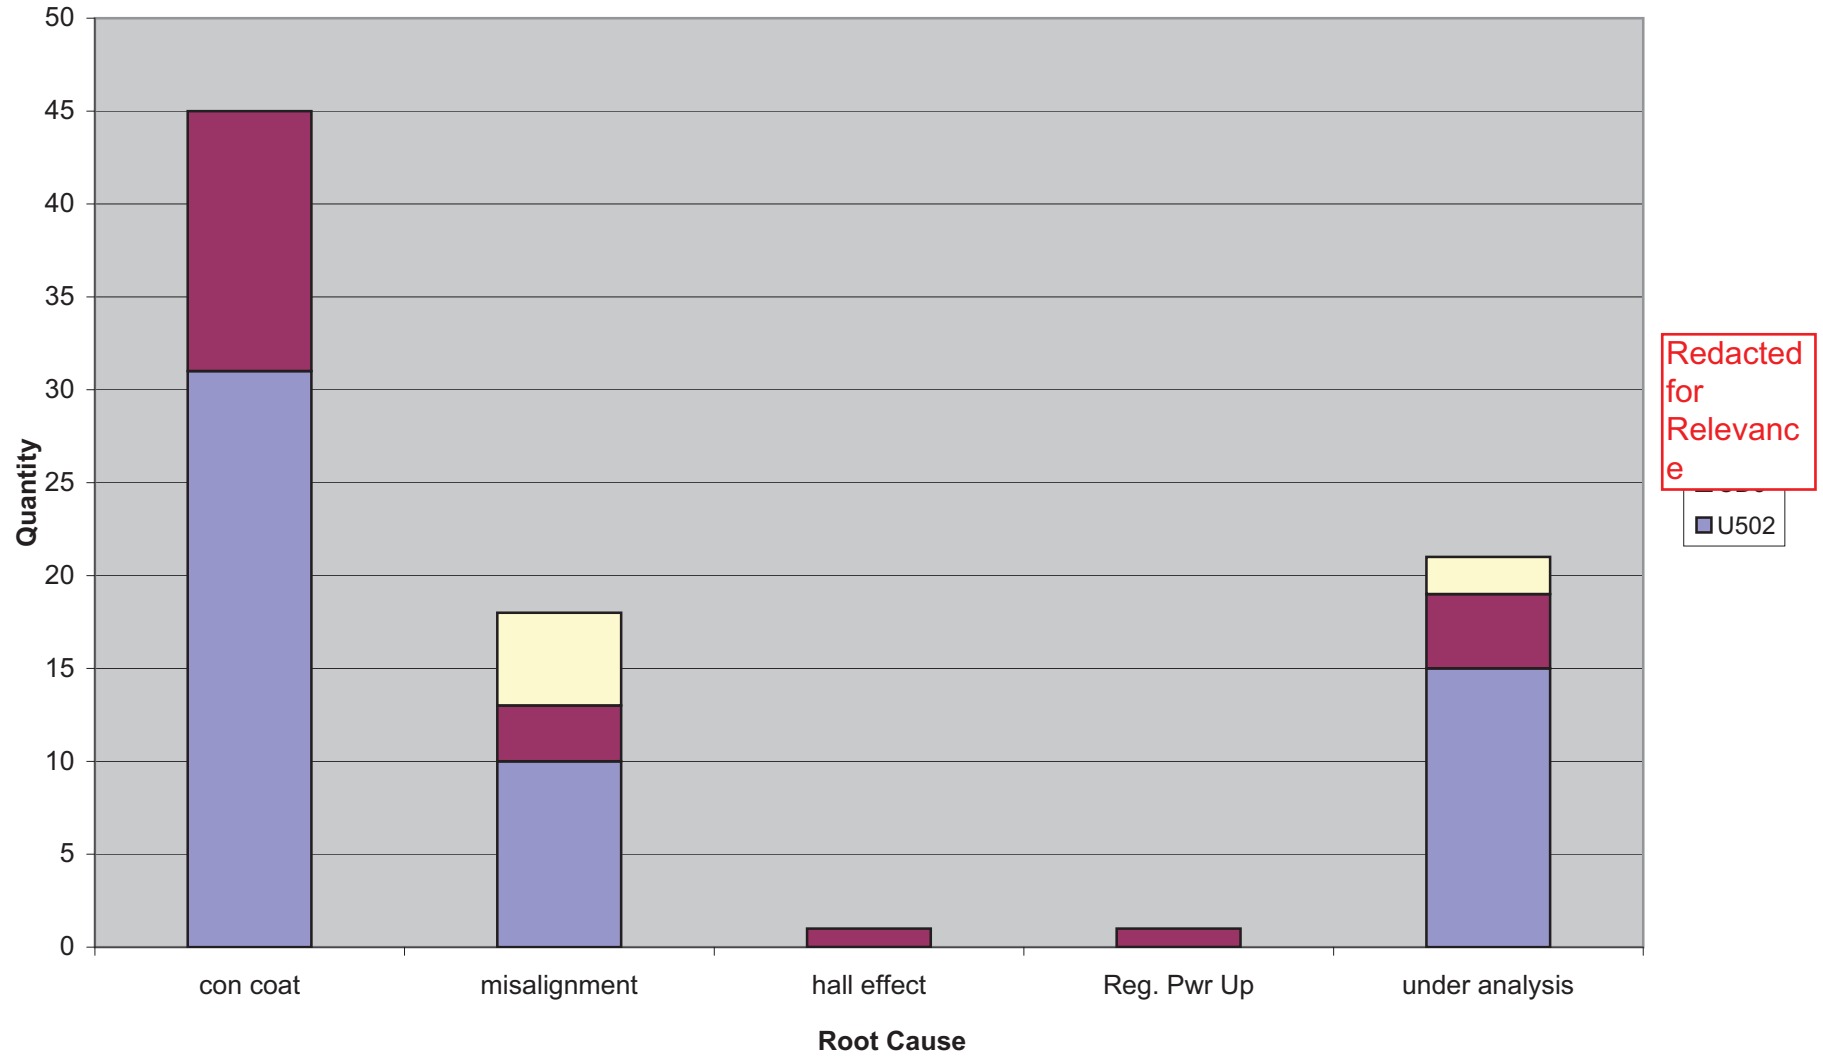
### B9A Root Causes

U502	Redacted
con coat	31	for
misalignment	10	Relevance
hall effect	0	
Reg. Pwr Up	0	
under analysis	15
