PE12-019

MADZA

APPENDIX 11

2002-2004 Tribute Accelerator  
Cable Recall 2704L

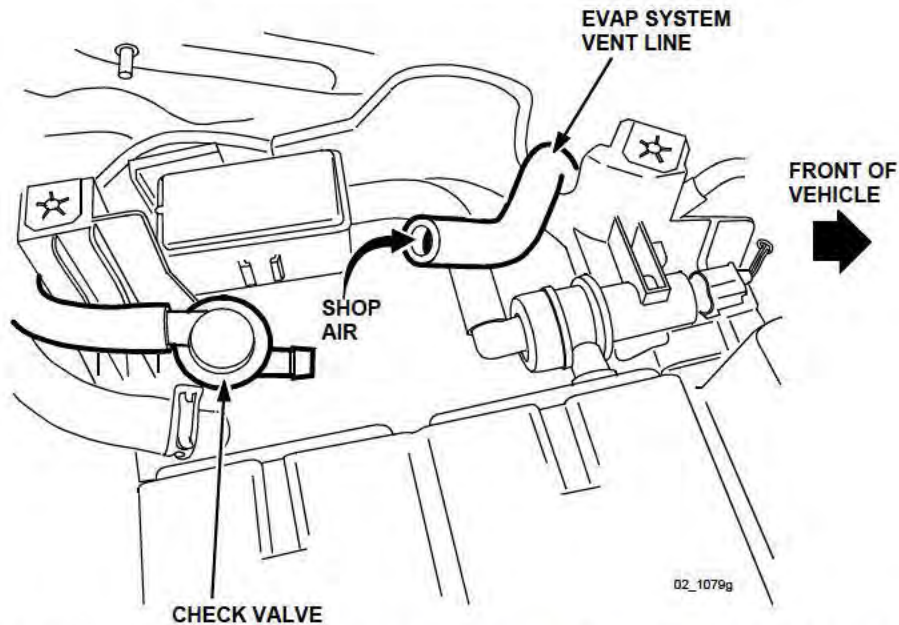
**CANISTER ASSEMBLY WITH BRACKET REMOVED**  
**(VIEW FROM UNDERNEATH VEHICLE)**

- b. Using shop air, blow the vent line from the check valve side forward (towards the brake booster). In the past, spiders have been known to construct webs in vent lines, so handle with caution. Possible obstructions in the vent line can prevent the evaporative emissions system from purging properly, and in some cases, can cause the condition to occur.
- c. Verify corrective action, then proceed to Step 3.

a. Disconnect the vent line in the evaporative emissions system from the check valve side. This connection is located just forward of the evaporative emissions canister assembly, underneath the vehicle in the area of the driver side rear seat.
