RE: Audit of Safety Recall 12V-288
My Client: Chapman Chevrolet

Subject: **Safety Recalls 12081 and 12133 - Oil Spills or Leaks onto Hot Surfaces / Potential Missing Welds in Rear Compartment**

SUBJECT: Oil Spills or Leaks onto Hot Surfaces – Modify Engine Shield

SUBJECT: Potential Missing Welds in Rear Compartment

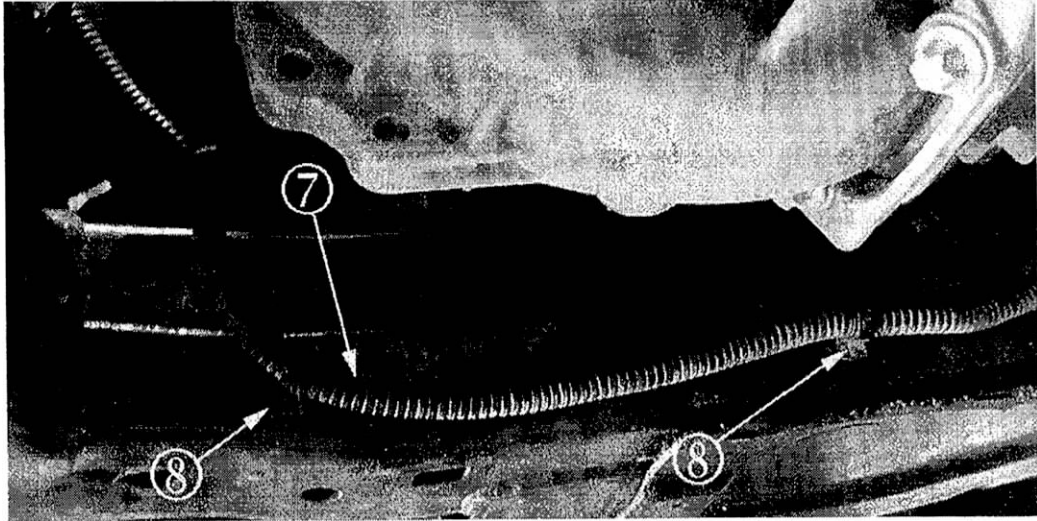
2863981

5. Locate the wire harness (7) along the driver side frame rail.
6. Remove wire harness retainers (8).

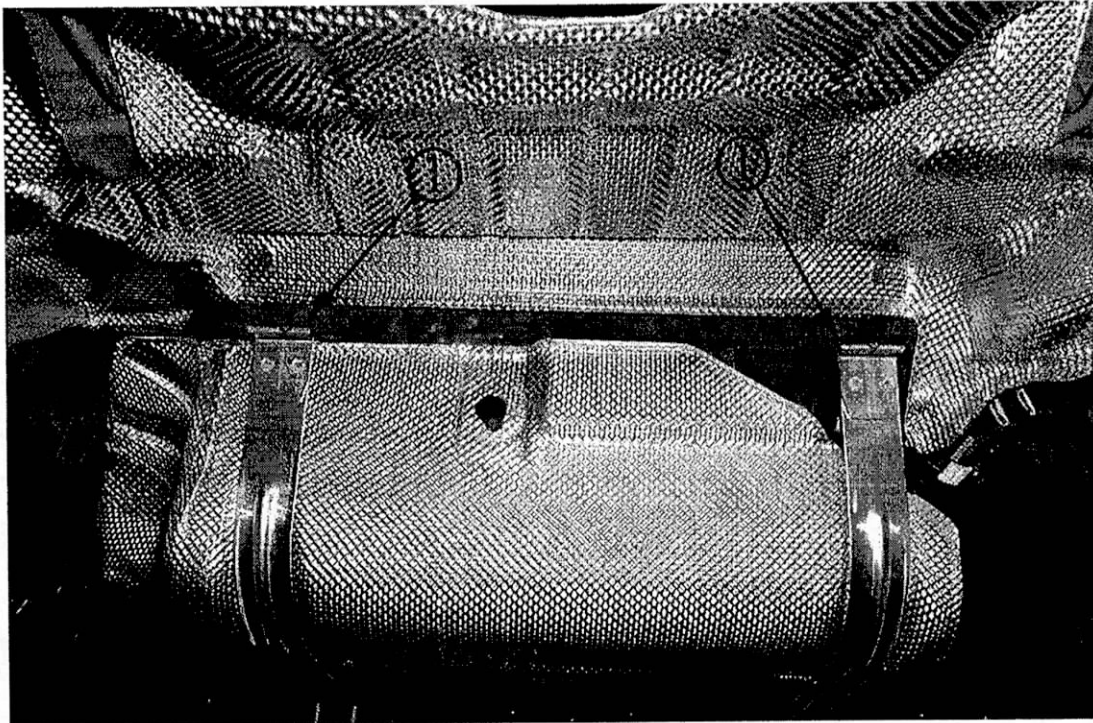
2877182

2. Locate the fuel tank strap brackets (1).

Note: The fuel tank strap must be spot welded flush to the floor pan to pass the inspection. Fuel tank straps that have been MIG welded to the floor pan **MUST** be repaired.

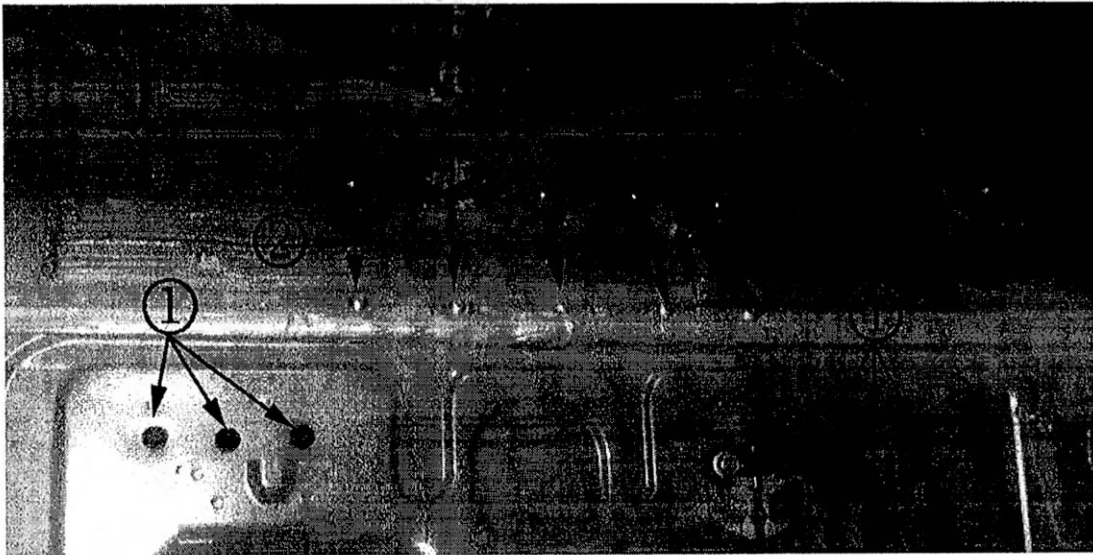
(1) Tank Strap Bracket Bolts (2) Rivets

27. Install 10 rivets (2) into the 10 holes in the 5 bar location. Install the rivets from inside of the vehicle.
28. Remove jack from fuel tank.

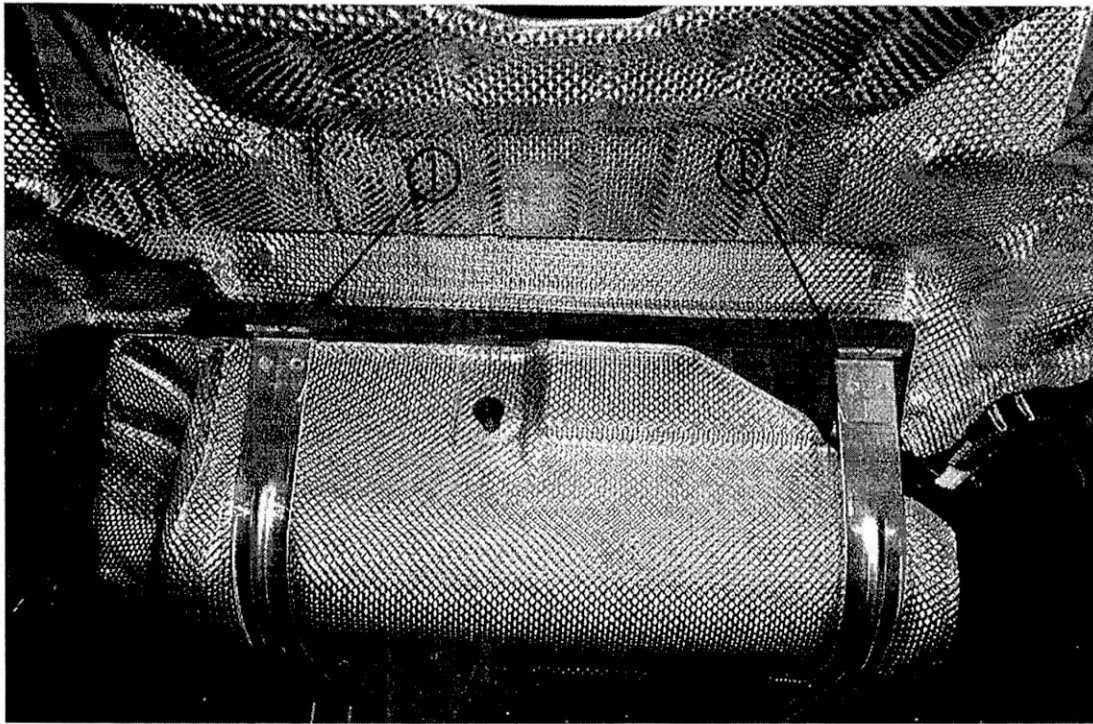
2877182

2. Locate the fuel tank strap brackets (1).

Note: The fuel tank strap must be spot welded flush to the floor pan to pass the inspection. Fuel tank straps that have been MIG welded to the floor pan **MUST** be repaired.

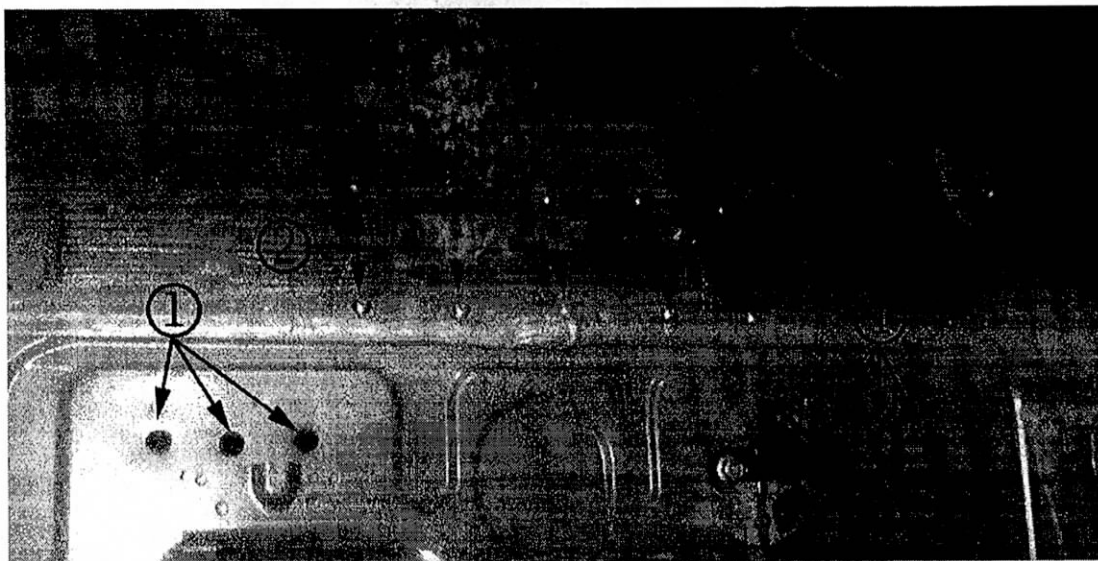
2877059

(1) Tank Strap Bracket Bolts (2) Rivets

27. Install 10 rivets (2) into the 10 holes in the 5 bar location. Install the rivets from inside of the vehicle.
28. Remove jack from fuel tank.
