August 31, 2012

Reference: NVS-rw214
PE12-011

This letter is in response to your letter of August 2, 2012, received in this office on August 9, 2012, concerning the request for information for a Preliminary Evaluation of an alleged high pressure oil line failing on the MY 2008 Navistar International CE School Buses.

MDT MY08 CE Bus (PB105) - High PSI Supply Hose Replacements

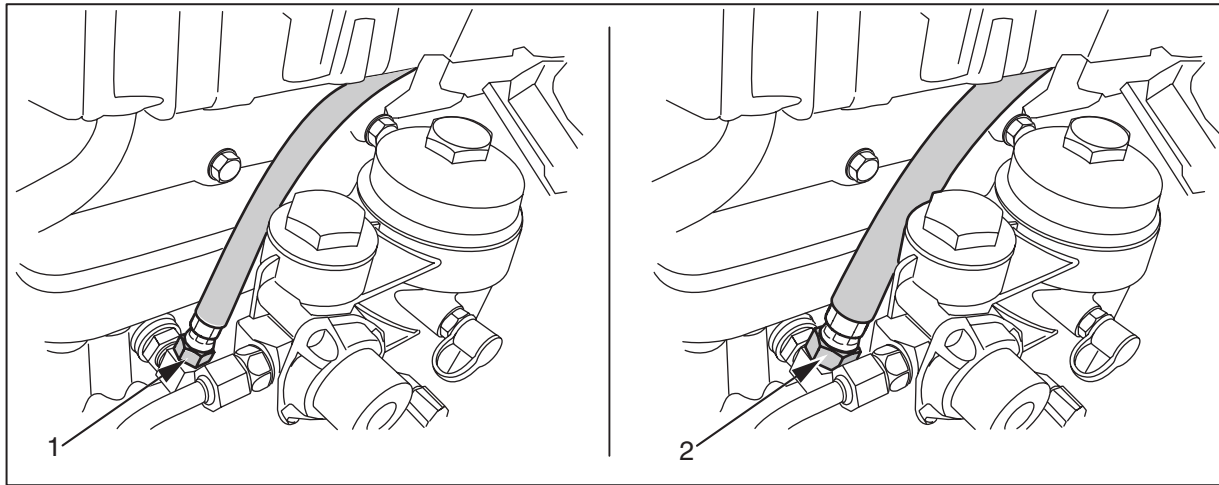
Figure 1 Small vs. large high-pressure hose and fittings

1. Small diameter 13/16-16
UNC-2B
2. Large diameter 1-1/4 inch
UNS-2B

Determine if you have a larger or small diameter high-pressure hose (see Figure 1 on page 2). Order parts for engines with the larger hose from Table 1. Order parts for engines with the smaller hose from Table 2. New service kits are available for both high-pressure oil hose configurations and all related parts.
