PE12-019

MADZA

APPENDIX 11

2002-2004 Tribute Accelerator
Cable Recall 2704L

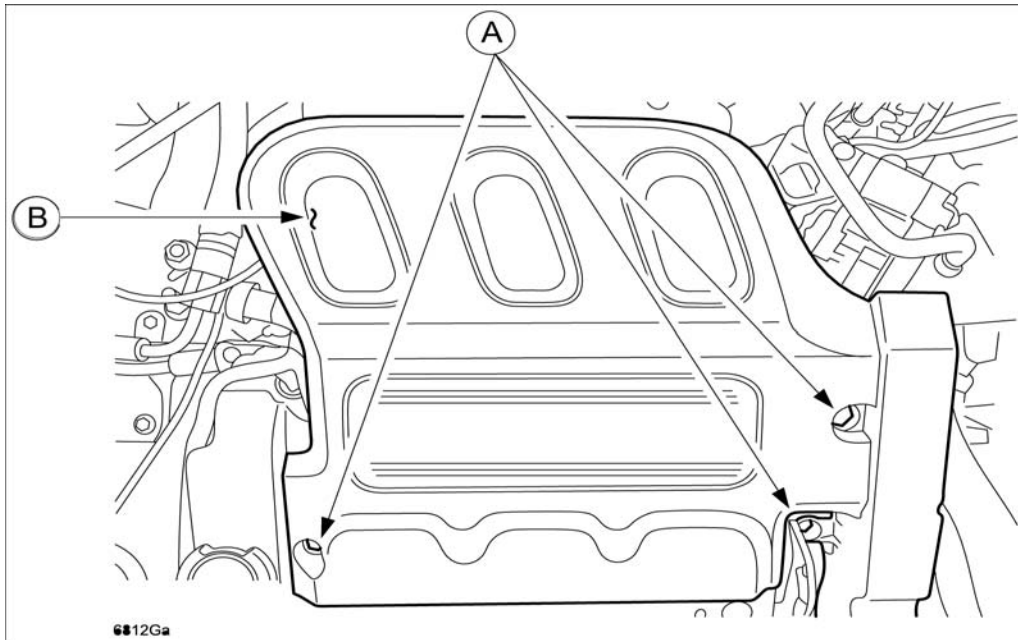
In some of the affected vehicles, there may be inadequate clearance between the engine cover and the speed control cable, which could allow the throttle to stick when the accelerator pedal is fully or almost- fully depressed, increasing the risk of an accident.

1. Remove the three nuts (A) and the engine cover (B).

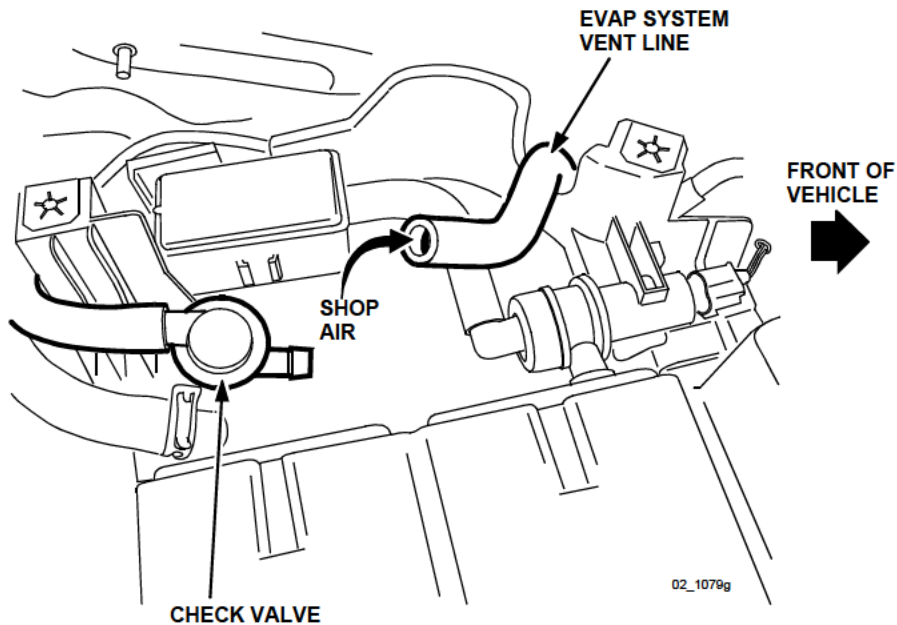
CANISTER ASSEMBLY WITH BRACKET REMOVED
(VIEW FROM UNDERNEATH VEHICLE)

- b. Using shop air, blow the vent line from the check valve side forward (towards the brake booster). In the past, spiders have been known to construct webs in vent lines, so handle with caution. Possible obstructions in the vent line can prevent the evaporative emissions system from purging properly, and in some cases, can cause the condition to occur.
- c. Verify corrective action, then proceed to Step 3.

a. Disconnect the vent line in the evaporative emissions system from the check valve side. This connection is located just forward of the evaporative emissions canister assembly, underneath the vehicle in the area of the driver side rear seat.
