PE12-019

APPENDIX 17

July 6, 2012 - Internal Mazda
communication regarding
NHTSA question of Mazda
update.

SUBJECT: Safety Recall 04S25: *Update*
All 2002 through 2004 Model Year Left Hand Drive (LHD) Escape Vehicles Equipped
with 3.0L Engines
Accelerator Cable Replacement

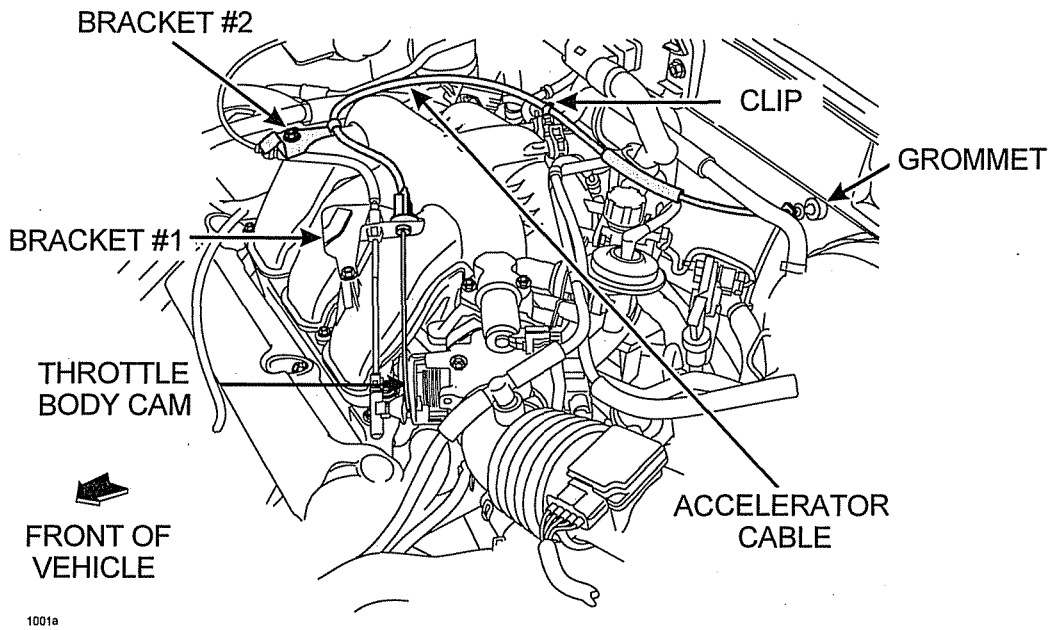
1001a

CAUTION: Damage to the speed control cable may result if the throttle body cam is rotated by lifting up on the speed control cable or the speed control cable connector end. When disconnecting the accelerator cable from the throttle body, rotate the throttle body cam only by lifting up on the cam itself. See Figure below.

3. Disconnect the accelerator cable as follows.

- Disconnect the cable by rotating the throttle body cam and sliding the cable barrel out of the cam.
- Remove the accelerator cable from bracket #1 by turning the cable housing 45 degrees either way and pulling it from the bracket.
- Open bracket #2 with a screwdriver and remove the accelerator cable from the bracket.

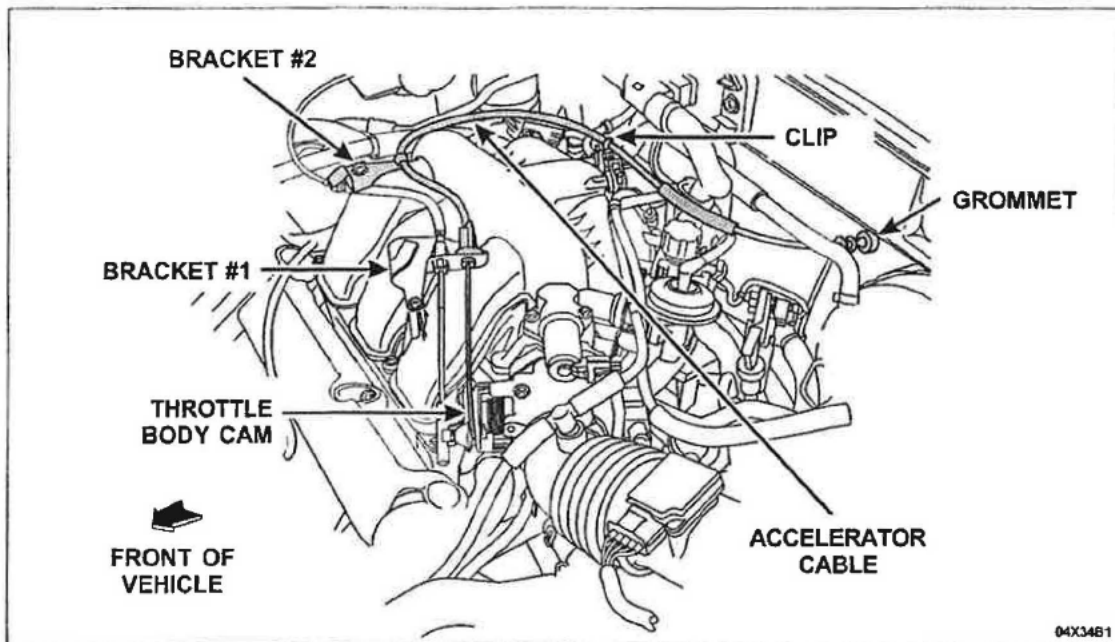
FIGURE 2

The purpose of this update is to inform dealers that updated illustrations and a warning have been added to the technical instructions (Attachment III) to help prevent damage to the speed control cable while performing the accelerator cable replacement procedure. In addition, warranty edits have been incorporated to prevent the payment of related damage claims for speed control cable replacement.

3. Disconnect the accelerator cable as follows: See Figure 2.

- A) Disconnect the cable by rotating the throttle body cam and sliding the cable barrel out of the cam.
- B) Remove the accelerator cable from bracket #1 by turning the cable housing 45 degrees either way and pulling it from the bracket.
