EA12-005 Reconstruction Testing for KJ Jeep Liberty and ZJ Grand Cherokee

July 2014

U.S Department of Transportation
National Highway Traffic Safety Administration

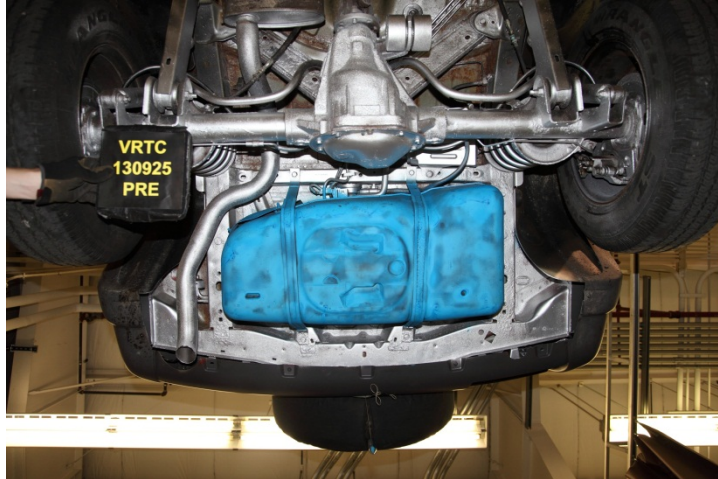
Figure 8 – Test #1 Pre-test target vehicle rear underbody view without hitch-receiver

This test used a 1997 Plymouth Neon as the bullet vehicle and a 2004 Jeep Liberty without a hitch-receiver as the target vehicle. Post-test observation of the impact damage to the target vehicle was compared to and found to be consistent with the damage of the vehicle in the real-world crash. The fuel tank was directly contacted by the Neon, and most of the 68.5 liters of Stoddard in the tank spilled by the end of 30 minutes. Review of the high-speed video footage revealed the Neon passed under the Jeep and significantly lifted the back end until the front wheels of the Neon contacted the back wheels of the Jeep to move it forward, indicating significant under-ride as shown in Figure 6.

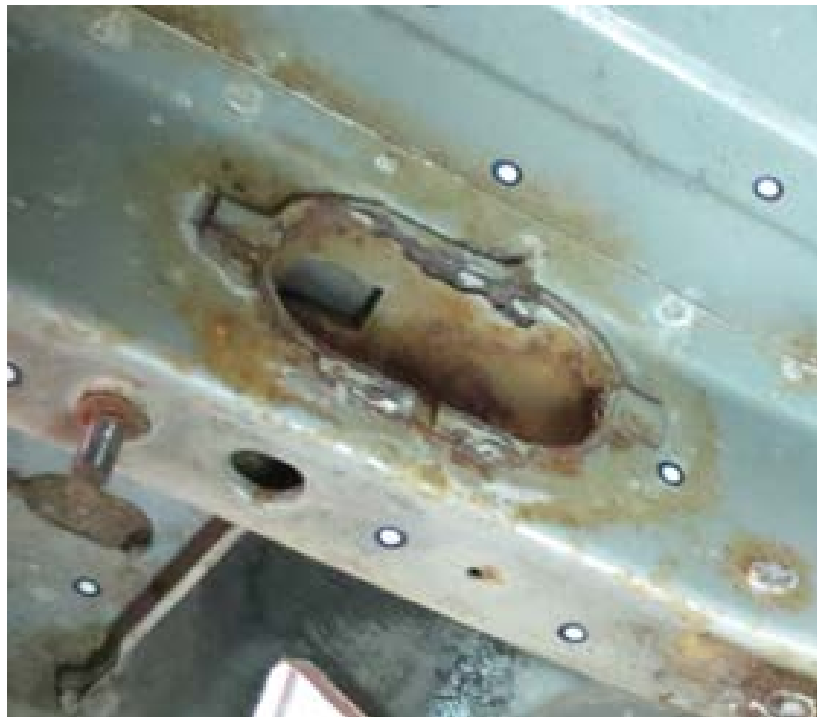
Figure 11 - Frame rail relief tunnel for fuel filler hoses

facts to support pre-impact braking. At the conclusion of the first test, it was evident that the Cadillac struck the Jeep with an impact point at least two inches higher than in the real-world crash based on intrusion patterns into the rear gate of the Jeep. At least one known source of the fuel leak in the real-world crash was a several inch long cut along the bottom of the tank. It is possible that other leak sources existed, but no other sources were documented. In the baseline crash, a fuel leak was produced; however it originated at the fuel filler hose connections. There is a relief tunnel (hole) through the left frame rail that routes the fuel filler hose along the path to the filler cap shown in Figure 11. The tunnel in the frame rail was crushed due to the force of the crash, combined with significant rust originating from the hollow, inside of the rail, and this resulted in the hoses being captured in the frame rail, shown in Figure 12. As the frame rail bent, it pulled upward on the fuel tank hose connections and broke them at their bases on the plastic tank, resulting in a significant leak, as shown in Figure 13.

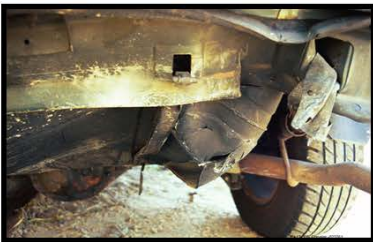
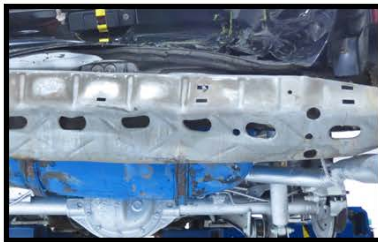
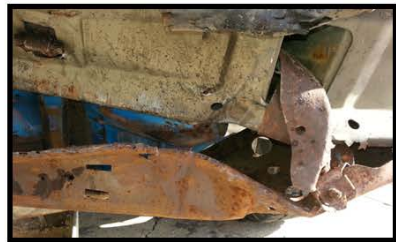
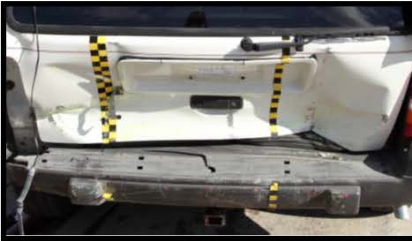
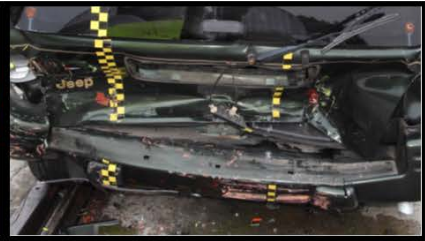
Figure 18 - Comparison of post-crash damage of the rear bumper reinforcement area between the baseline tests and the real-world crash

post-crash damage in the left rear D-pillar area, between the baseline test vehicles and the real-world crash is shown in Figure 17. A comparison of post-crash damage in the rear bumper reinforcement area between the baseline test vehicles and the real-world crash is shown in Figure 18. A comparison of post-crash damage in the rear lift gate area between the baseline test vehicles and the real-world crash is shown in Figure 19. A comparison of post-crash damage in the right rear area between the baseline test vehicles and the real-world crash is shown in Figure 20. A comparison of post-crash damage of the fuel tank area, between Test# 3 (no hitch-receiver) and Test #7 (hitch-receiver) is shown in Figure 21 and Figure 22, respectively.

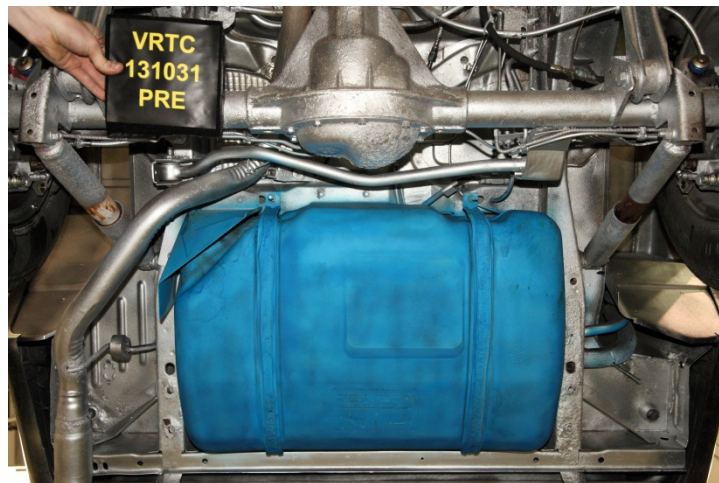
Figure 23 - Test #3 Pre-test target vehicle fuel tank close-up view without hitch-receiver

Pre-test and post-test photos of the target vehicle fuel tank from the baseline test (Test#3) are shown in Figure 23 and Figure 24, respectively. The post-test photo shows the scraping caused by the under-ride. Figure 25 shows the post-test photo of the comparative test (Test #7) with hitch-receiver installed. The fuel tank did not show signs of under-ride, but did show signs of impacting the rear differential of the Jeep.

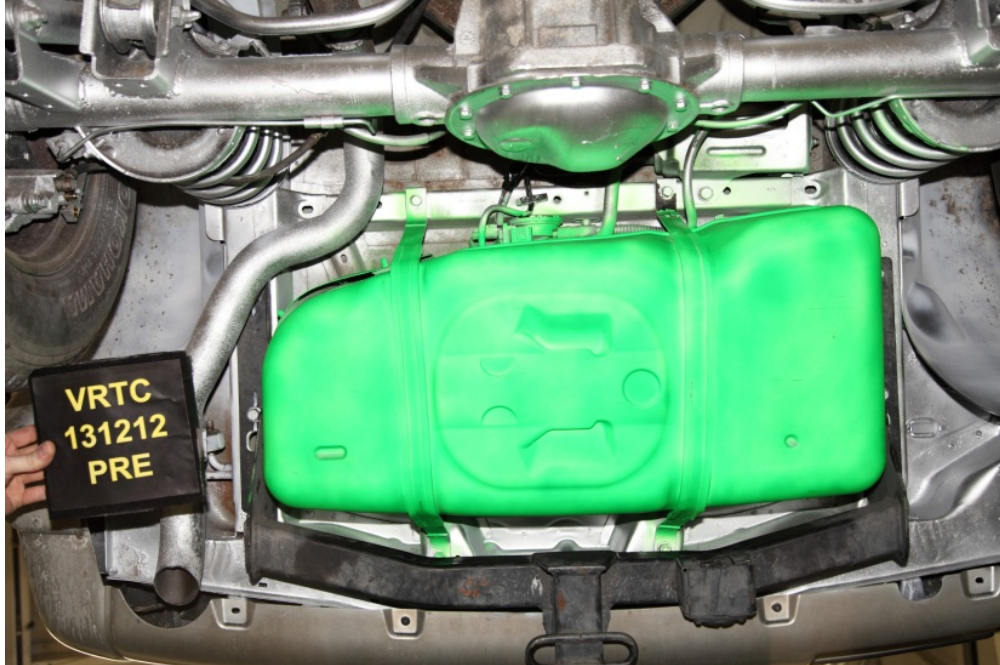
Figure 28 - Test #8 Pre-test target vehicle fuel tank close-up view

Pre-test and post-test photos of the target vehicle fuel tank from the baseline test (Test#8) are shown in Figure 28 and Figure 29, respectively. The post-test photo shows no signs of under-ride from the bullet vehicle. Post-test observations are compared to the real-world crash and shown in Table 11. Damage to the tested Jeep Liberty indicated that the energy levels were consistent with, if not in excess of that achieved in the real-world crash. In post-test observation and during the procedural longitudinal rollover test, leakage occurred when the vehicle was rolled in the rollover fixture. Upon disassembly, the source of the droplets was discovered to be the overfill vent connector and the charcoal vapor connector, which had broken off at the top of the fuel pump assembly (Figure 30). These connectors were made from a nylon material and were formed into the top of the housing. They do not carry fuel during normal operation because they function to vent vapors and prevent overfilling. A third connector of the same material, the high pressure supply connection, which does carry fuel during normal operation, remained intact. Further investigation of the fuel pump inside of the tank revealed that the bottom of the plastic pump housing assembly had been displaced forward, had shattered inside of the fuel tank, and had broken the internal supply tube to the fuel pump. This rendered the pump incapable of pressurizing the external fuel tube.

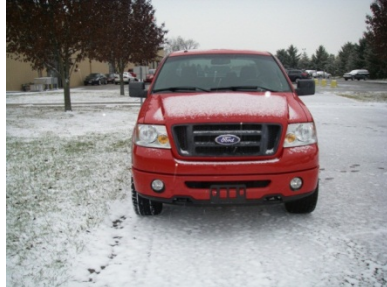
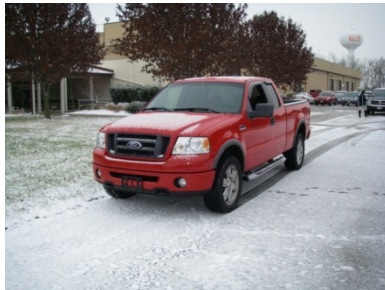
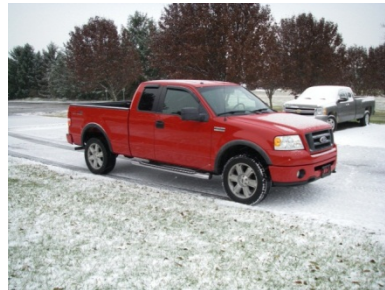
2008 Ford F-150, VIN: 1FTPX14V58Fxxxxxx
Bullet Vehicle Test# 8

The reconstruction of the F-150 into the KJ Liberty demonstrated the hitch was capable of withstanding a higher energy impact without the hitch-receiver cross-member fracturing and without piercing the tank. Damage to the tested Jeep Liberty indicated that the energy levels were consistent with, if not in excess of that achieved in the real-world crash. The presence of the aftermarket tow drawbar and tow ball inserted into hitch-receiver in the real-world crash seems to have increased the leverage acting upon the cross-member and may have contributed to the overload fracture. The droplets of fuel leakage during and immediately after the test that originated from the vent and vapor tube connectors ceased shortly after the impact. Significant leakage did not occur until the vehicle was rolled in the rollover fixture. The source of the leak was the overfill vent connector and the charcoal vapor connector, which had broken off of the top of the fuel pump assembly.

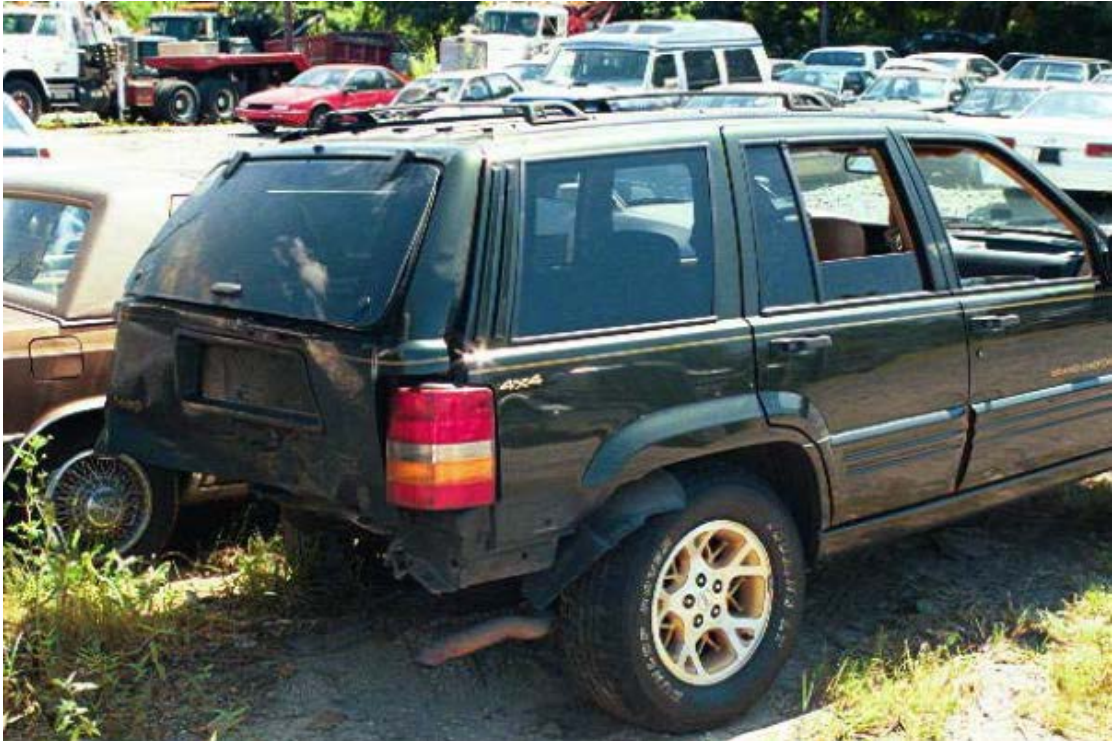
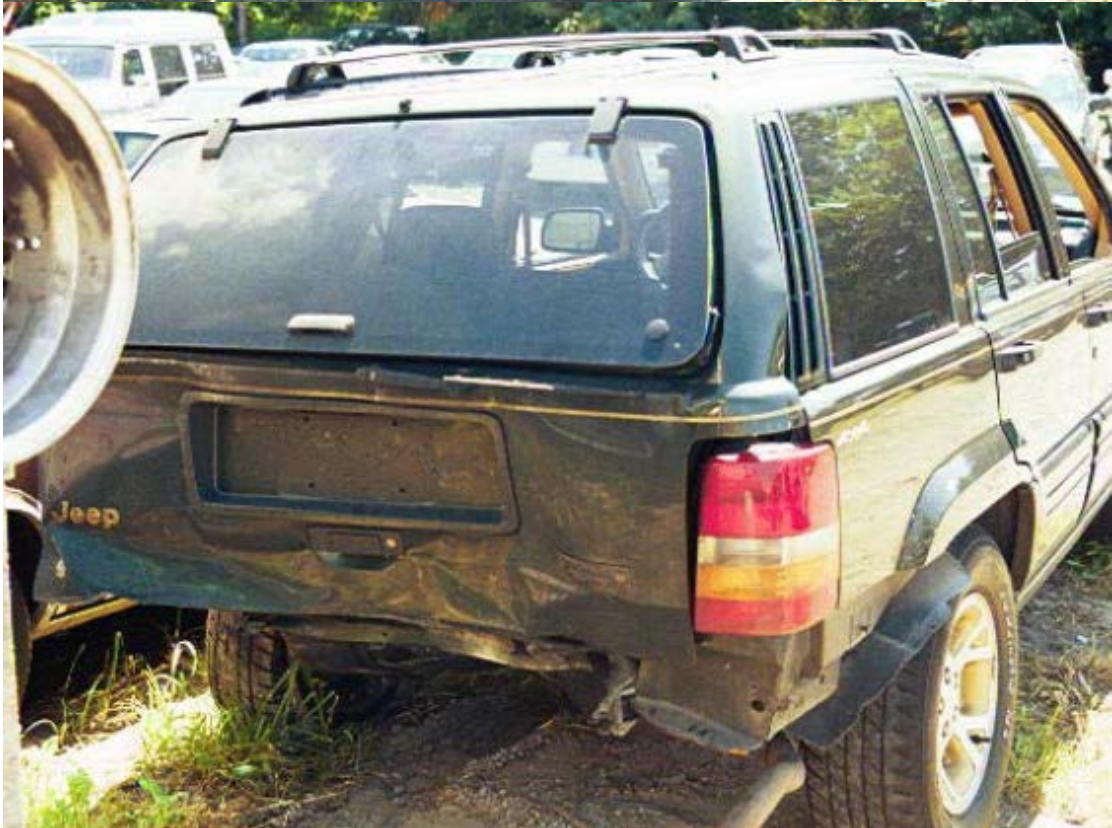
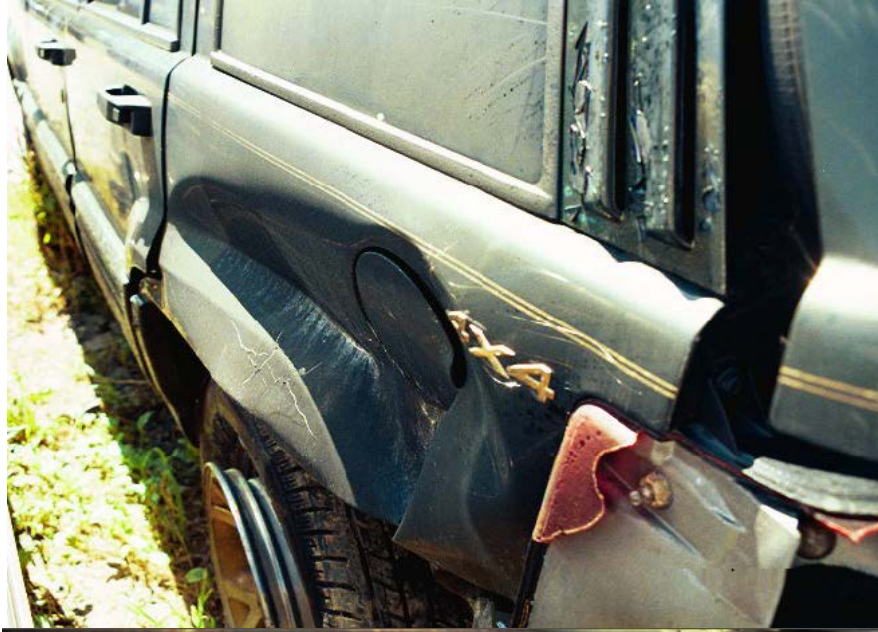
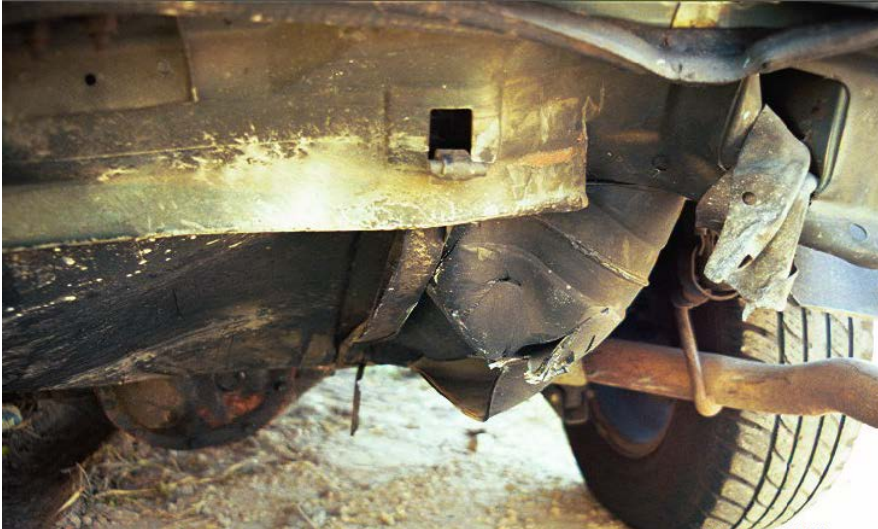
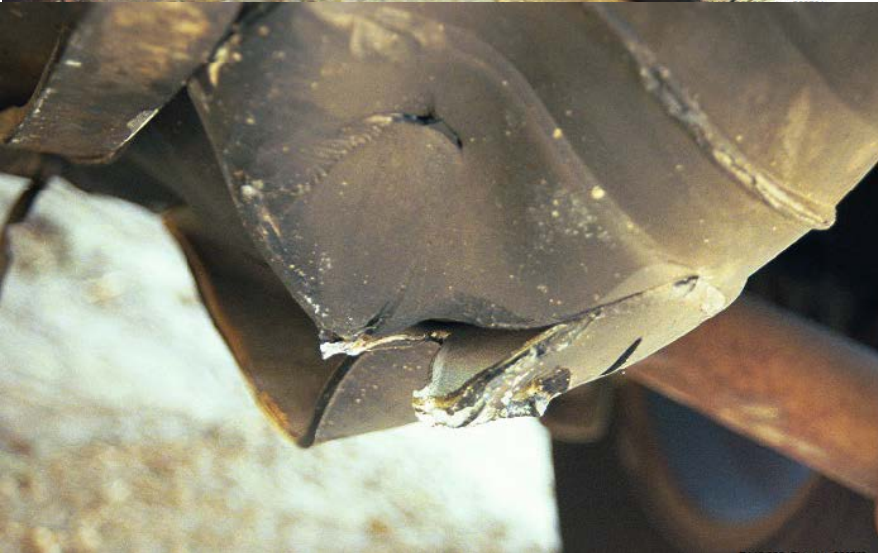
**Scenario 2 - Jeep Grand Cherokee
(Cadillac Deville pictures were not available)**

The reconstruction of the Cadillac Deville into the ZJ Jeep Grand Cherokee revealed a repeatable failure mode with the crushed and rusted frame rail pulling on the fuel filler hoses until they broke the connections from the plastic tank. It was confirmed that a vehicle with little to no rust could withstand the crash. The hitch-receiver bracket and mounting bolts provided a structural reinforcement that prevented the collapse of the moderately rusted frame rail relief tunnel in testing.
