Subject: PETITION FOR AN INVESTIGATION INTO DEFECT CONDITIONS IN UPPER IMMEDIATE
STEERING EXTENSION SHAFT #2 MANUFACTURING DEFECT IN THE 2004-2009 TOYOTA PRIUS
VEHICLES W/RESPECT TO RECALL 12V-537

PETITION, Toyota Prius Steering, Upper Intermediate Extension Shaft #2, Manufacturing Defect w/resp/to Recall 12V-537 (Lower Intermediate Extension Shaft #1, Manufacturing Defect)

Vehicle: Richwine Subject Vehicle 2005 Toyota Prius
VIN: JTDKB20U95 [REDACTED] MfgDt 10/04
Issue: Alleged Steering Malfunction

George Richwine, 05Prius
Data & Analysis, Steering Failure

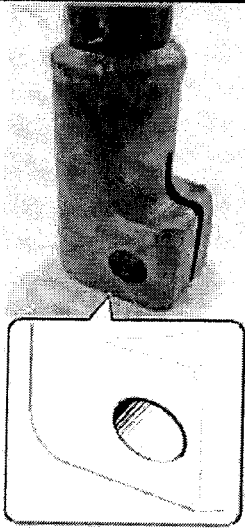
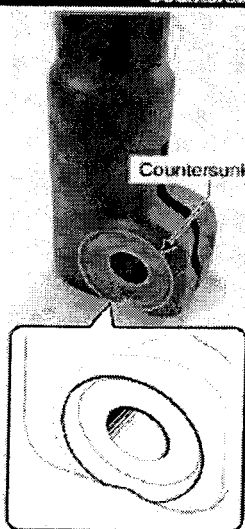
NO Countersink	Countersink
Shaft Design

Ball seating face of extension shaft
All extension shafts have a noncountersunk bolt hole if seen from this opposite side.
Be sure to inspect from the side the bolt head seats to (no threads).

Action Required	OK Replace the extension shaft bolt ONLY. Proceed to SECTION VII. EXTENSION SHAFT & BOLT REPLACEMENT. Complete STEPS 24-28 and 36-37.	NG Replace the extension shaft and 3 bolts. Proceed to SECTION VII. EXTENSION SHAFT & BOLT REPLACEMENT

NOTE: The new shaft in the kit (04001-41212) is manufactured with a countersink. DO NOT mix the old and new shaft.

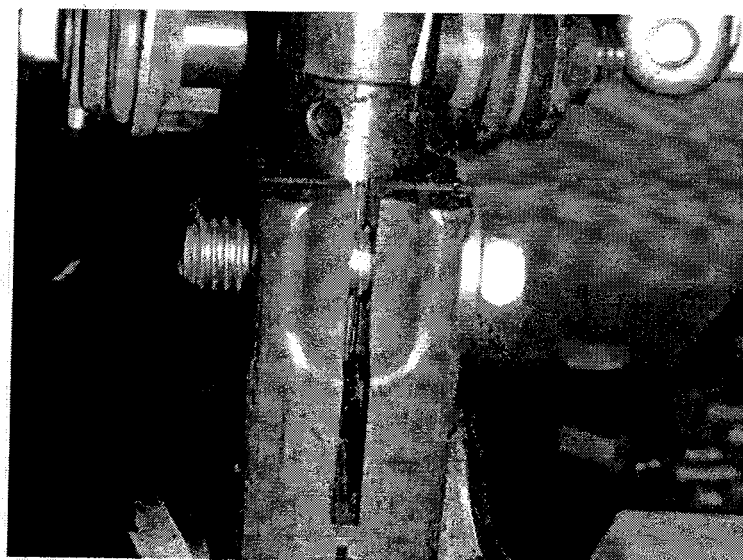
Exhibit 12 A photo sequence showing that exemplar vehicle and its upper intermediate steering shaft #2 assembly on the exemplar power assist exit spline annulus. These photos clearly show, with no ambiguity, that a proper installation includes the cinching bolt properly residing in the power assist exit spline annulus.
