DP13-001

TOYOTA

C0T Dealer Letter T-CP-C0T-

Subject: **Safety Recall - C0T Remedy Notification**
2004 to certain 2009 Model Year Prius Vehicles
Steering Intermediate Extension Shaft

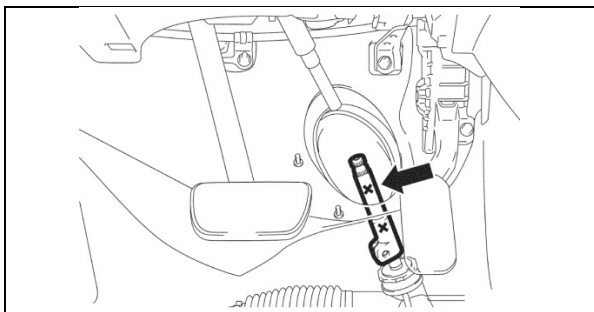
STOP The new shaft in the kit (04001-41212) is manufactured with a countersink, mark the NG shaft to confirm it is not reused.

18. REMOVE THE EXTENSION SHAFT

a) Remove the extension shaft.

b) Mark the shaft so it is not reused.

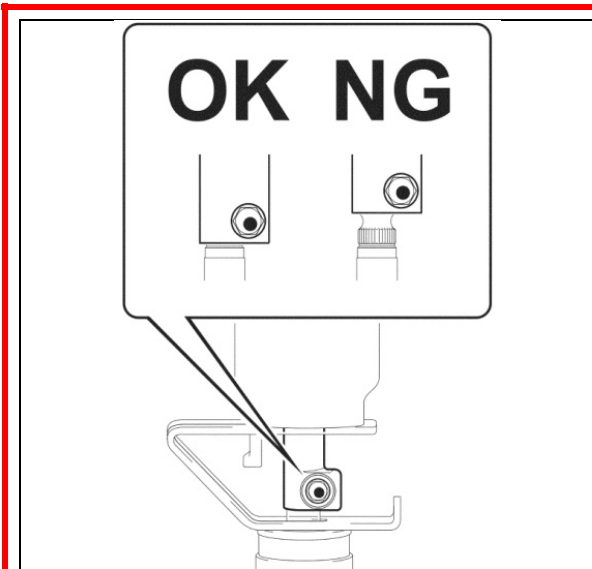
- a) Confirm that a **NEW** shaft and **NEW** bolt has been installed.
- b) Confirm the lower end of the shaft has been fully seated.
NOTE: If only the edge of the shaft is engaged, the bolt can be tightened but the shaft may become disconnected.

25. INSPECT THE EXTENSION SHAFT

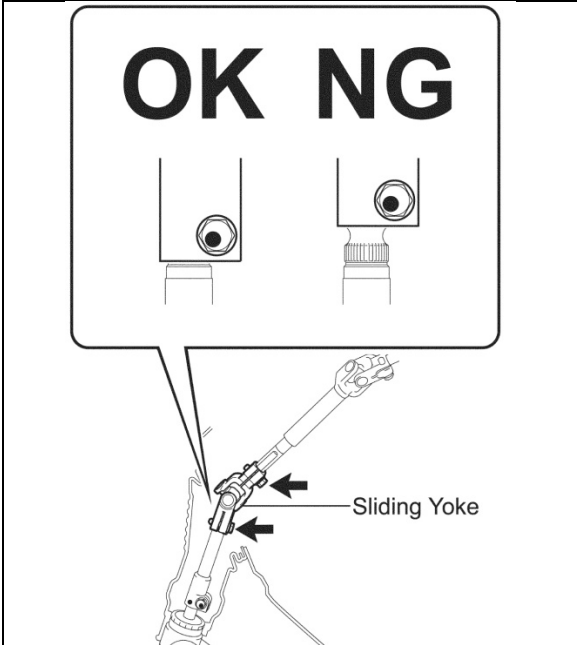
NOTE: If only the edge of the shaft is engaged, the bolt can be tightened but the shaft may become disconnected.

31. INSPECT THE EXTENSION SHAFT & YOKE

- a) Confirm two **NEW** bolts have been installed.
- b) Confirm the upper and lower ends of the yoke are fully installed.

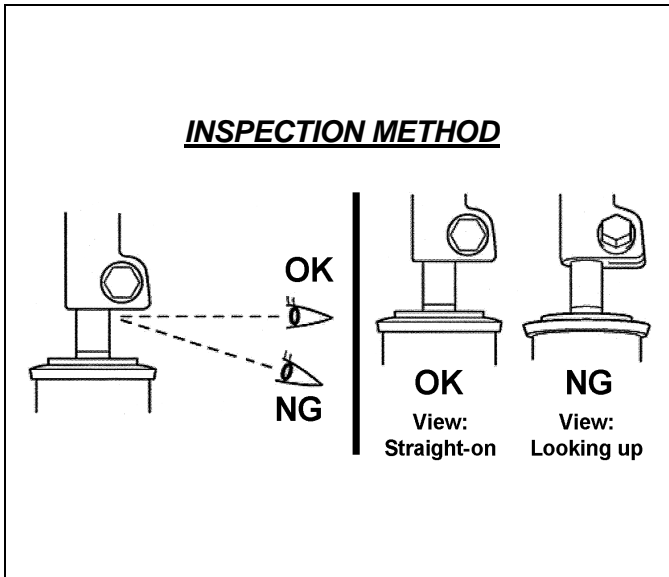
5. INSPECT THE INTERMEDIATE (EXTENSION) SHAFT NO. 1

- a) Turn the steering wheel to the right.
- b) While holding up the column hole cover, inspect the engagement point for the intermediate (extension) shaft No. 1 and steering gear by looking at it straight-on through the opening on the backside of the left front wheel well.

NOTE:
 Be sure to look at the engagement point straight-on. If viewed from underneath the vehicle the ends of the splines can be seen, even when the intermediate (extension) shaft No. 1 is fully inserted onto the steering gear. This may lead to an incorrect judgment of the condition.

- **OK Condition (splines not visible):**
Proceed to step C.

- **NG Condition (spline visible):**
Proceed to step D.

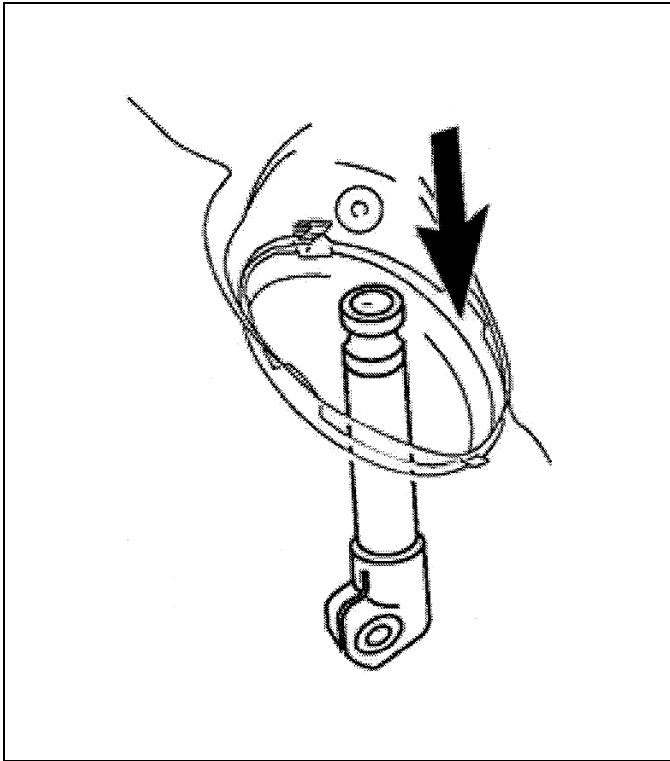
- b) Inspect the internal splines of the intermediate (extension) shaft No. 1 for damage. Is damage present?

NG, damaged:

- Intermediate (extension) shaft is **NG**. Replace the intermediate (extension) shaft No. 1 and the bolt with a **NEW** one.

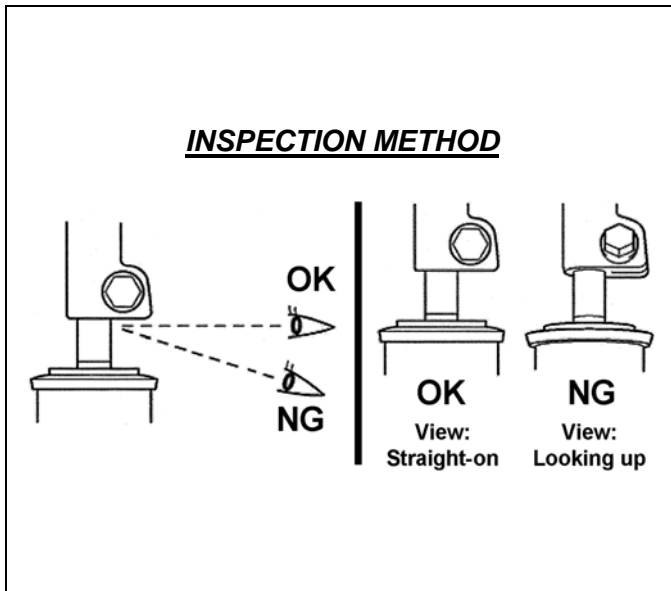
NOTE:

Be sure to look at the engagement point straight-on. If viewed from underneath the vehicle the ends of the splines can be seen, even when the intermediate (extension) shaft No. 1 is fully inserted onto the steering gear. This may lead to an incorrect judgment of the condition.

- **OK Condition (splines not visible):**
Proceed to step C.
- “C. RETORQUE THE INTERMEDIATE (EXTENSION) SHAFT NO. 1 BOLT, INSPECT THE SLIDING YOKE AND REPLACE THE INTERMEDIATE SHAFT NO. 2” on page 09.
- **NG Condition (spline visible):**
Proceed to step D.
- “D. DETAILED INSPECTION OF THE INTERMEDIATE (EXTENSION) SHAFT NO. 1, INSPECT THE SLIDING YOKE AND REPLACE THE INTERMEDIATE SHAFT NO. 2” on page. 20.

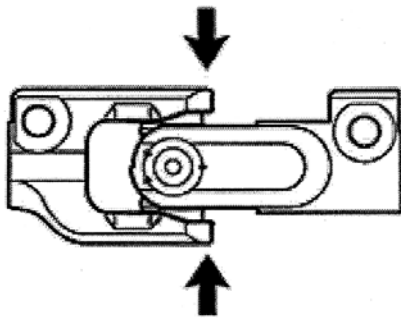
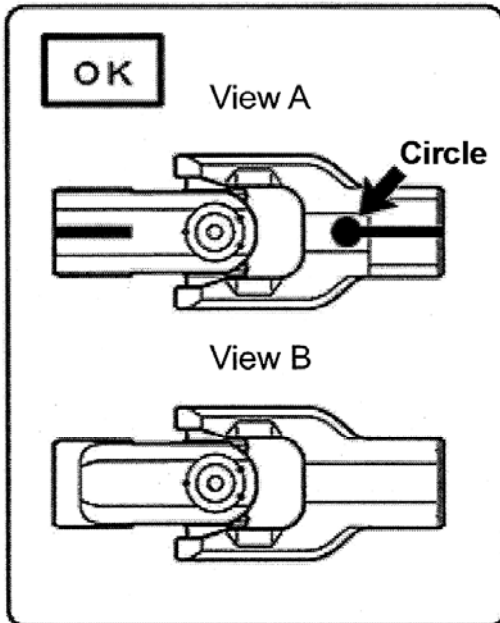
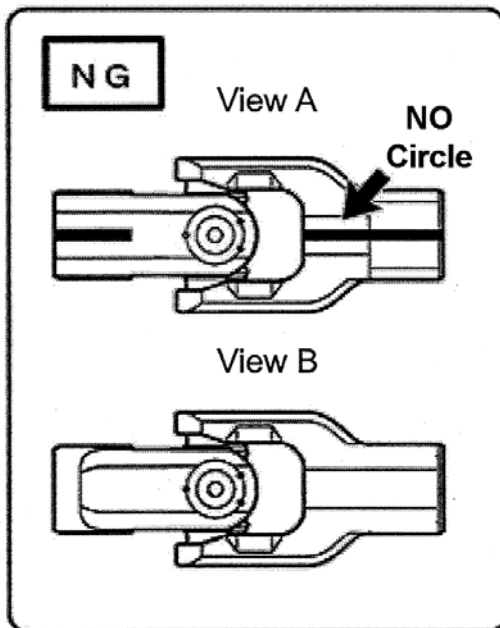
- a) Inspect the shape of the slot on the sliding yoke as shown in the illustration to determine if it is OK or NG.

- Replacement is **NOT** necessary, reuse the sliding yoke.

- Replace the sliding yoke with a **NEW** one.

If the part number 04005-72247 is no longer available, please use the part number 04005-72147 and replace the intermediate shaft with the sliding yoke.

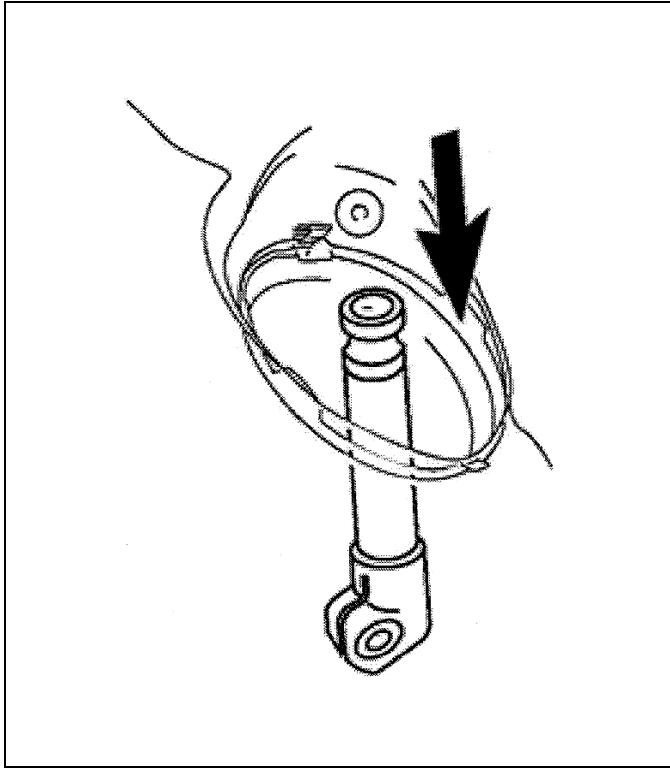
11. REMOVE THE INTERMEDIATE (EXTENSION) SHAFT NO. 1 AND INSPECT FOR DAMAGE

- b) Inspect the internal splines of the intermediate (extension) shaft No. 1 for damage. Is damage present?

NG, damaged:

- Intermediate (extension) shaft is **NG**. Replace the intermediate (extension) shaft No. 1 and the bolt with a **NEW** one.

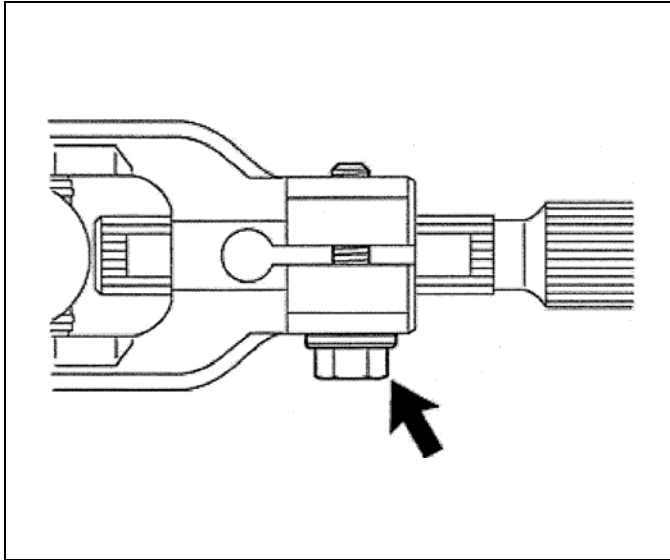
14. INSPECT THE SLIDING YOKE*

- a) Inspect the shape of the slot on the sliding yoke as shown in the illustration to determine if it is OK or NG.

- Replace the sliding yoke with a **NEW** one.

If the part number 04005-72247 is no longer available, please use the part number 04005-72147 and replace the intermediate shaft with the sliding yoke.
