maintenance-site-vpt ▶ Driveline - Active Issues... Question 9 Describe all modifications or changes made All Documents

PE13-002

VOLVO TRUCK

QUESTION 9

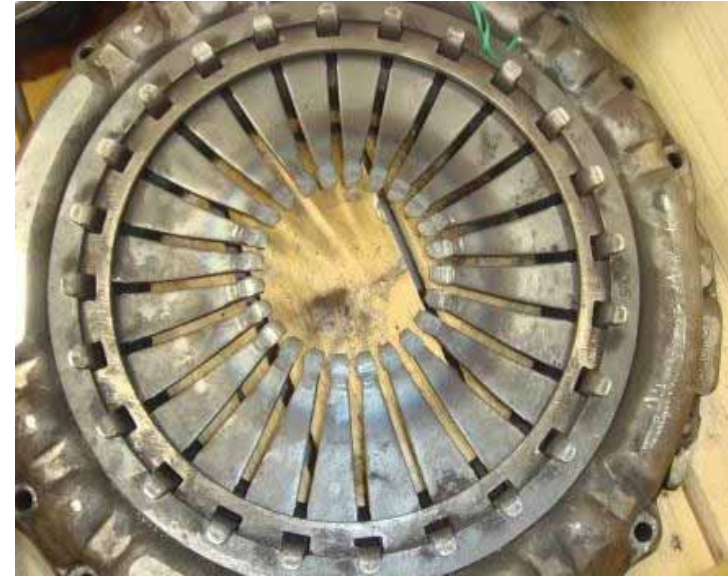
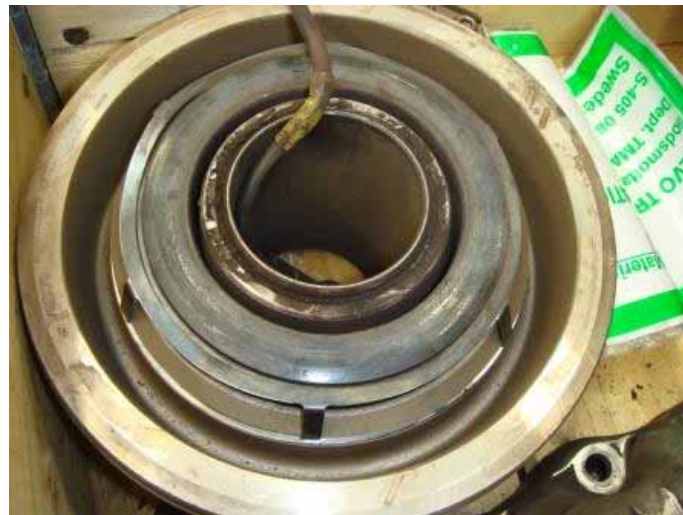
Claim info Importer: 1320 Dealer: 9630 Reference no: 318849 Job no: 1 Return to dealer: No		Repair date: 2009-05-30 Inspector report: No SCC code: SCC description:		Barcode: 0001320 9930031684901 Analysis Problem: Airleak clutch cylinder Result: Airleak clutch cylinder, Release bearing scored
Vehicle data Chassis id: B-496470 Mileage: 272443 Assembly date: 2007-11-21 Age: 18		Marketing type: FM13 42T Operating hours: Delivery date: 2007-12-10		Dealer feedback: Approved Root cause:
Cost summary (SEK)				Decision and status
Dist. Code	Labour costs	Material costs	Other costs	TMA decision: Approved
18	8.88	38.07	0	TMA status: Analysis pending
Received causal part				Third party analysis
Part number:	VO-20806451 CYLINDER	VO-20806451 CYLINDER	Part mileage:	Third party:
Serial no:			Part age:	Third party decision:
Supplier:	6992 ZF SACHS AG	6992 ZF SACHS AG	Part fitted date:	Third party result:
Func. group:	4312 housing: clutch casing	4312 housing: clutch casing	Defect code:

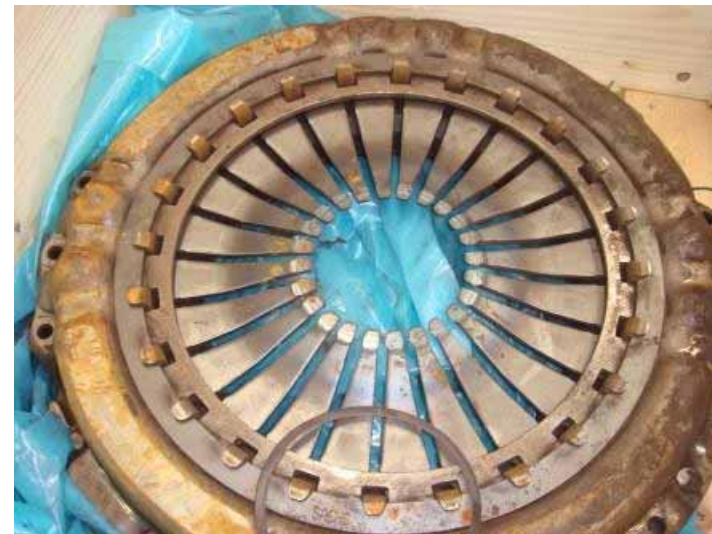
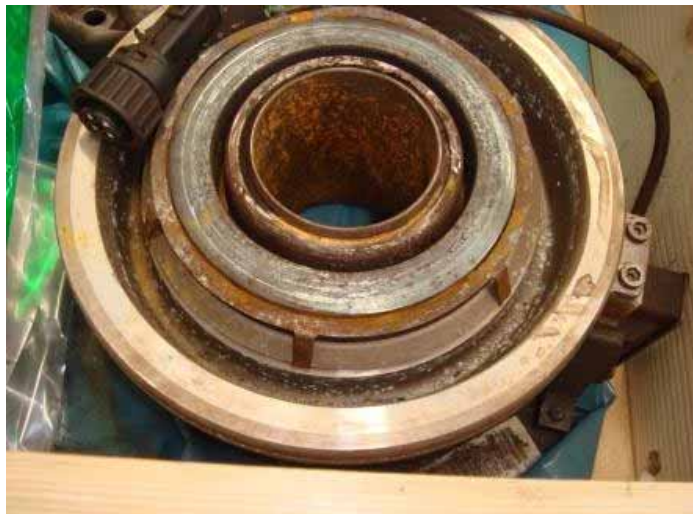
B-499831

Claim info Importer: 1320 Repair date: 2009-07-01 Dealer: 9930 Inspector report: No		Barcode: 0001320 9930031705701	
Reference no: 317057 SCC code: Job no: 1 SCC description: Return to dealer: No		Analysis Problem: Release bearing seized Result: Release bearing seized Pressure plate disintegrating tps badly worn	
Vehicle data Chassis nr: S-490831 Marketing: FM13 42T Mileage: 286857 Operating type: Assembly date: 2007-12-13 Operating hours: Age: 18 Delivery date: 2008-01-02		Dealer: Approved Feedback: Root cause:	
Cost summary (SEK) Deb. Code Labour costs Material costs Other costs 18 27.40 36.32 0		Decision and status TMA decision: Approved TMA status: Analysis pending	
Received causal part Part number: VO-20806451 CYLINDER Serial no: Supplier: 6992 ZF SACHS AG Func. group: 4312 housing; clutch casing Func. area: 8 Transmission		Part number: VO-20806451 CYLINDER Serial no: Supplier: 8992 ZF SACHS AG Func. group: 4312 housing; clutch casing Defect code: 32

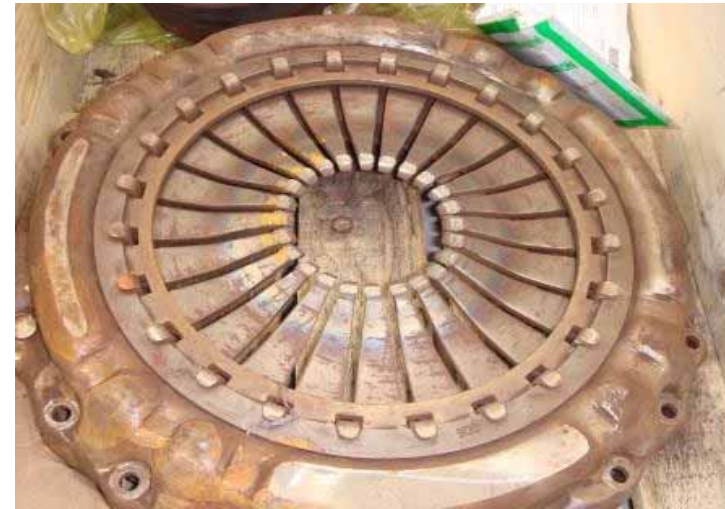
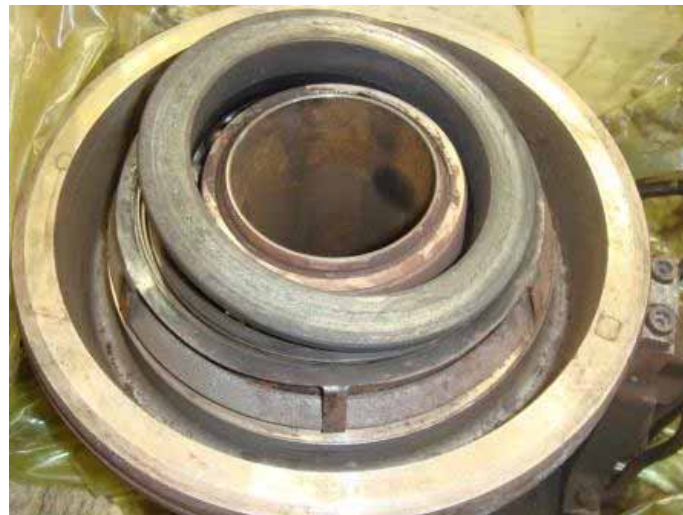
Claim Info Inspector: 1320 Repair date: 2009-07-06 Dealer: 1183 Inspector report: No Reference no: 322398 SCC code: Job no: 1 SCC description: Return to dealer: No				Analysis Problem: Result: Release bearing seized, Pressureplate diaphragmspring lips badly worn			
Vehicle data Chassis id: B-480637 Marketing type: FH13 62T Mileage: 233673 Operating hours: Assembly date: 2007-06-29 Age: 24 Delivery date: 2007-07-23				Dealer feedback: Approved Root cause:			
Cost summary (SEK) Dist. Code Labour costs Material costs Other costs 18 33.96 97.19 0				Decision and status TMA decision: Approved TMA status: Analysis pending Third party analysis Third party: Third party decision: Third party result:			
Received causal part Part number: VO-20806451 CYLINDER Serial no: Supplier: 6992 ZF SACHS AG Func. group: 4312 housing; clutch casing				VO-20806451 CYLINDER 6992 ZF SACHS AG 4312 housing; clutch casing Part mileage: Part age: Part fitted date: Defect code: 43

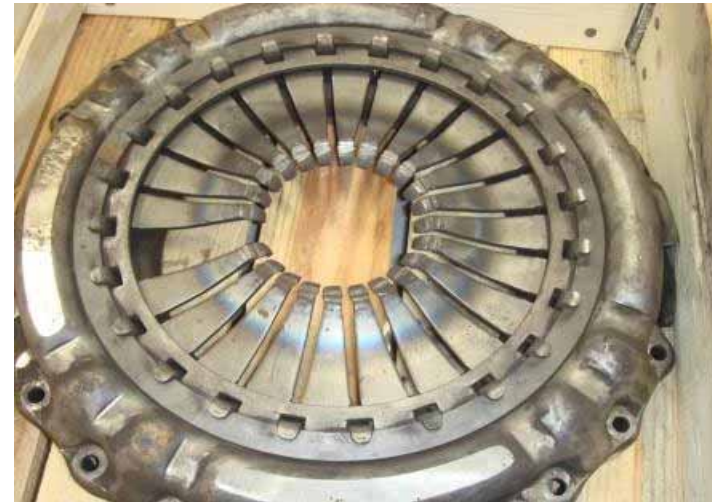
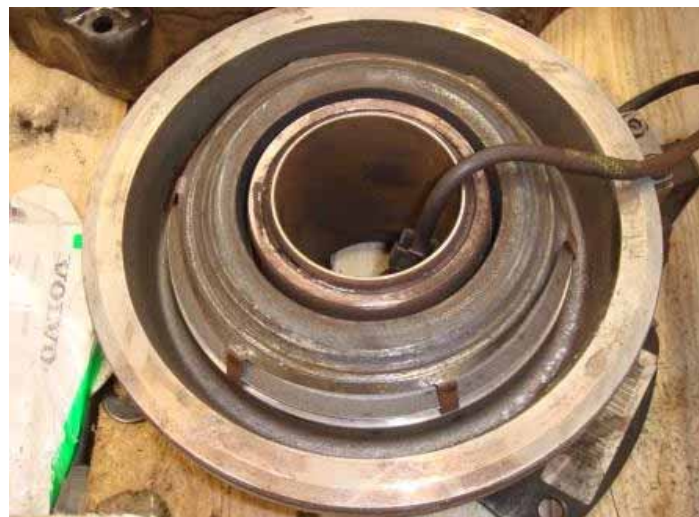
Claim info Importer: 1320 Repair date: 2009-06-10 Dealer: 1184 Inspector report: No Reference no: 341880 SCC code: Job no: 1 SCC description: Return to dealer: No				0001320 1184034189001 Analysis Problem: Release bearing seized Result: Release bearing seized. Service failure	
Vehicle data Chassis id: A-650148 Marketing type: FH13 62T Mileage: 195066 Operating hours: Assembly date: 2007-07-09 Age: 24 Delivery date: 2007-08-31				Dealer feedback: Approved Root cause:	
Cost summary (SEK) Deb. Code Labour costs Material costs Other costs 18 35.89 96.85 0				Decision and status TMA decision: Approved TMA status: Analysis pending Third party analysis Third party decision: Third party result:	
Received causal part Part number: VO-20806451 CYLINDER VO-20806451 CYLINDER Part mileage: Serial no: Part age: Supplier: 6992 ZF SACHS AG 6992 ZF SACHS AG Part fitted date: Func. group: 4312 housing; clutch casing 4312 housing; clutch casing Defect code: 32 Func. area: 6 Transmission

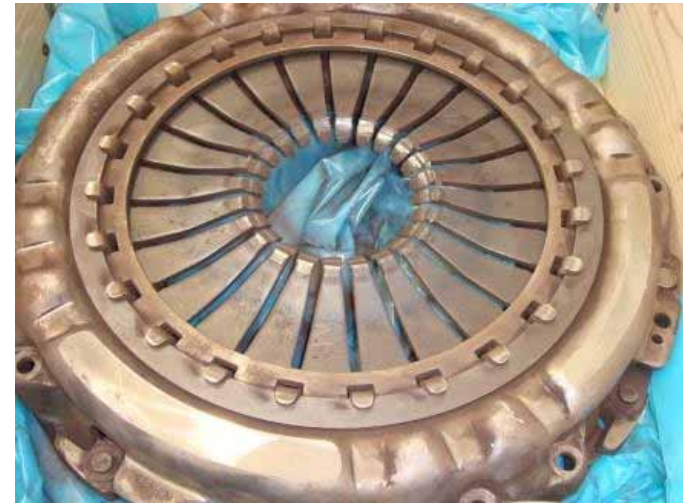
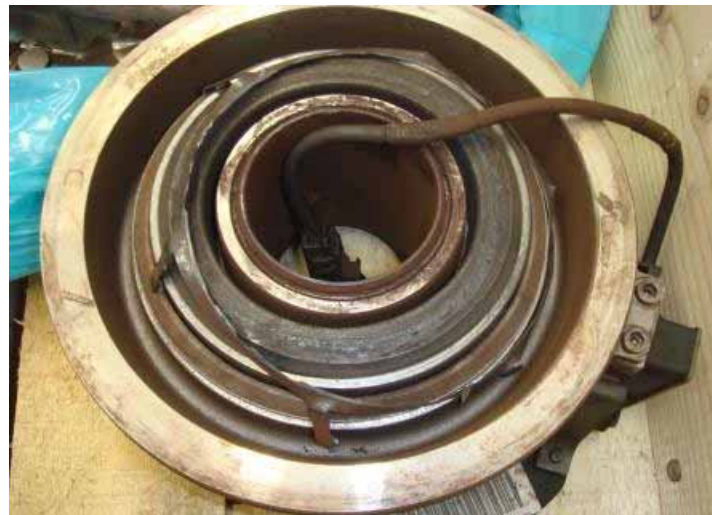
Claim info Importer: 1320 Repair date: 2009-07-30 Dealer: 1072 Inspector report: No Reference no: 312928 SCC code: Job no: SCC description: Return to dealer: No				0001320 1072031292801 Analysis Problem: Sensor failure Result: Sensor failure, releasebearing scored																	
Vehicle data Chassis id: B-486568 Marking: FH13 62T Mileage: 270291 type: Assembly date: 2007-09-10 Operating hours: Age: 22 Delivery date: 2007-10-15				Dealer: Approved feedback: Root cause:																	
Cost summary (SEK) Deb.Code Labour costs Material costs Other costs 18 34.35 97.08 0				Decision and status TMA decision: Approved TMA status: Analysts pending Third party analysis Third party: Third party decision: Third party result:																	
Received causal part Part number: VO-20806451 CYLINDER VO-20806451 CYLINDER Part mileage: Serial no: Part age: Supplier: 6992 ZF SACHS AG 6992 ZF SACHS AG Part fitted date: Func. group: 4312 housing; clutch casing 4312 housing; clutch casing Defect code: 32 Func. area: 6 Transmission																					
Included material <table border="1"> <thead> <tr> <th>Ref</th> <th>Rac</th> <th>New</th> <th>Prefix</th> <th>Part number</th> <th>Description</th> <th>Serial no</th> <th>Quantity</th> </tr> </thead> <tbody> <tr> <td></td> <td></td> <td></td> <td></td> <td></td> <td></td> <td></td> <td></td> </tr> </tbody> </table>				Ref	Rac	New	Prefix	Part number	Description	Serial no	Quantity										
Ref	Rac	New	Prefix	Part number	Description	Serial no	Quantity

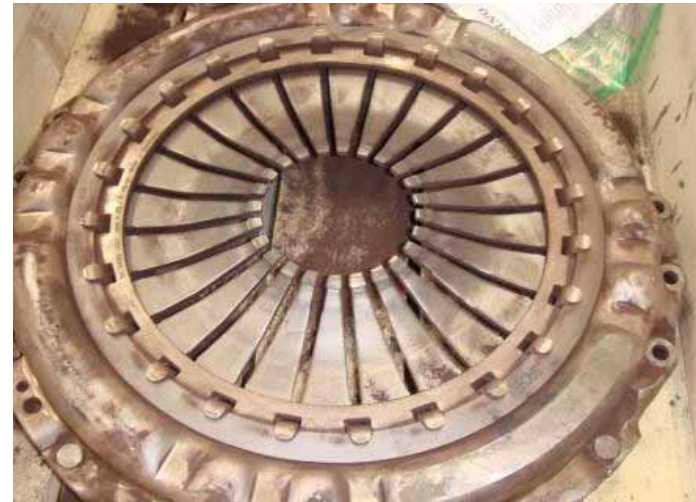
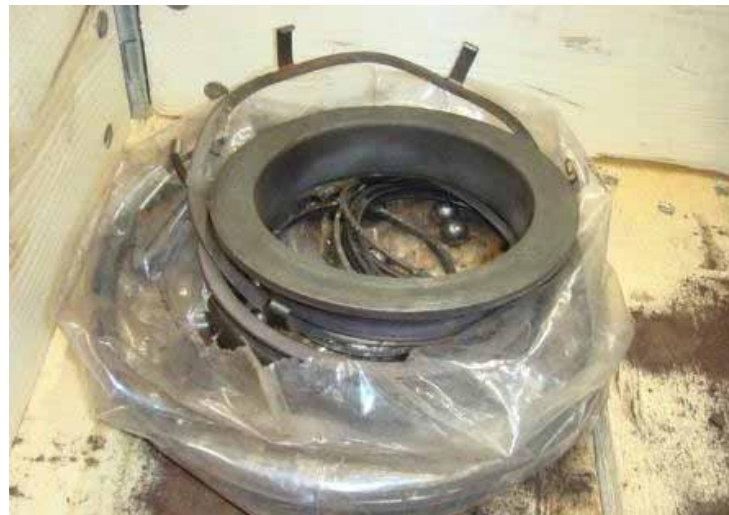
A649602

Claim info Importer: 82 Dealer: 330 Reference no: 3005273 Job no: 1 Return to dealer: Yes		Repeat date: 2009-07-21 Inspector report: No SDC code: SDC description:		Barcode: 0000062 330300527301 Analysis Problem: Releasebearing stored Result: Releasebearing stored, cylinder repaired, Protosuplein damaged	
Vehicle data Chassis nr: A-649602 Mileage: 298143 Assembly date: 2007-07-02 Age: 21		Marketing type: FH13 64R Operating hours: Delivery date: 2007-11-02		Dealer feedback: Approved Root cause:	
Cost summary (SEK) Def. Code: 18 Labour costs: 6566.80 Material costs: 4439.12 Other costs: 0		Decision and status TMA decision: Approved TMA status: Analysis pending Third party analysis Third party: Third party decision: Third party result:		Received causal part Part number: VQ-20806451 CYLINDER Serial no: Supplier: Func. group: 4312 housing, clutch casing Func. area: 8 Transmission Defect code: 62

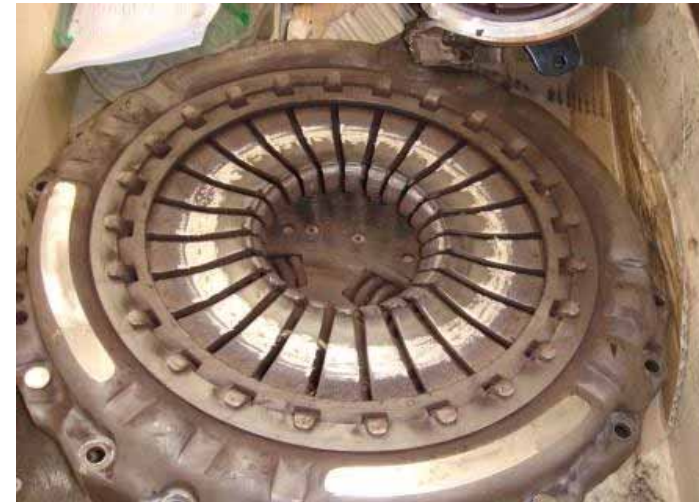
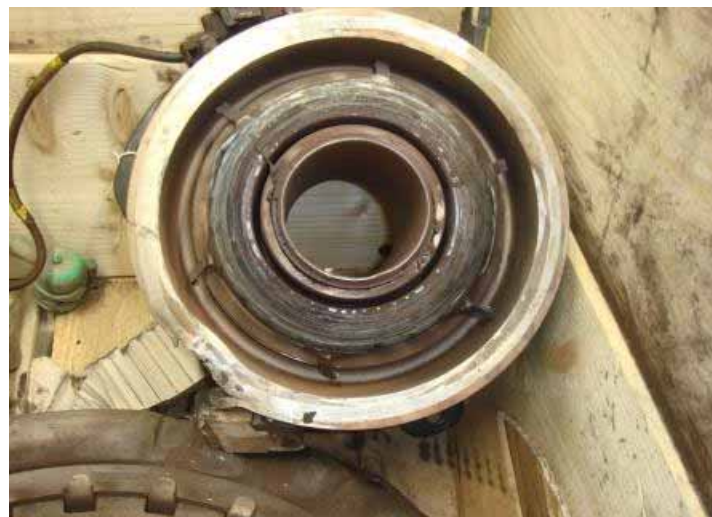
B-482695

Claim info Importer: 1320 Dealer: 1480 Repair date: 2009-04-07 Inspector report: No		Barcode: 0001320 1480030218901	
References no: 302189 Job no: 1 Return to dealer: No		SCC code: SCC description:	
Vehicle data Chassis Id: B-482885 Mileage: 155853 Assembly date: 2007-07-12 Age: 16		Marketing type: FM13 62R Operating hours: Delivery date: 2007-12-17	
Cost summary (SEK) Dia. Code: 18 Labour costs: 30.92 Material costs: 105.12 Other costs: 0		Decision and status TMA decision: Approved TMA status: Analysis pending Third party analysis Third party: Third party decision: Third party result:	
Received causal part Part number: VO-20806451 CYLINDER Serial no: Supplier: 6992 ZF SACHS AG		VO-20806451 CYLINDER 6992 ZF SACHS AG 4312 housing: clutch casing Part mileage: Part age: Part fitted date: Defect code: 11

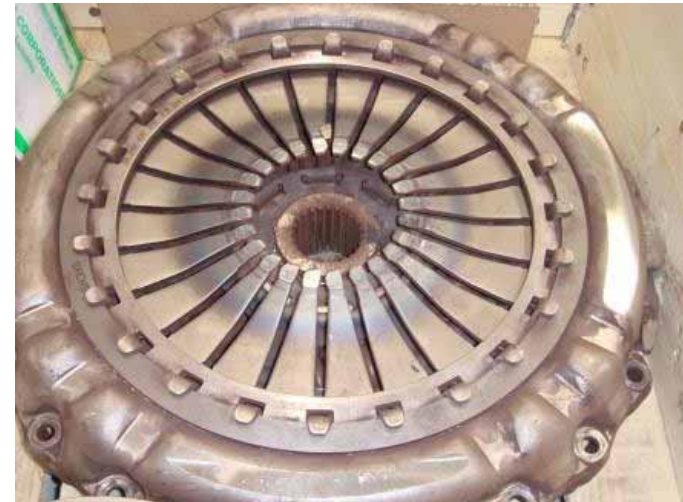
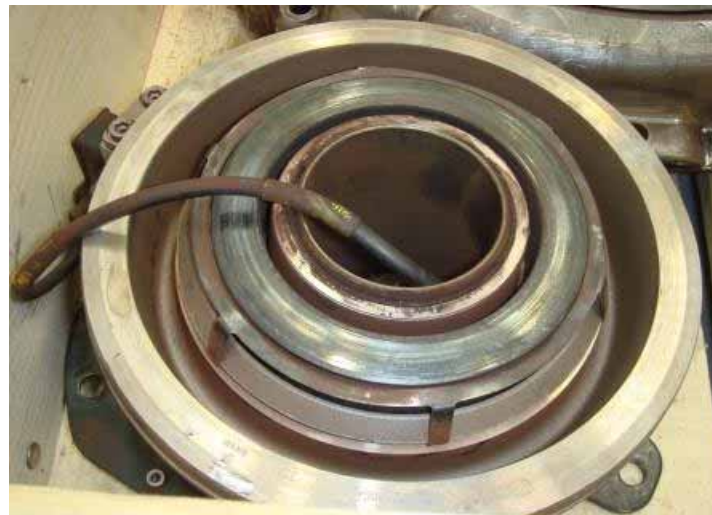
Claim info Importer: 1320 Repair date: 2009-05-28 Dealer: 1486 Inspector report: No Reference no: 300625 SCC code: Job no: 1 SCC description: Return to dealer: No			0001320 1486030082501 Analysis Problem: Release bearing seized Result: Release bearing seized Pressureplate diaphragmspring tips badly worn
Vehicle data Chassis Id: B-479874 Marketing type: FM13 62R Mileage: 184000 Operating hours: Assembly date: 2007-06-25 Dealer: Approved Age: 20 Delivery date: 2007-10-10 feedback: Root cause:			
Cost summary (SEK) Deb. Code Labour costs Material costs Other costs 18 29.87 103.08 0			
Decision and status TMA decision: Approved TMA status: Analysis pending Third party analysis Third party: Third party decision: Third party result:			
Received causal part Part number: VO-20806451 CYLINDER VO-20806451 CYLINDER Part mileage: Serial no: Part age: Supplier: 6902 ZF SACHS AG 6902 ZF SACHS AG Part fitted date:

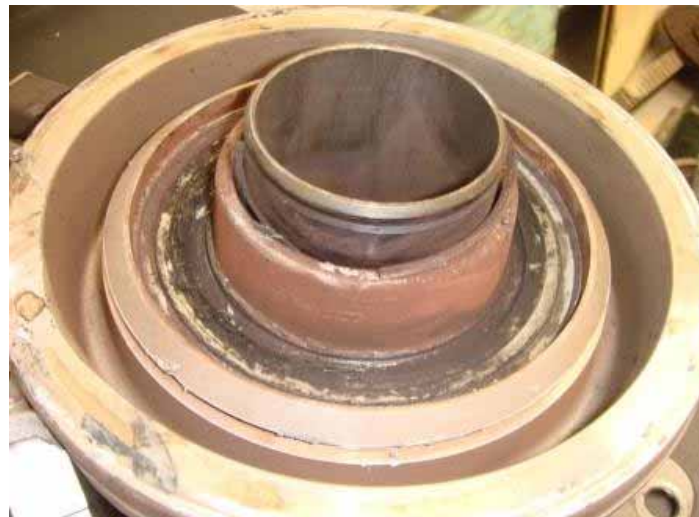
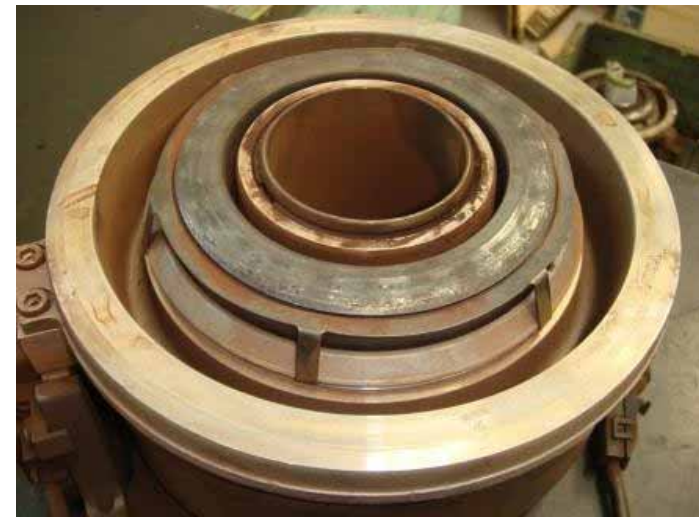
Claim info Importer: 1320 Dealer: 8930 Reference no: 318948 Job no: 2 Return to dealer: No		Repair date: 2009-06-11 Inspector report: No SCC code: SCC description:		Barcode: 0001320 9930031694802 Analysis Problem: Clutch cylinder stuck Result: Clutch cylinder stuck	
Vehicle data Chassis id: B-496599 Mileage: 288358 Assembly date: 2007-11-22 Age: 19		Marketing type: FM13 42T Operating hours: Dealer feedback: Approved Root cause:		Delivery date: 2007-12-01	
Cost summary (SEK) Deb. Code: 18 Labour costs: 24.41 Material costs: 55.70 Other costs: 0				Decision and status TMA decision: Approved TMA status: Analysis pending	
Received causal part Part number: VO-20806451 CYLINDER Serial no: NONE Supplier: 6992 ZF SACHS AG Part group: 4312 housing; clutch casing Part age: 6 Transmission Part fitted date: 32 Defect code:

Claim info Importer: 1320 Dealer: 1465 Reference no: 306282 Job no: 1 Return to dealer: Yes		Repair date: 2009-07-29 Inspector report: No SCC code: SCC description:		Barcode: 0001320 1465030528201 Analysis Problem: Sensor failure Result: Sensor failure - release bearing scored as consequence. Dustcover loose	
Vehicle data Chassis id: A-646346 Mileage: 284821 Assembly date: 2007-05-15 Age: 23		Marketing type: FH13 62T Operating hours: Dealer feedback: Approved Root cause:		Delivery date: 2007-09-01	
Cost summary (SEK) Deb. Code: 18 Labour costs: 30.85 Material costs: 63.76 Other costs: 0				Decision and status TMA decision: Approved TMA status: Analysis pending	
Received causal part Part number: VO-20806451 CYLINDER Serial no: NONE Supplier: 6992 ZF SACHS AG Part group: 4312 housing; clutch casing Part age: 82 Part fitted date: Defect code:

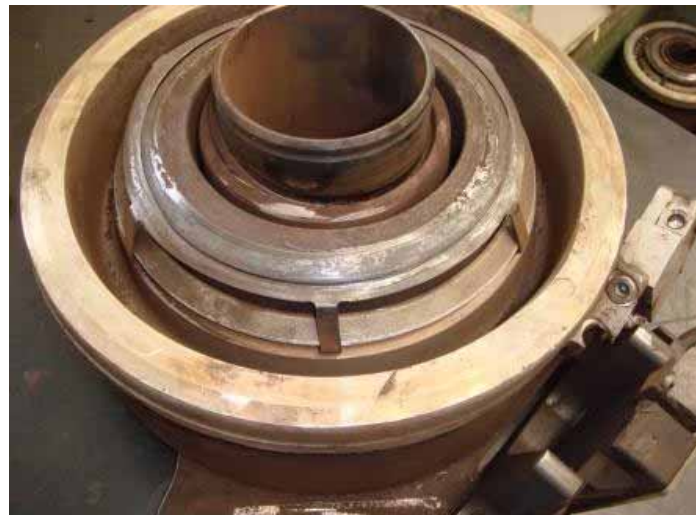
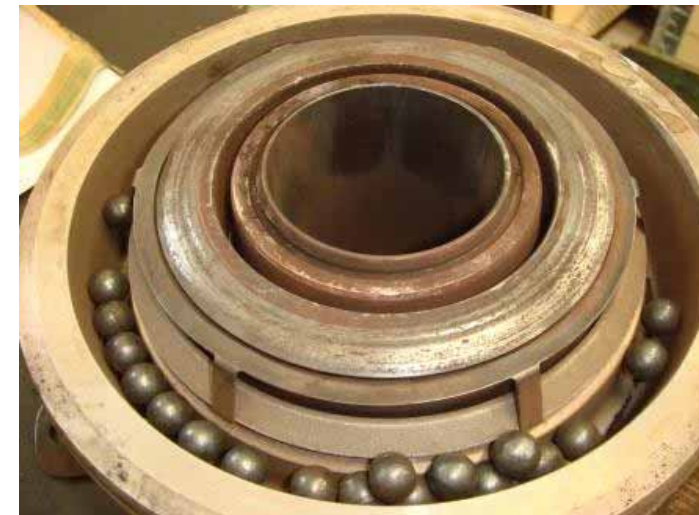
Claim info Importer: 1320 Dealer: 1239 Reference no: 320789 Job no: 1 Return to dealer: No		Repair date: 2009-07-09 Inspector report: No SCC code: SCC description:		Barcode: 0001320 1239032078901 Analysis Problem: Release bearing seized Result: Release bearing seized. Contact totally destroyed. Pressure plate deformed. Spring too badly worn.	
Vehicle data Chassis id: B-490664 Mileage: 286521 Assembly date: 2007-10-08 Age: 20		Marketing type: FM13 62T Operating hours: Dealer feedback: Approved Root cause:		Decision and status TMA decision: Approved TMA status: Analysis pending Third party analysis Third party decision: Third party result:	
Cost summary (SEK) Del. Code: 18 Labour costs: 19.36 Material costs: 38.50 Other costs: 3.22		Received causal part Part number: VO-20806451 CYLINDER Serial no: Supplier: 6992 ZF SACHS AG Func. group: 4312 housing; clutch casing Func. area:		Part mileage: Part age: Part fitted date: Defect code: 21

Claim info Importer: 1480 Dealer: 902589 Reference no: 1100512 Job no: 1 Return to dealer: No		Repair date: 2009-06-16 Inspector report: No SCC code: SCC description:		Barcode: 0001460902569110051201 Analysis Problem: Sensor failure Result: Sensor failure, release bearing across	
Vehicle data Chassis id: A-854191 Mileage: 190613 Assembly date: 2007-10-04 Age: 19		Marketing type: FM13 64R Operating hours: Dealer feedback: Approved Root cause:		Decision and status TMA decision: Approved TMA status: Analysis pending Third party analysis Third party decision: Third party result:	
Cost summary (SEK) Del. Code: 18 Labour costs: 95.95 Material costs: 99.07 Other costs: 0		Received causal part Part number: VO-20806451 CYLINDRE Serial no: Supplier: 6992 ZF SACHS AG Func. group: 4312 housing; clutch casing Func. area: 6 Transmission		Part mileage: Part age: Part fitted date: Defect code: 32

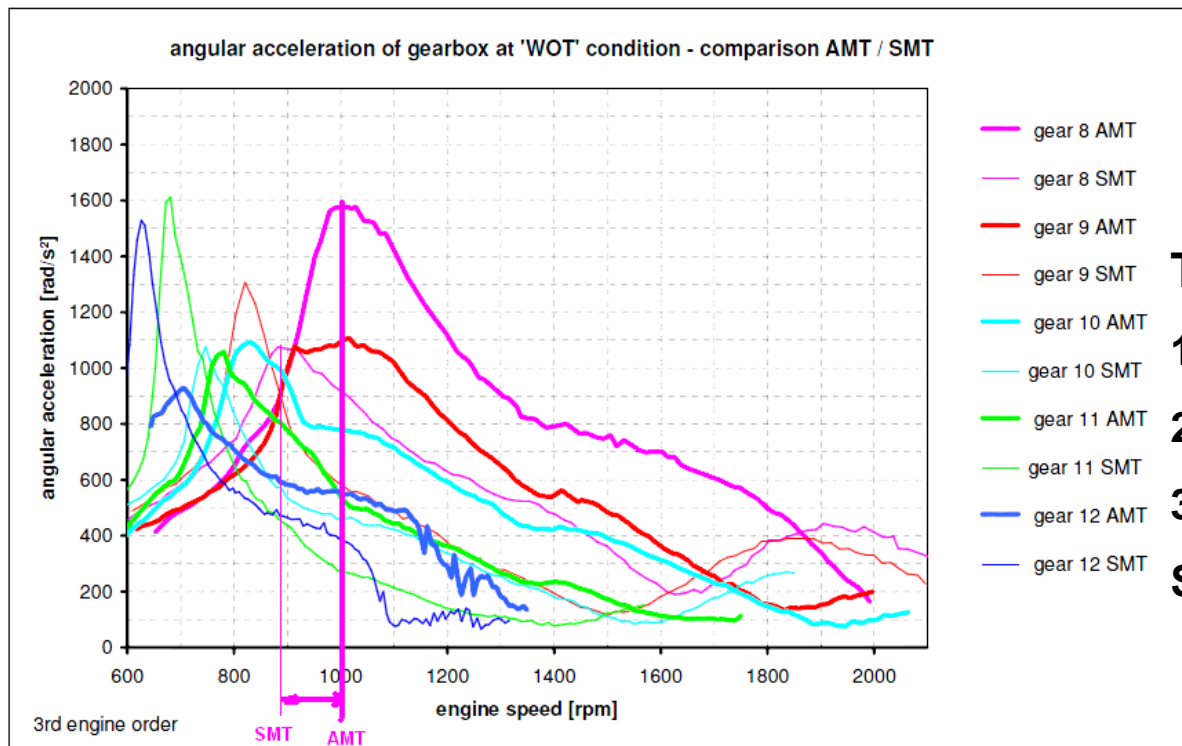
position of resonance peak – comparison AMT / SMT

Test ongoing to confirm

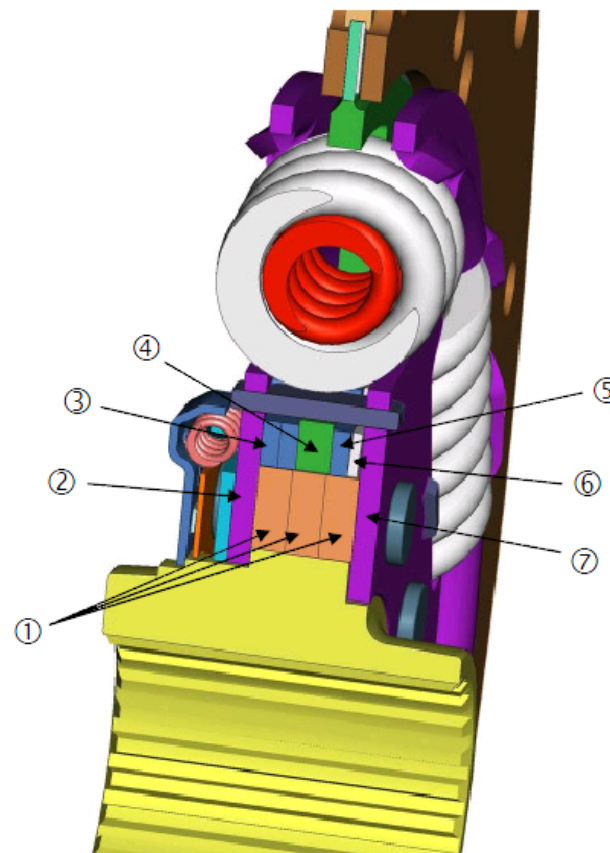
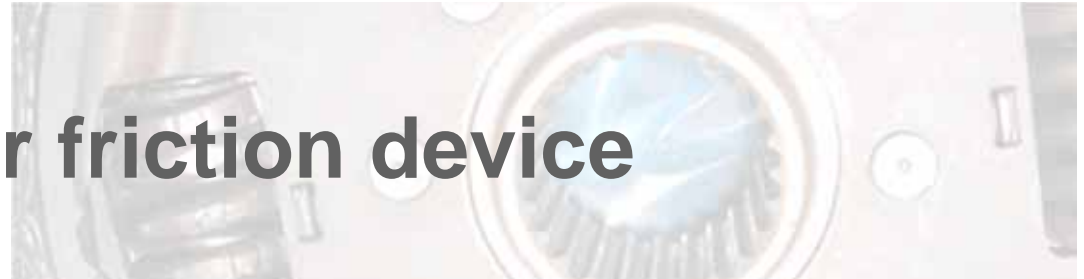
Clutch disc damper friction device

- Retainer plate ②
- 2x Engine sided friction ring ③
- Driven disc ④
- Gearbox sided friction ring ⑤
- Belleville spring ⑥
- Retainer plate ⑦

- Piece cost: +1.35€
- Tooling VPT share: 59 K€

- Field tests in UK, Finland and Sweden. W22->
- Accelerated test for wear on friction device, TBD

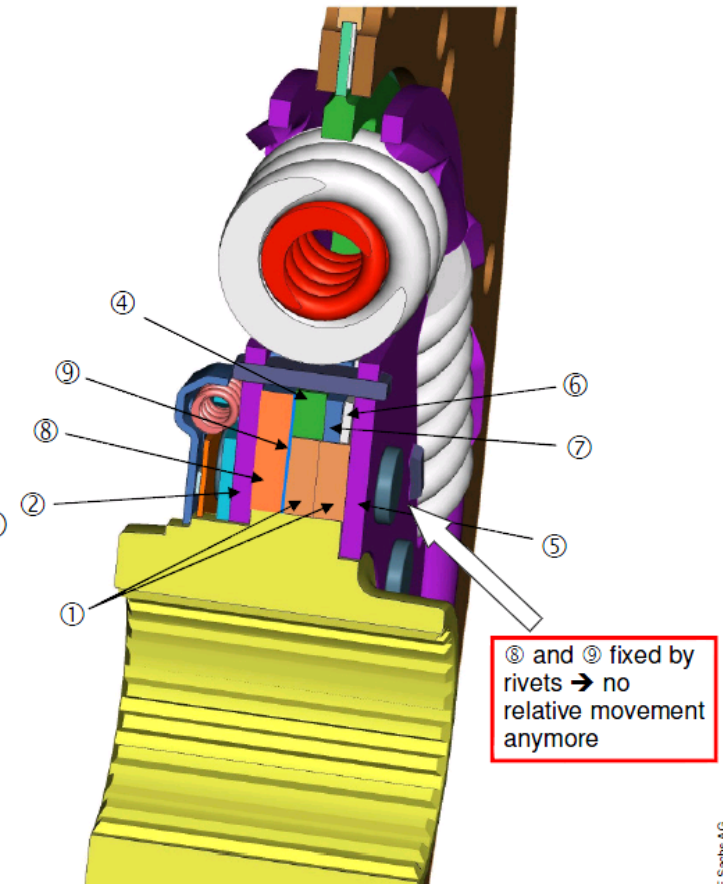
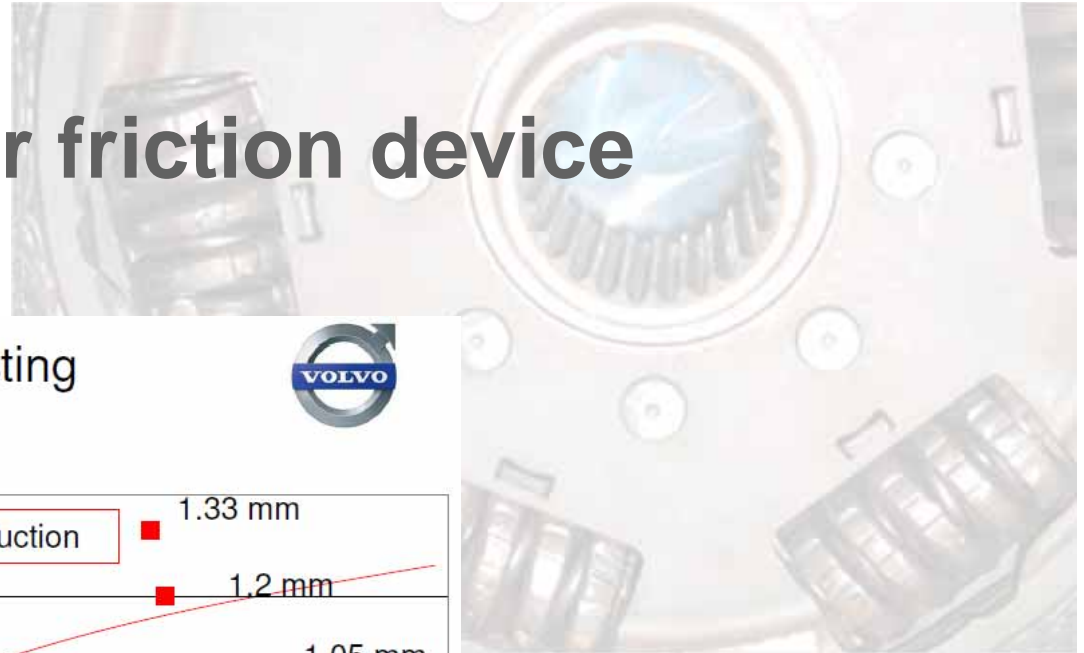
Clutch disc damper friction device

- Retainer plate ②
- 1x Hub friction ring ⑧
- 1x Hub friction ring (friction layer) ⑨
hardened → lower wear
- Driven disc ④
- Gearbox sided friction ring ⑤
- Belleville spring ⑥
- Retainer plate ⑦

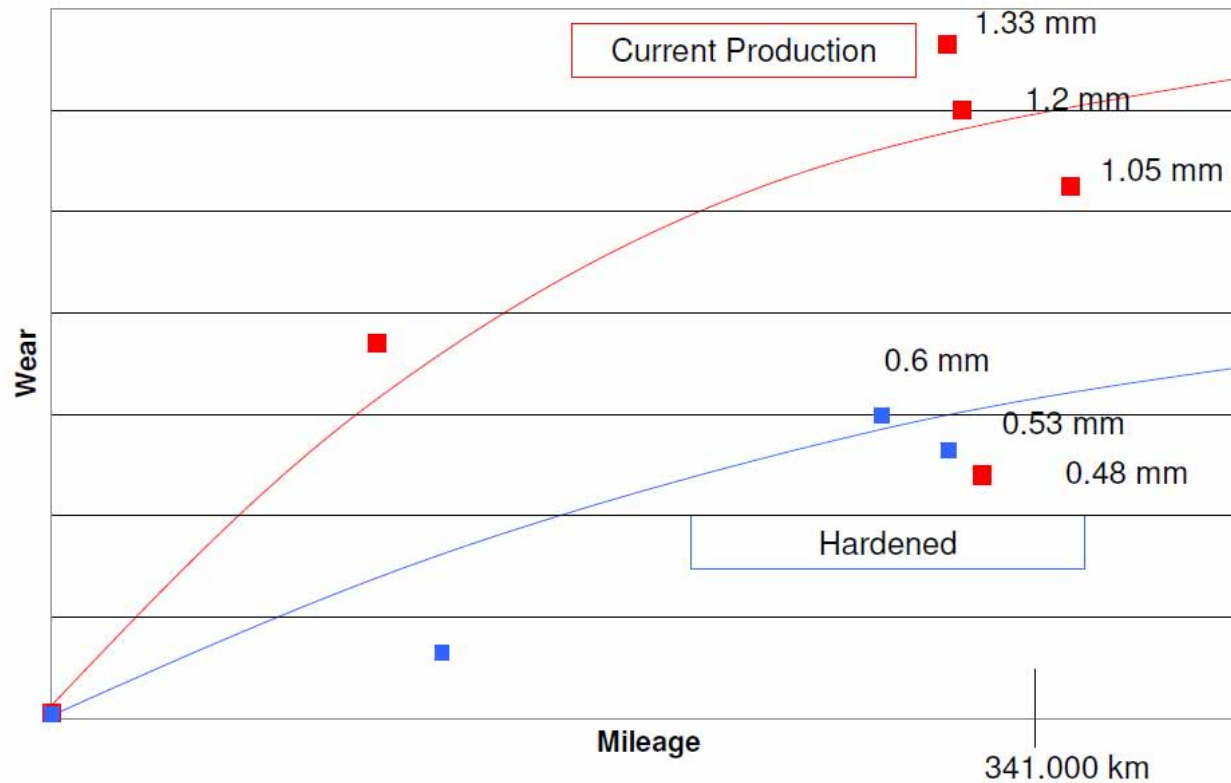
Results of Prototype Testing

For field testing with VPT
50 000 km gives a good
hint of wear.

But to get an idee of the wear
curve longer test are needed

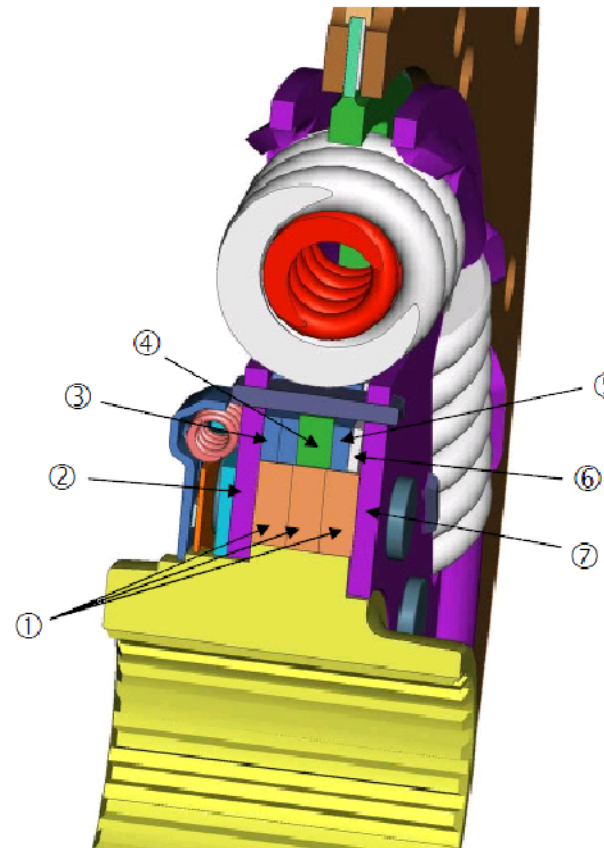
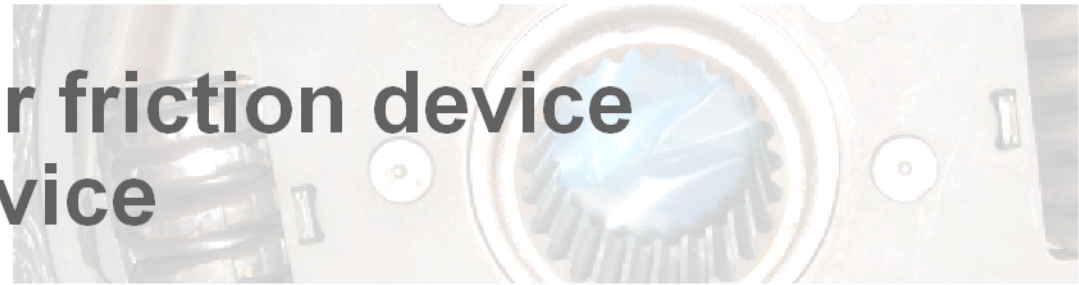
Clutch disc damper friction device

- Retainer plate ②
- 2x Engine sided friction ring ③
- Driven disc ④
- Gearbox sided friction ring ⑤
- Belleville spring ⑥
- Retainer plate ⑦

Wear of friction device

- Piece cost: +1.35€
- Tooling VPT share: 59 K€

- Field tests in UK, Finland and Sweden. W22->
- Accelerated test for wear on friction device, TBD

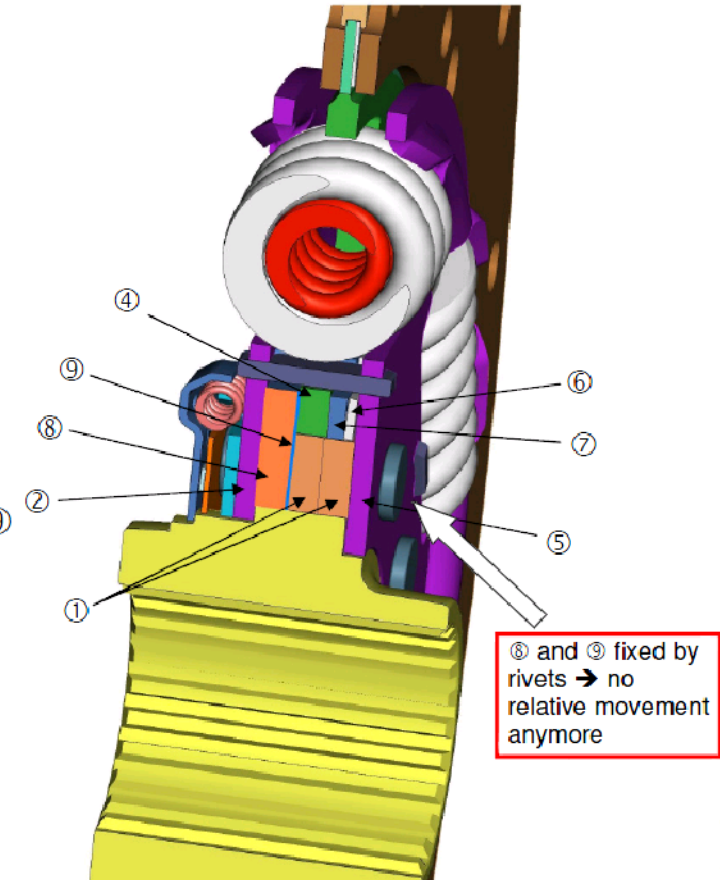
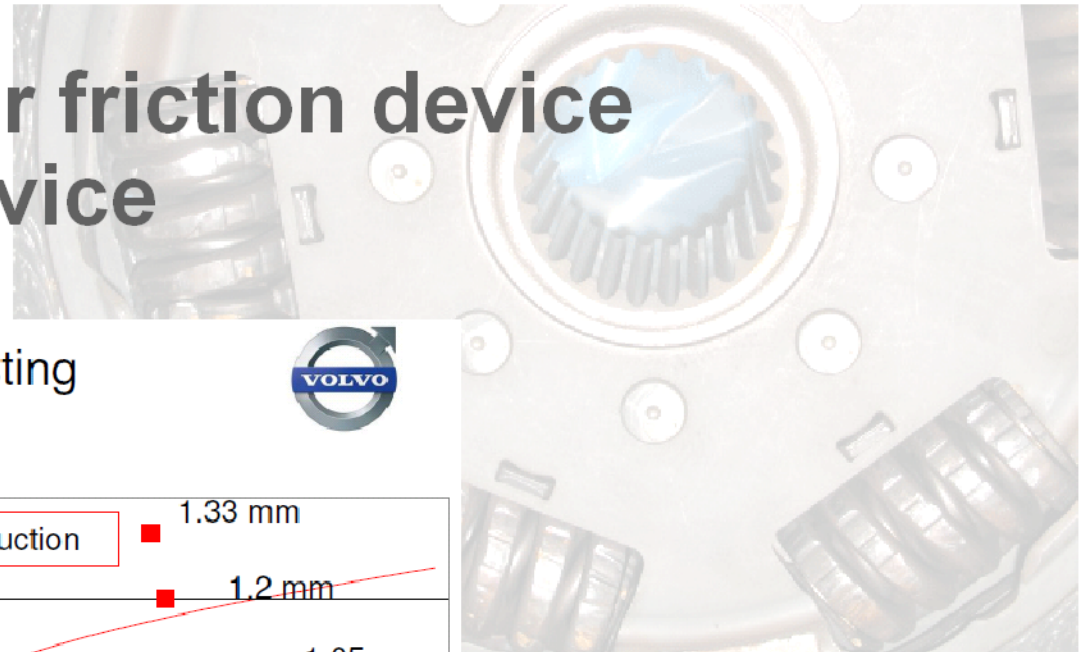
Clutch disc damper friction device

- Retainer plate ②
- 1x Hub friction ring ⑧
- 1x Hub friction ring (friction layer) ⑨
hardened → lower wear
- Driven disc ④
- Gearbox sided friction ring ⑤
- Belleville spring ⑥
- Retainer plate ⑦

Wear of friction device

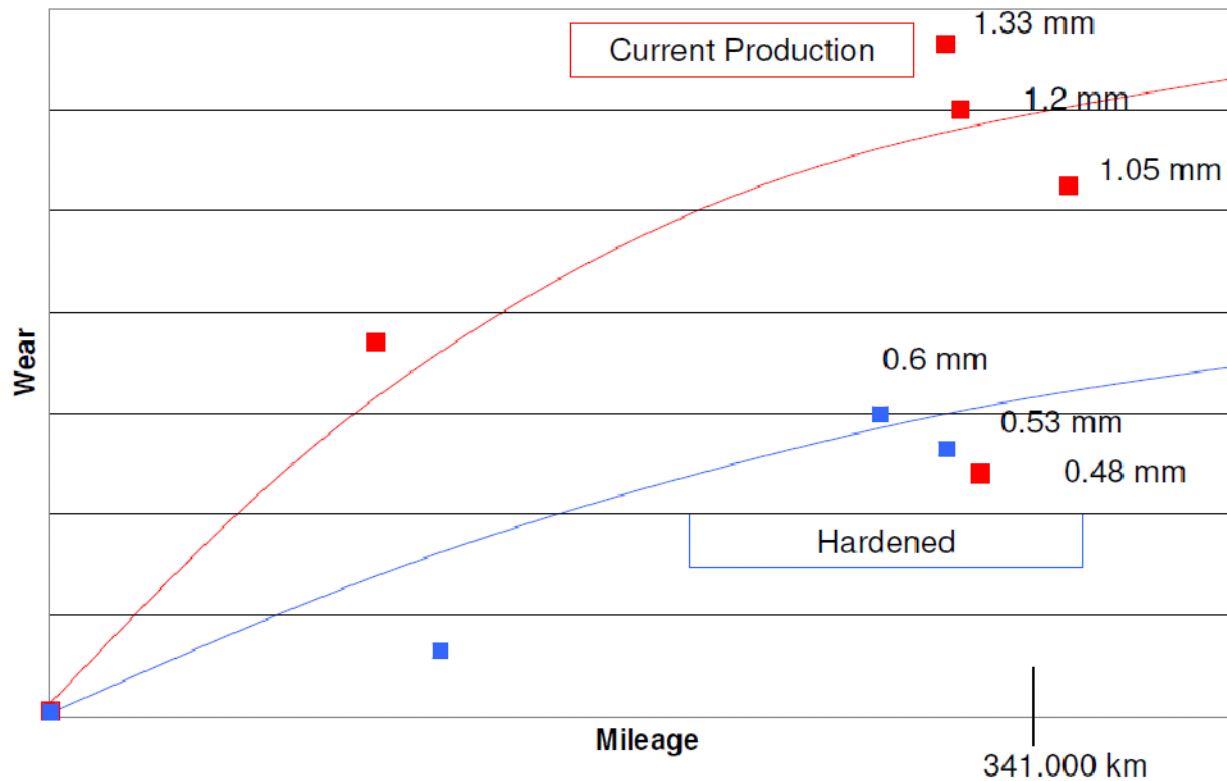
Results of Prototype Testing

For field testing with VPT
50 000 km gives a good
hint of wear.
But to get an idee of the wear
curve longer test are needed

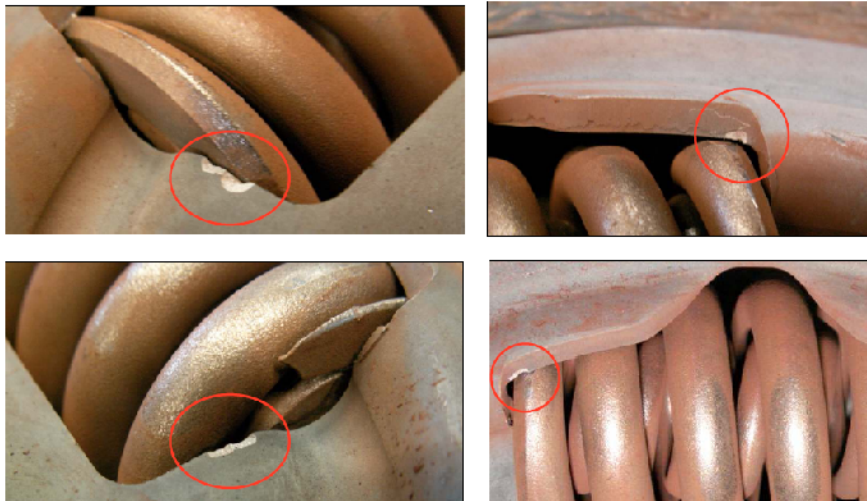
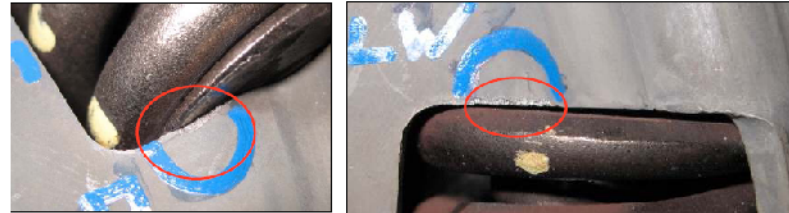
- Flaking is not a new phenomena, it was found on both materials(new and old).
- It is not a VOLVO specific problems acc. To ZFSachs
- ZF Sachs was not aware of this until VOLVO found it.
- ZFSachs are analyzing this and will present a plan of improvements for VOLVO.

flakings of the Volvo field test clutch

test results

serial retainer plates - C10

- 2 major flakings on plate 1843000025 (flywheel-side)

- 1 major flaking on plate 1843000028 (gearbox-side)

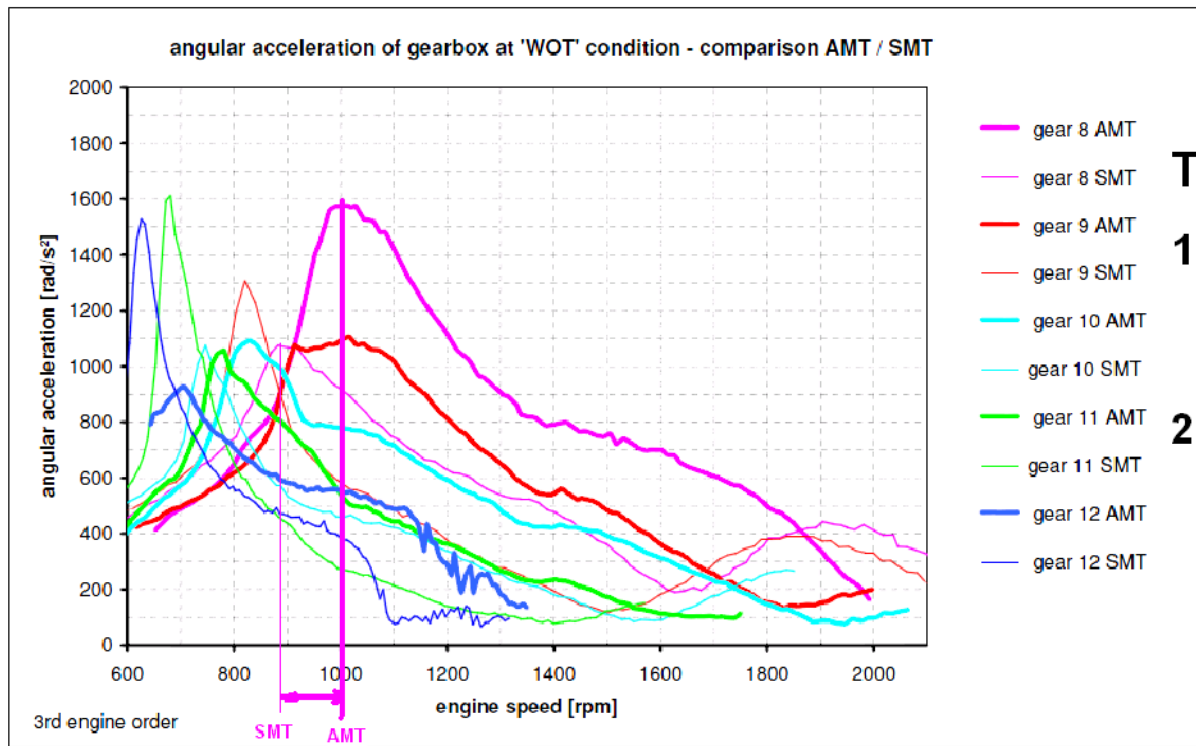
position of resonance peak – comparison AMT / SMT

Test has confirmed results

1. AMT has a higher resonance rpm compared to SMT (+100rpm)
2. AMT drives more frequent in lower rpm (resonance rpm's) compared to a SMT.

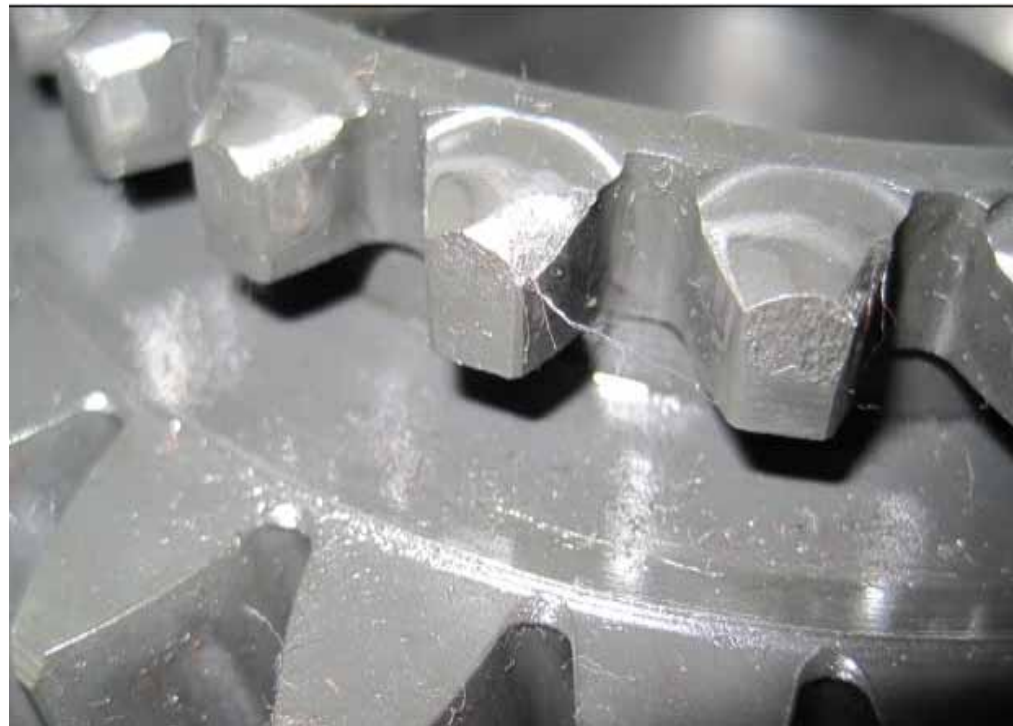
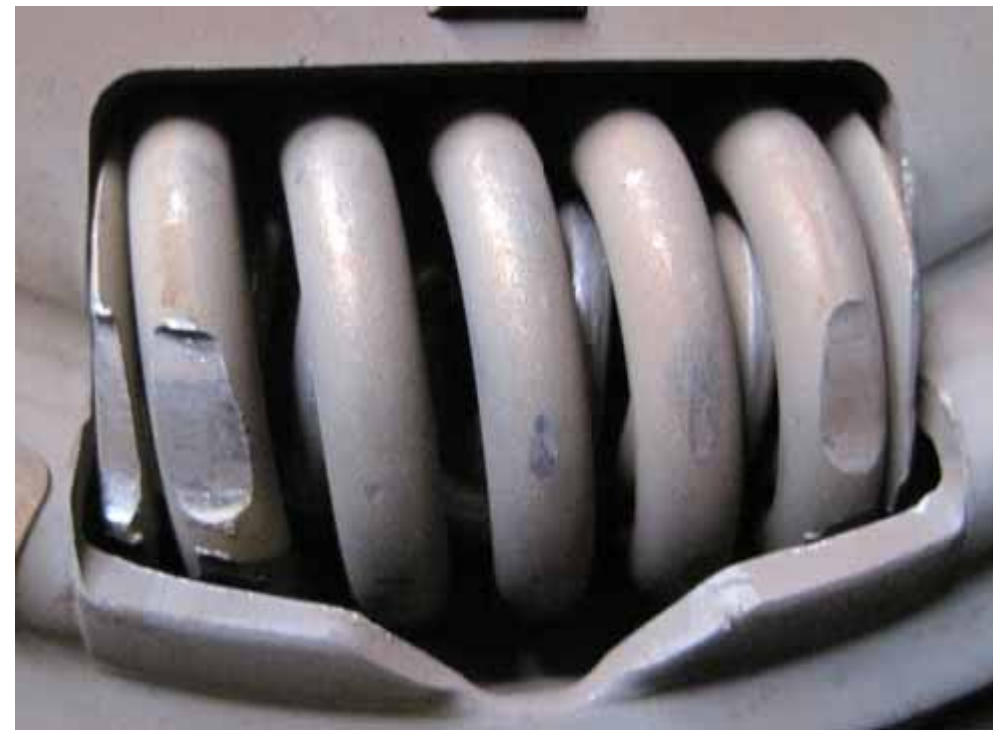
A-659144 - 283154klms

Variant C Gear Jump Out

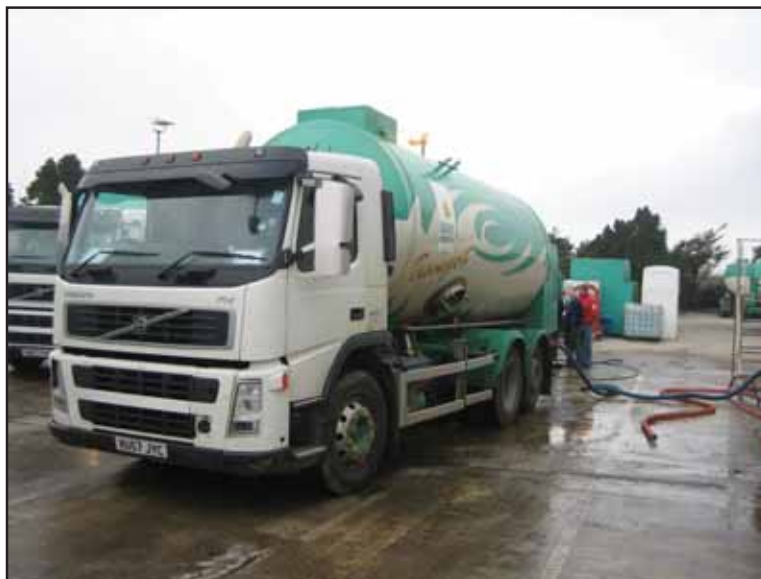
Figure 1 Milk truck from Dairy Crest.

The vehicle was delivered in the end of 2007, all problem listed below is only transmission related.

- 2008-12-04, mileage 125 484Km: Change clutch disc and pressure plate because of damaged damper springs. Kit no. 85000907.
- 2009-05-21 mileage 183 000Km: Gear jumping out. Changed gear, engaging sleeve etc. As a pre-caution they changed the clutch disc also. Part no. 85000625.
- 2010-02-11 mileage 263 145Km: One piston rod in the GCU broken, change of the complete GCU. Part no. 21314138
- Also see Argus QJ 1-1359387371 & MQR 1320-2522.

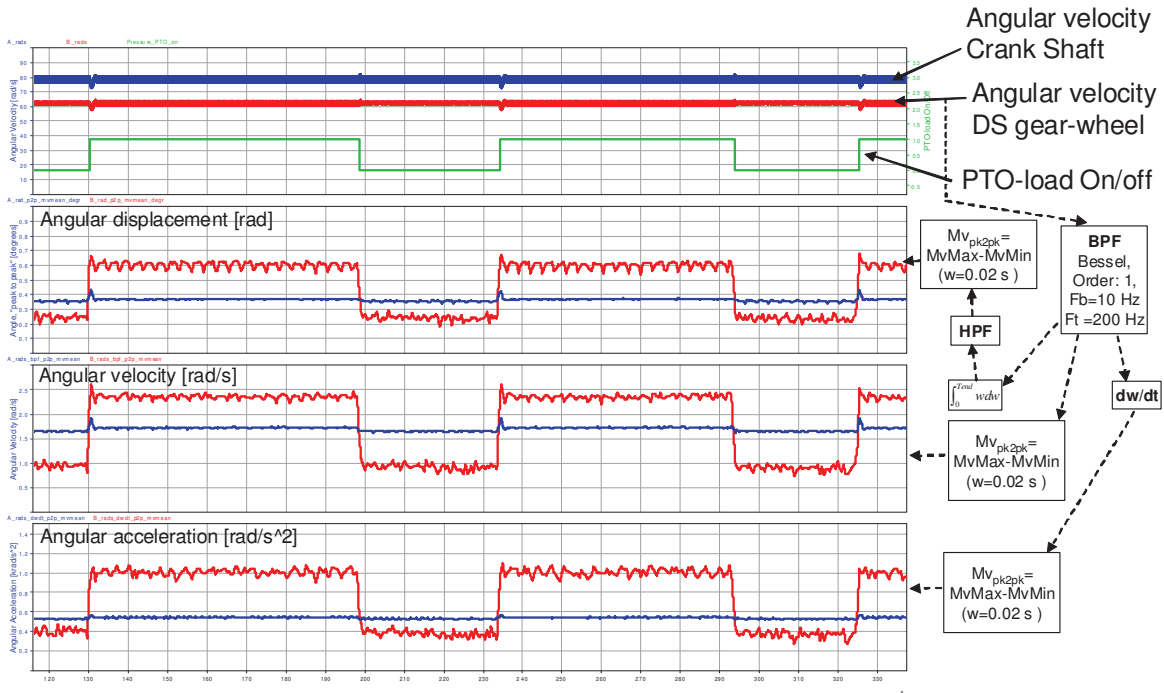
Engine load on engaged PTO was very low (~2kW @ 760 rpm).

PTO runtime is ~40-50% of total engine hours, the milk compressor in on 48% of the PTO run time.

Figure 3 PTO-load on/off (typical for loading milk, dataset d107)
