maintenance-site-vpt ▶ Driveline - Active Issues... Question 9 Describe all modifications or changes made All Documents

PE13-002

VOLVO TRUCK

QUESTION 9

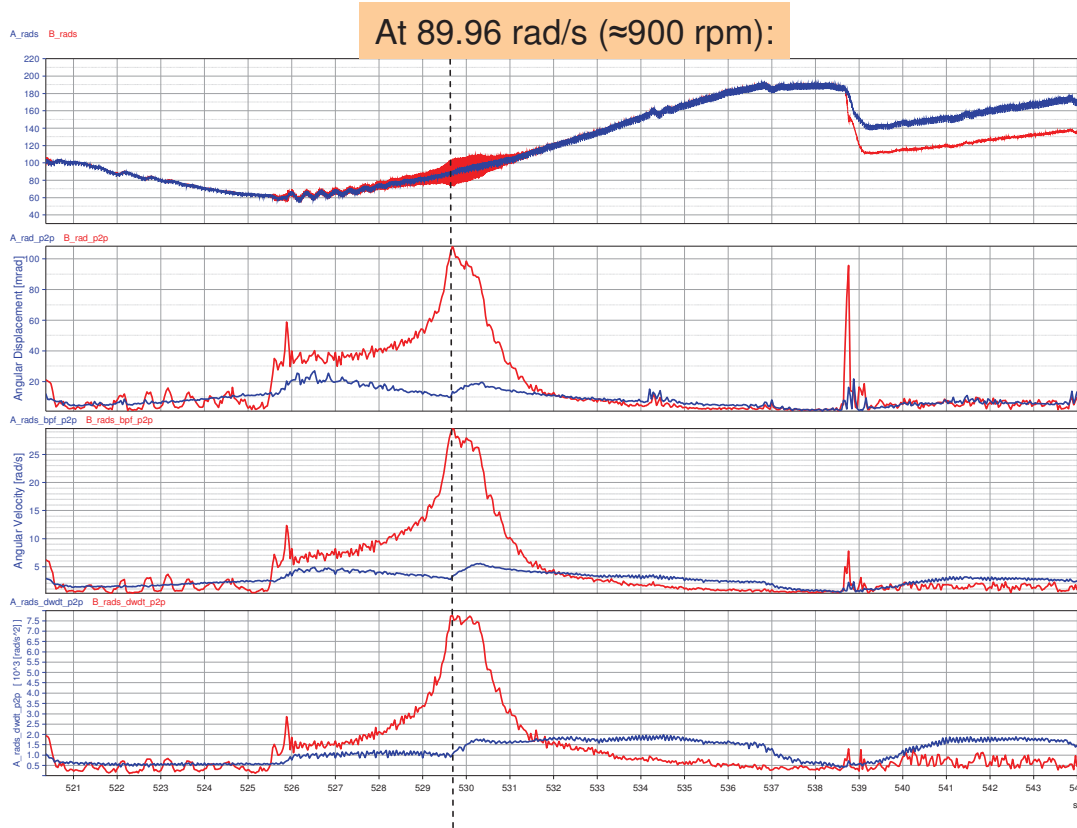
Figure 8 Typical acceleration with Bad Clutch, dataset = d209.

3.4.3 Full load sweeps
Bad clutch

At low engine speeds the clutch system acts as an amplifier for the third order torsional vibrations. This can be seen in all the measurement with worn clutches. On PTO load the amplitude of the torsional vibration differs with engine load.

Improve the clutch and measure what gets worn, when and why.

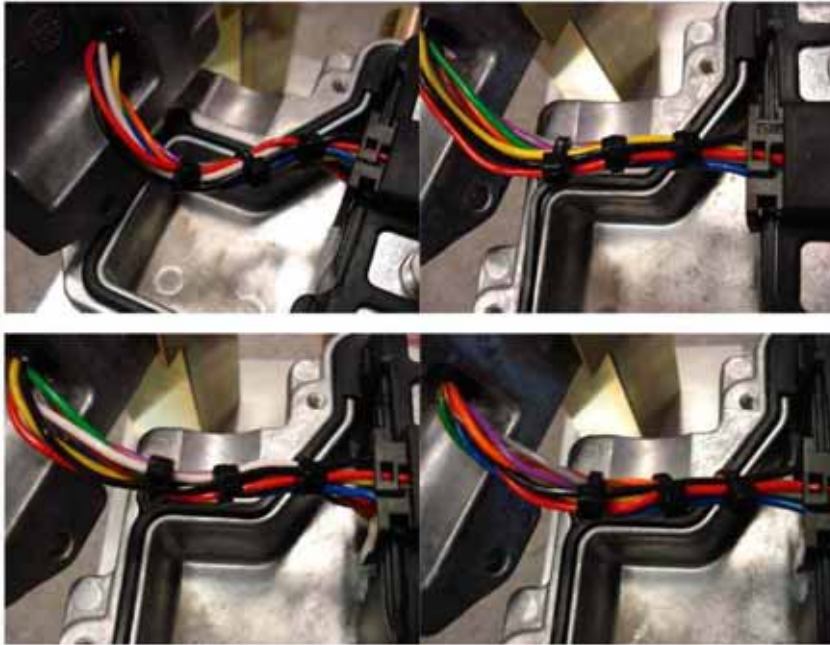
Due to not sufficient clamping of CVU internal cables, there have been claims of electrical connection broken and of water intrusion. Some cables have been squeezed between cover and housing during assembly at supplier.

After S/N 36050 the assembly process has been changed. 3 cable ties are mounted:

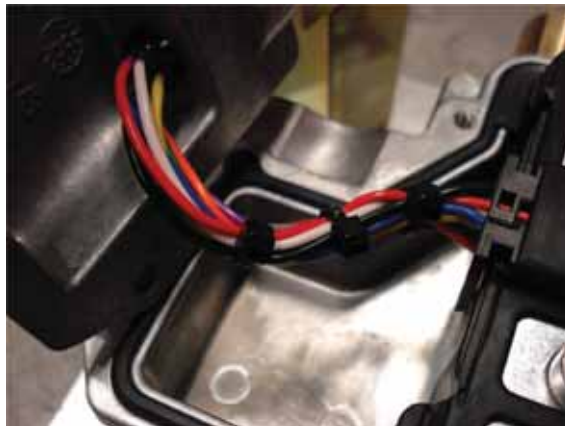
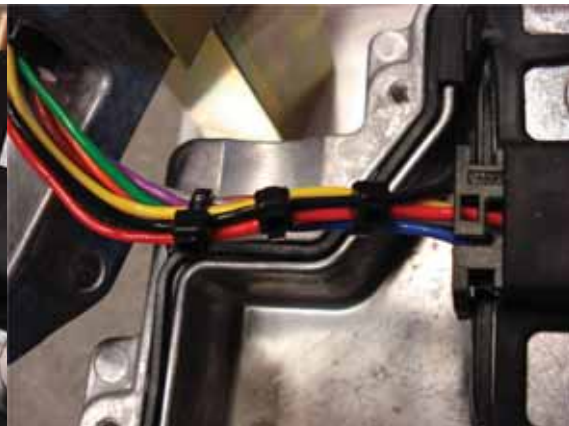
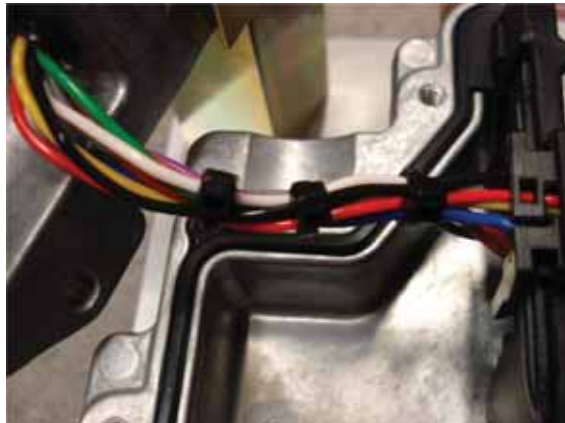
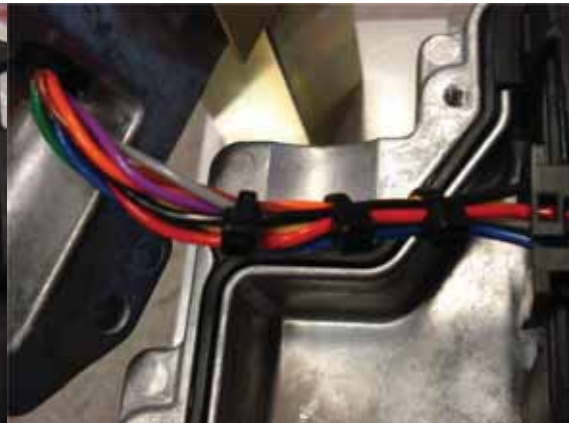
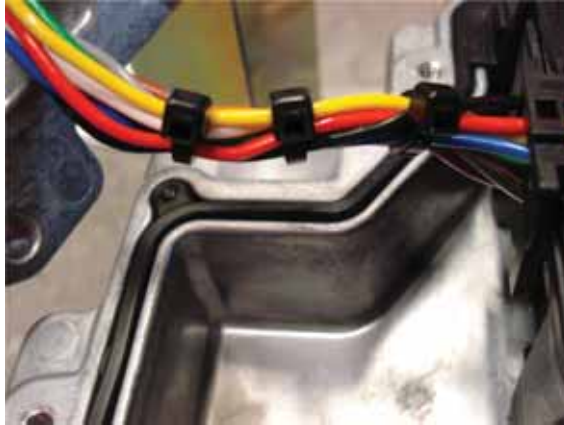
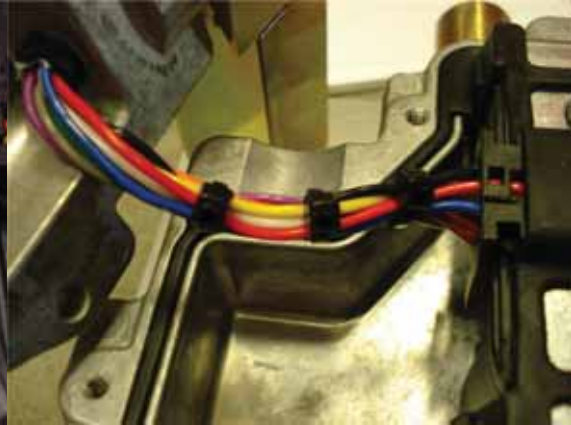
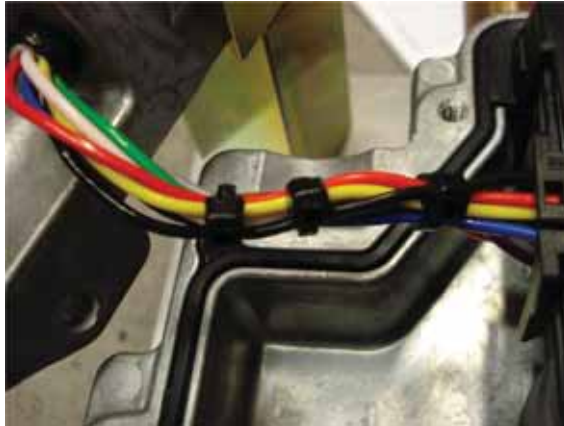
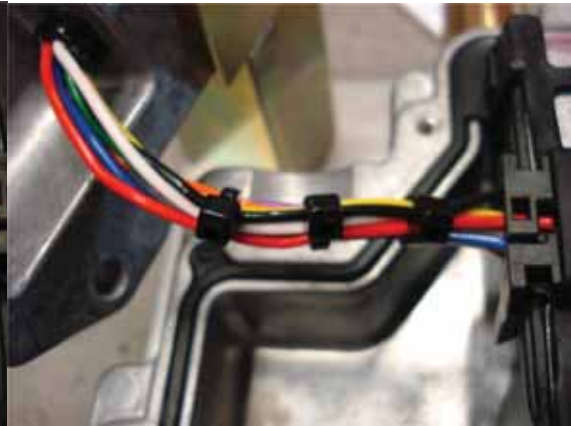
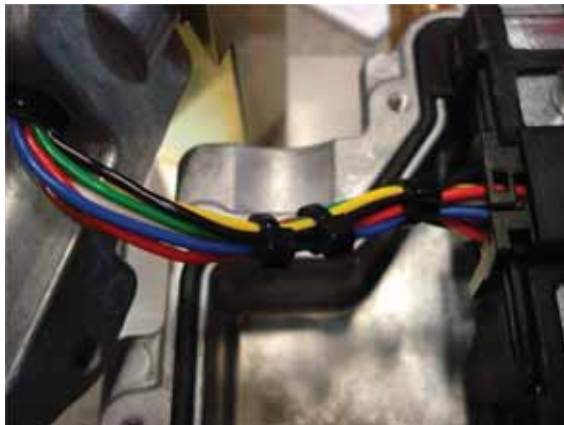
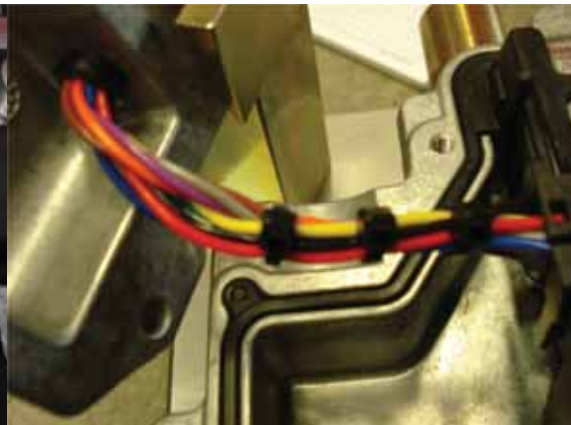
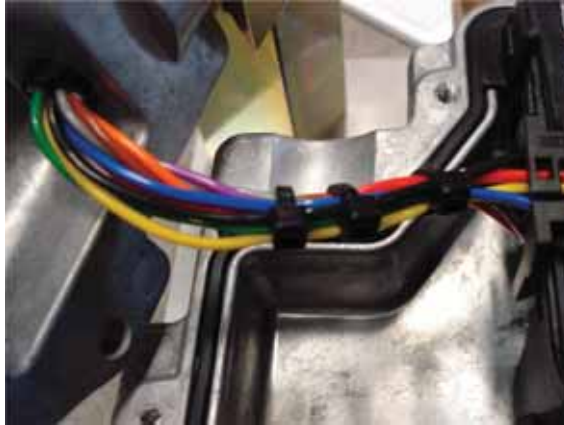
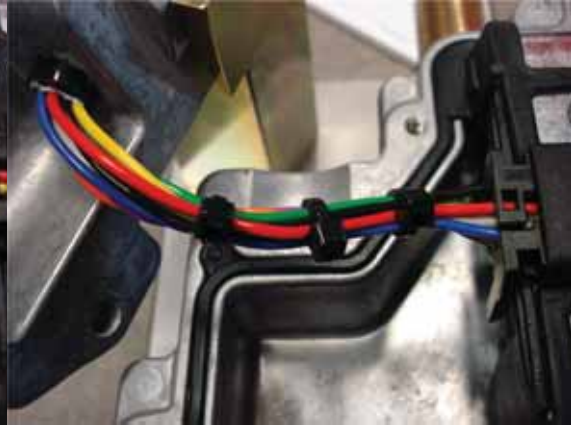
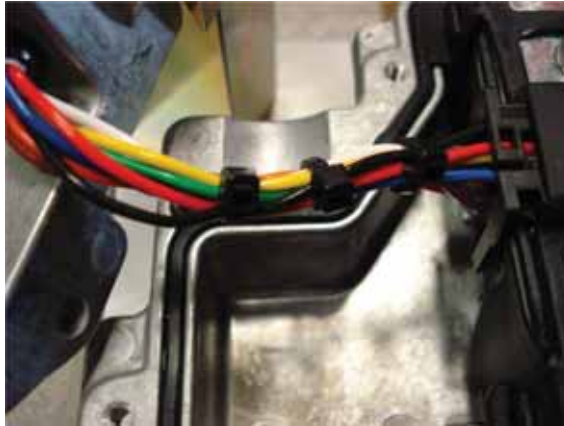
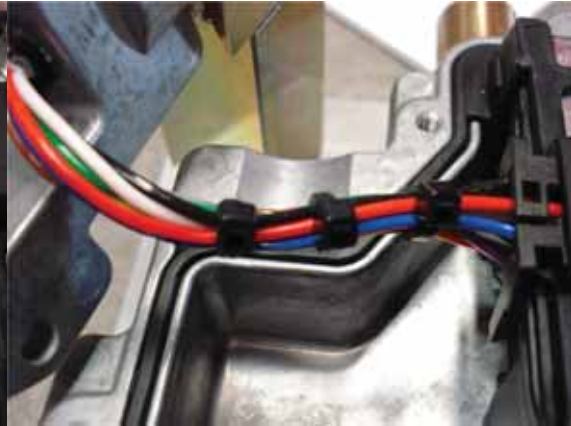
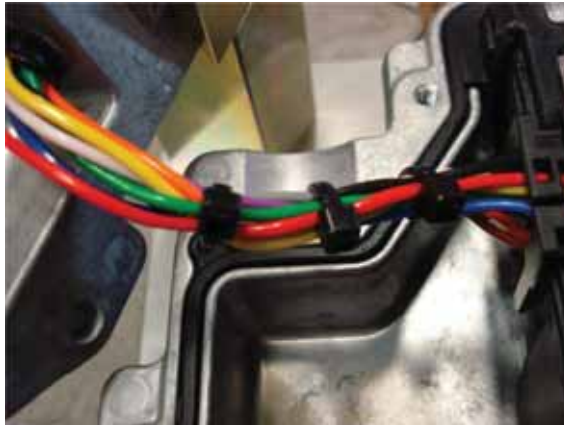
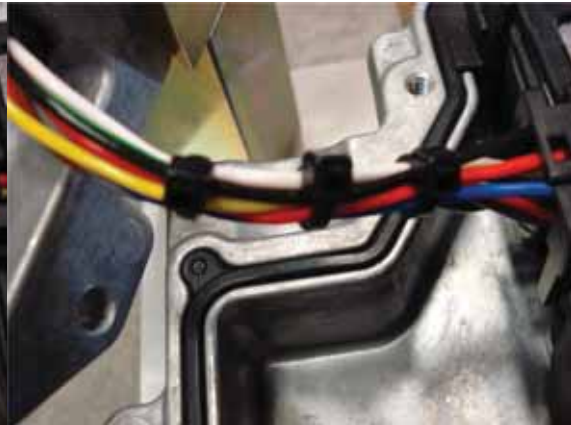
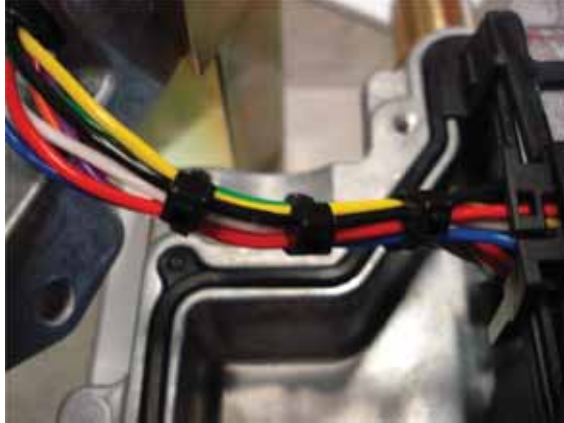
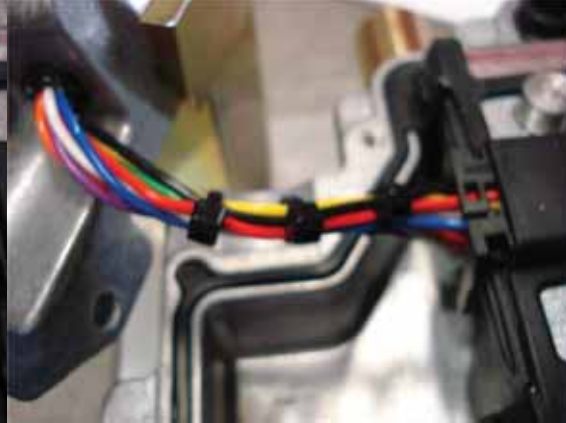
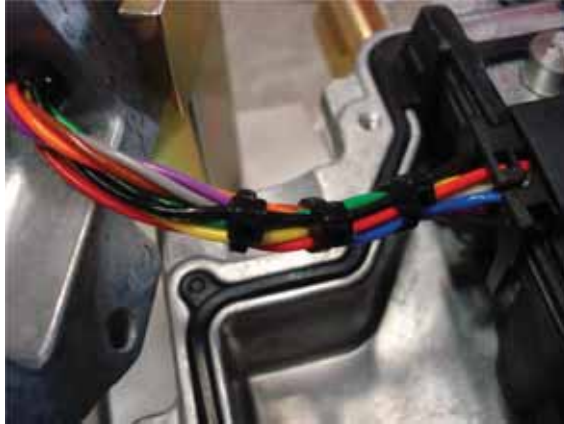
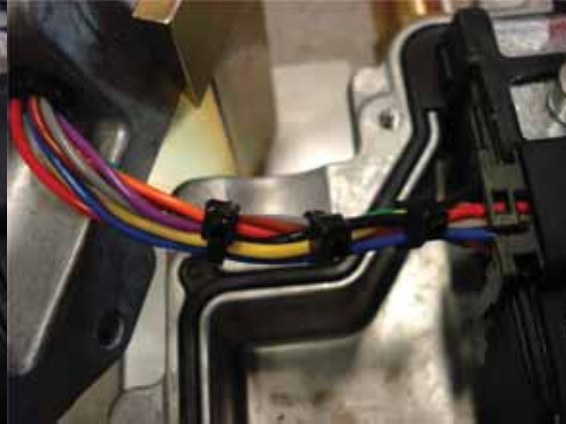
Nedan följer bilder från verifieringen i den följd som ventilerna plockades för verifiering.

Samtliga ventiler hade tre stripes och dessa satt enligt gällande förfarande.
Inga klämda kablar och klämrisken anses minimal.
