PE13-017

SUTPHEN

7-25-2013

Enclosed is the information that was requested as part of Preliminary Evaluation PE13-017.

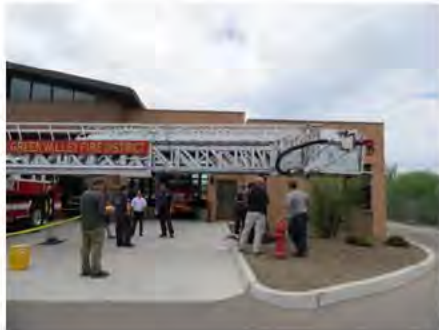
When [REDACTED] arrived we had swung the boom to the right sight side of the apparatus to get a better view of the underside of the boom assembly.

Mr. [REDACTED] asked [REDACTED] to take the pulley wheels apart. The pin appeared to be difficult to remove and required considerable force to drive the pin out.

Once the first wheel was removed we found that there was no visible lubricant and the composite bearing was worn completely away on one side. The pin itself was worn flat about 3/16 to 1/4". The wheel is showing signs of abnormal wear on both the top and bottom side where it was rubbing on the bracket.
