PE13-018

FORD

APPENDIX G

Engineering Review

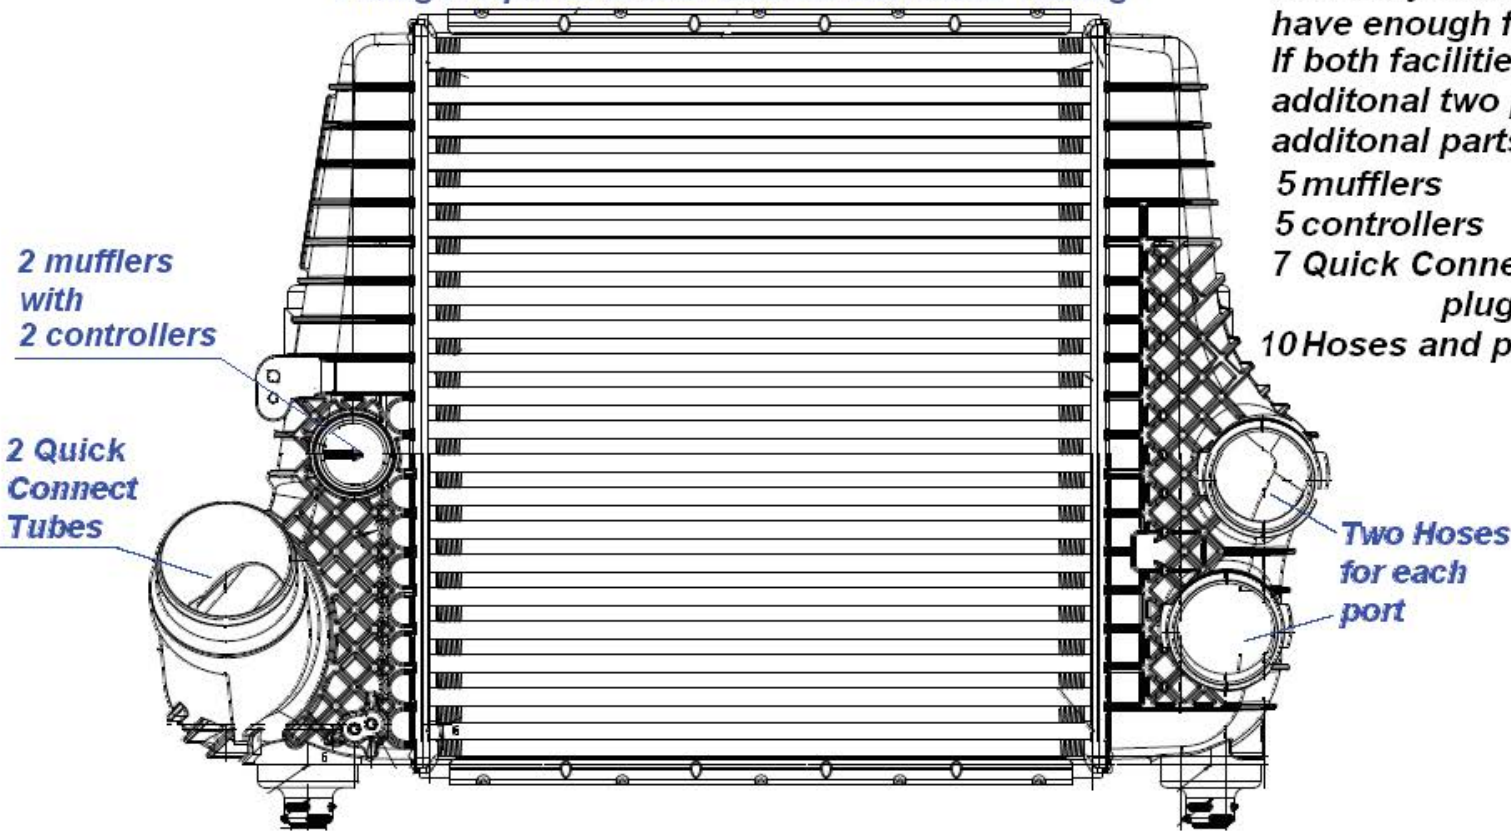
These five openings need to be plugged

**Fittings required to seal CAC for Corrosion Testing**

**Currently Auburn hills and Greensburg have enough fittings to test 2 parts each. If both facilities will need to test and additional two parts each the following additional parts will be needed**

- 5 mufflers**
- 5 controllers**
- 7 Quick Connect Tubes and plugs for (outlet port)**
- 10 Hoses and plugs for (inlet port).**

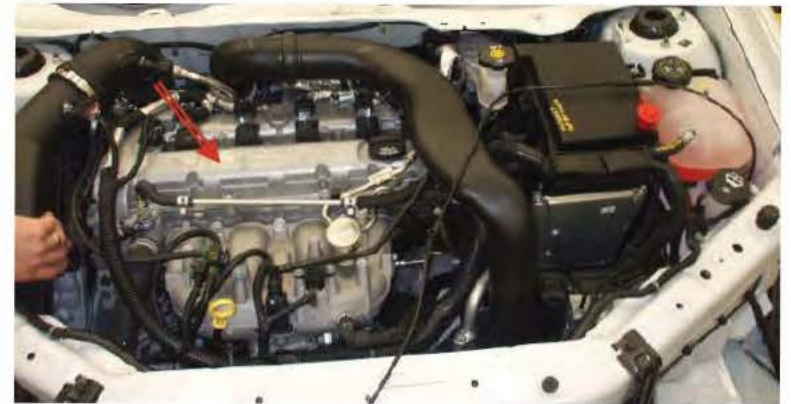
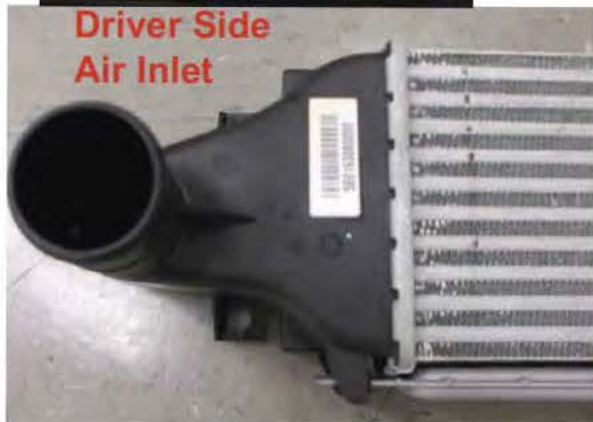
Core 74X705x160 mm  
10 tubes, Int/Ext Fin, 62 FPD  
in/out ports: ID/OD=54/60mm  
Core=6.64lb, total =9.1lb  
CBE = \$28.62  
water collector on bottom
