PE13-018

FORD

APPENDIX G

Engineering Review

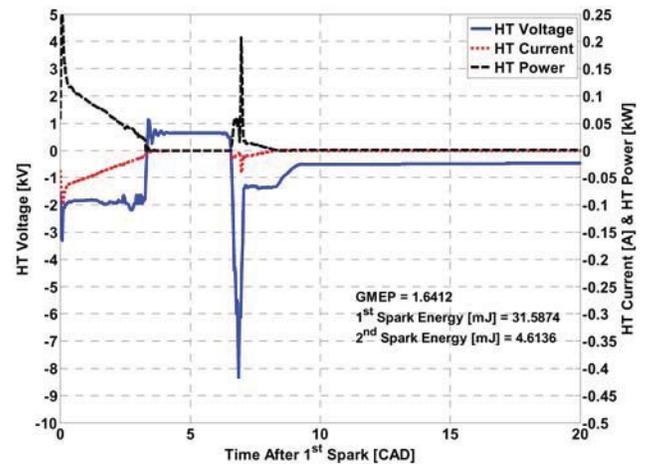
[Figure 29](#) shows the HT voltage, HT current and instantaneous power for a firing cycle. The end of the 2nd injection occurred at 0.2 CAD aIGN. The HT voltage for both the 1st and the 2nd spark is extremely stable. The arc current is decaying away to zero. The HT trace shows that at this spark plug orientation, the arc is not being stretched, either for the 1st spark or for the 2nd spark [8].

Figure 29. Arc histories for the 2 o'clock spark plug orientation EOI2 0.2 CAD aIGN firing cycle showing no evidence of the flow stretching the arc

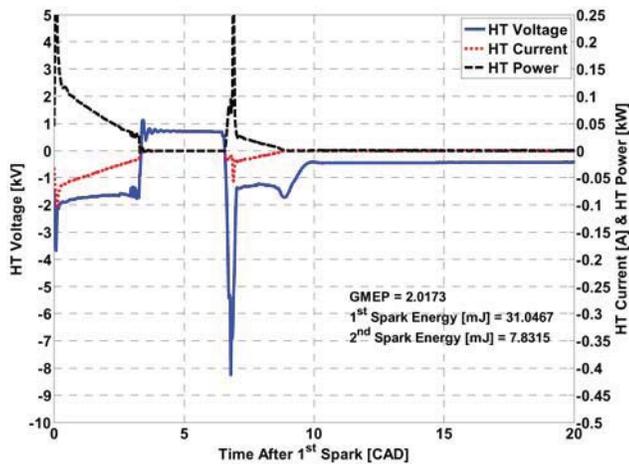
The same behavior is seen when the end of the injection occurs 12.2 CAD aIGN, as shown in [Figure 30](#) for a firing cycle and [Figure 31](#) for a misfiring cycle.

At the 2 o'clock spark plug orientation. No stretching of the arc is seen, even when the end of the 2nd injection occurs extremely close to the spark.

Figure 30. Arc histories for the 2 o'clock spark plug orientation EO12 12.2 CAD aIGN firing cycle showing no evidence of the flow stretching the arc

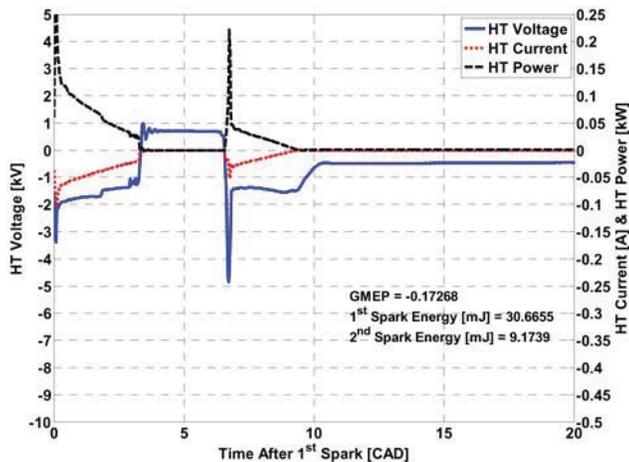
Misfires are seen, only when the 2nd injection is retarded from the spark. The HT traces shown indicate, that both sparks of the twin spark strategy are being struck. The twin spark strategy increases the probability of ignition hence reducing the frequency of the misfires. However, the spark does not appear to be the cause of the misfiring cycle.

Figure 31. Arc histories for the 2 o'clock spark plug orientation EO12 12.2 CAD aIGN misfiring cycle showing no evidence of the flow stretching the arc

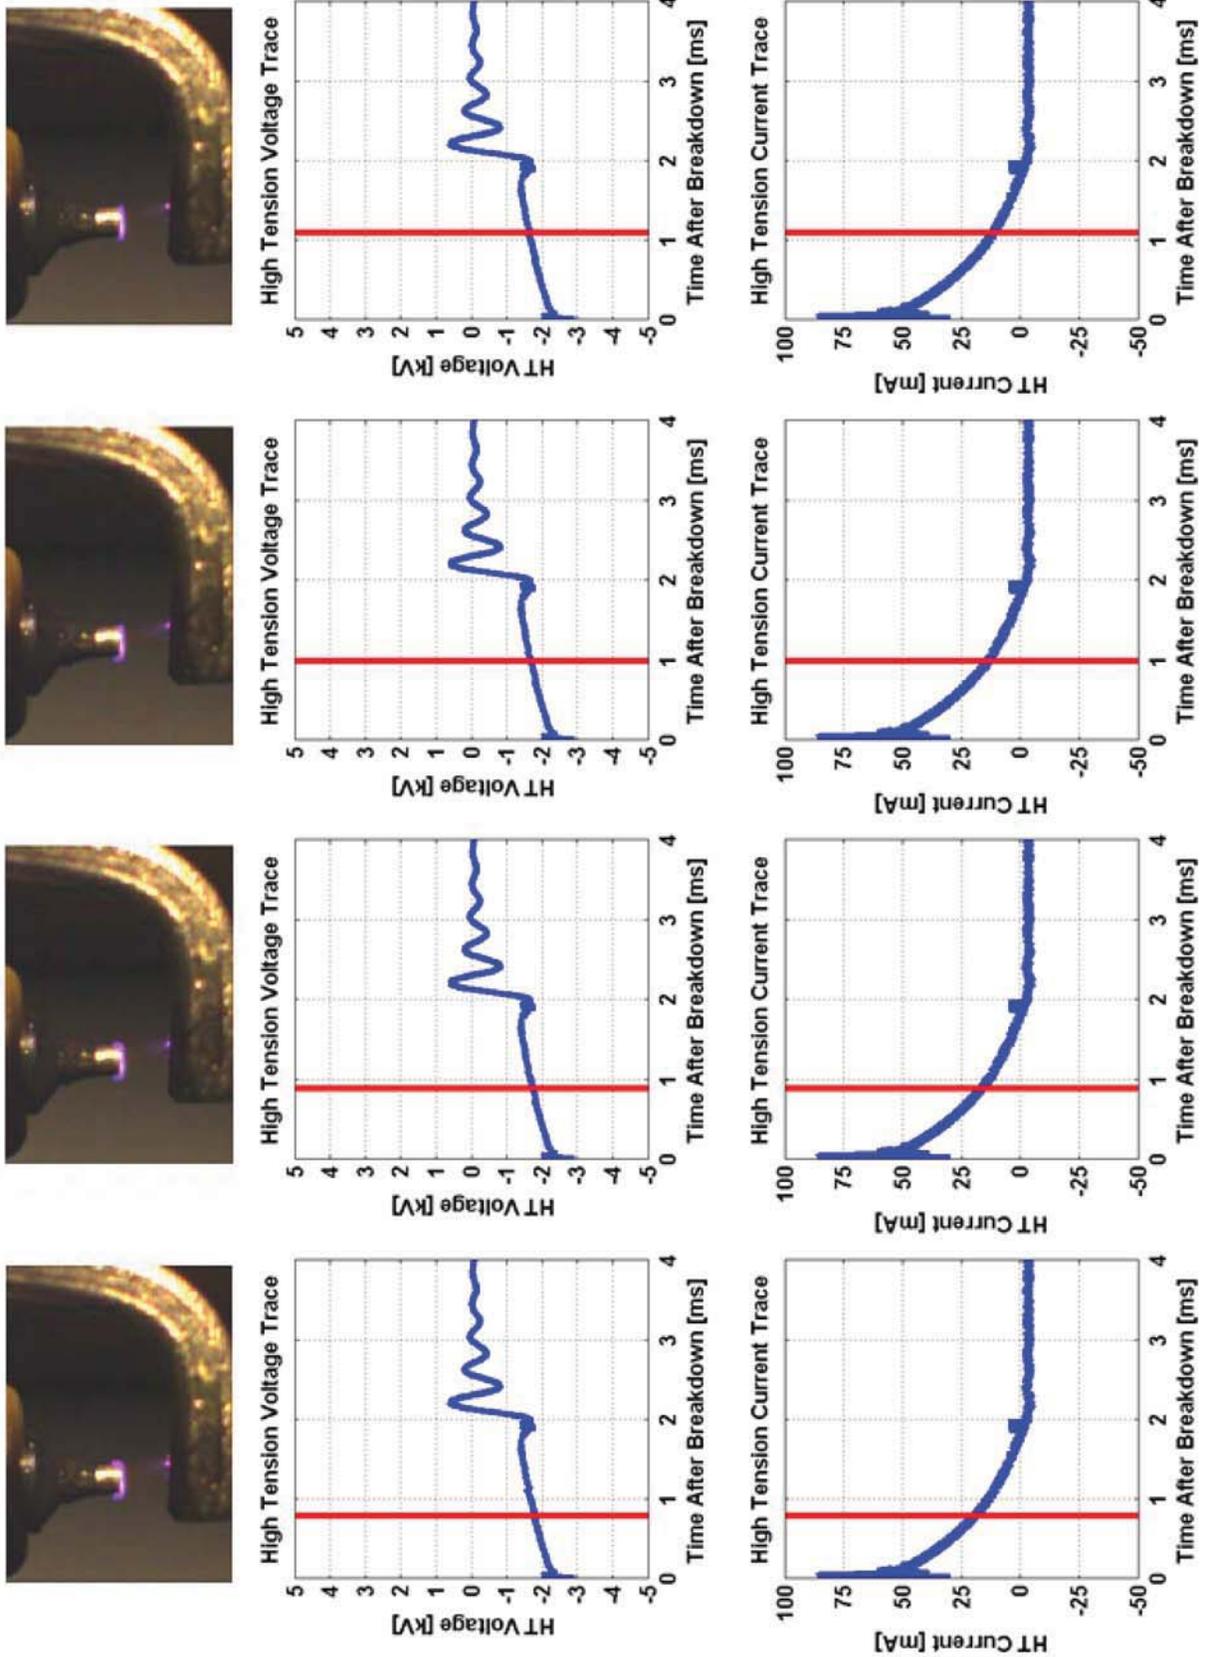
[Figure 6](#) shows the case when there was no flow or any liquid fuel. The HT measurements show a fairly constant arc voltage and an arc current which decays away to zero. The arc duration is 2.0 ms. This is defined as the length of time which the current takes to decay to zero. The image shows that the arc has been formed between the corner of the positive electrode to a point vertically below it. There is no displacement of the arc along the ground electrode. The arc will form between the points of highest electrical potential, hence the corner of the centre electrode.

Figure 6. Bench Top Spark Image with no airflow and no fuel droplet, the cursor indicates the timing of the image

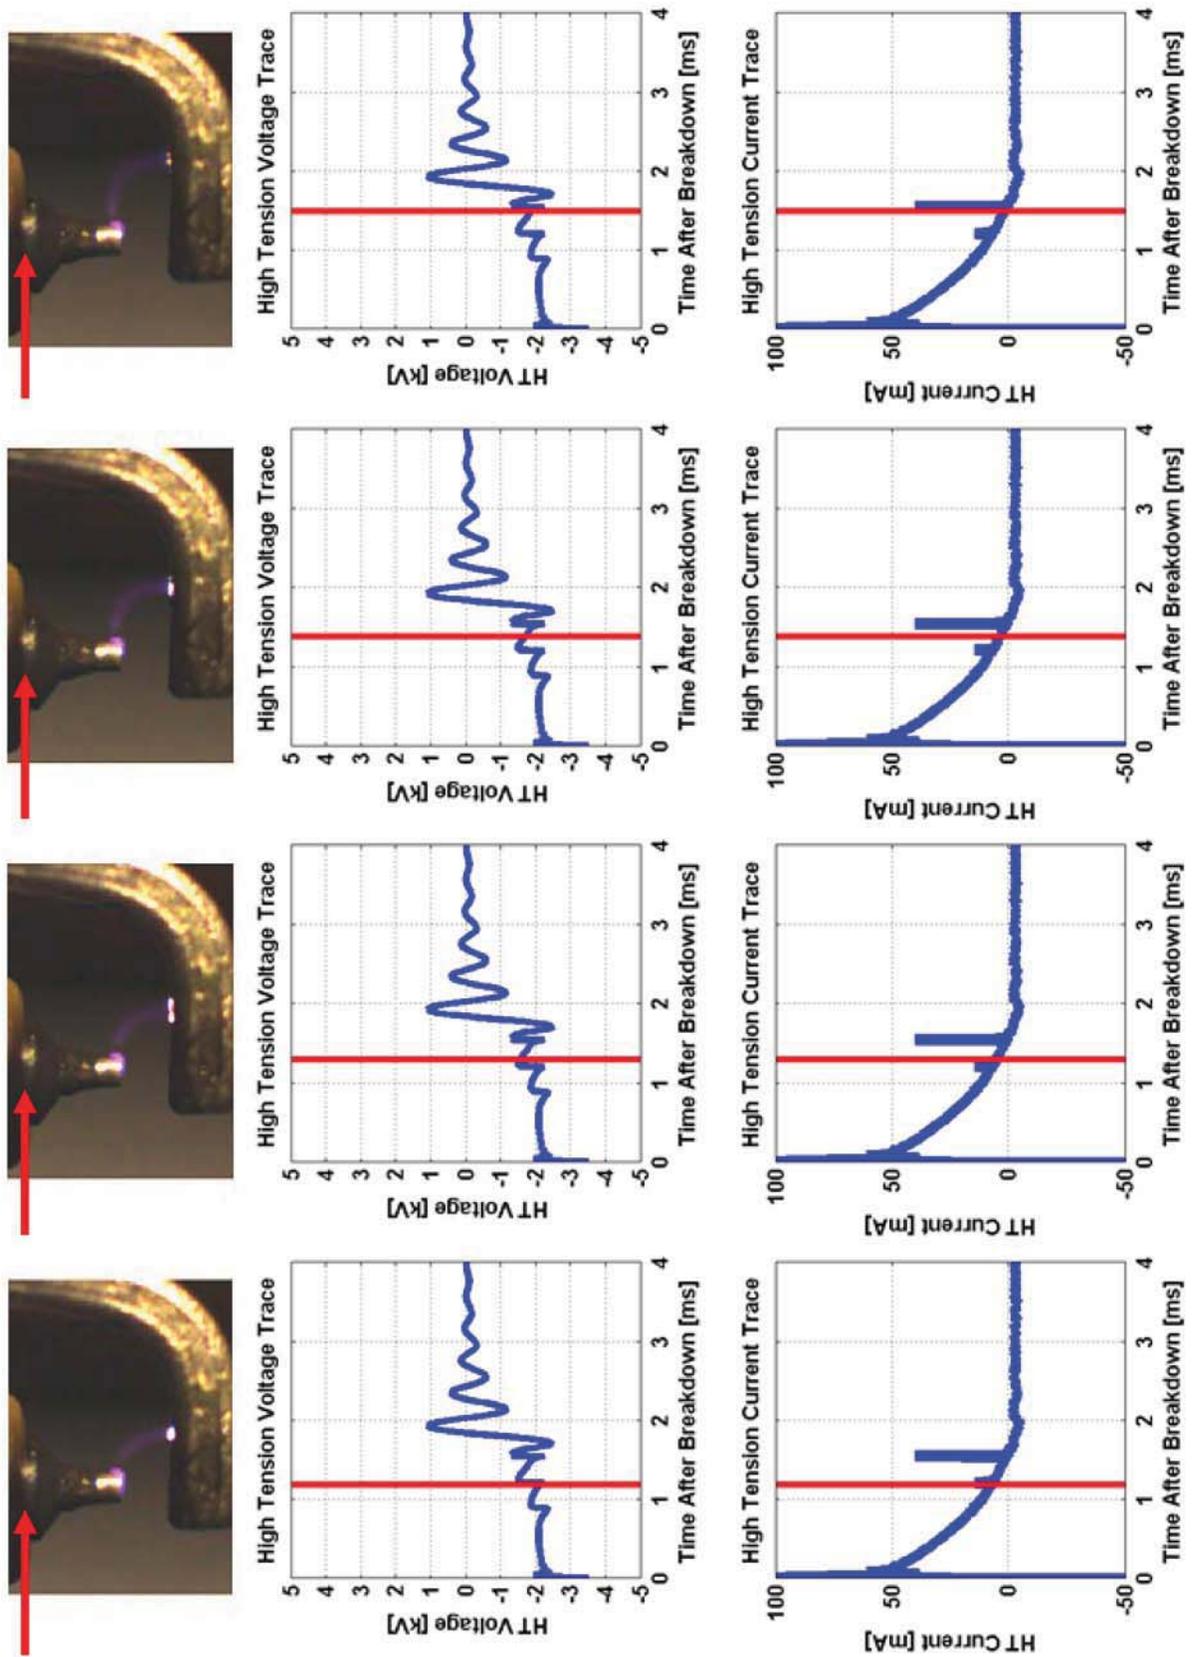
[Figure 7](#) shows the case where airflow, orthogonal to the line of sight of the camera, is passed through the spark plug gap. As explained in the previous section, this air flow is designed to resemble the airflow induced by the 2nd injection. The images show that the air flow is causing the arc to be stretched. The arc is seen to ‘track’ its way along the ground strap, presumably finding defects on the surface of the ground strap whose corners will lead to a higher electrical field. The HT voltage trace shows a non constant arc voltage, as the arc is being stretched the voltage appears to oscillate. As the arc is stretched, a larger voltage is needed in order for the arc to remain struck between the electrodes.[8] Stretching the arc too much would cause the arc to be extinguished. The arc duration is 1.8 ms, indicating that the airflow through the spark plug gap shortens the arc duration. The velocity of the air was fixed in these particular tests. However, an interesting study would be to vary the velocity of the air jet and see the effect of this velocity on the amount of arc stretch.

Figure 7. Bench Top Spark Image with airflow and no fuel droplet, the arrow indicates the direction of the airflow, the cursor indicates the timing of the image

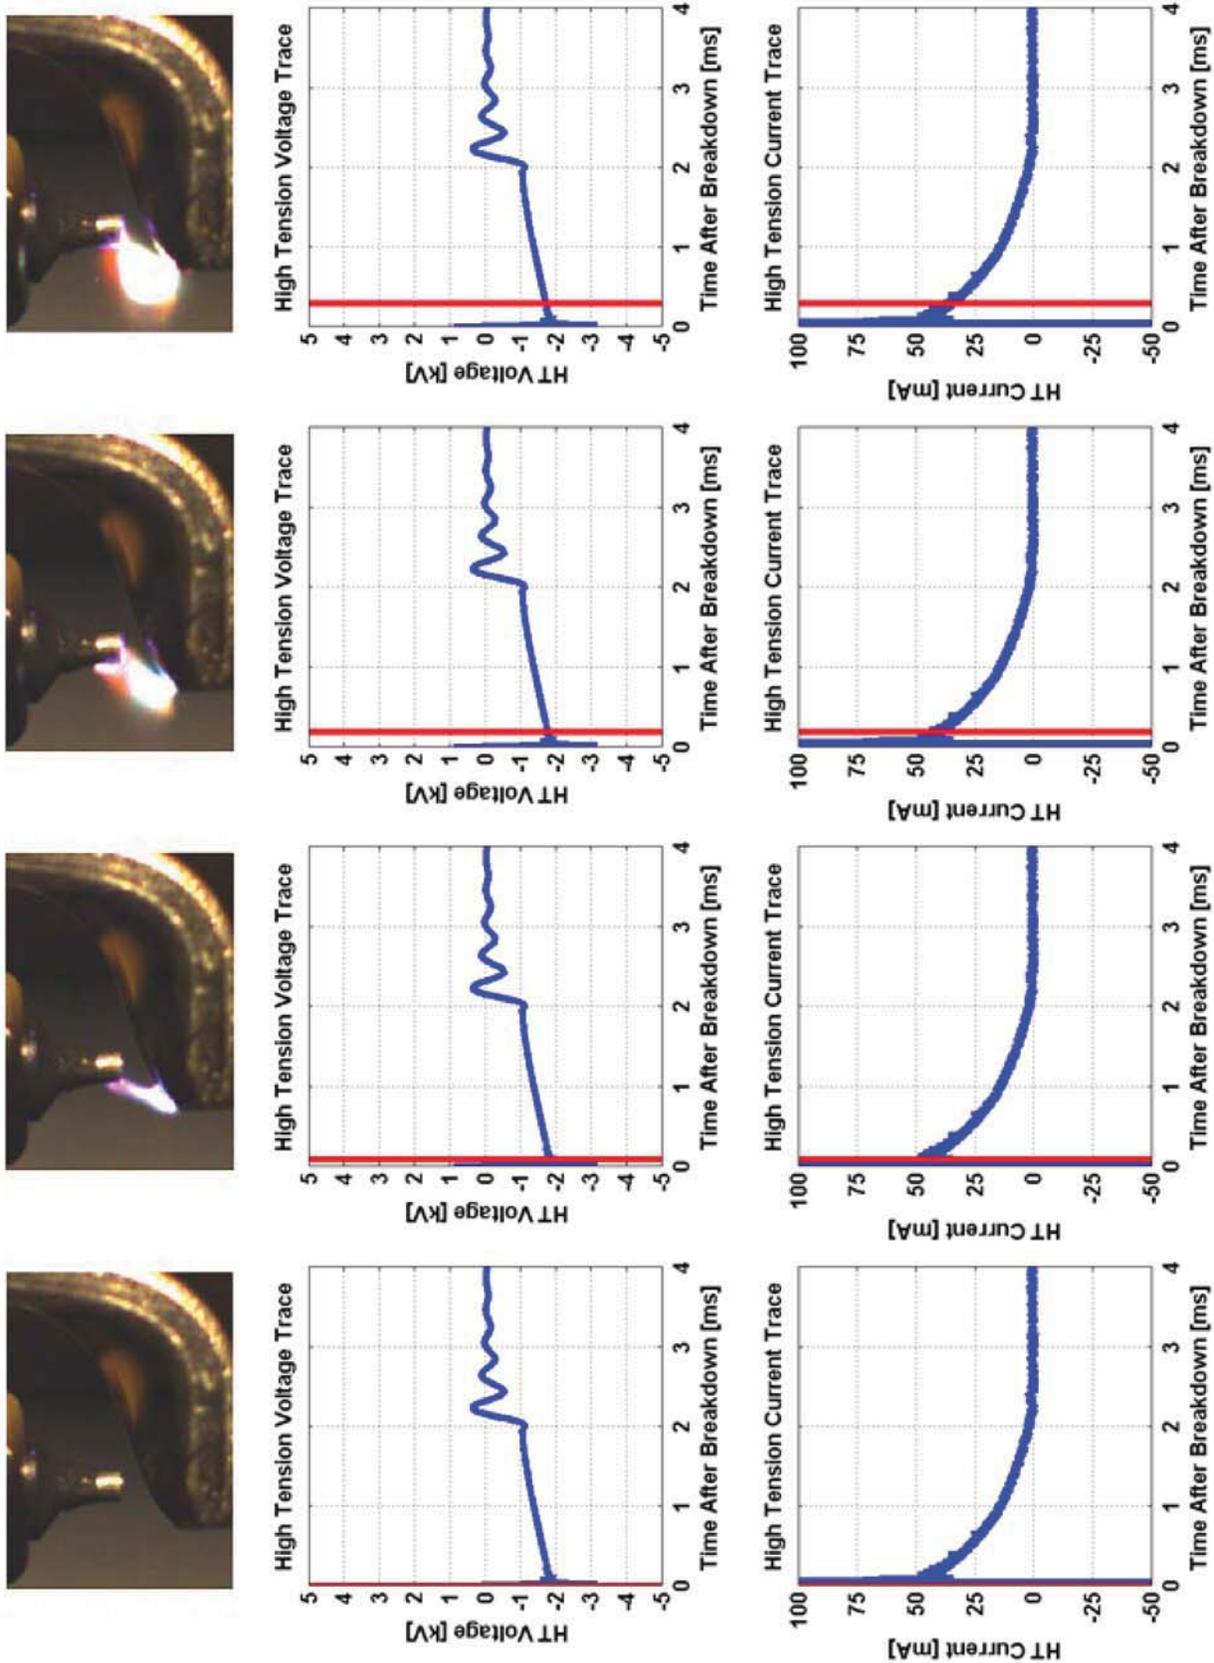
Figure 8 shows the case where a large fuel droplet is sitting on the ground electrode. The image shows that despite the large fuel drop, the arc is still formed. The arc is seen to 'track' down the side of the fuel droplet.

Figure 8. Bench Top Spark Image with no airflow and a fuel droplet, the cursor indicates the timing of the image

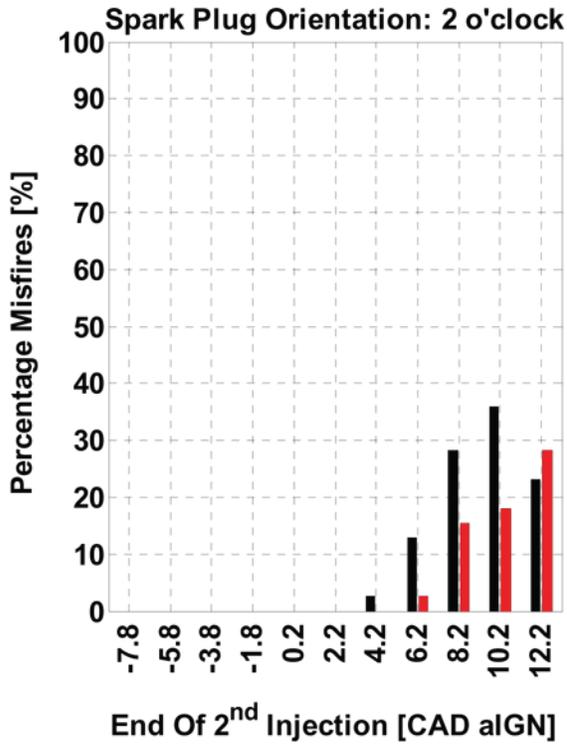
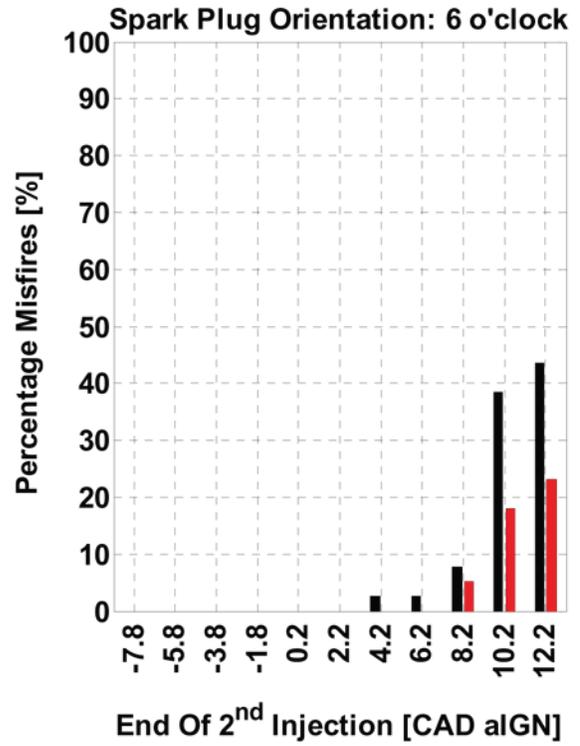
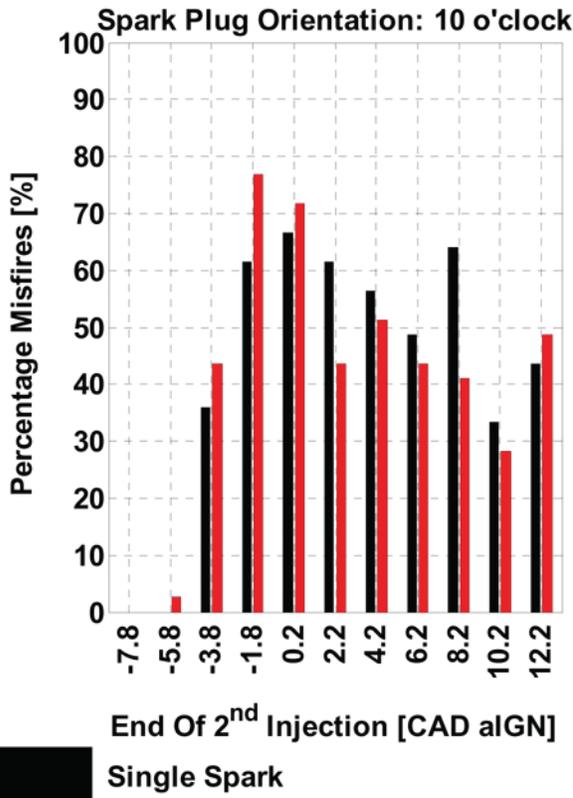
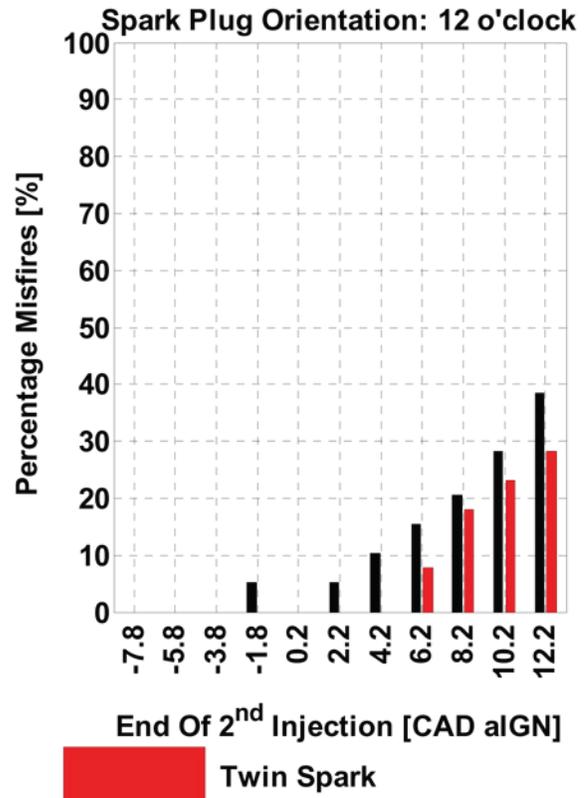
Figure 10 shows the misfiring trends for 2,6,10 and 12 o'clock spark plug orientations. The data is shown for different timings of the second injection in relation to the spark. The data is presented for both a single and a twin spark strategy. Retarding the 2nd injection increases the number of misfires for the 2 o'clock, 6 o'clock and 12 o'clock orientations. For these three spark plug orientations the majority of the misfires occur when the end of the 2nd injection occurs later than the spark. The maximum misfiring percentage is 35% for the 2 o'clock spark plug orientation, 45% for the 6 o'clock orientation and 40% for the 12 o'clock spark plug orientation. The twin spark strategy reduces the number of misfiring cycles compared to the single spark strategy. This is as expected since there are now two chances of ignition compared to one.

Figure 10. Single cylinder misfiring characteristics for single and twin spark strategies
