2005-2009MY Pontiac G6 Stop Lamp VOQ and Warranty IPTV graphed in Month of Build

2012CY Update of G6 Stop Lamp Warranty Claims

#08-05-22-009: Intermittently Brake Lights (Stop Lamp) Do Not Function Correctly, Extended Travel to Shift Out of Park, Cruise Control Inoperative, DTC C0161/C0277 Set (Perform Repair as Outlined) - (Dec 4, 2008)

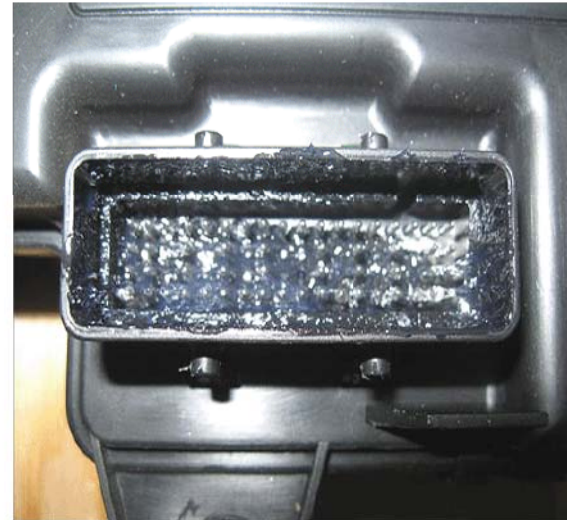
Condition: Certain fretting corrosion in the Body Control Module connector causes an increase in resistance that results in a lower BAS signal voltage to the BCM.

Potential Field Action: Apply dielectric lubricant (clear gel) on all the BCM C2 connector pins. Apply with a one-inch nylon bristle brush. (this will treat the pins against fretting corrosion).

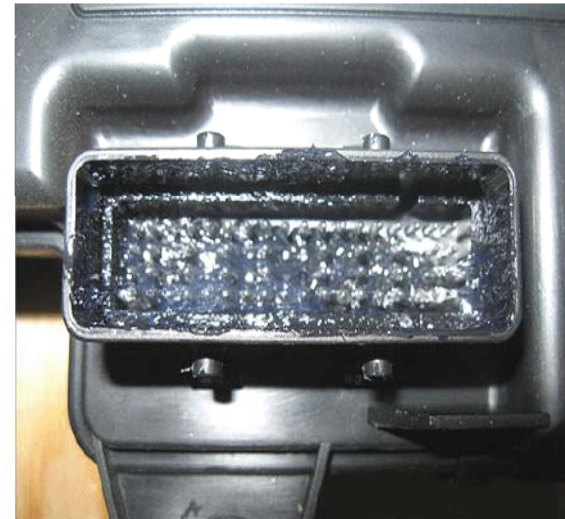
Condition: Certain fretting corrosion in the Body Control Module connector causes an increase in resistance that results in a lower BAS signal voltage to the BCM.

Potential Field Action: Apply dielectric lubricant (clear gel) on all the BCM C2 connector pins. Apply with a one-inch nylon bristle brush. (this will treat the pins against fretting corrosion).

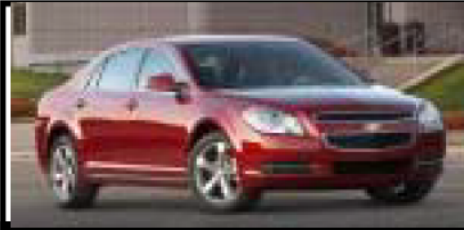
Brake Lamps Malfunction due to BCM Connector

Certain fretting corrosion in the Body Control Module connector causes an increase in resistance that results in a lower BAS signal voltage to the BCM.

A driver in a following vehicle may not be able to discern the braking status of the vehicle in front of them. Operators whose vehicles have this condition may notice that the cruise control will not engage and the brake pedal requires additional travel to remove the gear shift mechanism from PARK.

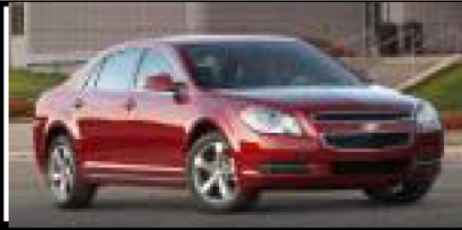
Brake Lamps Malfunction due to BCM Connector

Certain fretting corrosion in the Body Control Module connector causes an increase in resistance that results in a lower BAS signal voltage to the BCM.

A driver in a following vehicle may not be able to discern the braking status of the vehicle in front of them. Operators whose vehicles have this condition may notice that the cruise control will not engage and the brake pedal requires additional travel to remove the gear shift mechanism from PARK.

Potential Field Remedy: Apply dielectric lubricant (clear gel) on all the BCM C2 connector pins. Apply with a one-inch nylon bristle brush. (this will treat the pins against fretting corrosion).

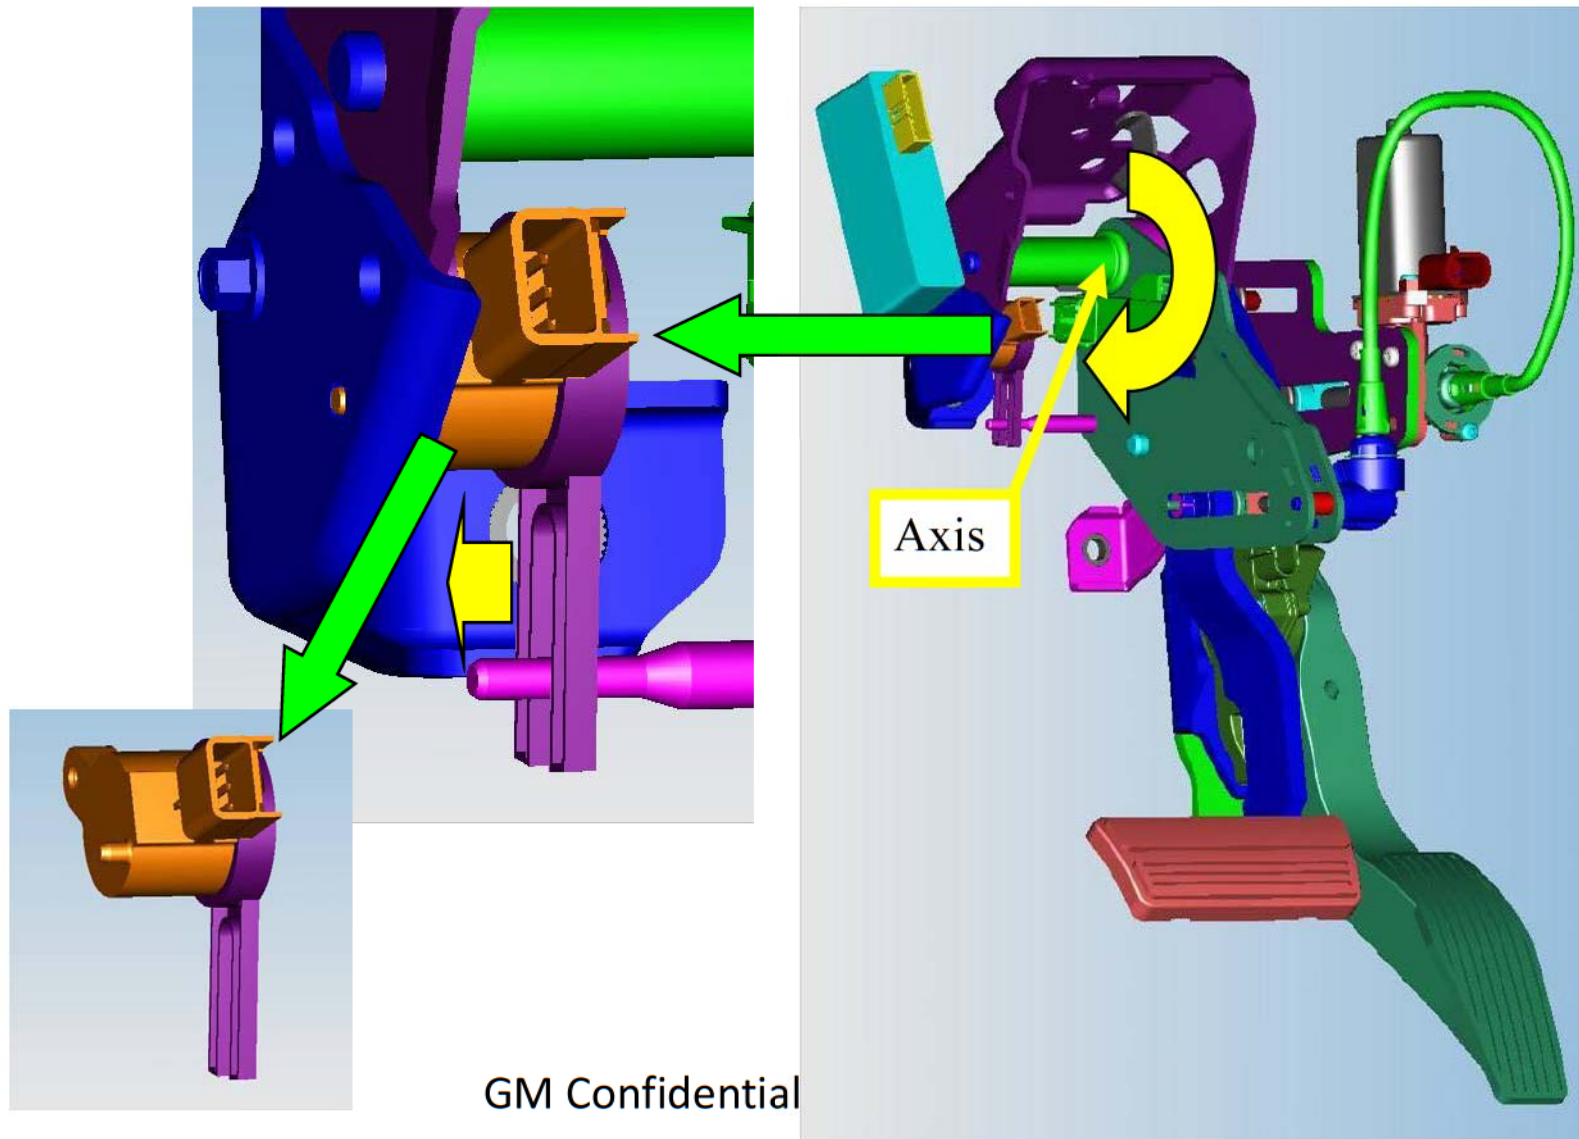
2005 - 2007 G6 Brake Apply Sensing System

Pedal/Sensor Movement

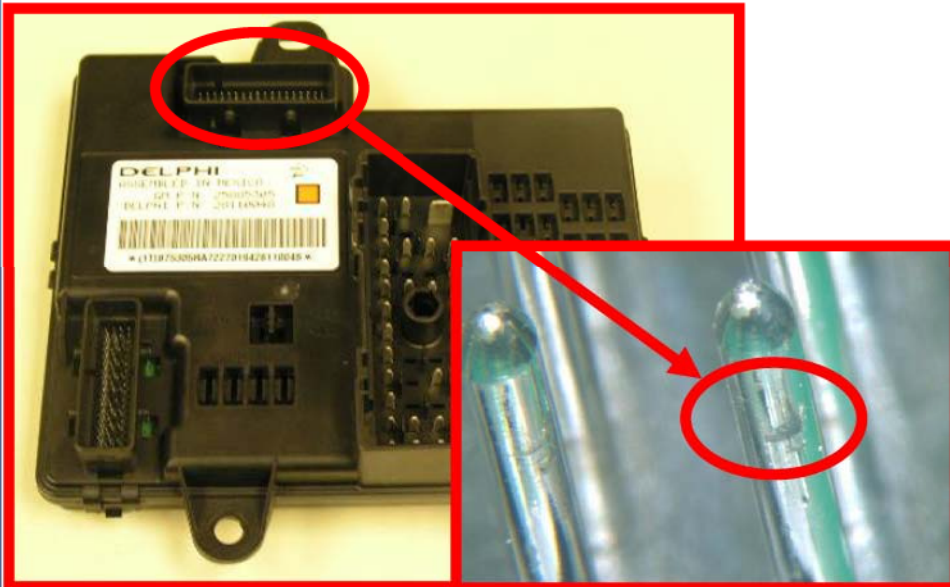
Condition: Certain fretting corrosion in the Body Control Module connector causes an increase in resistance that results in a lower BAS signal voltage to the BCM.

Effect of the Condition: A driver in a following vehicle may not be able to discern the braking status of the vehicle in front of them. Operators whose vehicles have this condition may notice that the cruise control will not engage and the brake pedal requires additional travel to remove the gear shift mechanism from PARK. Additionally, the transmission converter clutch will not engage.

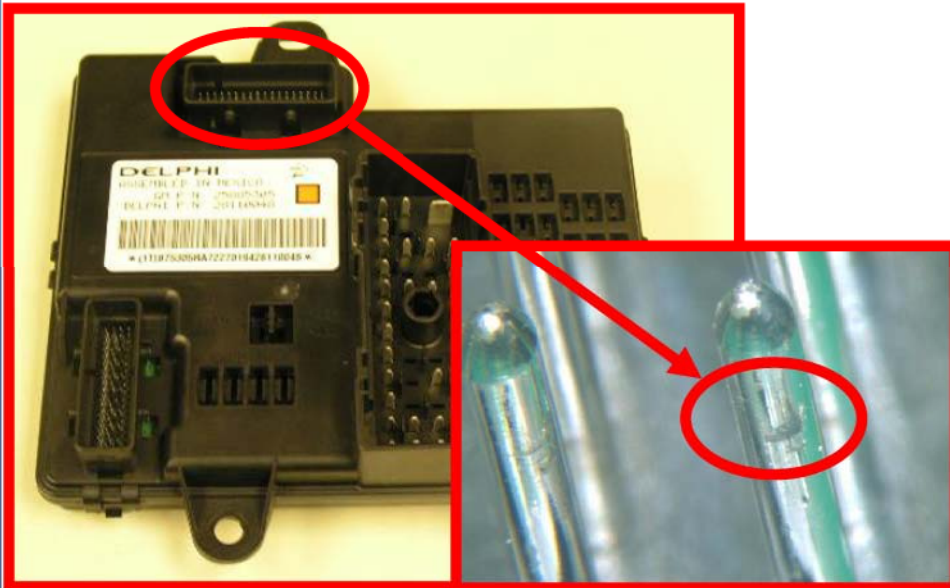
Condition: Certain fretting corrosion in the Body Control Module connector causes an increase in resistance that results in a lower BAS signal voltage to the BCM.

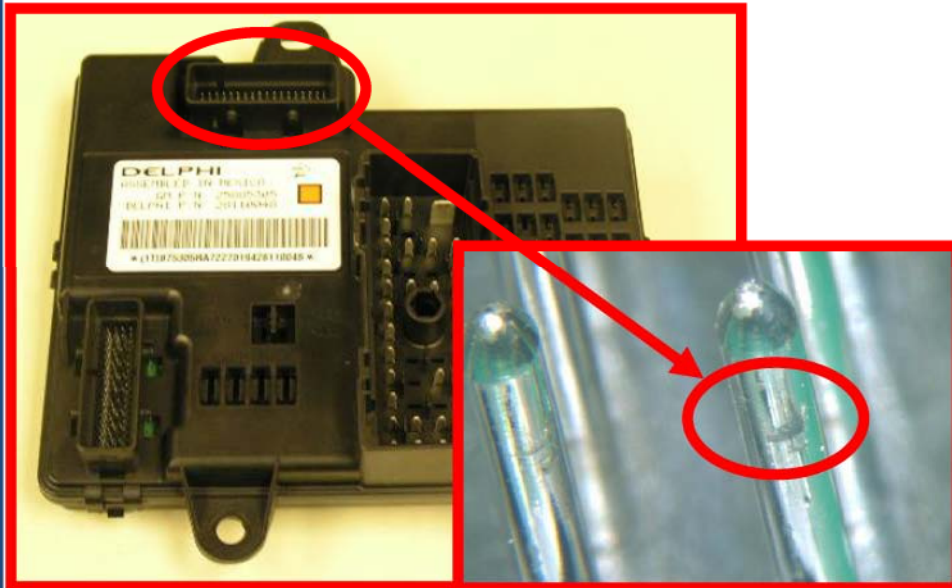
Condition: Certain fretting corrosion in the Body Control Module connector causes an increase in resistance that results in a lower BAS signal voltage to the BCM.

Potential Field Action: Apply dielectric lubricant (clear gel) on all the BCM C2 connector pins. Apply with a one-inch nylon bristle brush. (this will treat the pins against fretting corrosion).

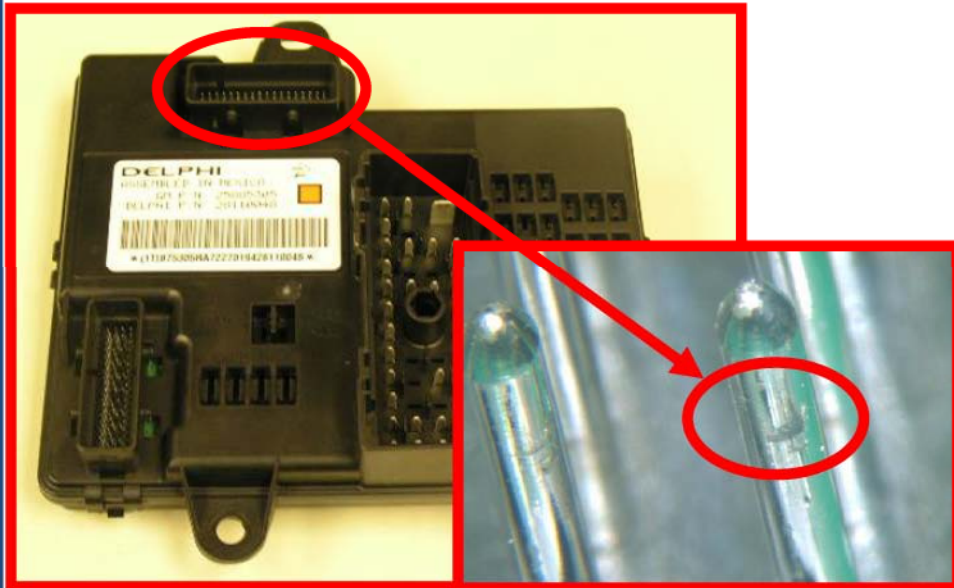
Pontiac G6 Brake Apply Sensing System (BASS)

Condition: Certain fretting corrosion in the Body Control Module connector causes an increase in resistance that results in a lower BAS signal voltage to the BCM.

Potential Field Action: Apply dielectric lubricant (clear gel) on all the BCM C2 connector pins. Apply with a one-inch nylon bristle brush. (this will treat the pins against fretting corrosion).

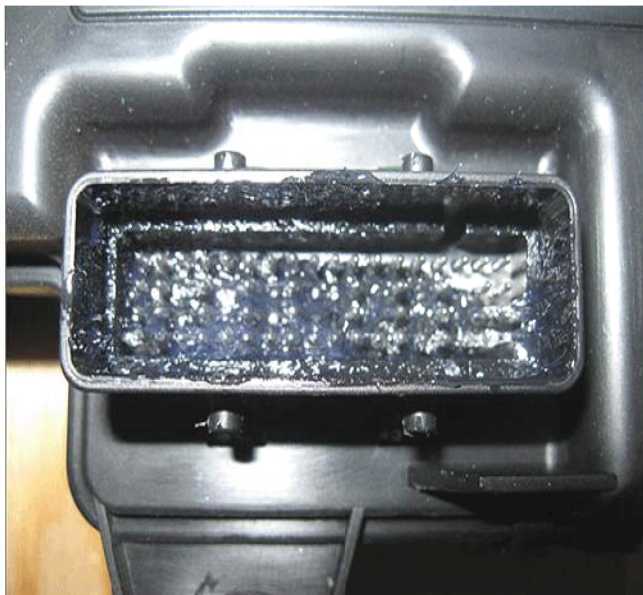
#08-05-22-009: Intermittently Brake Lights (Stop Lamp) Do Not Function Correctly, Extended Travel to Shift Out of Park, Cruise Control Inoperative, DTC C0161/C0277 Set (Perform Repair as Outlined) - (Dec 4, 2008)

Subject: Intermittently Brake Lights (Stop Lamp) Do Not Function Correctly, Extended Travel to Shift Out of Park, Cruise Control Inoperative, DTCs C0161/C0277 Set (Perform Repair as Outlined)

Apply dielectric lubricant (clear gel) GM P/N 12377900 (In Canada, use P/N 10953529) on the BCM C2 pins (apply with a one-inch nylon bristle brush) on all the C2 connector pins (this will treat the pins against fretting corrosion).

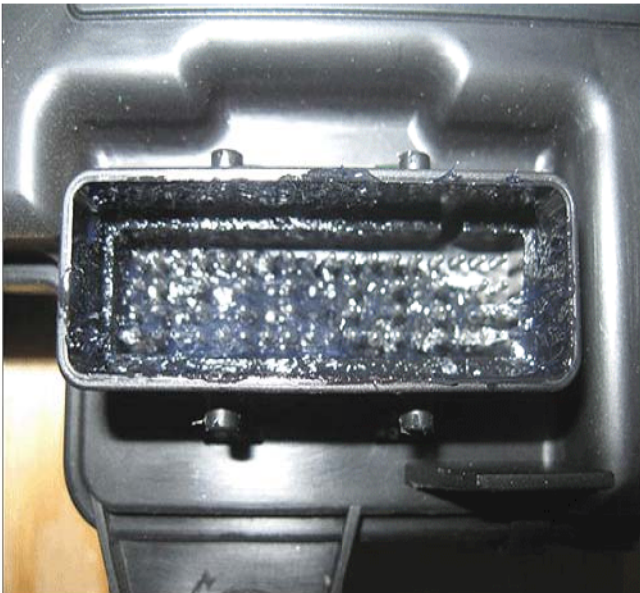
#08-05-22-009: Intermittently Brake Lights (Stop Lamp) Do Not Function Correctly, Extended Travel to Shift Out of Park, Cruise Control Inoperative, DTC C0161/C0277 Set (Perform Repair as Outlined) - (Dec 4, 2008)

Subject: Intermittently Brake Lights (Stop Lamp) Do Not Function Correctly, Extended Travel to Shift Out of Park, Cruise Control Inoperative, DTCs C0161/C0277 Set (Perform Repair as Outlined)

Apply dielectric lubricant (clear gel) GM P/N 12377900 (In Canada, use P/N 10953529) on the BCM C2 pins (apply with a one-inch nylon bristle brush) on all the C2 connector pins (this will treat the pins against fretting corrosion).

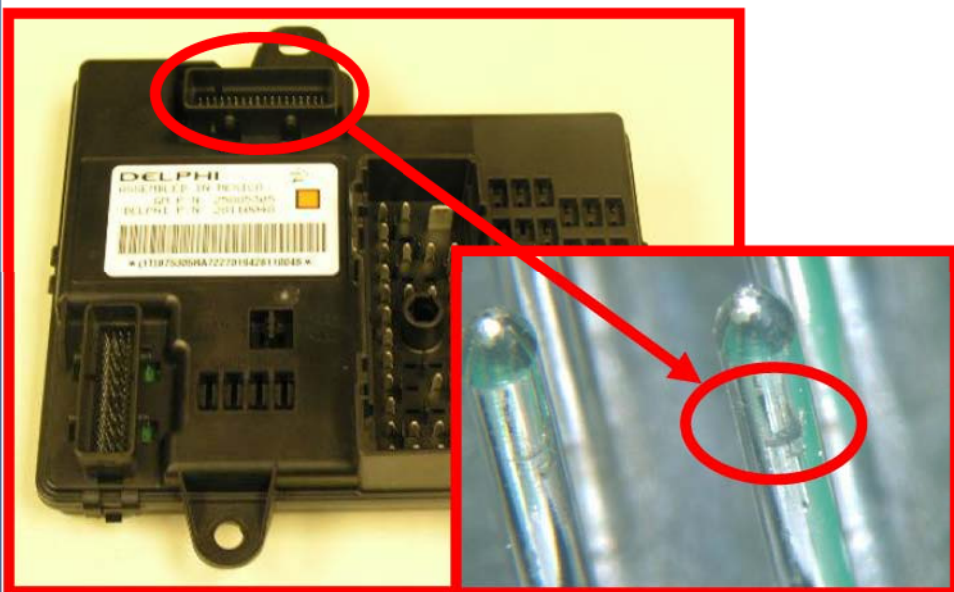
Pontiac G6 Brake Apply Sensing System (BASS)

Condition: Certain fretting corrosion in the Body Control Module connector causes an increase in resistance that results in a lower BAS signal voltage to the BCM.

Effect of the Condition: A driver in a following vehicle may not be able to discern the braking status of the vehicle in front of them. Operators whose vehicles have this condition may notice that the cruise control will not engage and the brake pedal requires additional travel to remove the gear shift mechanism from PARK. Additionally, the transmission converter clutch will not engage.

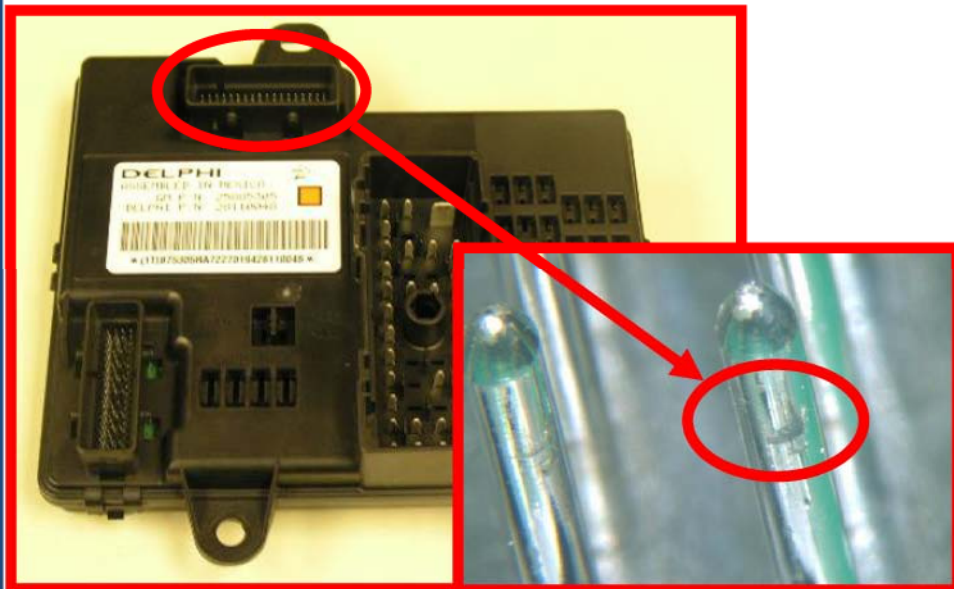
Pontiac G6 Brake Apply Sensing System (BASS)

Condition: Certain fretting corrosion in the Body Control Module connector causes an increase in resistance that results in a lower BAS signal voltage to the BCM.

Potential Field Action: Apply dielectric lubricant (clear gel) on all the BCM C2 connector pins. Apply with a one-inch nylon bristle brush. (this will treat the pins against fretting corrosion).

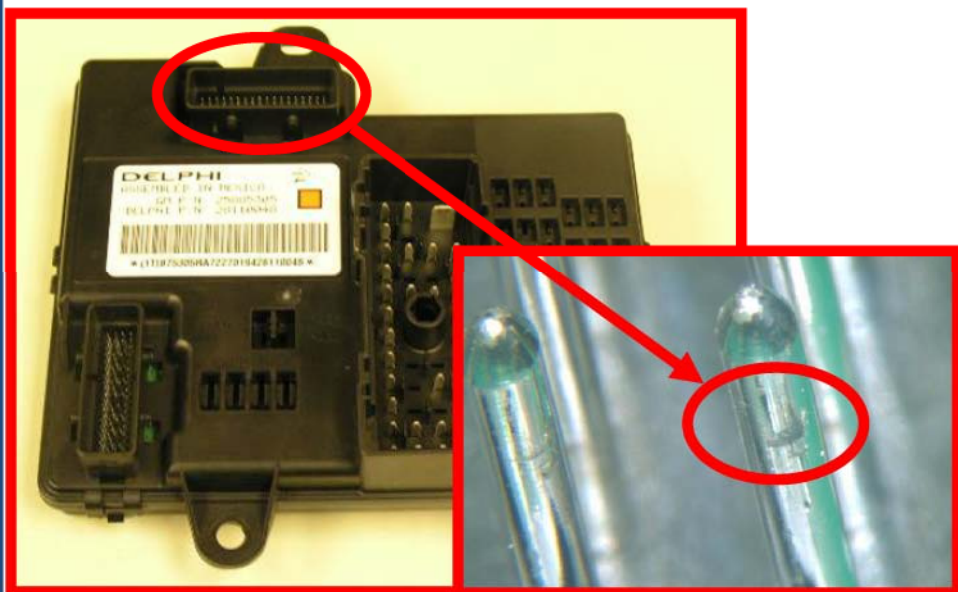
Pontiac G6 Brake Apply Sensing System (BASS)

Condition: Certain fretting corrosion in the Body Control Module connector causes an increase in resistance that results in a lower BAS signal voltage to the BCM.

Apply dielectric lubricant (clear gel) on all the BCM C2 connector pins. Apply with a one-inch nylon bristle brush. (this will treat the pins against fretting corrosion).

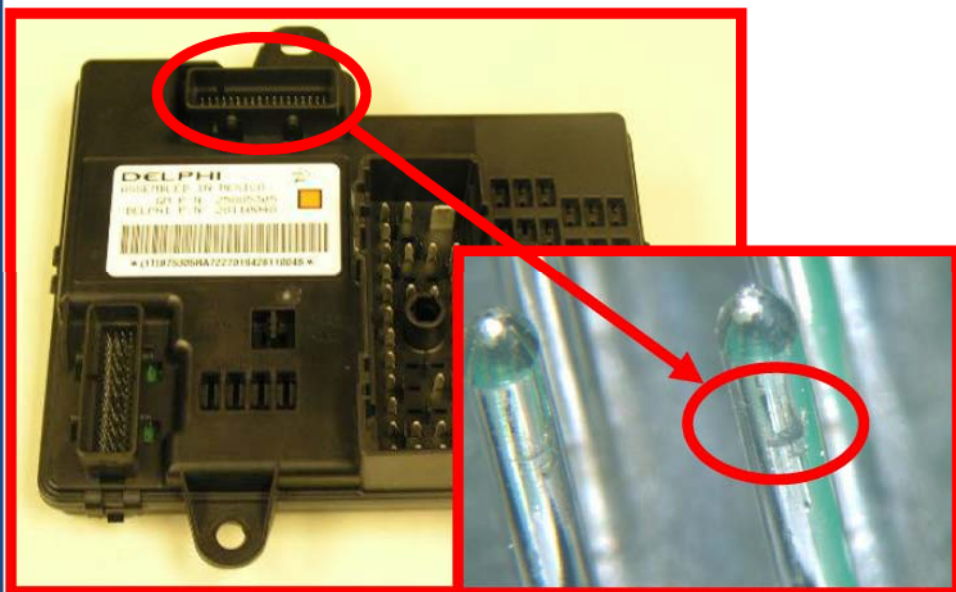
Pontiac G6 Brake Apply Sensing System (BASS)

Condition: Certain fretting corrosion in the Body Control Module connector causes an increase in resistance that results in a lower BAS signal voltage to the BCM.

Effect of the Condition: A driver in a following vehicle may not be able to discern the braking status of the vehicle in front of them. Operators whose vehicles have this condition may notice that the cruise control will not engage and the brake pedal requires additional travel to remove the gear shift mechanism from PARK. Additionally, the transmission converter clutch will not engage.

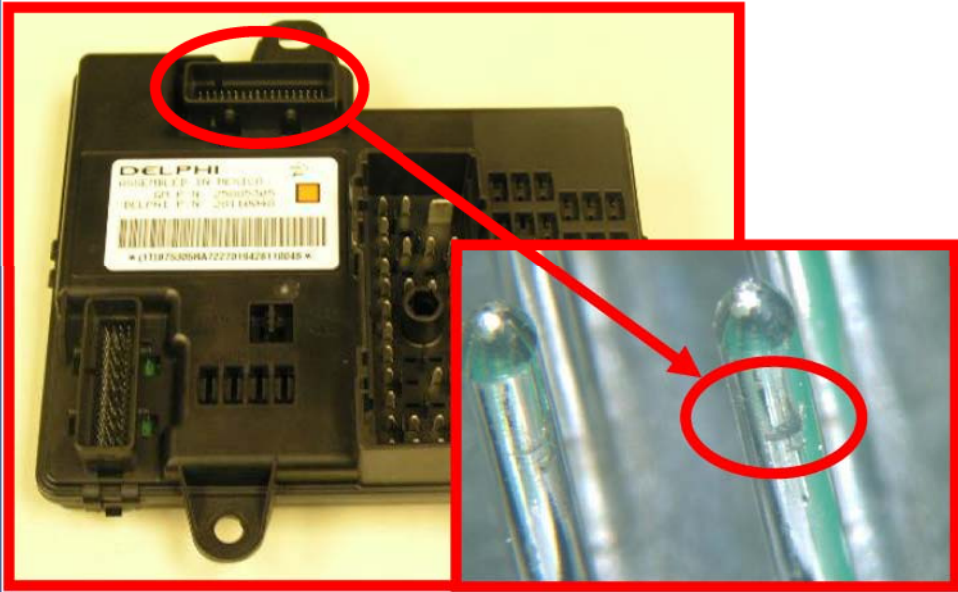
Pontiac G6 Brake Apply Sensing System (BASS)

Condition: Certain fretting corrosion in the Body Control Module connector causes an increase in resistance that results in a lower BAS signal voltage to the BCM.

Potential Field Action: Apply dielectric lubricant (clear gel) on all the BCM C2 connector pins. Apply with a one-inch nylon bristle brush. (this will treat the pins against fretting corrosion).
