RQ13-002

2012 Camaro-Cruze-Verano-
Sonic airbag connector-20 Jan
13 NHTSA

Shorting Bar within the Driver's Airbag Connector

**Model Year: 2012 Cruze, Verano, Camaro, and Sonic
4,101 vehicles**

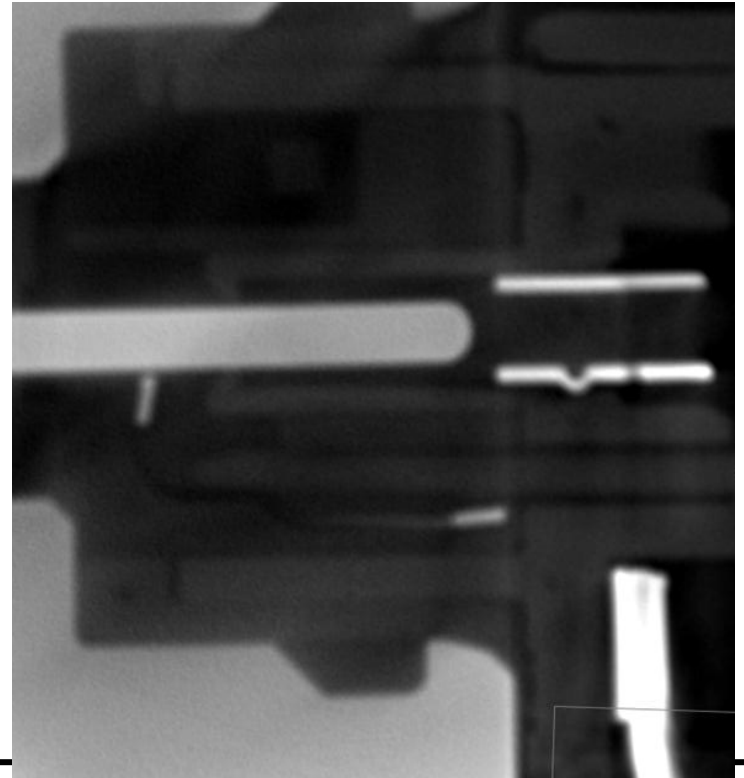
Primary and Secondary Stage Inflator Connectors

Condition: Some 2012 Cruze, Verano, Camaro, and Sonic vehicles have a driver's side airbag connector shorting bar that may have been damaged during assembly of the airbag.

Effect of the Condition: A vehicle in this condition may set diagnostic trouble code B0013 (secondary stage inflator). The Sensing and Diagnostic Module (SDM) will request the instrument cluster to illuminate the AIRBAG indicator. If a crash event occurs the the SDM will attempt deployment, but, if the shorting bar is in contact with the airbag terminals, the airbag will not deploy.

Technical Root Cause: During the retainer seating process the shorting bars were not fully retracted to prevent contact with the airbag terminals.

Primary Stage
Inflator Connector
(sets DTC B0012)

Secondary Stage
Inflator Connector
(sets DTC B0013)

Potential Field Remedy: Replace the clock spring.

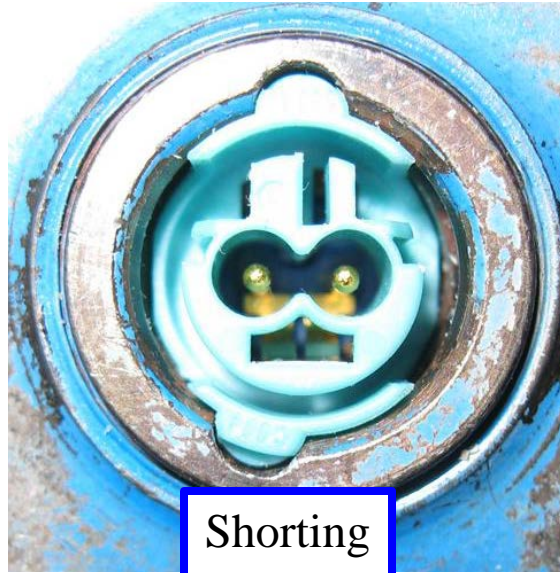
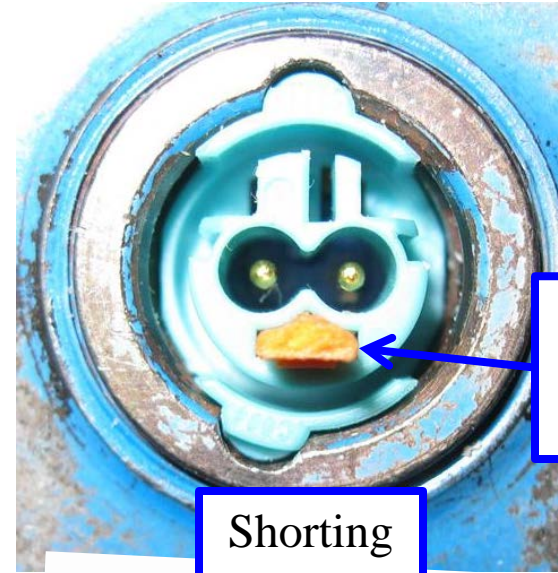
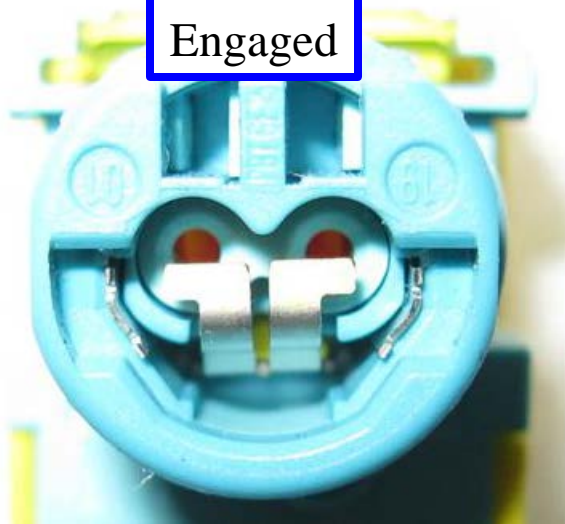
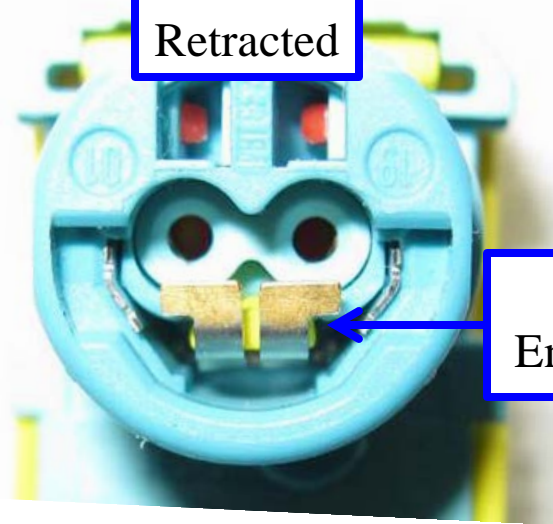
Male Connector - Retracting the Shorting Bar

Shorting Bar Engaged

Actuator Finger Inserted

Shorting Bar Retracted

CPA Engaged

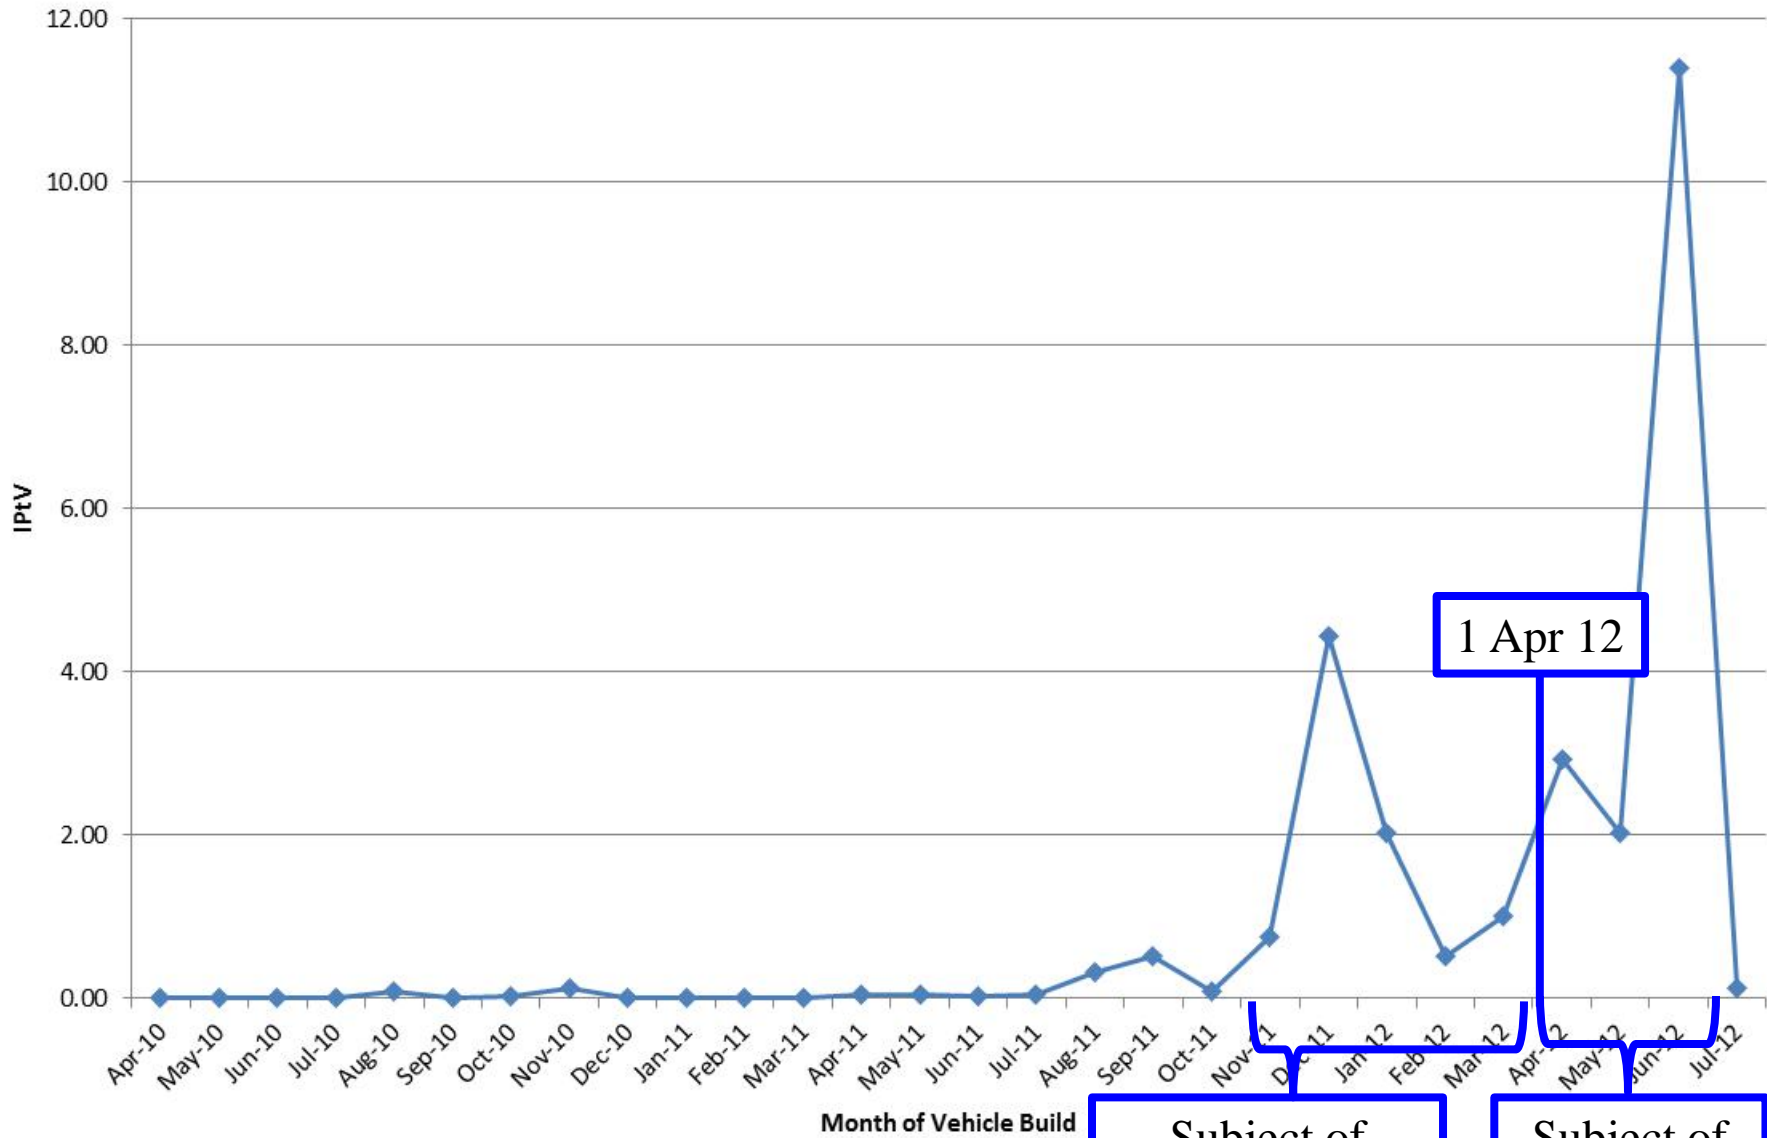
2011/2012 Camaro, Cruze, Sonic, and Verano Airbag Filtered Warranty IPTV vs Month of Build

- Did the issue start in April 12
- Infant mortality

Subject of
further analysis

Subject of
field action

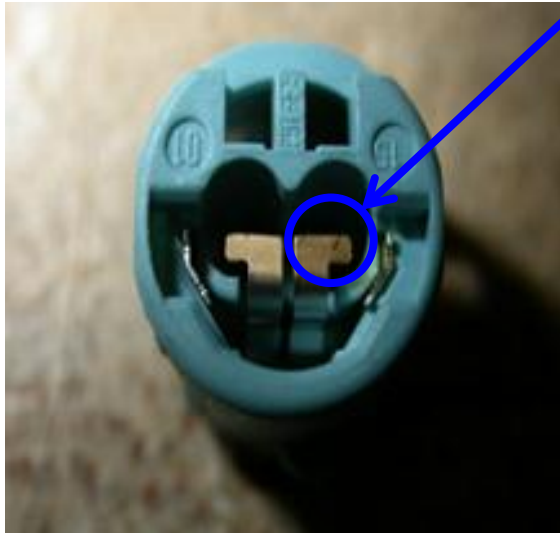
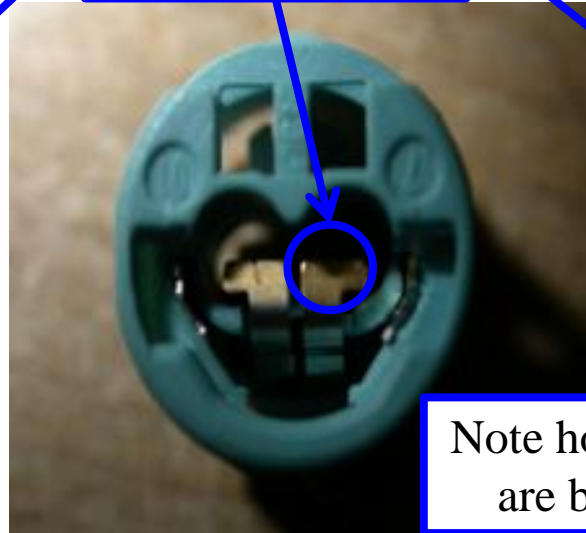
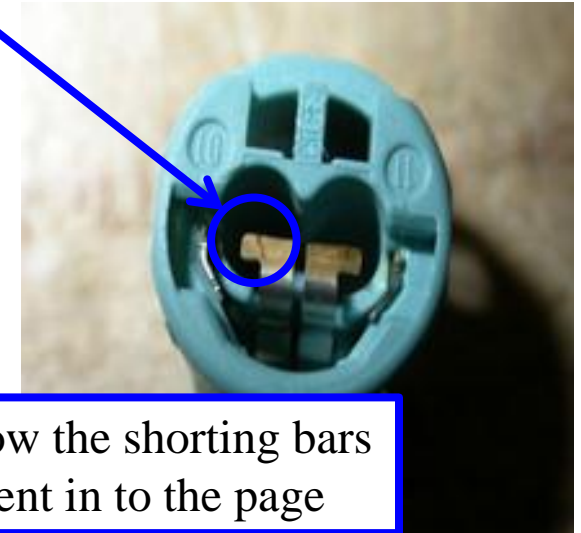
Witness marks on shorting bars

Note how the shorting bars are bent in to the page

- Bent DAB inflator shorting clips due to damage to installation tool.
- Supplier quality spill at inflator facility.

- Replaced shorting clip installation tool.

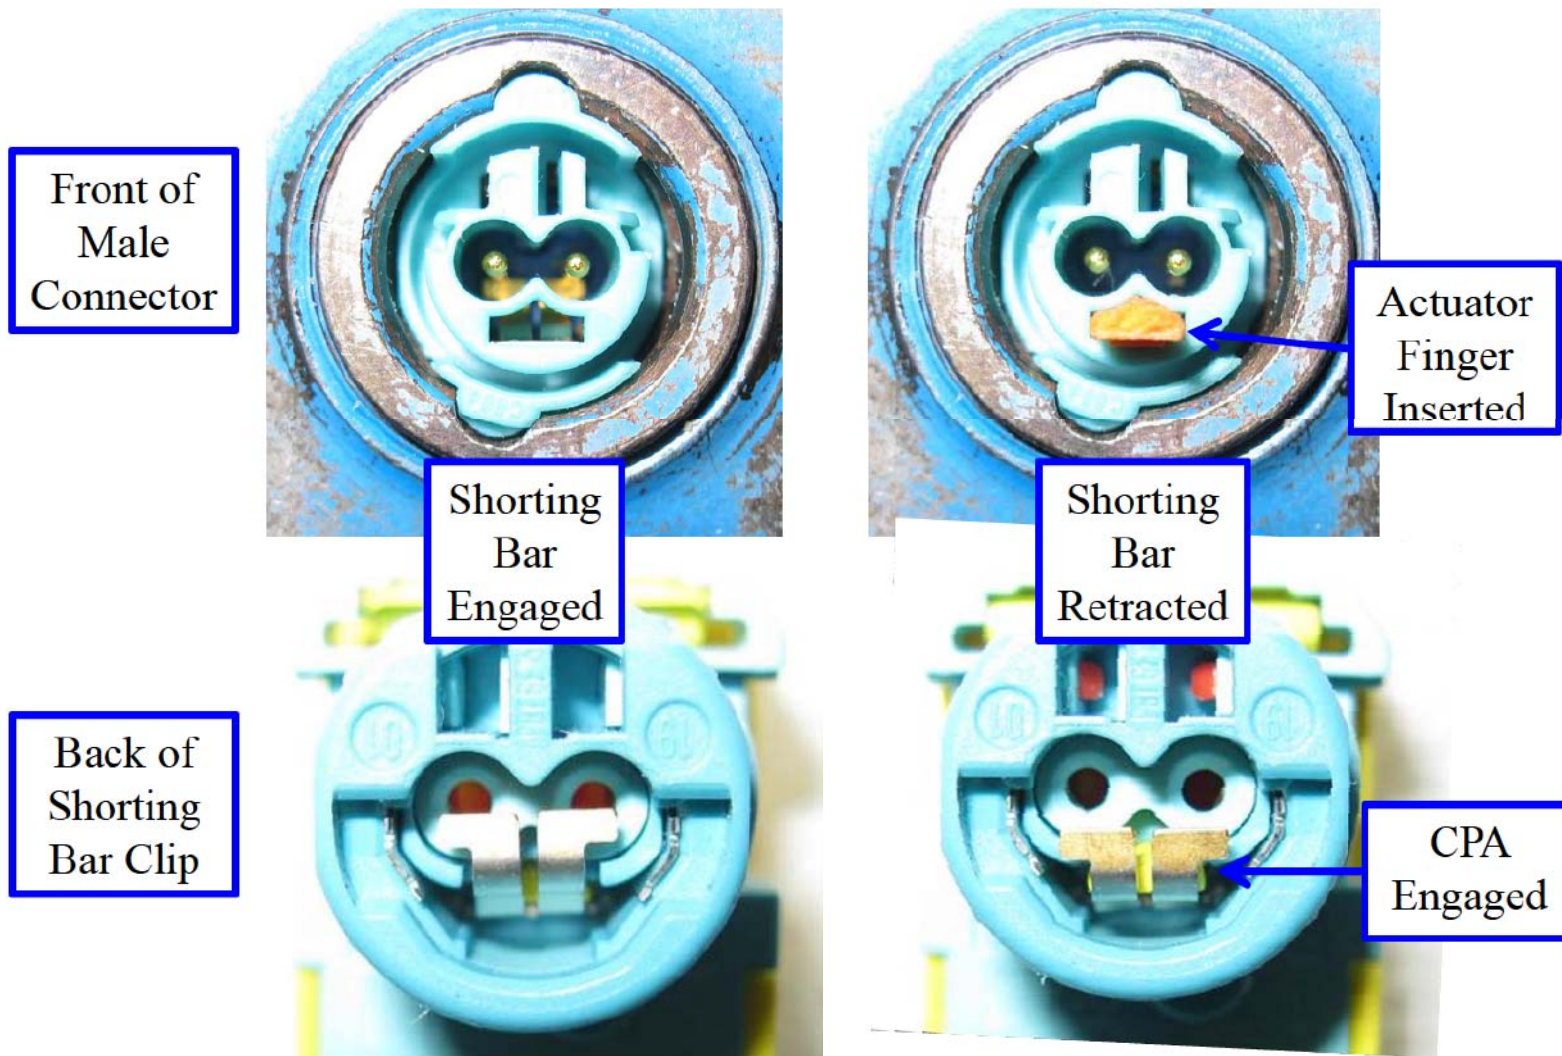
2012 Chevrolet Cruze, Verano, and Sonic Male Connector - Retracting the Shorting Bar

2012 Chevrolet Cruze, Verano, and Sonic Root Cause

The length of the Push Tab was measured using a microscope. The push tab length of the primary chamber shorting clip insertion tool was shorter than the secondary chamber shorting clip insertion tool.

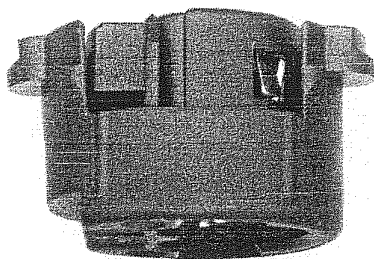
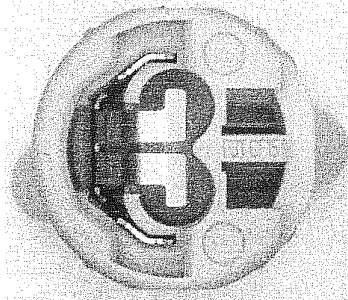
No.	Test	Requirement	Result	Remark
E 0.1	Visual inspection DIN IEC 512 P.2	No mech. defects on insulator ring; no corrosion or damage on contact surfaces	No deviations	O.K.
B21.1	Dry heat	Long term temperature storage T = 120°C Duration: 1000 hrs.	Accomplished at AMPHENOL TUCHEL Electronics GmbH	O.K.
	Storage	Storage at room temperature Duration: 7 days	Accomplished at AMPHENOL TUCHEL Electronics GmbH	O.K.
E 0.1	Visual inspection DIN IEC 512 P.2	No mech. defects on insulator ring; no corrosion or damage on contact surfaces	No deviations, no cracks, no delaminations, see photographs below:	O.K.

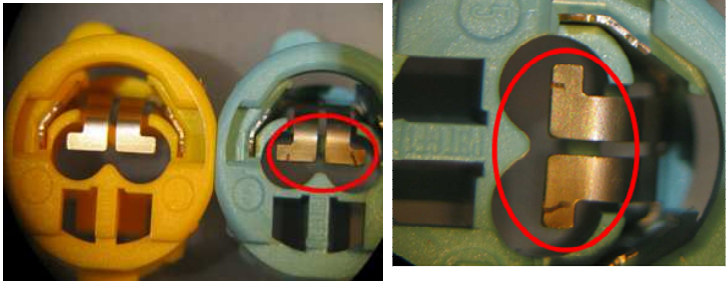
D3 Interim Containment Action(s) 1. RED-X team was assembled at TKH lead by Pradeep Singh to evaluate BOB/WOW. The team worked with BOB/WOW samples from Lordstown and Orion. Investigation into the body side connector / shorting clip / the team concluded the shorting clip (code2) was the RED-X.	% Effective 100	Date Implemented 06/14/12

2. TKH MIO - Validate no marks on Shorting bar during assembly process (10 pieces each hour)	100	06/15/12
3. TKH MIO – Replaced the primary stage installation tool with a revised tool matching the secondary stage dimensional and design intent.	100	06/16/12

4. TKH MIO - Validate shorting bar retraction reference dimension (>2.50mm) between shorting clip base and shorting clip bar when shorting clip is placed on tool. (1 at beginning each shift / 1 at change over)	100	06/16/12

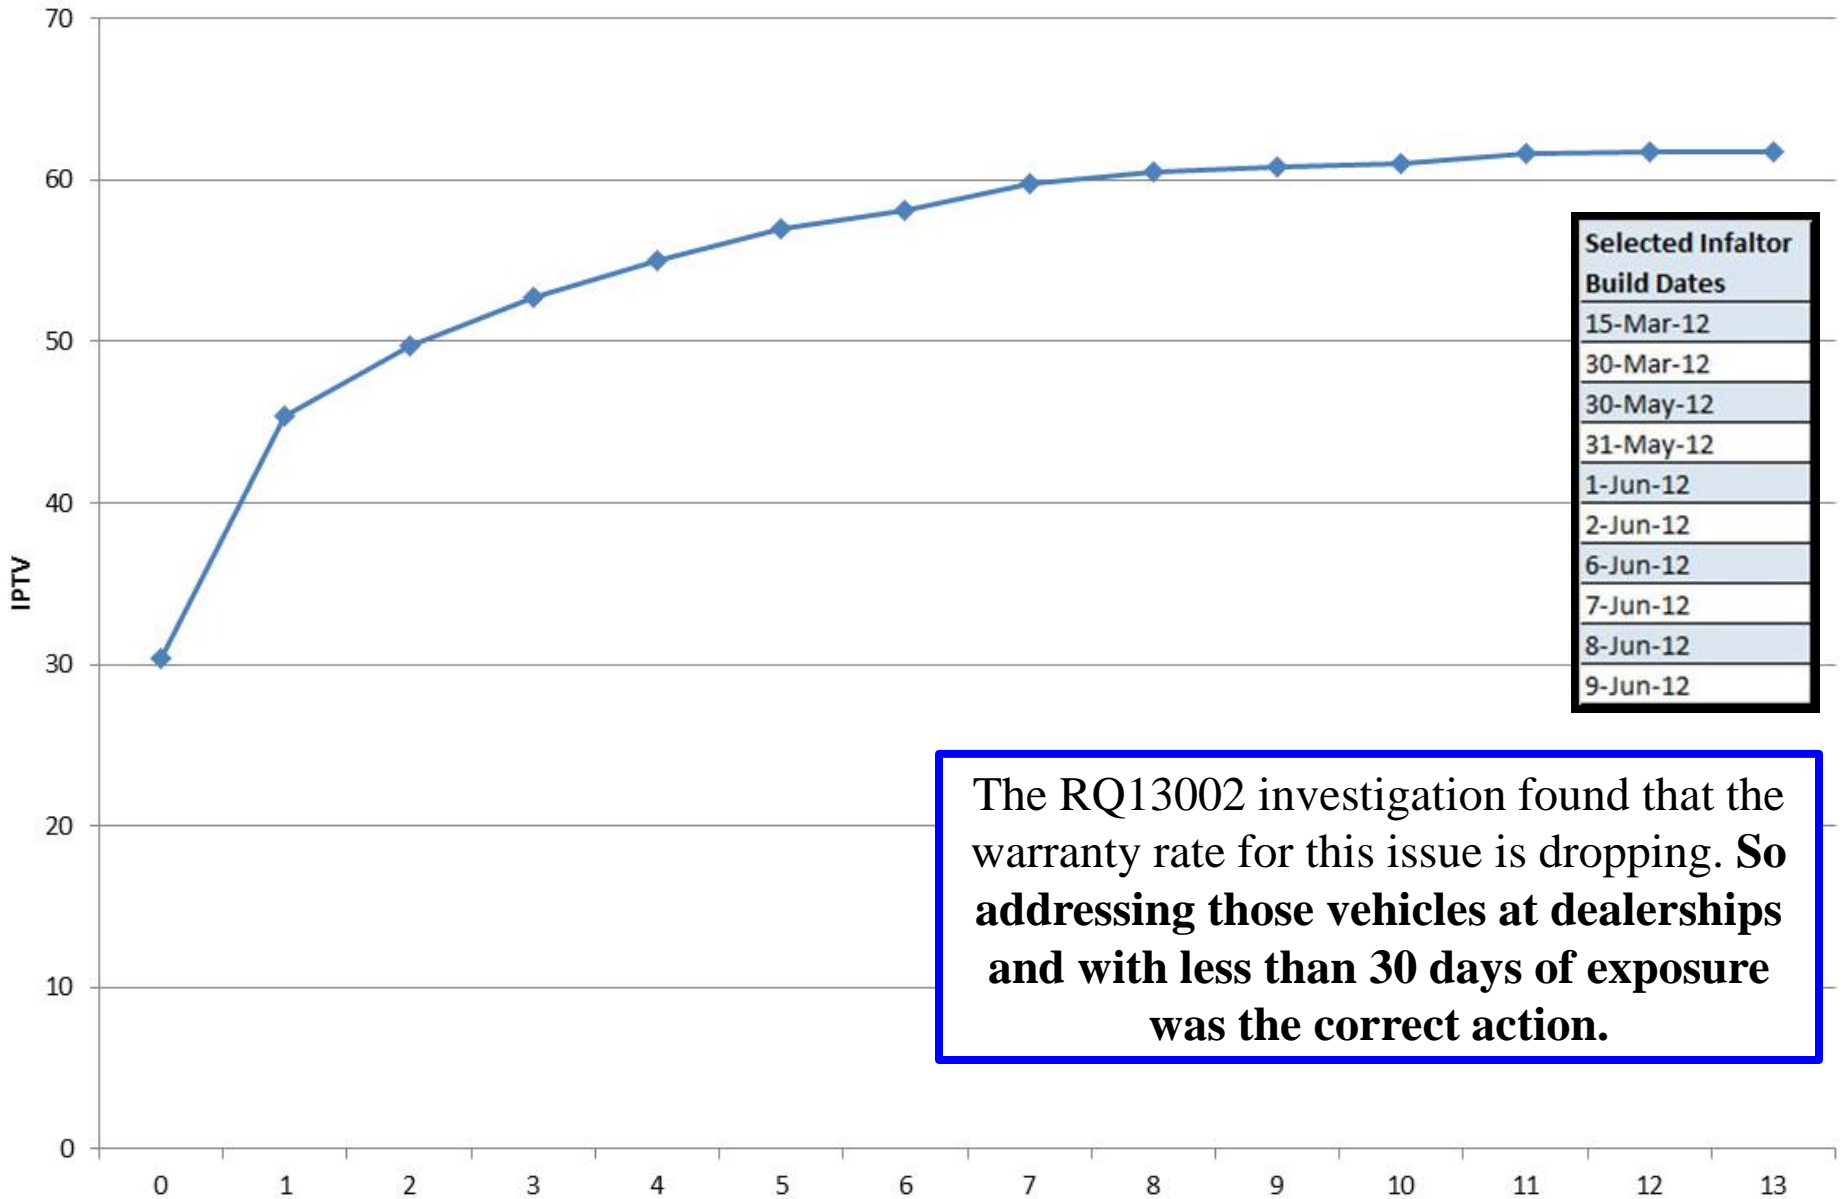
2012 Camaro, Cruze, Sonic, and Verano Airbag Filtered Warranty Cumulative IPTV for N120261 Inflator Build Dates

The RQ13002 investigation found that the warranty rate for this issue is dropping. **So addressing those vehicles at dealerships and with less than 30 days of exposure was the correct action.**

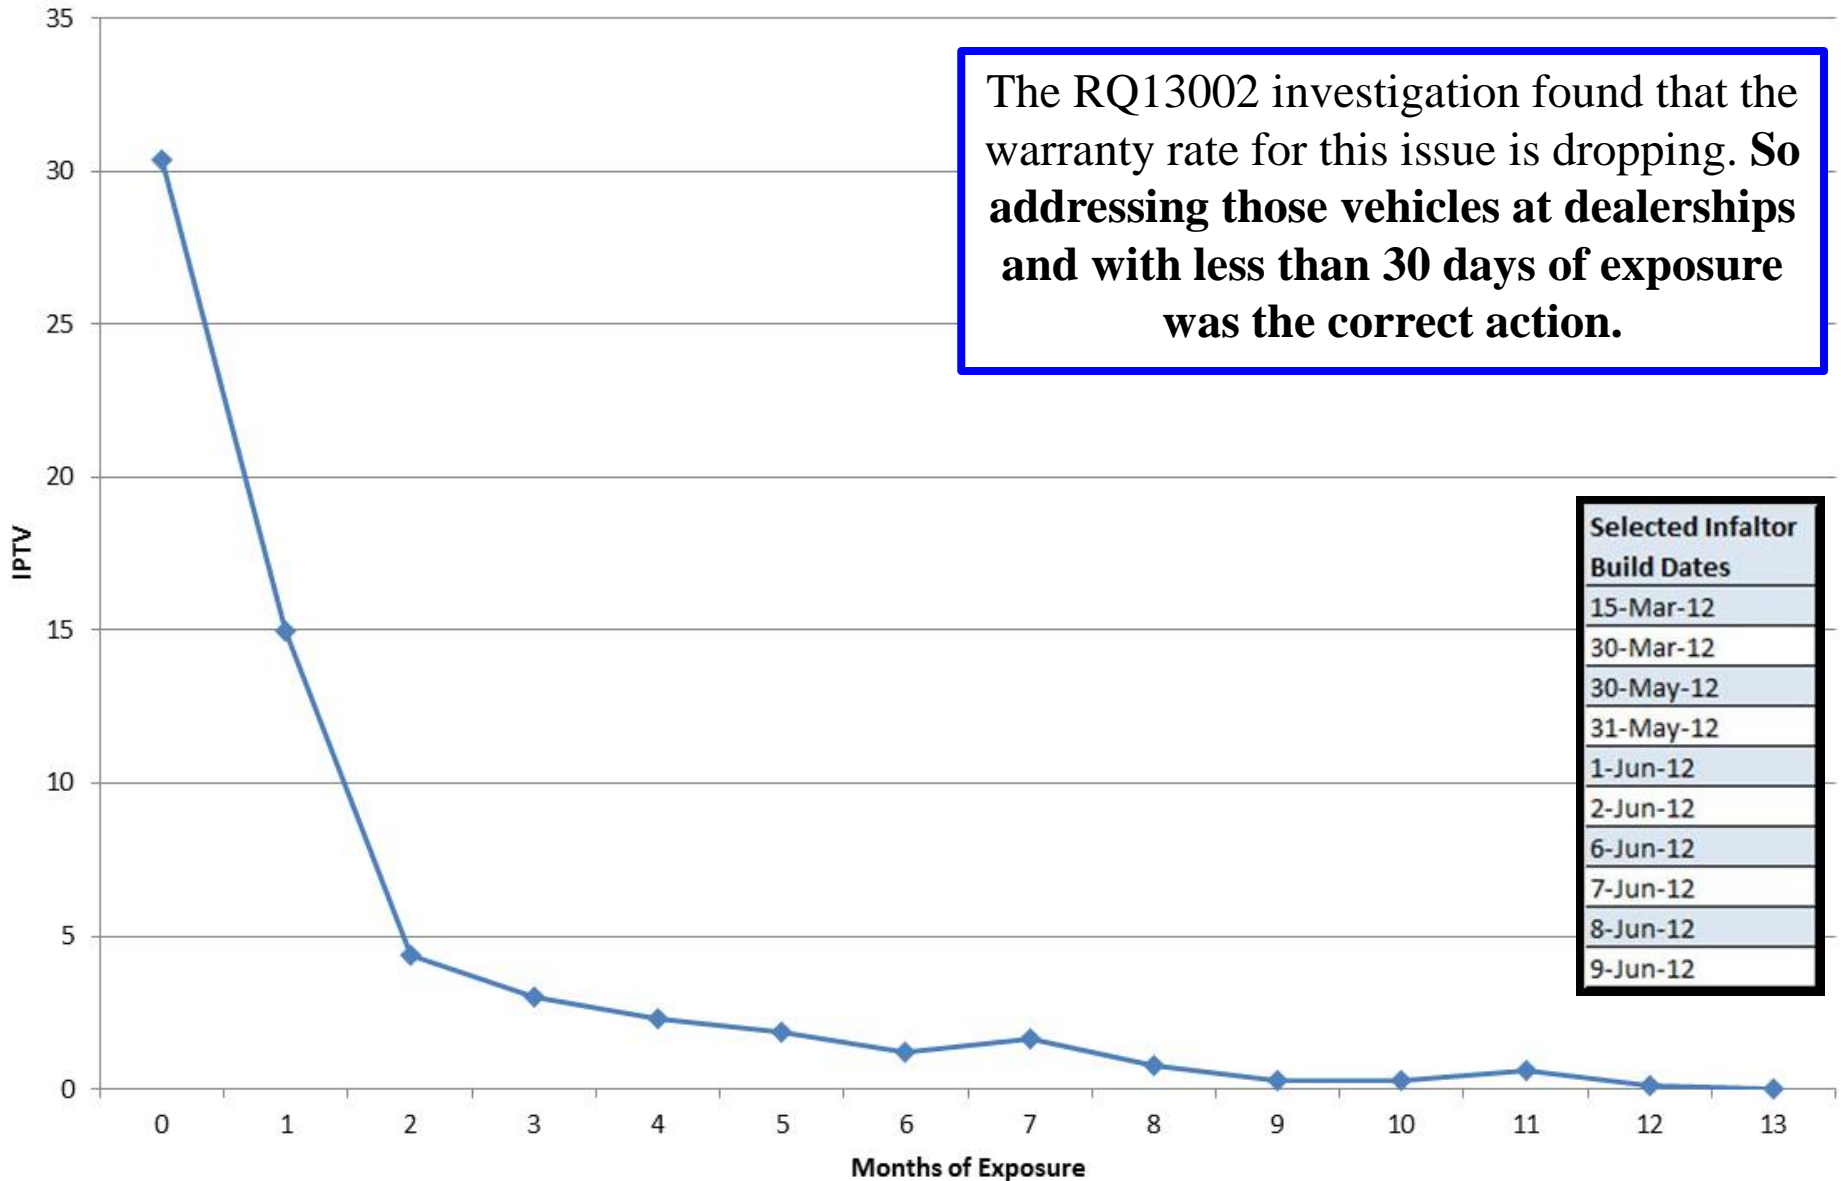
2012 Camaro, Cruze, Sonic, and Verano Airbag Filtered Warranty Incremental IPTV for N120261 Inflator Build Dates

The RQ13002 investigation found that the warranty rate for this issue is dropping. **So addressing those vehicles at dealerships and with less than 30 days of exposure was the correct action.**

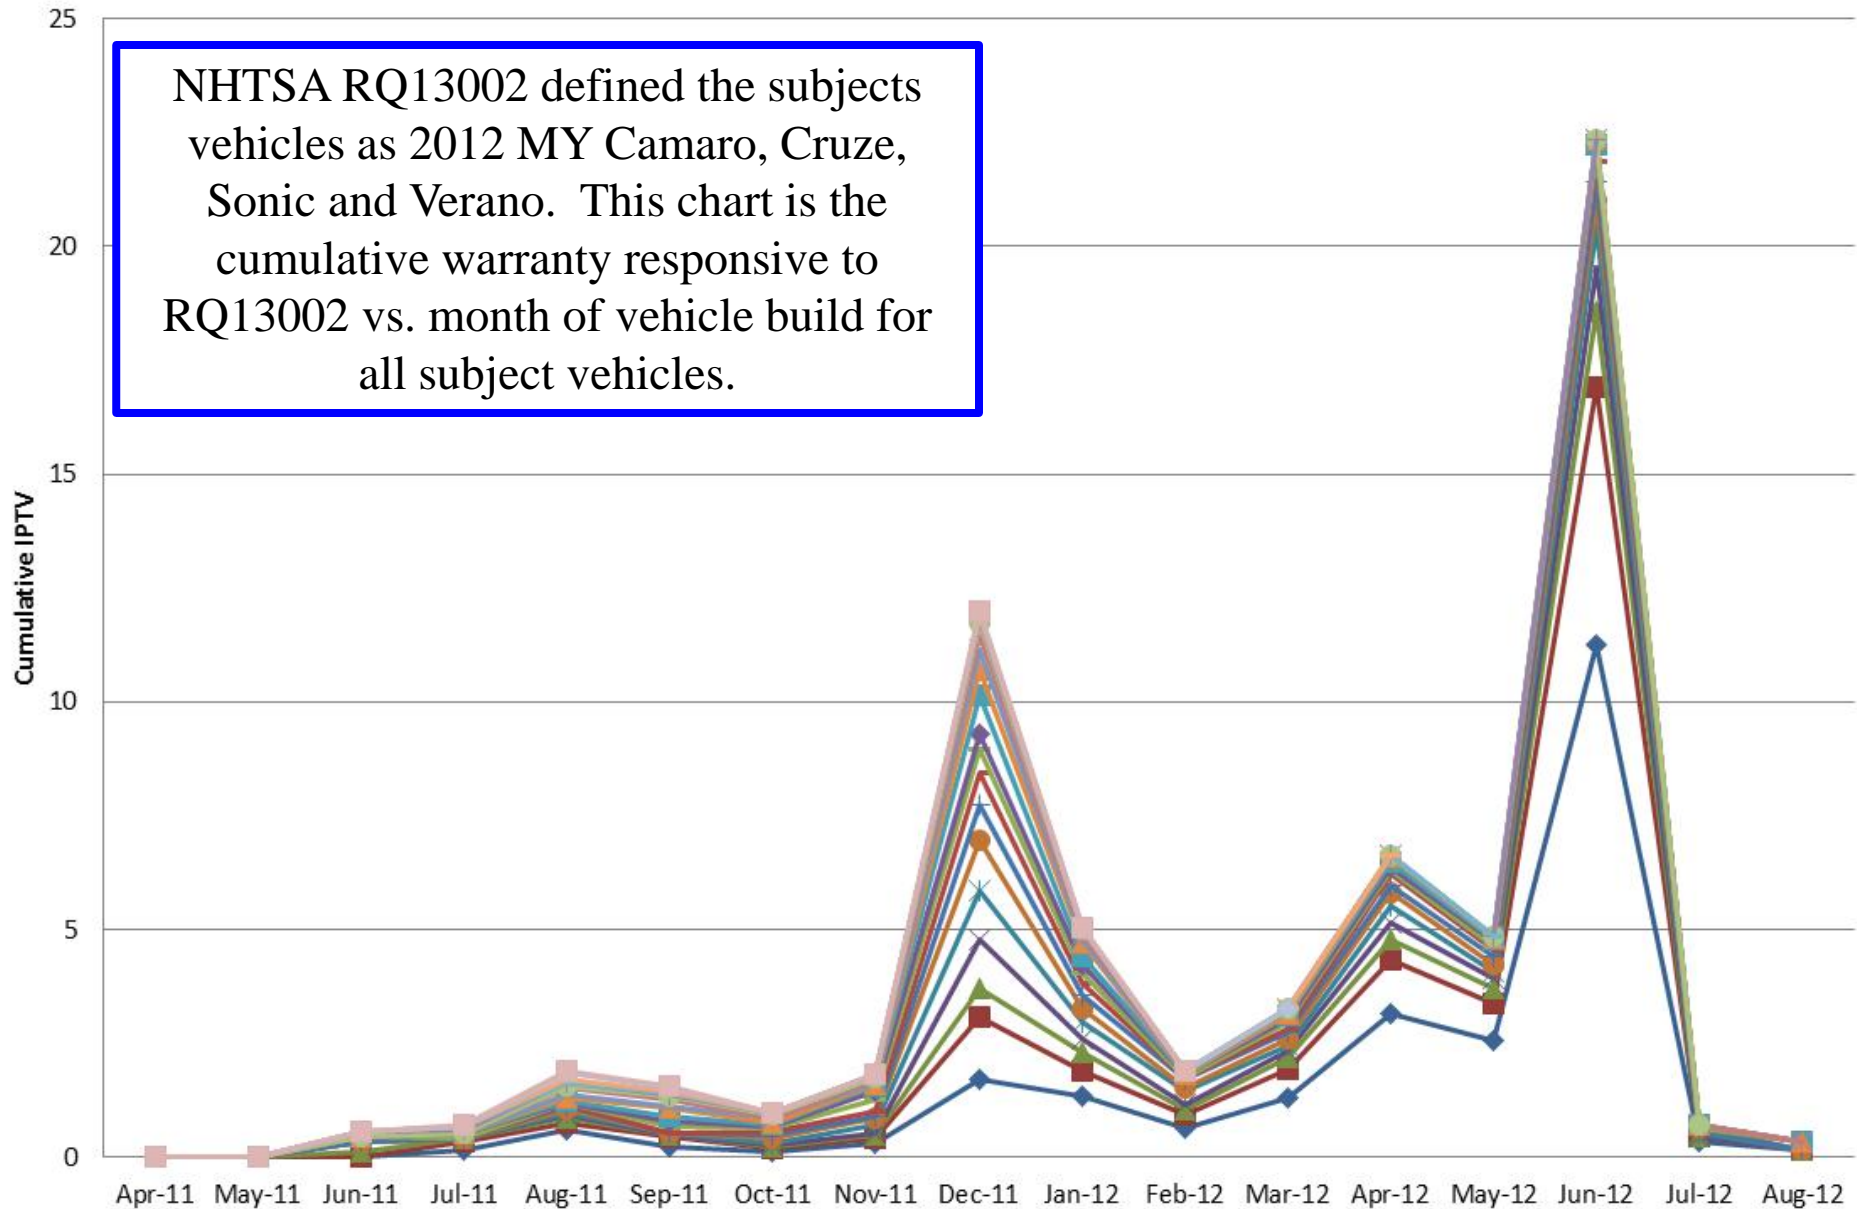
2012 Camaro, Cruze, Sonic, and Verano Airbag Filtered Warranty IPTV vs Month of Vehicle Build

NHTSA RQ13002 defined the subjects vehicles as 2012 MY Camaro, Cruze, Sonic and Verano. This chart is the cumulative warranty responsive to RQ13002 vs. month of vehicle build for all subject vehicles.

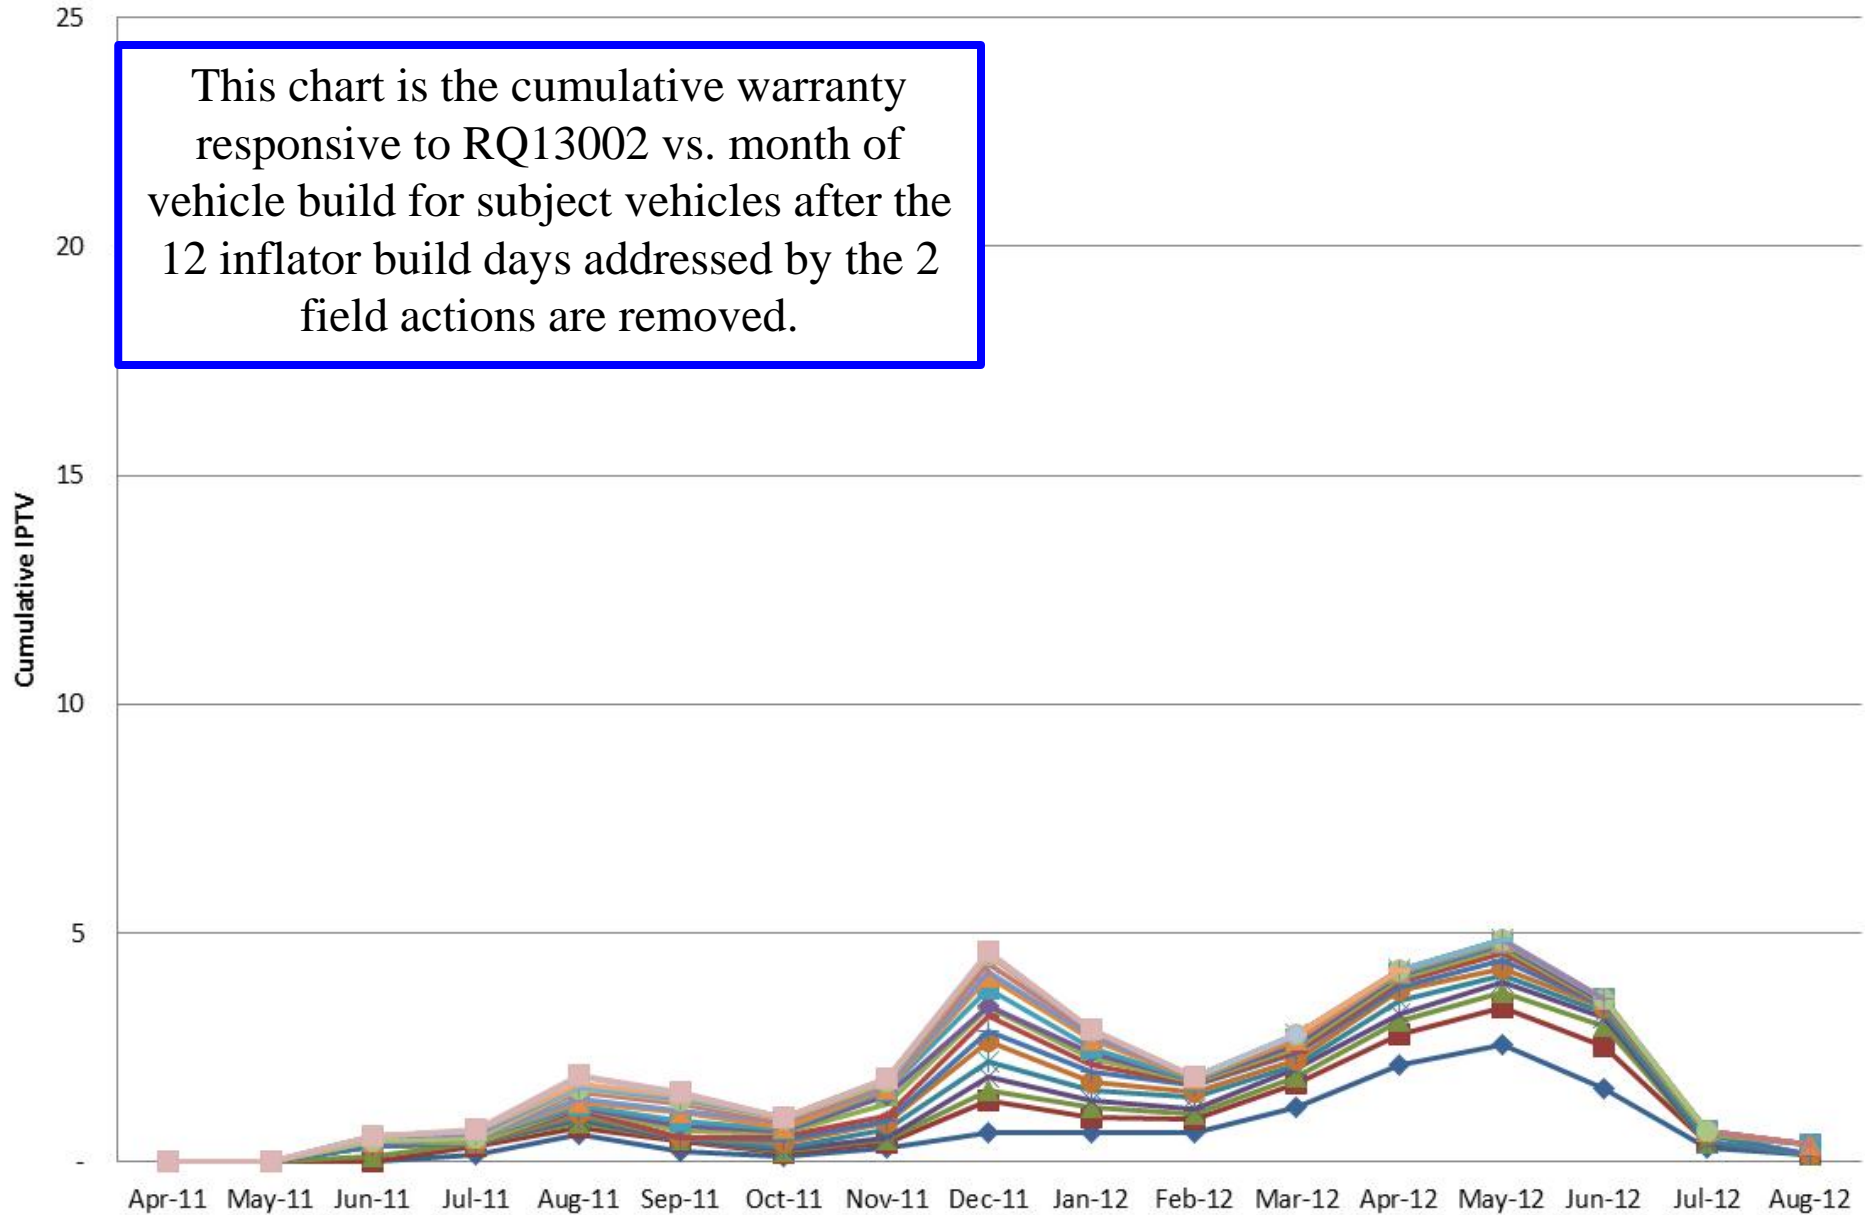
2012 Camaro, Cruze, Sonic, and Verano Airbag Filtered Warranty IPTV vs Month of Vehicle Build After Removal of 12 Days

This chart is the cumulative warranty responsive to RQ13002 vs. month of vehicle build for subject vehicles after the 12 inflator build days addressed by the 2 field actions are removed.

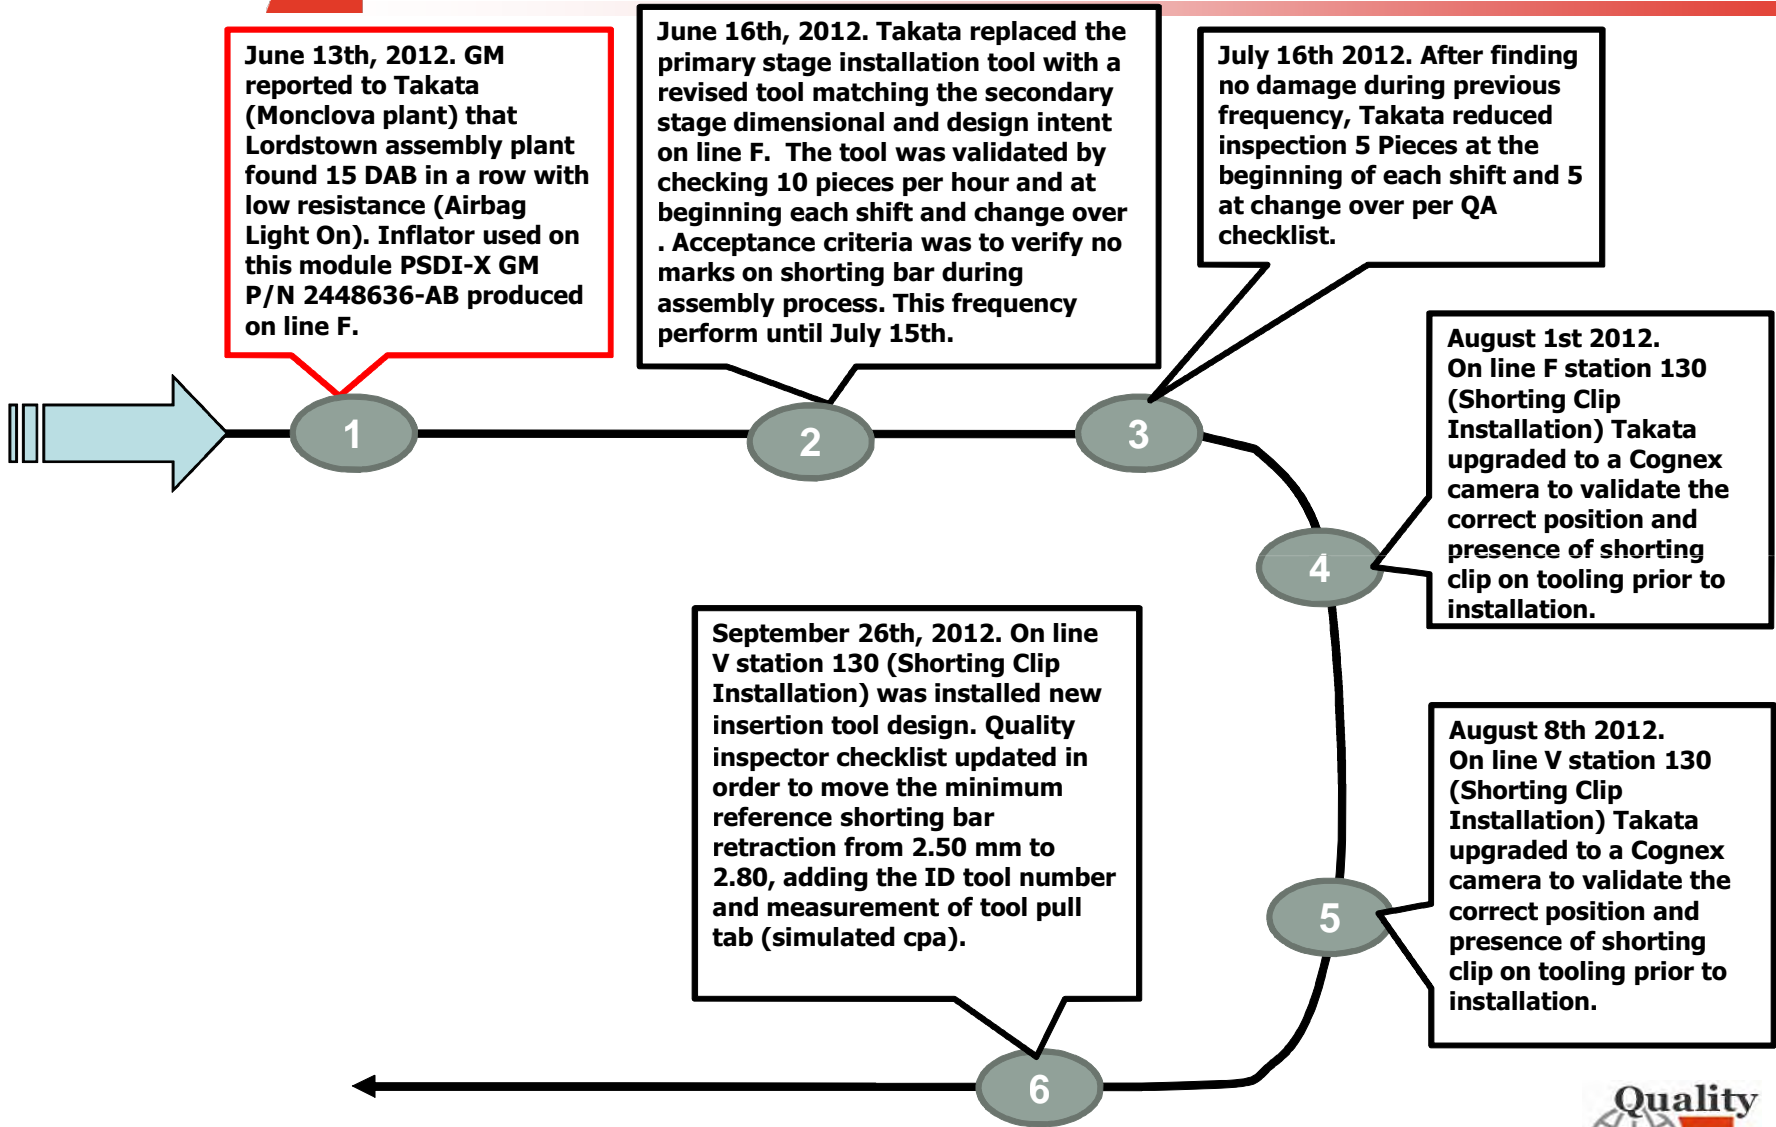
PSDI-X GM 2448636-AB
Intermittent Issue

Root Cause (Snake chart point 2)

Examination of the manufacturing process found that the shorting bar was not fully retracted during insertion process resulting in interference/contact between initiator pins and shorting bar. Additional comparisons were made to secondary stage (no reported issues) and a 0.3 mm shorter difference in tab (simulated cpa) length was detected in the insertion tool itself.
