RQ13-003

ATTACHMENT 1

Bulletin No.: 10-00-89-017Z

**Subject:** Car and Truck Fix it Right the First Time Issues

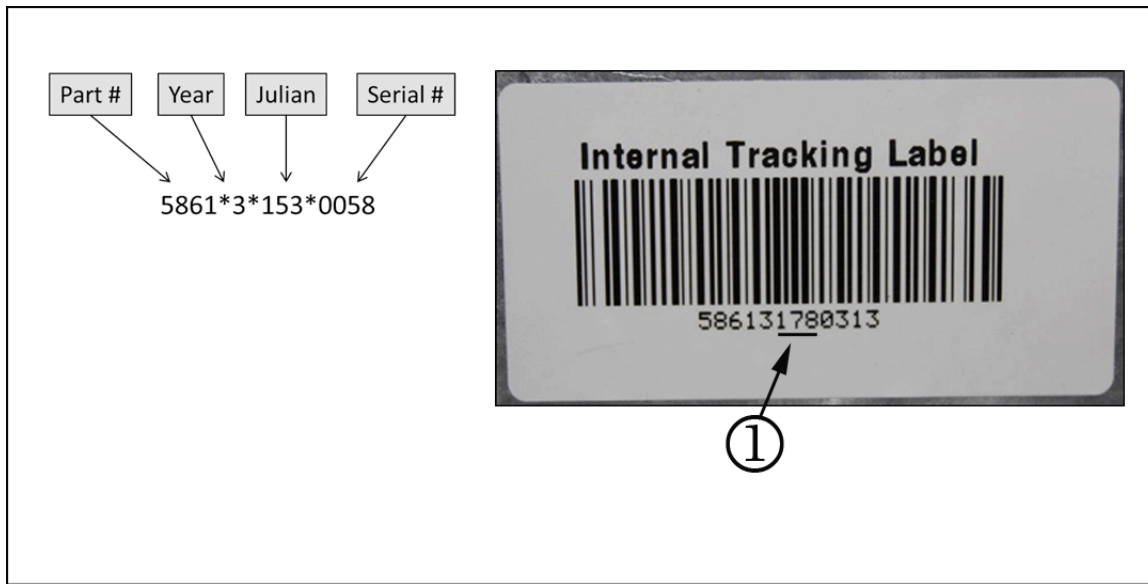
3600552

Generator Control Modules (GCM) with part number 24269448 or 24266403 require an inspection prior to installation in a vehicle. GCMs with part number 24267940 or 24267941 do NOT require inspection prior to installation in a vehicle.

Do NOT provide technicians with GCMs (p/n 24269448 or 24266403) that have a Julian date of 171 through 199. Determine the Julian date following the steps below. Return modules that fail the inspection according to Special Return Bulletin #G\_0000171850.

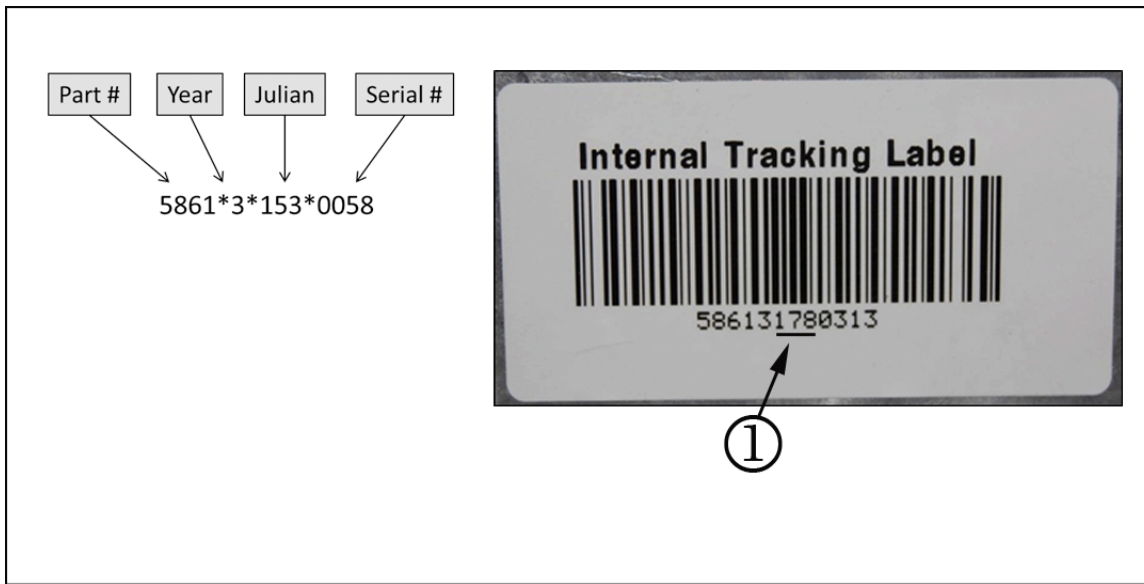
**Note:** Do NOT install GCMs with a Julian date of 171 through 199. Return those modules according to Special Return Bulletin #G\_0000171850.

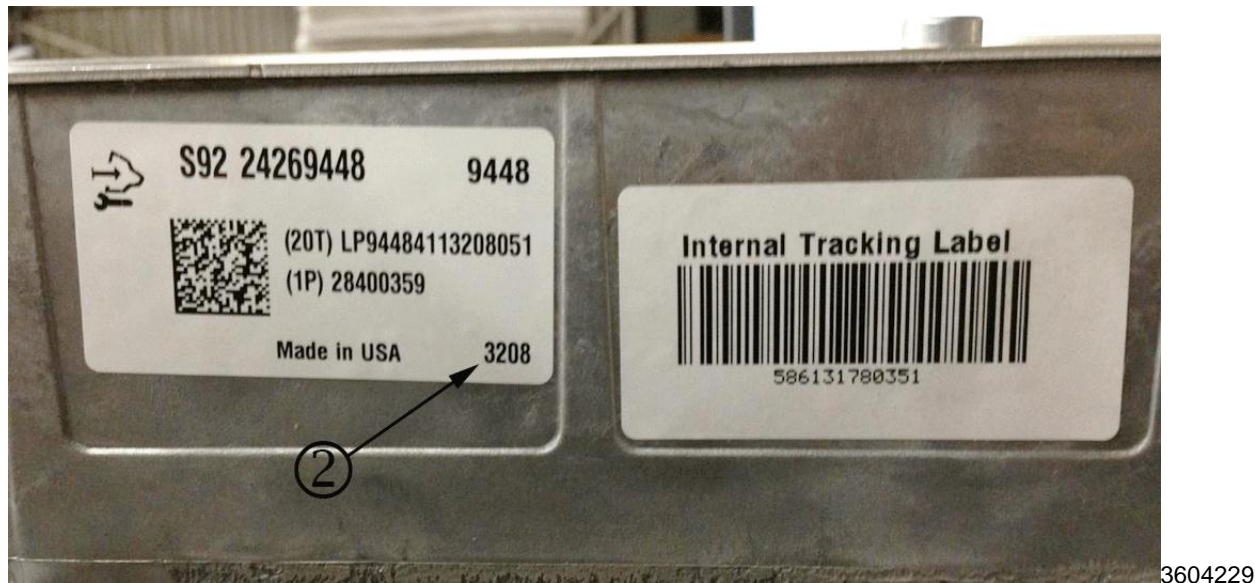
3. Locate the Flash label on the GCM.

- If the number on the lower right-hand side of the label (2) is 3203 or lower, do NOT use the GCM. Obtain another module and perform the inspection again.
- If the number on the lower right-hand side of the label (2) is 3204 or higher, install the GCM in the vehicle.

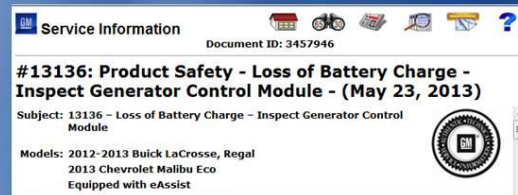
## 13136: Loss of Battery Charge Inspect Generator Control Module

- The bulletin requires a GCM inspection be performed
- Testing is intended to stress the GCM beyond normal customer use
- Rare cases may result in smoke, thermal damage to the GCM

**Bulletin 13136 requires a Generator Control Module or GCM inspection be performed. This testing is intended to stress the GCM beyond normal customer use and in rare cases may result in smoke and thermal damage to the GCM.**
