RQ13-003

GM

ATTACHMENT A

Q09B

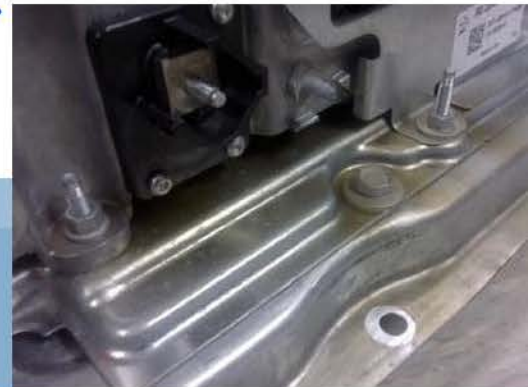
Black marks found on Powerpack sheet metal and BPIM electrical connector.

Connector still functional and in vehicle, no other distress to vehicle noted.

Vehicle Detail: VIN: LSGGF53G4BH210807, VESCOM 10.3, Powerpack: LQ5812411144002
