- NHTSA has contacted GM in regard to (est.) 82 cases of thermal verbatims included in TREAD reports for eAssist vehicles
- Root cause is shorting between layers of printed circuit boards inside metal-encased eAssist inverter / DC-DC converter (“BPIM/APM”), which is part of the eAssist “Powerpack” (metal box in trunk that contains BPIM/APM and Lithium-Ion battery)

- Approximately 54,000 LaCrosse/Regal/Malibu vehicles built prior to January 2013 have potential for this issue. There are three different “buckets” of vehicles with different risk profiles, one higher than the other two.

eAssist: BPIM/APM Circuit Board Failures

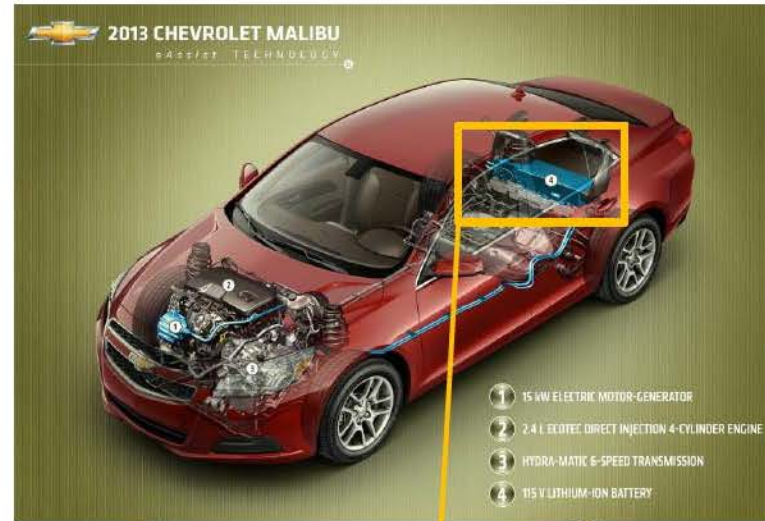
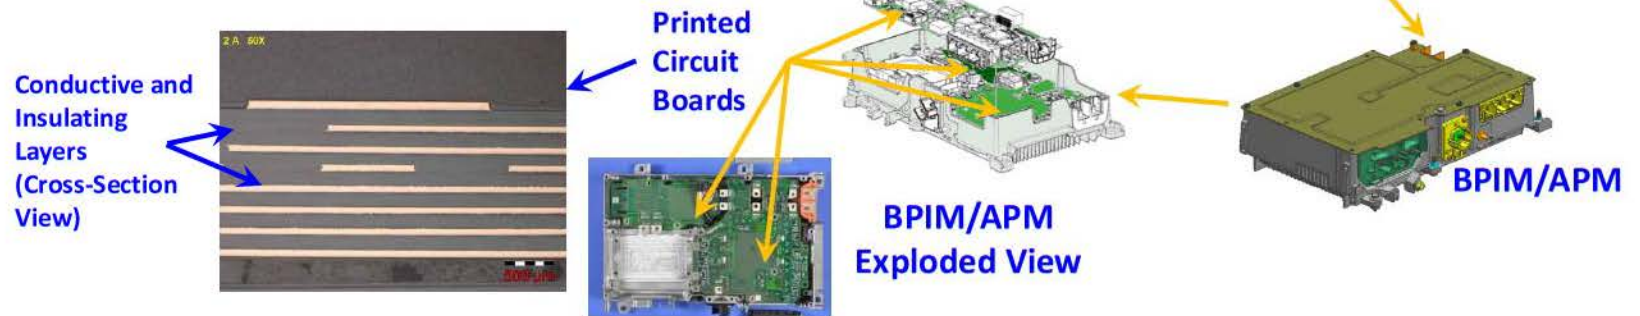
- All eAssist vehicles have a **Powerpack** which contains a **BAS Power Inverter Module (BPIM) / Accessory Power Module (APM)**, and a **115-V Lithium-Ion battery**
- The BPIM/APM contains three multi-layered **Printed Circuit Boards (PCBs)** comprised of conductive layers separated by isolating layers
- General practice is for two layers of isolation between conductive layers or one layer of adequate thickness.
- The three PCBs in the eAssist BPIM/APM have **at least one instance of conductive layers separate by only one isolating layer**
- This design showed **no issues during validation** but some isolation failures (short) began to occur in production
- The **failure rate increase dramatically coinciding with several board build lots in 2012**
- All boards built since January 2013 have **dual isolation layers** and the failure rate for isolation faults has been zero

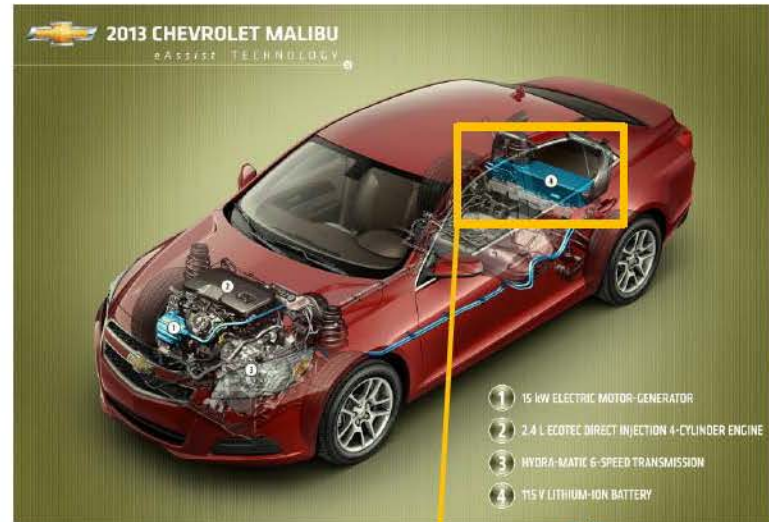
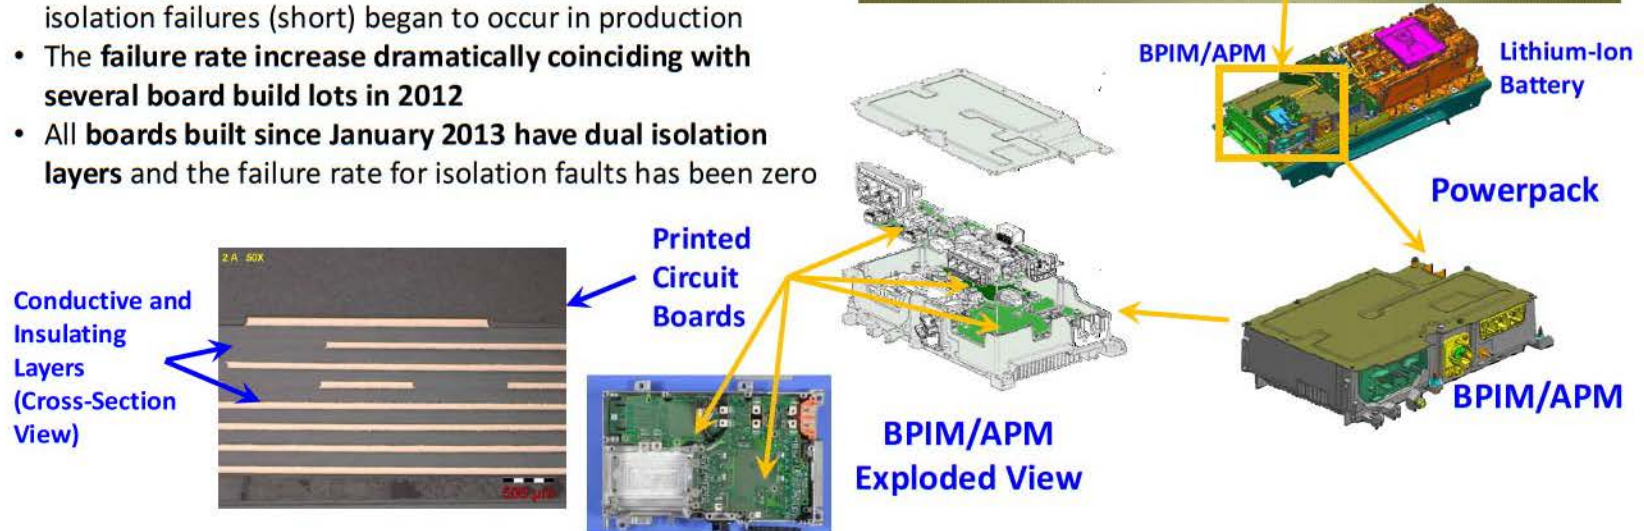
eAssist: BPIM/APM Circuit Board Failures

- All eAssist vehicles have a **Powerpack** which contains a **BAS Power Inverter Module (BPIM) / Accessory Power Module (APM)**, and a **115-V Lithium-Ion battery**
- The BPIM/APM contains three multi-layered **Printed Circuit Boards (PCBs)** comprised of conductive layers separated by isolating layers
- General practice is for two layers of isolation between conductive layers or one layer of adequate thickness.
- The three PCBs in the eAssist BPIM/APM have **at least one instance of conductive layers separate by only one isolating layer**
- This design showed **no issues during validation** but some isolation failures (short) began to occur in production
- The **failure rate increase dramatically coinciding with several board build lots in 2012**
- All **boards built since January 2013** have dual isolation layers and the failure rate for isolation faults has been zero

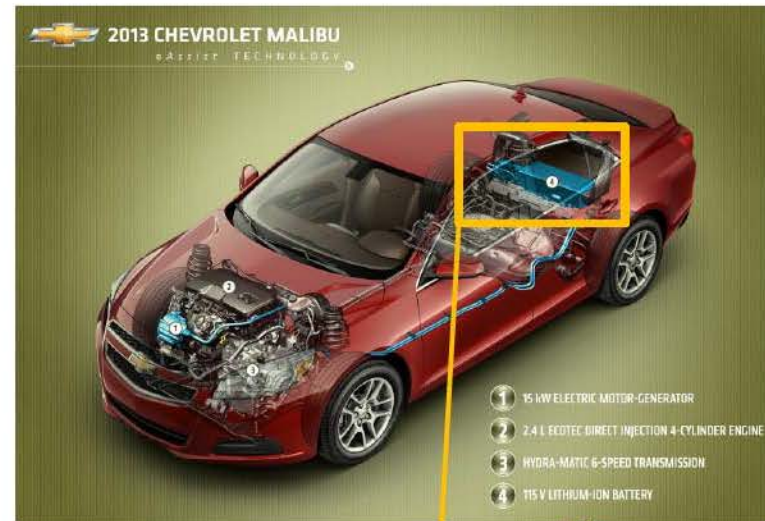
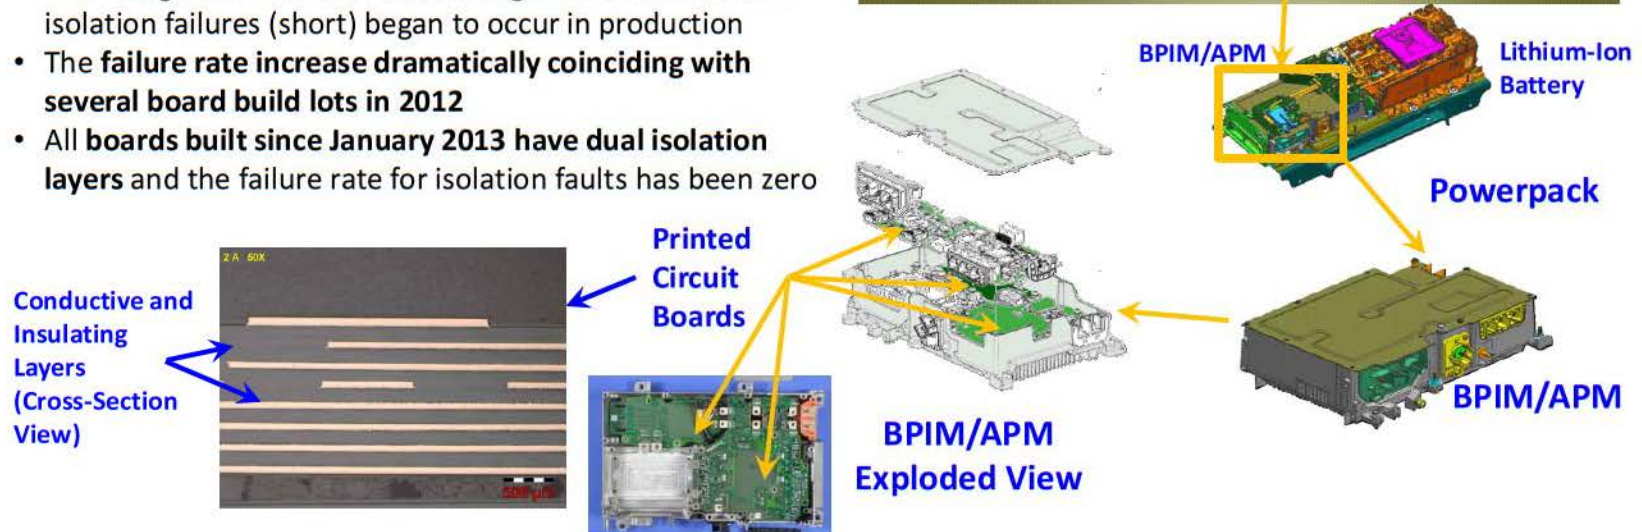
eAssist: BPIM/APM Circuit Board Failures

- All eAssist vehicles have a **Powerpack** which contains a **BAS Power Inverter Module (BPIM) / Accessory Power Module (APM)**, and a **115-V Lithium-Ion battery**
- The BPIM/APM contains three multi-layered **Printed Circuit Boards (PCBs)** comprised of conductive layers separated by isolating layers
- General practice is for two layers of isolation between conductive layers or one layer of adequate thickness.
- The three PCBs in the eAssist BPIM/APM have **at least one instance of conductive layers separate by only one isolating layer**
- This design showed **no issues during validation** but some isolation failures (short) began to occur in production
- The **failure rate increase dramatically coinciding with several board build lots in 2012**
- All boards built since January 2013 have dual isolation layers and the failure rate for isolation faults has been zero

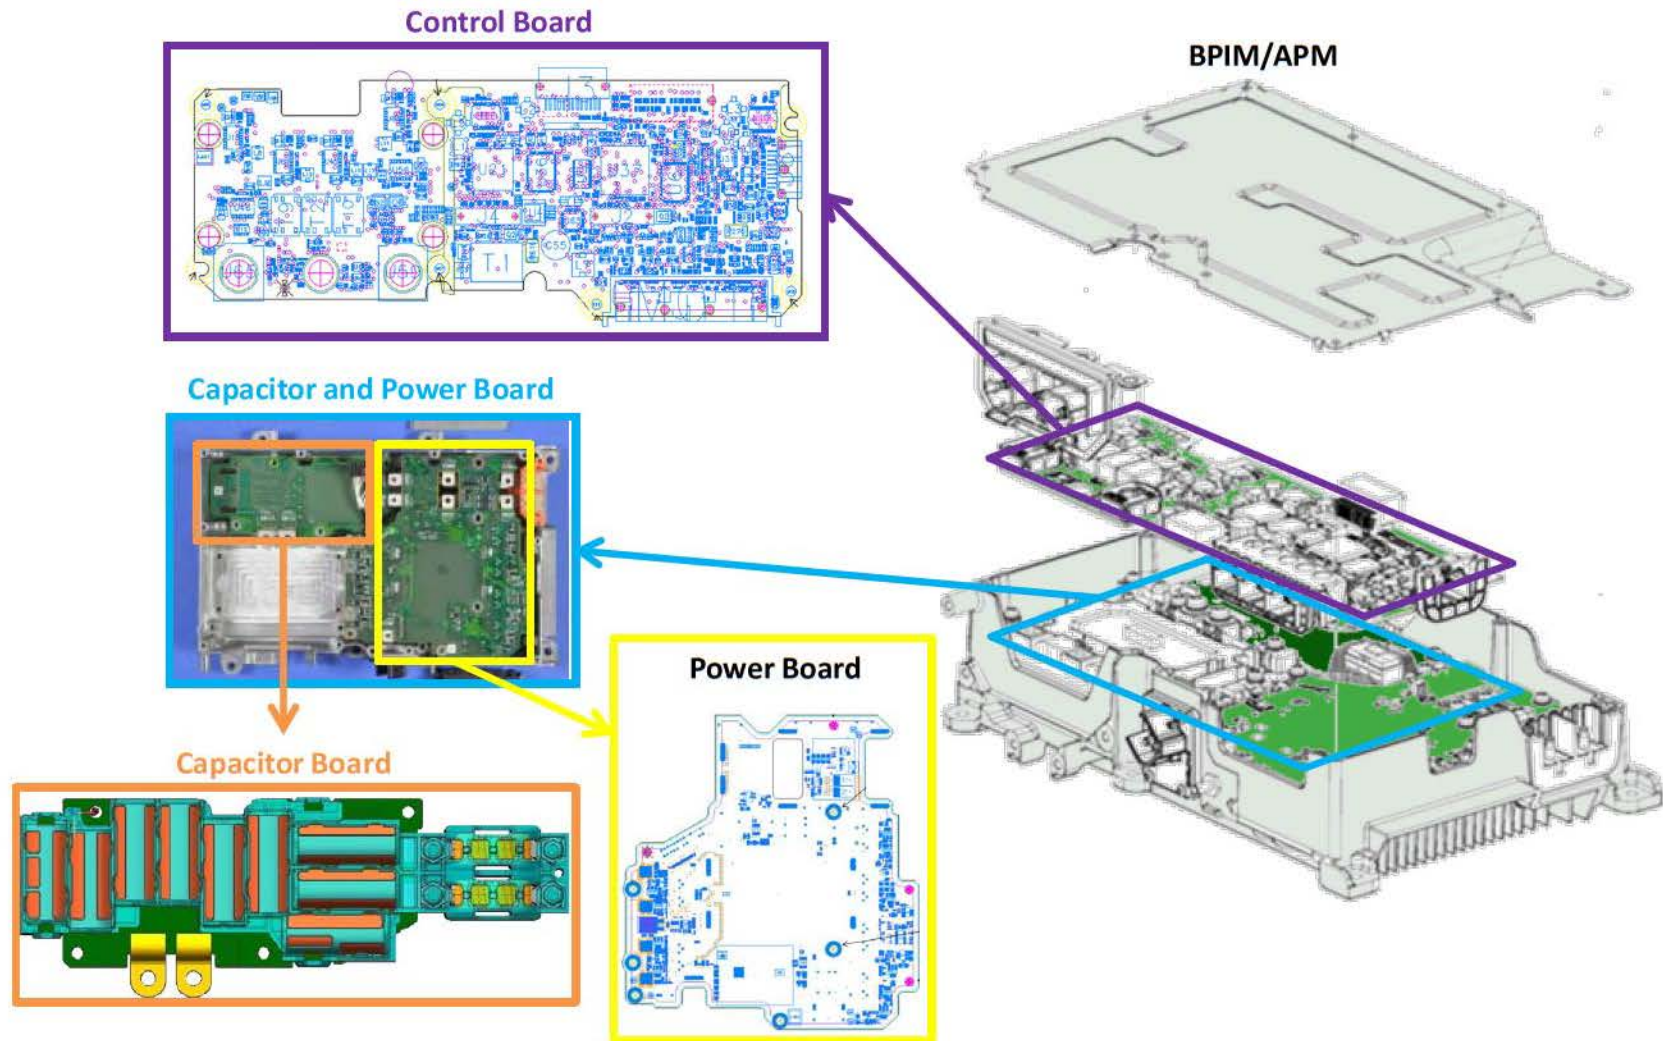
eAssist: BPIM/APM Printed Circuit Boards

- When failures occur, most result in eventual loss of 12-V power (**walk-home**)
- Many cases happen without noticeable symptoms, but others **can exhibit some odor, smoke, soot, etc.**

- **Most parts with single-layer design appear to have no issue** and are not expected to fail or have reduced reliability in service
- **Failures generally consistent with infant mortality** – typically < 100 miles, nearly all < 1000 miles
- But a **few cases have occurred at higher mileage** (up to 20-30k mi)

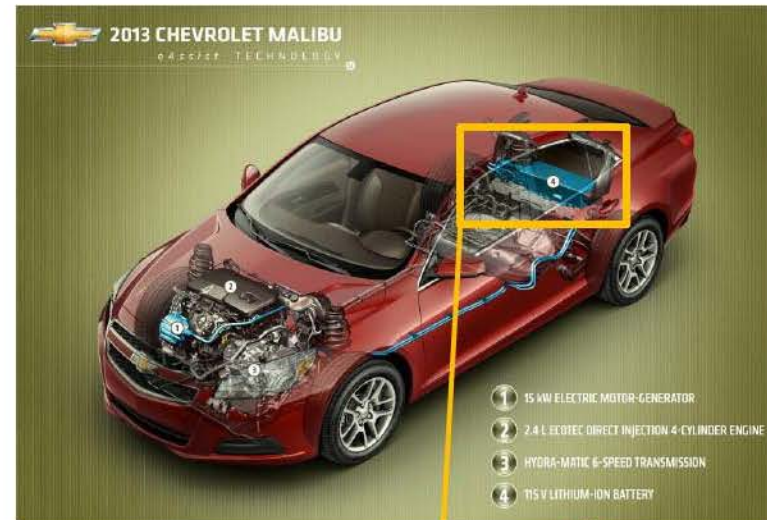
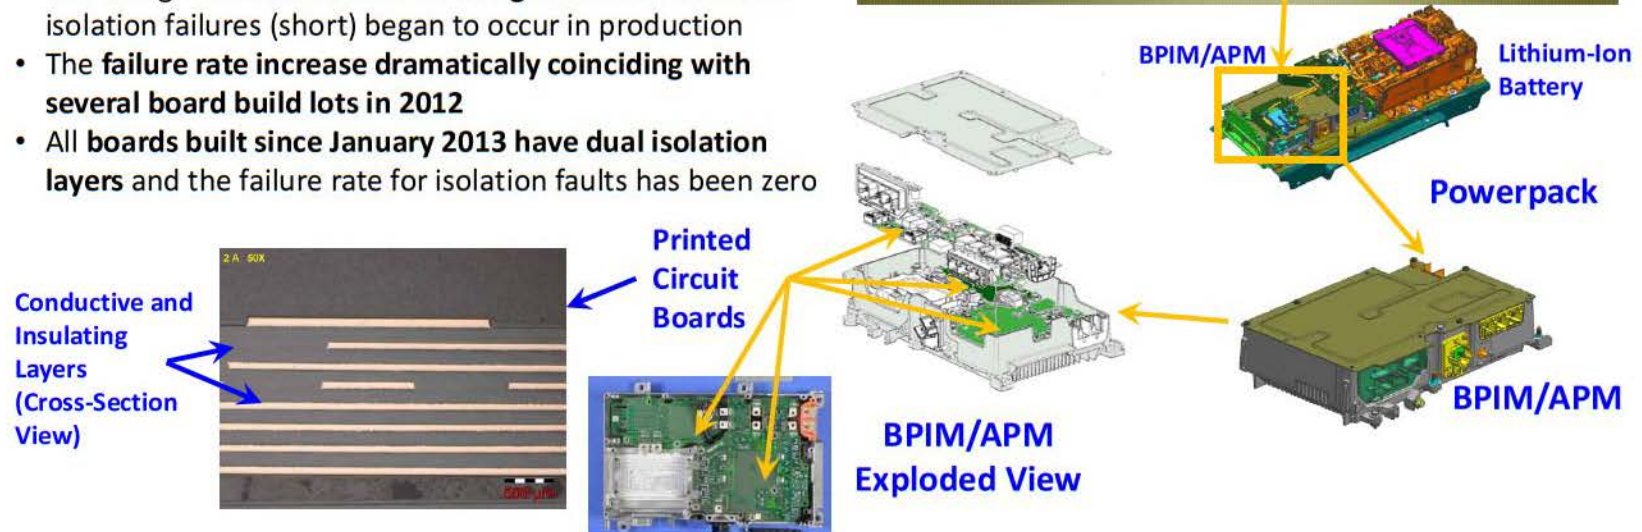
- All eAssist vehicles have a **Powerpack** which contains a **BAS Power Inverter Module (BPIM) / Accessory Power Module (APM)**, and a **115-V Lithium-Ion battery**
- The BPIM/APM contains three multi-layered **Printed Circuit Boards (PCBs)** comprised of conductive layers separated by isolating layers
- General practice is for two layers of isolation between conductive layers or one layer of adequate thickness.
- The three PCBs in the eAssist BPIM/APM have **at least one instance of conductive layers separate by only one isolating layer**
- This design showed **no issues during validation** but some isolation failures (short) began to occur in production
- The **failure rate increase dramatically coinciding with several board build lots in 2012**
- All boards built since January 2013 have dual isolation layers and the failure rate for isolation faults has been zero

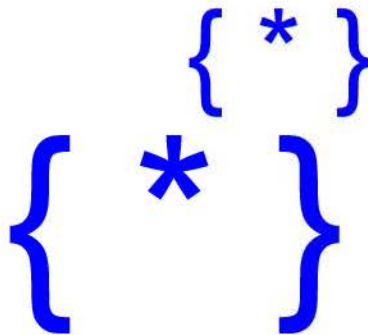
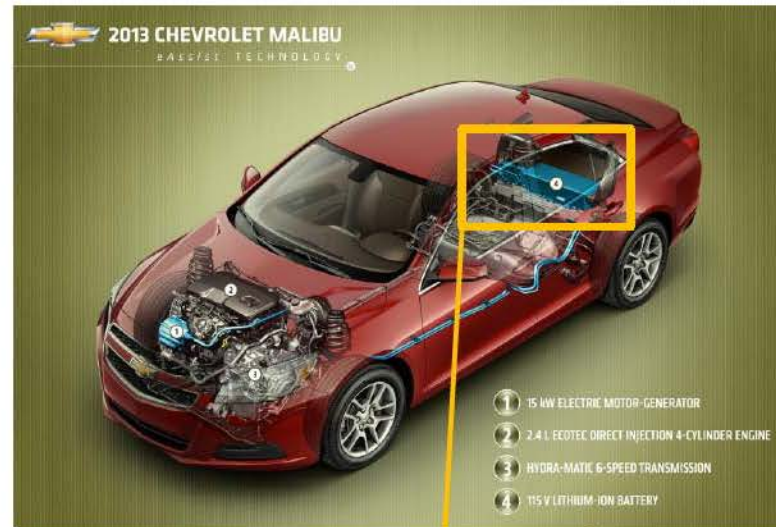
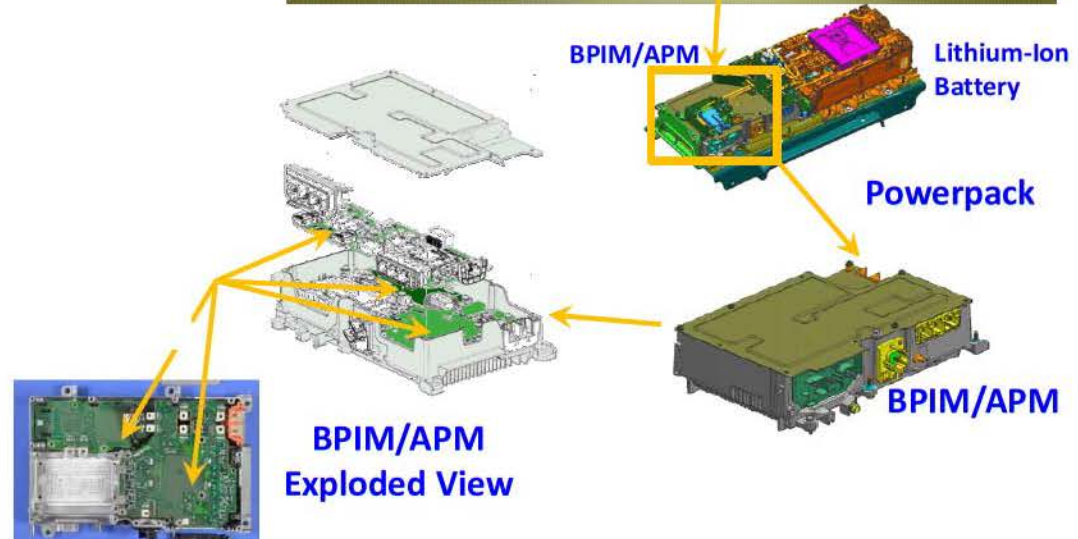
eAssist: BPIM/APM Circuit Board Failures

- All eAssist vehicles have a **Powerpack** which contains a **BAS Power Inverter Module (BPIM) / Accessory Power Module (APM)**.
- The BPIM/APM contains three multi-layered **Printed Circuit Boards (PCBs)** comprised of conductive layers separated by isolating layers.
- General practice is for two layers of isolation between conductive layers or one layer of adequate thickness.

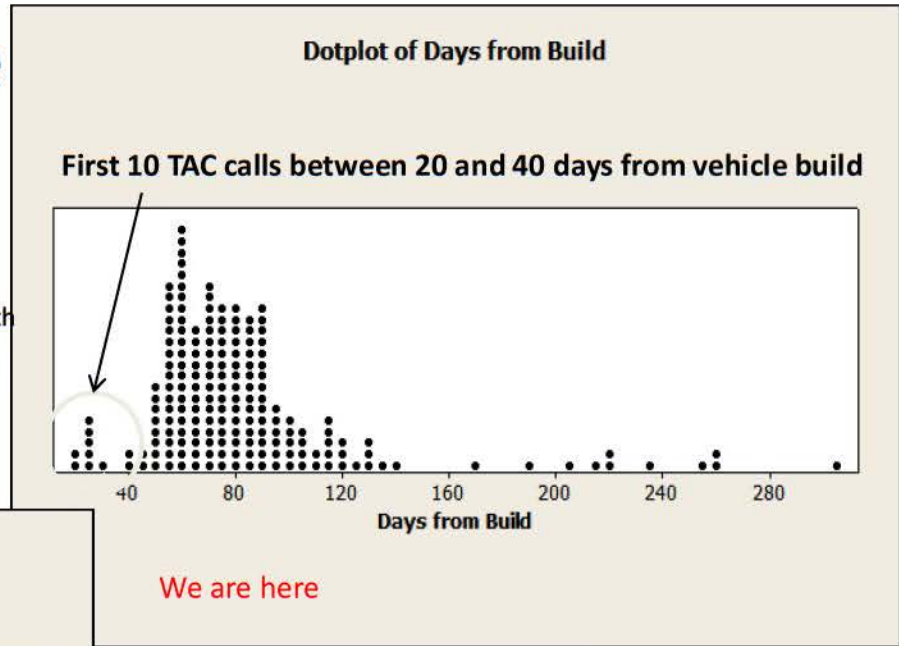
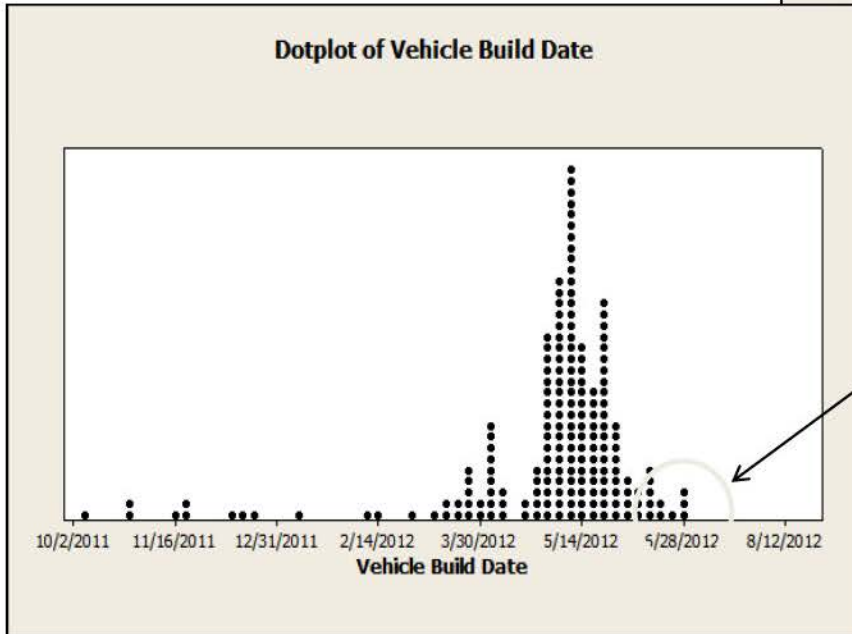
TAC Case vs Build Date

1. Assume first non-suspect parts in cars July 16 (Monday after shutdown)
2. 25 days between July 16) and August 10th
3. If no change in distributions, expect TAC cases to begin by 20 days after July 16.

End of March- May suspect batches – June 15
Last TAC case build date June 29

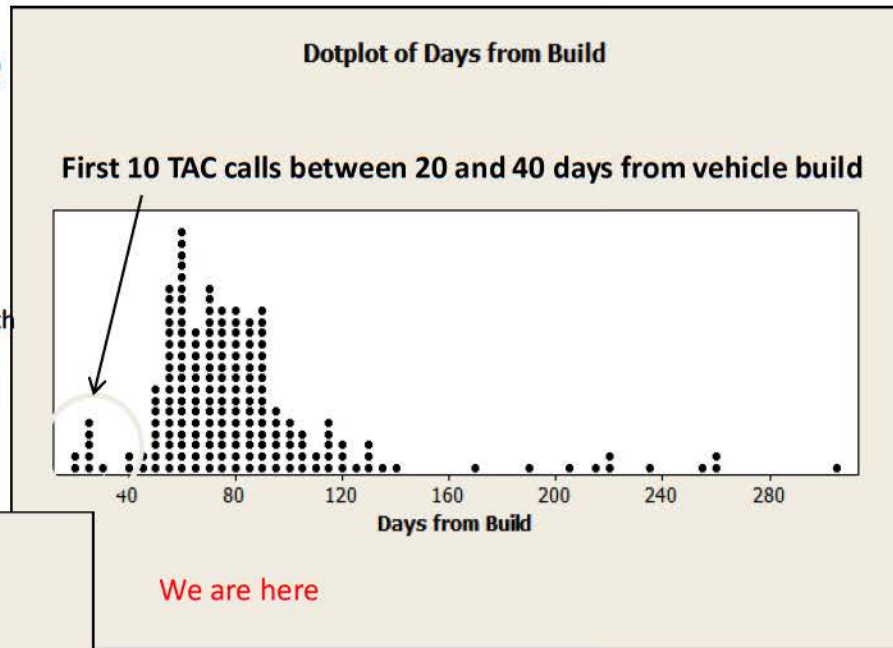
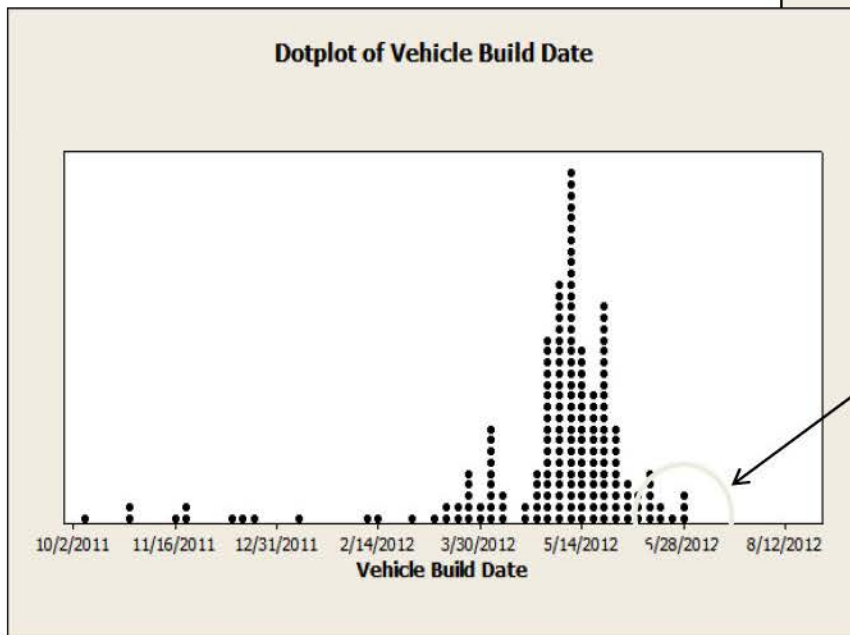
TAC Case vs Build Date

1. Assume first non-suspect parts in cars July 16 (Monday after shutdown)
2. 25 days between July 16) and August 10th
3. If no change in distributions, expect TAC cases to begin by 20 days after July 16.

End of March- May suspect batches – June 15
Last TAC case build date June 29

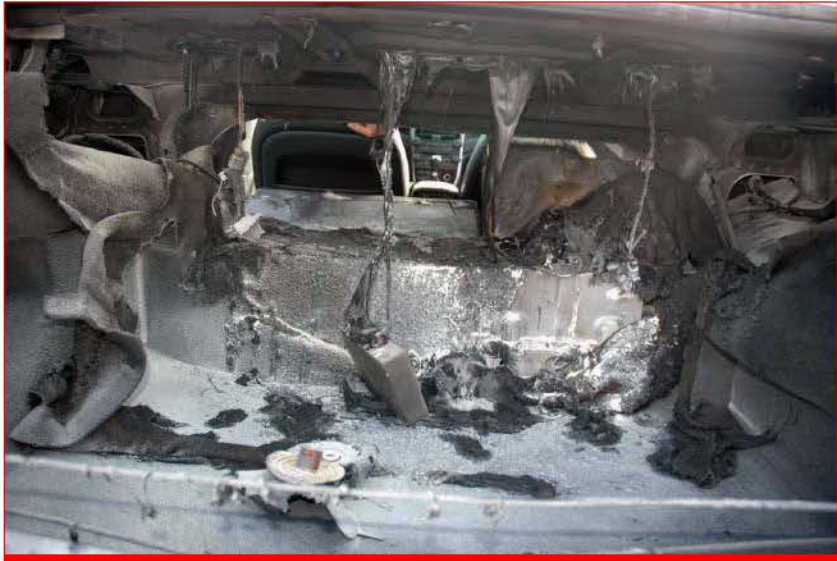
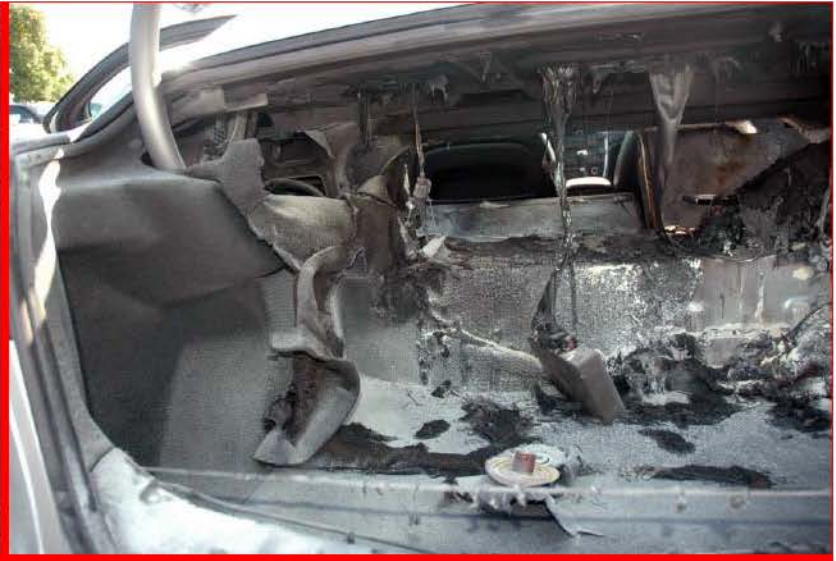
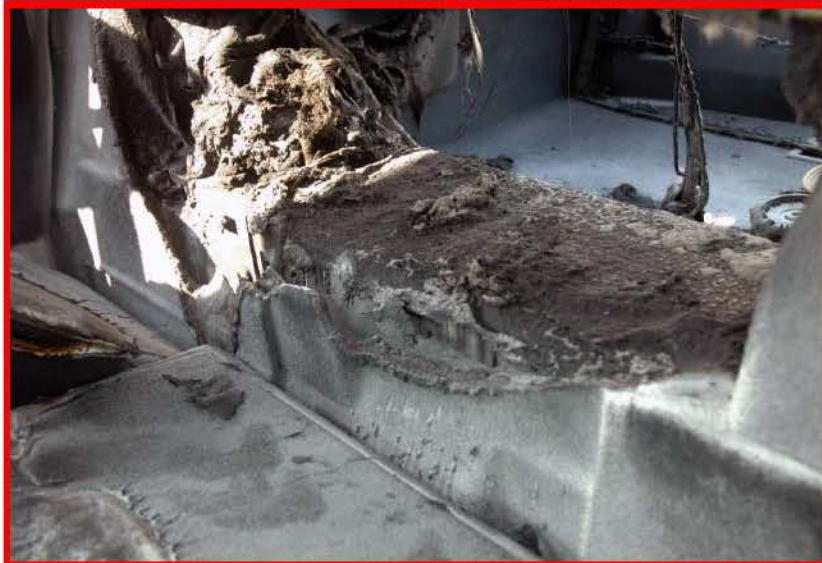
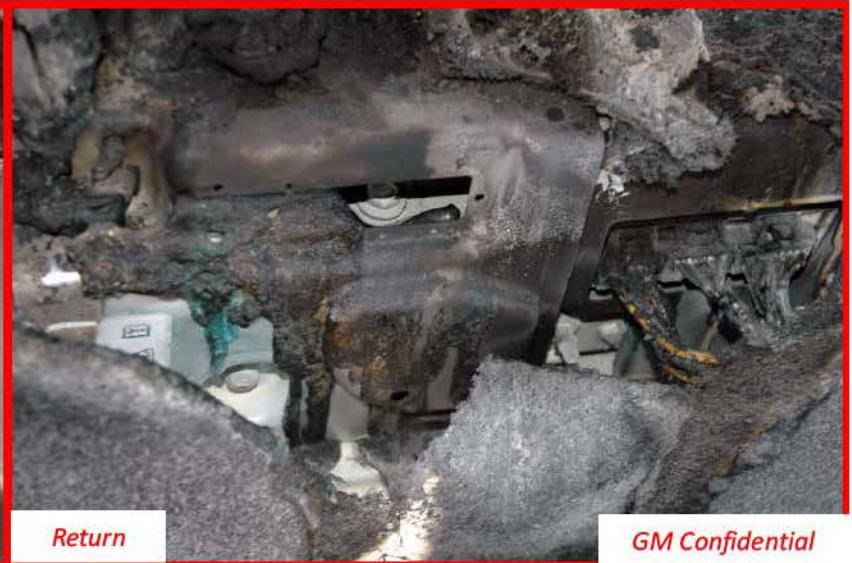
VEHICLE 2013 CHEV. MALIBU
VIN No. 1G11F5RRODF118790
PHOTOGRAPHER RON ORLANDO

- One at dealer that was investigated at MPG ([see photos](#)).
- Other from a normal warranty return
 - No external evidence and was replaced for a dash light and DTC.
 - GMCH found small burn spot on the cap board

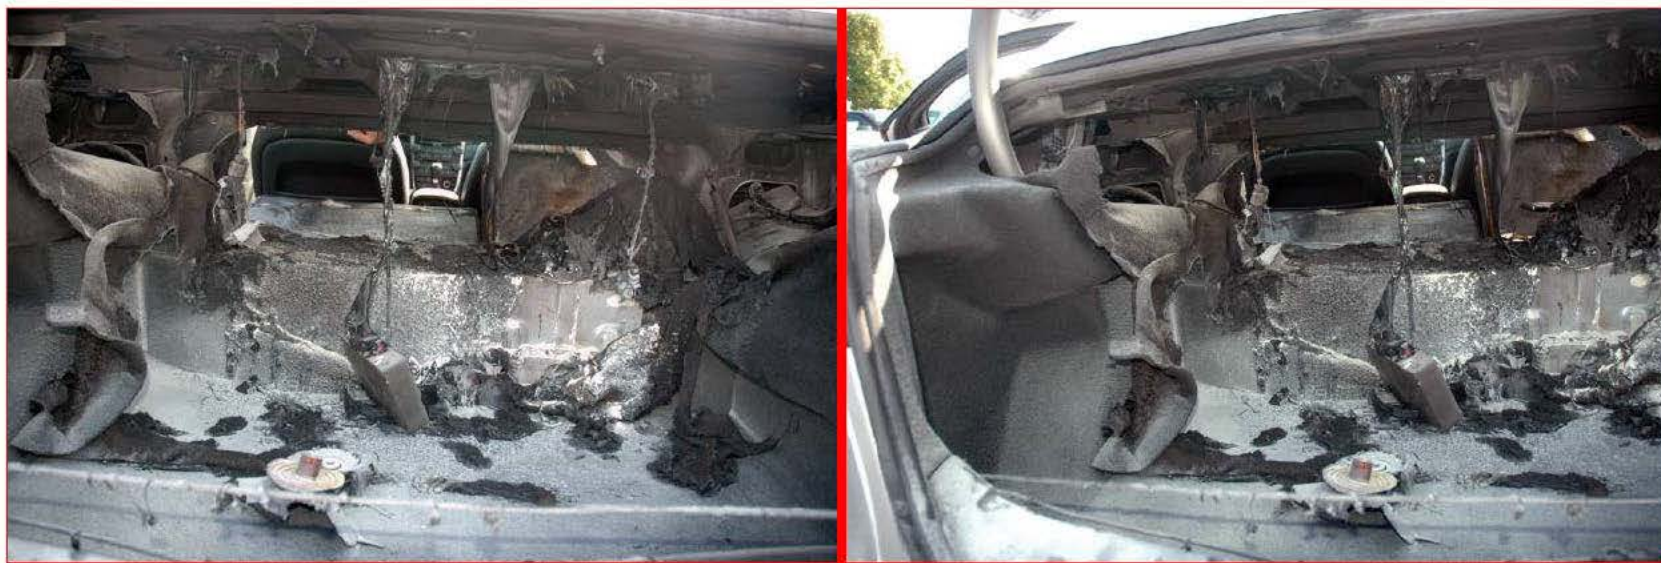
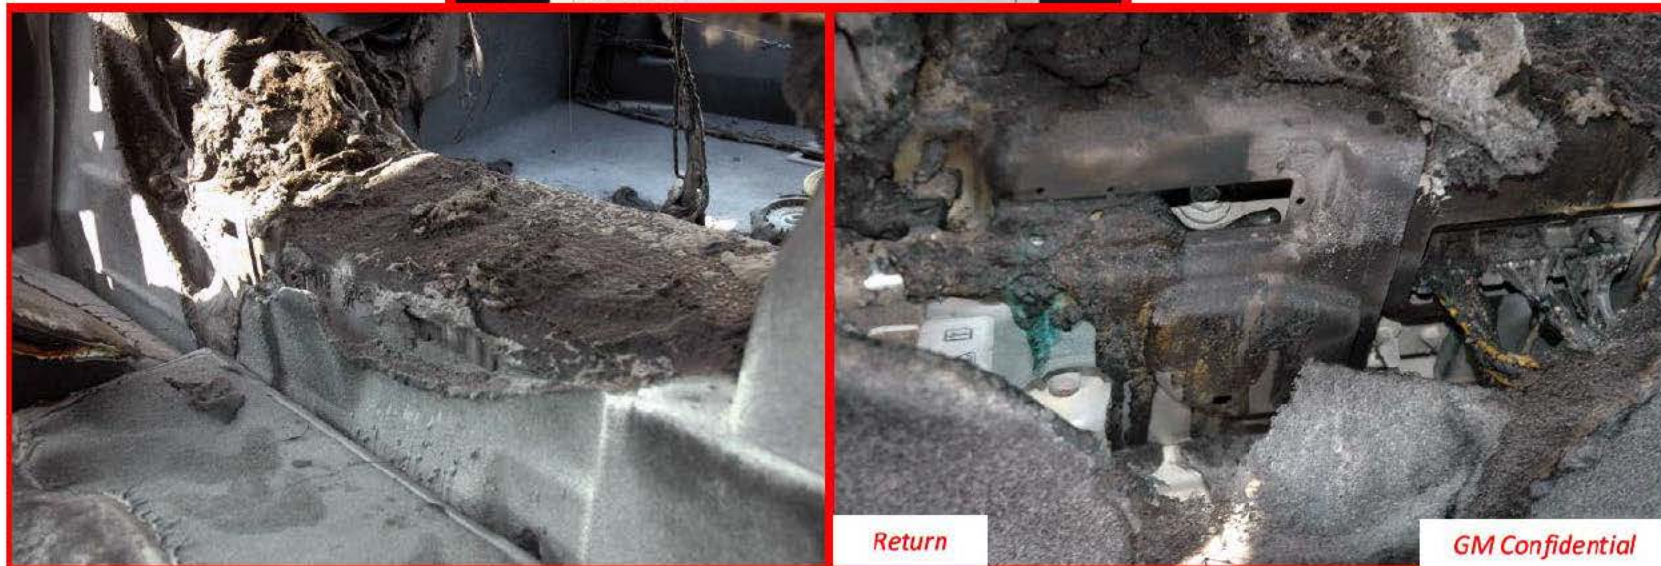
VEHICLE 2013 CHEV. MALIBU
VIN No. 1G11FSRROD8
PHOTOGRAPHER RON ORLANDO

- One at dealer that was investigated at MPG ([see photos](#)).
- Other from a normal warranty return
 - No external evidence and was replaced for a dash light and DTC.
 - GMCH found small burn spot on the cap board
