RQ13-004

HYUNDAI-KIA

RESPONSE TO REQUEST 8

# Elantra Touring CAB deployment verification test – (2/12/14)

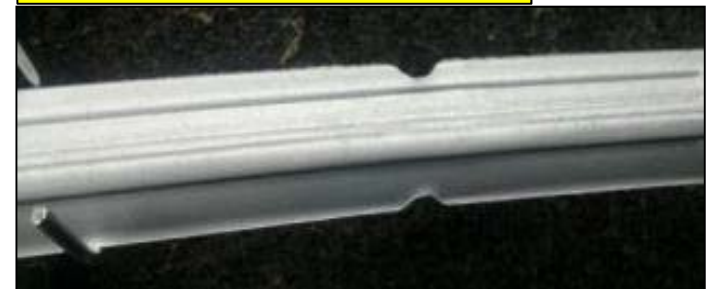
NG : Insufficient spray(overall)
