Analysis of Fuel Tank Leaks on Model Year 2003-08 Mercedes-Benz E-Class Vehicles

FINAL REPORT

December 2014

U. S. Department of Transportation
National Highway Traffic Safety Administration

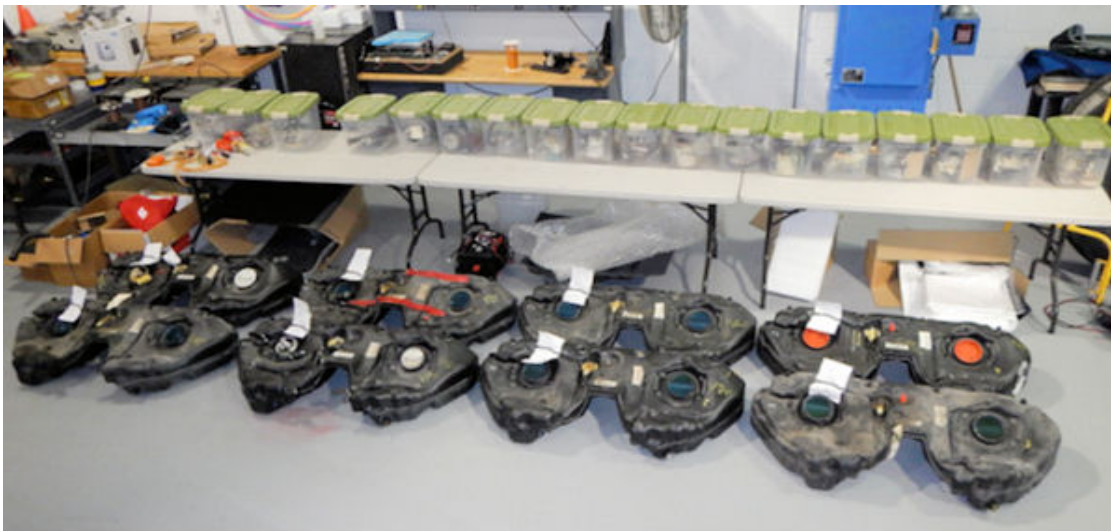
The fuel tanks, pumps, and filters collected during the analysis were marked with identifying information. The pumps and filters were stored in plastic bins. The collection of retrieved components is shown in Figure 1 below and listed in Tables 1 and 2 in Appendix 1.

Figure 1 – The Fuel Tank Components were Labeled, Inspected, and Photographed before Testing

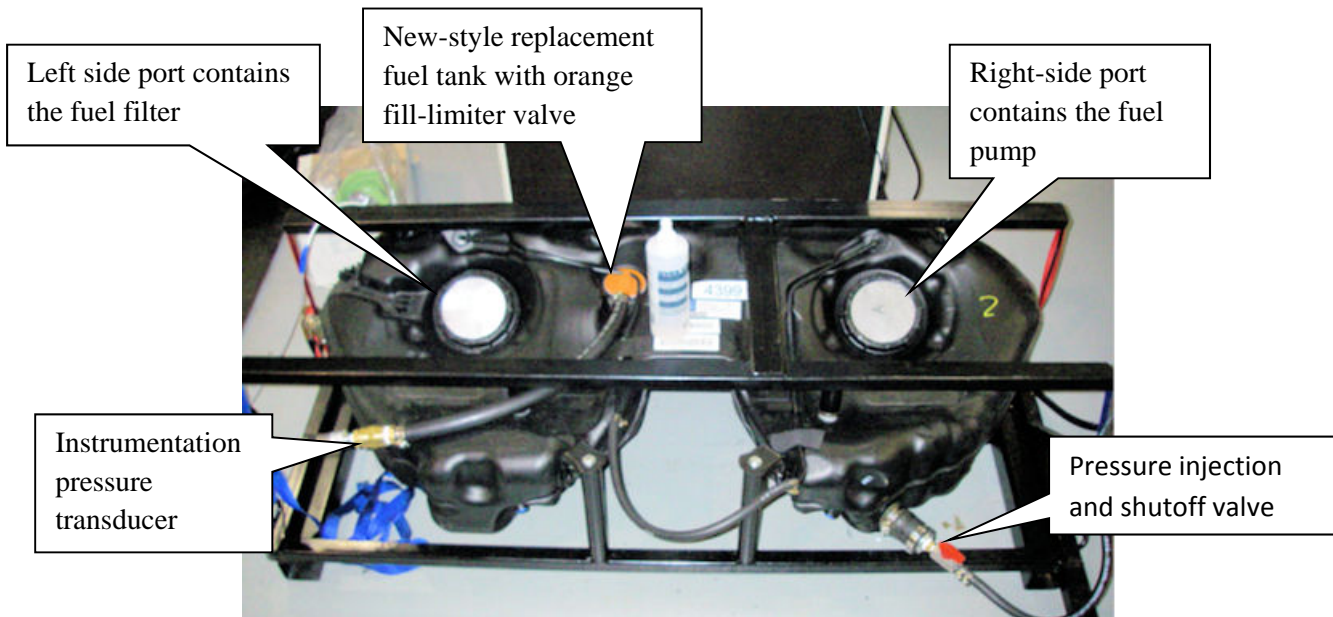
As shown in Figure 7, the bench test stand was outfitted with a pressure transducer at the large diameter hose connected to the fuel filling limiter valve, and pressure was injected at the large diameter fuel refilling port through a shutoff valve. The two small-diameter vent lines, from the top of each sidesaddle compartment, were sealed off and not used for pressure monitoring or injection due to possible flow restrictions from their long length and small diameter. However, one of these vent lines was used during tests to determine the pressure drop over 30 seconds with an orifice of a known diameter causing a calibrated leak. Figure 8 shows the leak orifice devices selected for use in this program to produce the major, minor, and micro leaks described previously. Figure 9 shows the tablet computer used for data collection and real-time display of the pressure in the tank.

Figure 7 - The Bench Test for Evaluating the Fuel Pumps and Filters Consisted of a New Side-Saddle Fuel Tank, with Pressure Monitoring (center port) and Pressure Injection with a Red-Levered Shutoff Valve (right port)

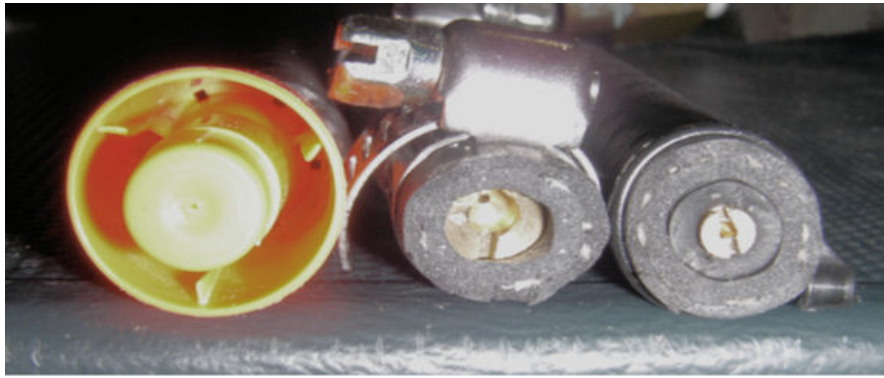
Figure 8 - Leak Orifices included a 1.0-mm Drilled Hole in a Plastic Cap, a 0.5-mm Carburetor Main Jet, and a 0.3-mm Carburetor Air Jet

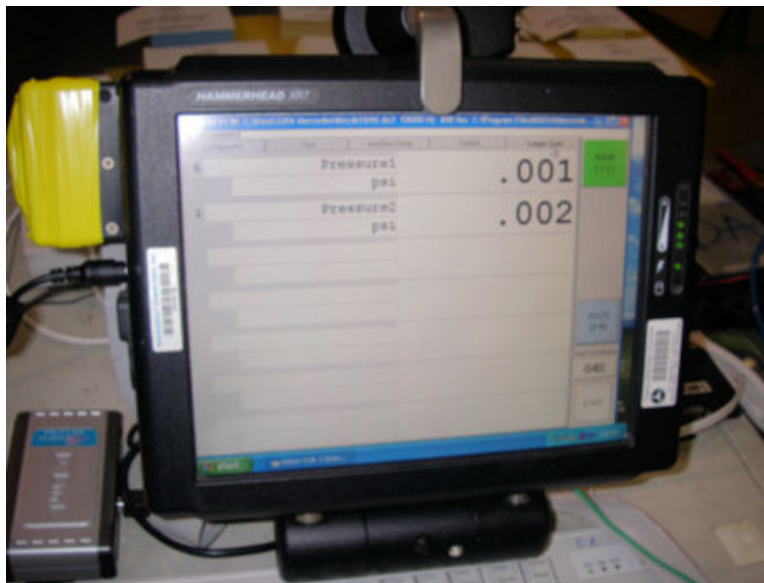
Figure 9 - A Tablet PC was used for Instrumentation Setup, Data Collection, and Real-Time Display of the Tank Pressure

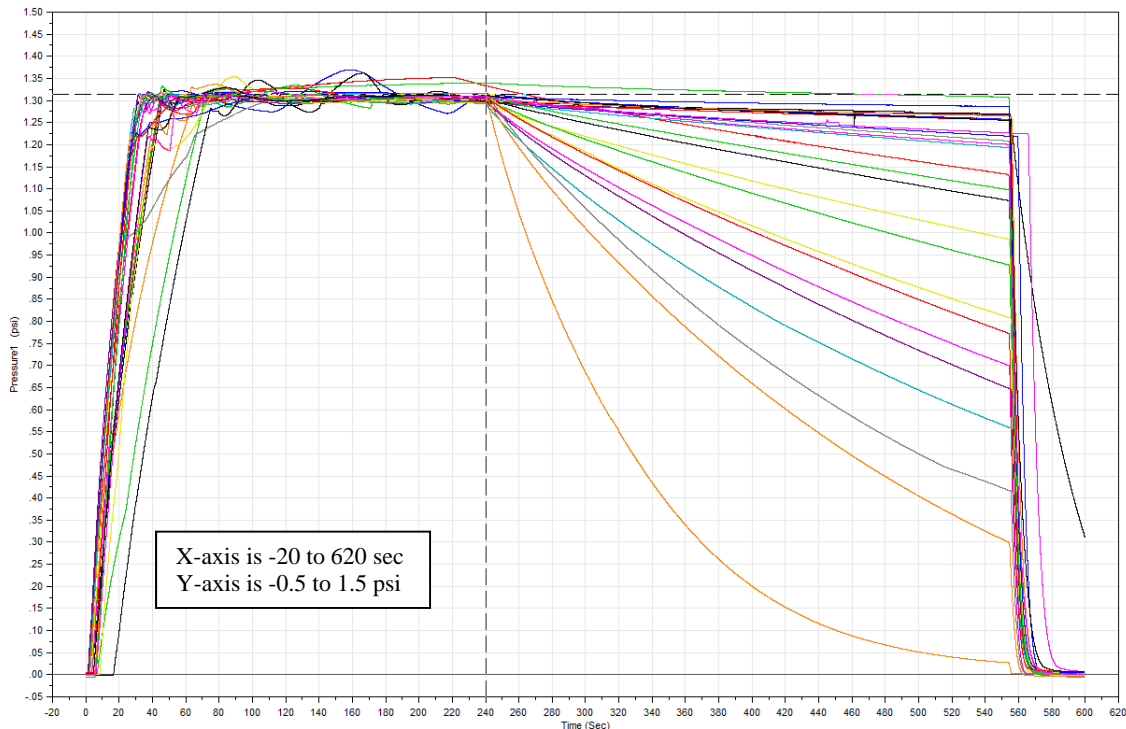
The data before 240 sec indicates the consistency of the manual pretest procedure. Data after 240 sec shows the resulting pressure decay for each test, which is dependent upon the amount of leakage in the component(s). These pressure decay traces include four threshold tests; three with the calibrated orifices discussed earlier, and one test with the new-style sealed fuel tank. These test results were used to grade (or evaluate) the leak rates of the collected components. More information on the development of the test procedure is shown in the Appendix 2.

Figure 10 - A Composite Time History Plot of all Final Procedure Test Runs

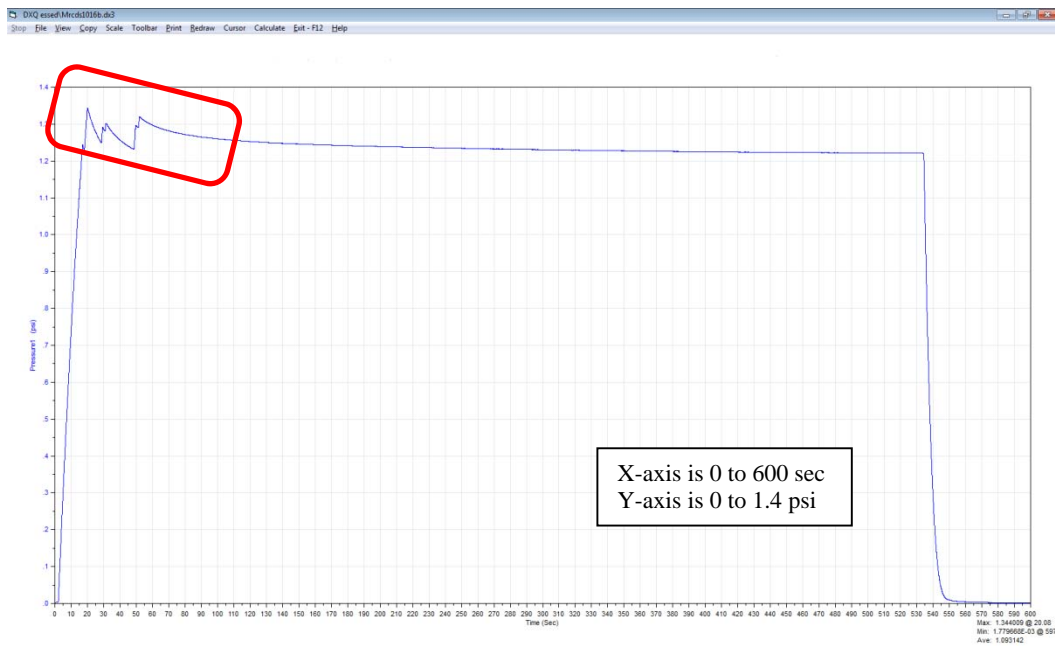
An early practice test run on the new sealed fuel tank, filled from a pressure cylinder, found that the injected pressure in the tank immediately dropped a significant amount and then the rate of pressure drop slowed to a near constant rate. Calculating the slope of this curved trace would not result in the true decay rate. In an attempt to produce a linear rate of pressure loss, the fuel tank was pressurized by opening and closing the shutoff valve multiple times. However, the pressure still dropped off, as shown in the time-history plot in Figure 15 for a sealed tank and in Figure 16 for a tank with a calibrated leak orifice of 0.3-mm diameter.

Figure 15 - During a Procedure Development Test Run, the New Fuel Tank was Pressurized Three Times from a Pressure Cylinder, and the Pressure Decay Rate did not Stabilize until after 60 Seconds

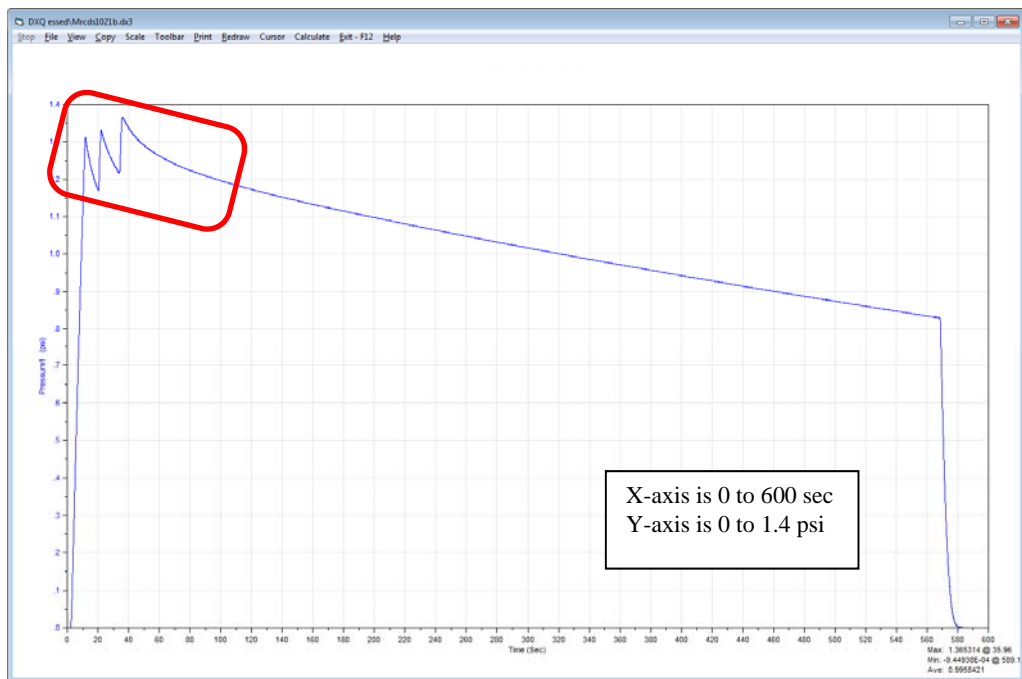
Figure 16 - Another Procedure Development Test Run with a 0.3-mm Diameter Calibrated Leak, the New Fuel Tank was Pressurized Three Times from a Pressure Cylinder, and the Pressure Decay Rate did not Stabilize until after 100 Seconds

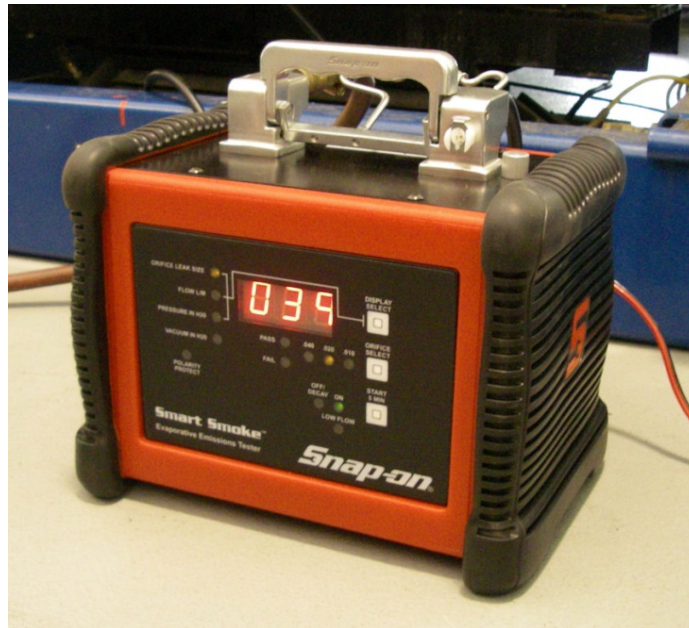
In another attempt to create a smoother pressure rate of change (or slope), a Snap-On smoke-leak and evaporative-emissions tester (Model EELD500), shown in Figure 17, was attached to the bench-test tank to observe the procedure used by Snap-On to conduct their automated 5-minute pass/fail test at 0.5 psi (35 hPa). After a small overshoot, the fuel tank pressure was stabilized just under 0.50 psi, held for four minutes, and then the pressure decay was allowed to occur and was monitored to establish the leak rate, as shown in Figure 18.

Figure 17 - The Snap-On Smoke Leak and Evaporative Emissions Tester Model EELD500

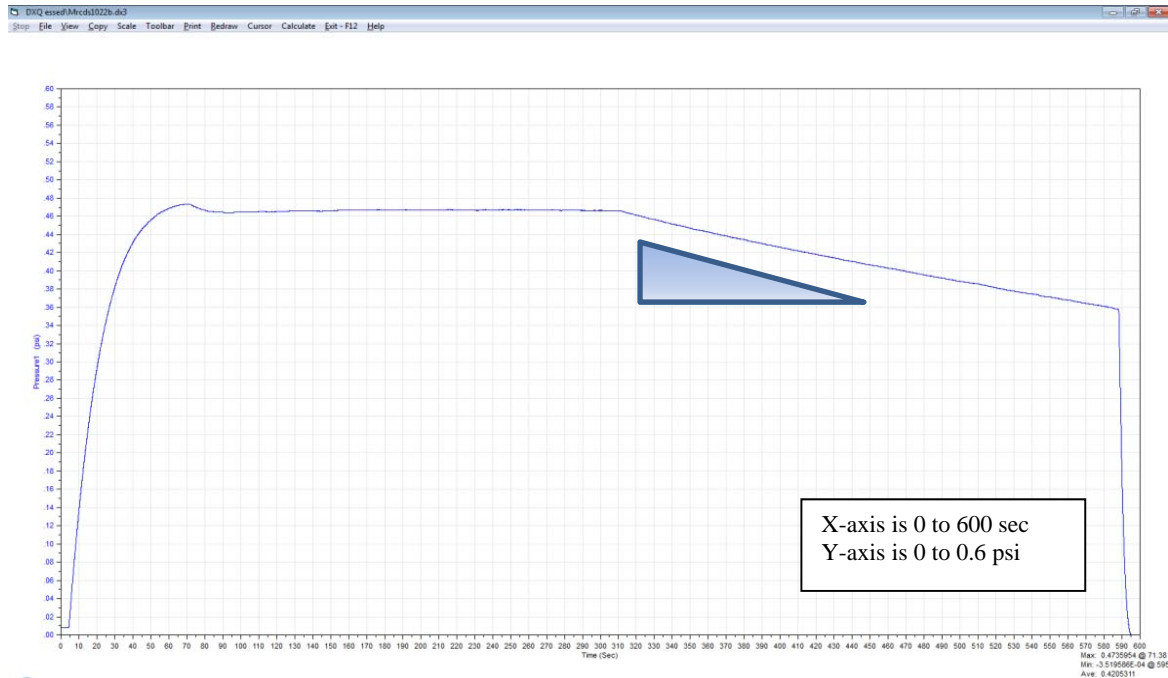
It was theorized that the plastic tank slowly swelled with the increased pressure and the four-minute hold period allowed the tank pressure and volume to stabilize. The exact pressure injection procedure used by Mercedes-Benz was not known. Since the Snap-On tester resulted in a steady pressure of only 0.46 psi (32 hPa), which was lower than the 1.23 psi pressure used by the manufacturer, use of this device was not pursued further, however a similar method of filling the tank with air was used, as described next.

Figure 18 - In an Attempt to Develop a Better Procedure, the Snap-On Evaporative Emissions Tester was used to Charge the Fuel Tank and found to be Pressurizing the Tank for 240 Seconds and then Monitoring the Pressure Decay for 30 Seconds

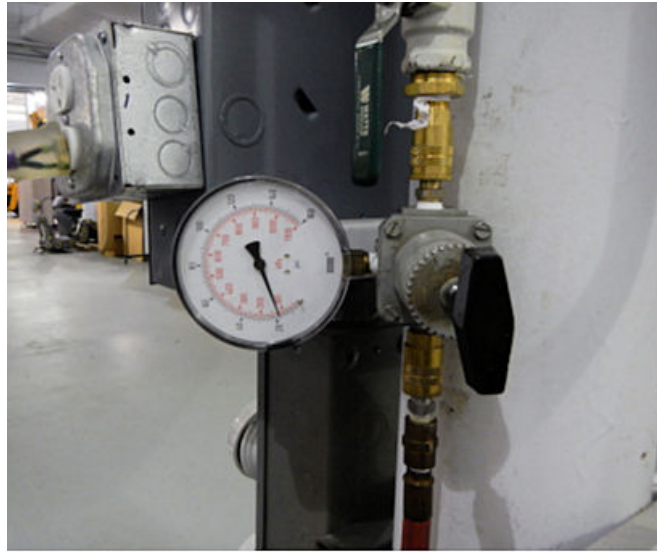
To accomplish this, the injection pressure was stepped down from the 120-psi shop air supply to 18 psi with a primary pressure regulator (Figure 19), and then the air passed through a 30-ft long hose to minimize temperature changes after the air expansion and pressure drop. A second regulator was used to reduce the pressure further to approximately 2 psi. In order to adjust the injection air as close to 1.32 psi as possible, two in-line hand-controlled valves were used to vent a portion of the injected air to the atmosphere, as shown in Figure 20. This allowed the injected pressure to be manually raised or lowered to hit the target pressure.

Figure 19 - The First Pressure Regulator was used to Drop the Shop Pressure to Approximately 18 psi

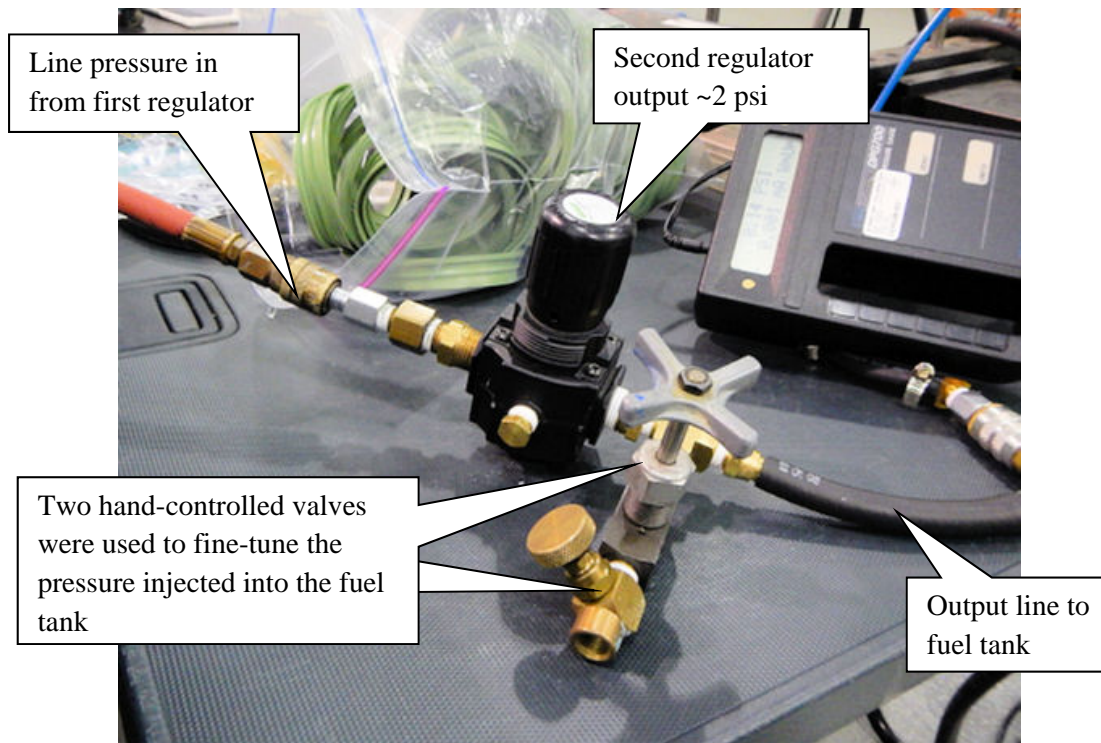
Figure 20 - A Second Pressure Regulator Dropped the Pressure to 2 psi and a Controlled Leak to Atmosphere was used to Manually Fine Tune the Injection Pressure to 1.32 psi for 240 Seconds
